MASS MOVEMENT AND STORMS IN THE DRAINAGE BASIN
OF REDWOOD CREEK, HUMBOLDT COUNTY, CALIFORNIA--
A PROGRESS REPORT

By Deborah R. Harden, Richard J. Janda,
and K. Michael Nolan

Open-File Report 78-486

Prepared in cooperation with the
National Park Service

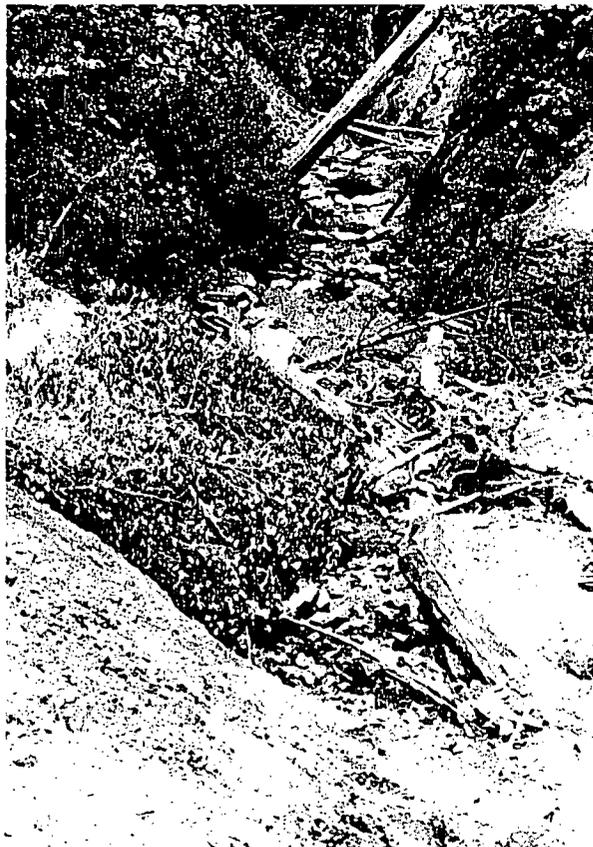
FIGURE 2. Photograph showing the interactions between streamside landslides and the stream channel in upper Lacks Creek. Channel is approximately 90 feet (27 m) wide.

Abundant streamside slides along tributaries of Redwood Creek are shown on the erosional-landform map (Nolan, Harden, and Colman, 1976). Field inspection indicates that these slides and similar features too small to show on the map can strongly influence the character of streambanks and channel at the site of sliding and in adjacent reaches. Streambank slides may expand by progressive lateral or headward failure. Stream deflection or aggradation caused by slide debris in the channel may also trigger new sliding on the bank opposite the initial failure and in downstream areas. Particularly massive slides may even block the channel completely and cause upstream aggradation and further instability. Thus, streamside instability can spread to upstream or downstream sites well away from the initial failure (fig. 2).

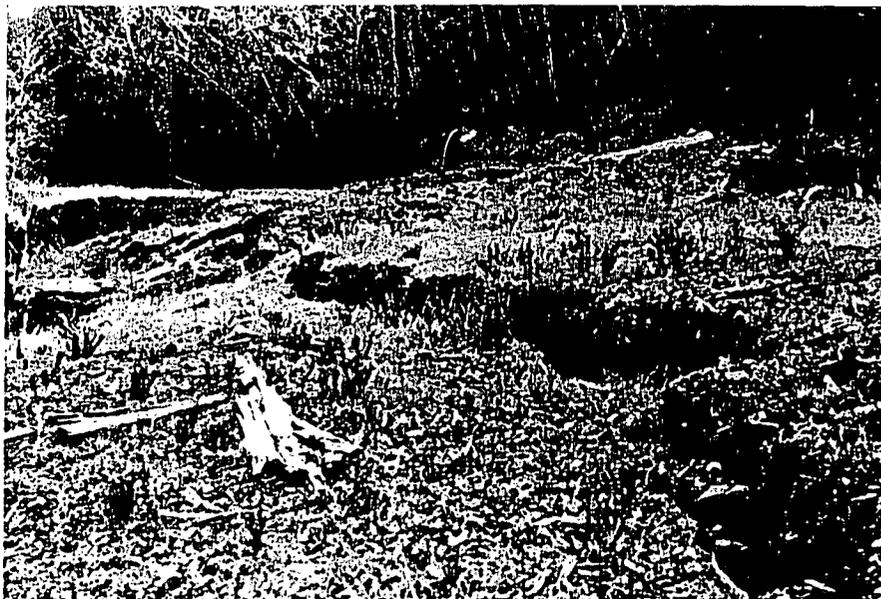
FIGURE 3. Photograph showing failure of old logging road adjacent to Redwood Creek along the present Bridge Creek Trail in Redwood National Park. The pull-away scarp is about 2-3 feet (60-90 cm) high. A photograph of this slide from Redwood Creek is shown in Figure 30.

Inspection of aerial photographs shows that active debris slides adjacent to Redwood Creek tributaries are most common near roads or in cutover areas. Field inspections in the lower basin revealed that roads adjacent to streams have caused some failures whose effects have extended downstream into the Park. Such a slide occurred where an old roadfill failed, along Forty-Four Creek just above the Park boundary, probably during a major storm in March 1975. This slide apparently dammed the creek temporarily and backed up sediment and debris behind the dam. The breaking of this dam led to rapid introduction of large quantities of poorly-sorted, coarse sediment and organic debris into parkland reaches of Forty-Four Creek. Deposition of the sediment and debris altered the habitat and appearance of the creek. A second example of the impact of roads on streamside instability in the Park is provided by the numerous failures along the old M-line which now serves as the Park trail from Tall Trees to Bridge Creek (fig. 3). Considering the large number of

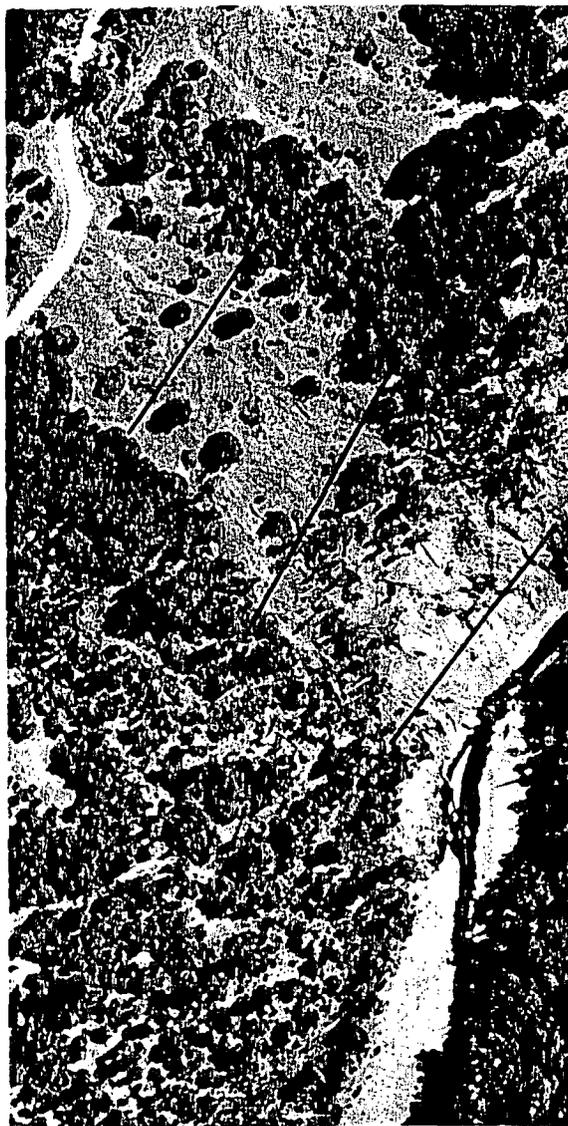
FIGURE 22. Aerial photograph showing mass movement monitoring Site 1, Poison Oak Prairie. Approximate scale 1:3,300. Photo taken September 1975.

The bottom stake line (line 3) transects the active, unvegetated streamside toe of the earthflow. On 1962 aerial photographs taken for the Humboldt County timber assessor's office, a logging road can be seen transecting this lower part of the flow; this road has been completely removed by sliding.

The south part of the middle stake line (line 2) is located in a relatively flat break in slope exhibiting ponded drainage and backward rotation of slump blocks. The north end is a steep, bare gully bounded by a steep lateral scarp. The end points of line 2 also extend into a forest with relatively few tilted trees.

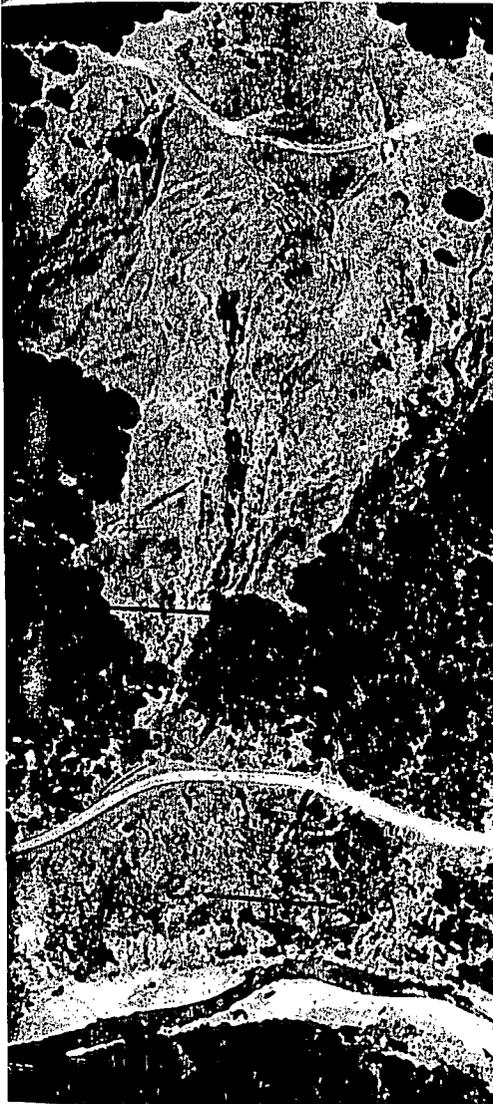
RE 25, (left). Aerial photograph showing mass-movement monitoring Site 3, in Gage earthflow. Approximate scale 1:3,300.

Sites 3 and 4, Rain Gage earthflow and Devils Creek earthflow, are active earthflows adjacent to the east bank of Redwood Creek between the mouths of Coyote Creek and Copper Creek (figs. 1, 21, 25, 26).

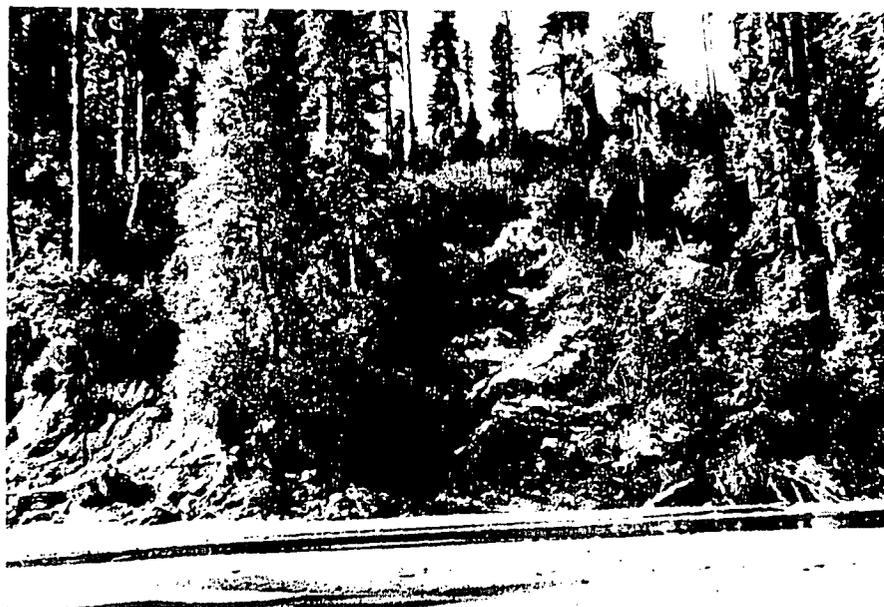
FIGURE 30. Mass-movement monitoring Site 8, Bridge Creek Trail slide. Approximate width of slide is 100 feet (30 m) wide. Ground photograph taken September 1972.

Two stake lines transect the slide. Line 1 is located at the top of the slide immediately below the scarp and line 2 is near the bare streamside toe.
