THE RESOURCES AGENCY OF CALIFORNIA
Department of Fish and Game

STREAM SURVEY

Name: Redwood Creek

Stream Section: From powerlines in Sec. 3 to Hwy. 299. Length: 15 mi.

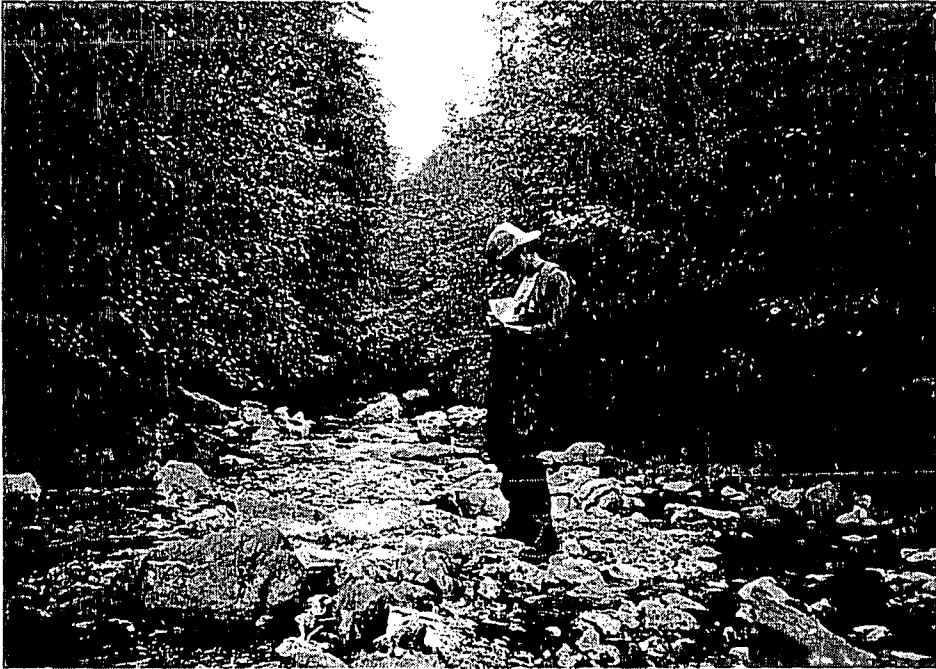
This section was typified by long low gradient riffle sections with very few pools. The bottom composition changed to about 40% boulders, that averaged 2' and ranged from 1' to 4', rubble 15%, cobble 10%, gravel 20%, sand and silt 15%. The wetted width of the stream increased to about 20', riffles were 4"d, and pools averaged 3'd.

Typical stream section
— just upstream of Pardee Cr.

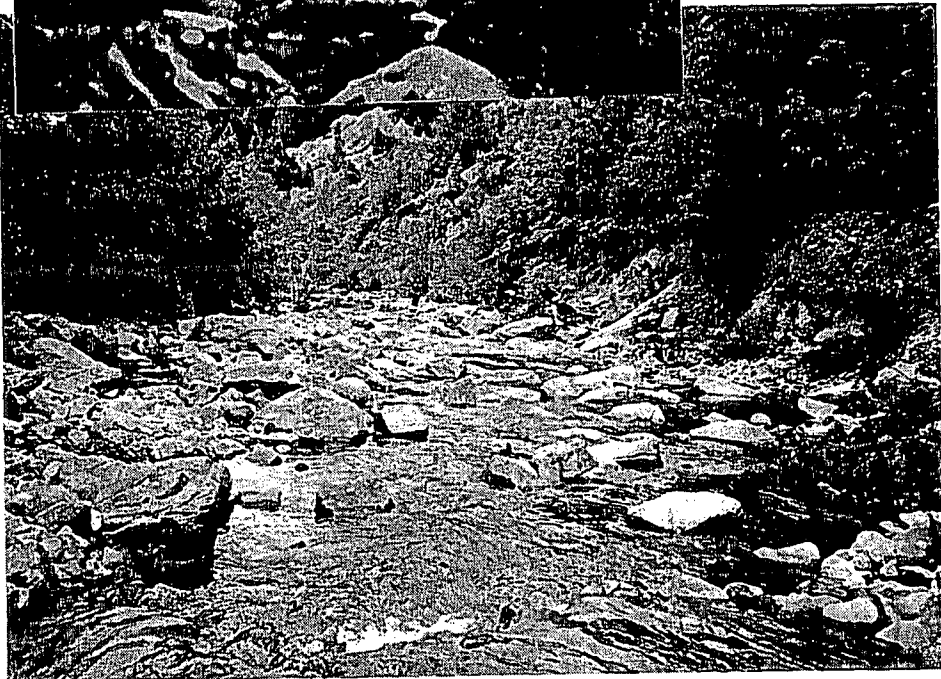
Much of the woody debris was stored on the flood terraces created in the '64' flood. Some of the terraces were 15' high. There were small log jams and woody debris accumulations in pools at 300 yd. intervals.

Typical stream section
downstream of Pardee Cr
Note gravel terrace on
right bank.

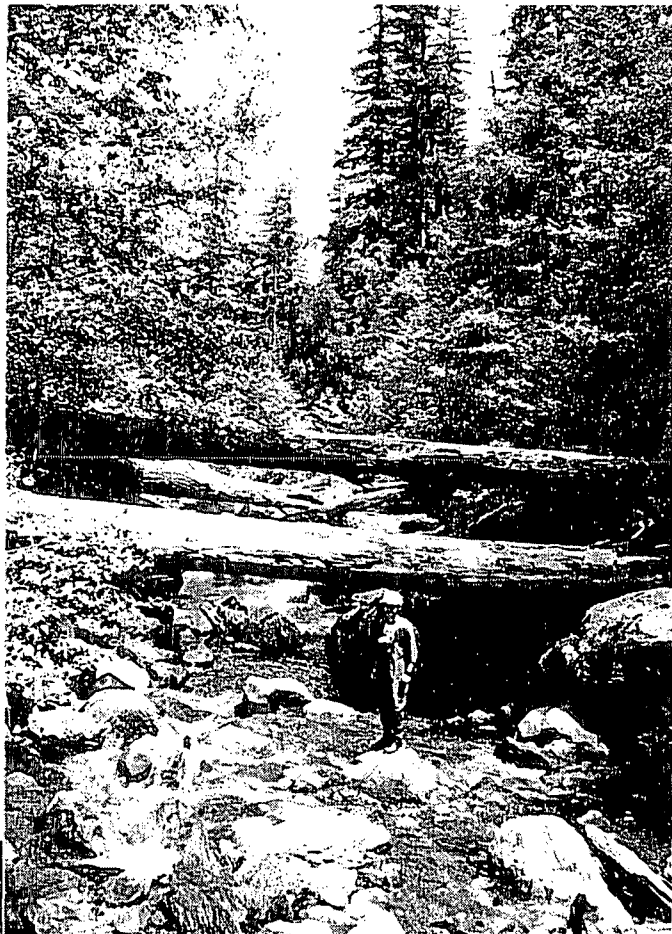
The stream channel in this section was generally steep and narrow with exposed bedrock and boulders dominating the channel. The wetted width averaged 10', bankfull width was about 30', and total channel was about 75' wide. Average riffle depth was about 3". Pools ranged from 2'w x 4'l x 1'd, to 15'w x 30'l x 3'd, and averaged 4'w x 10'l x 18"d.

Typical stream section
3/4 mile below powerlines
section 3.

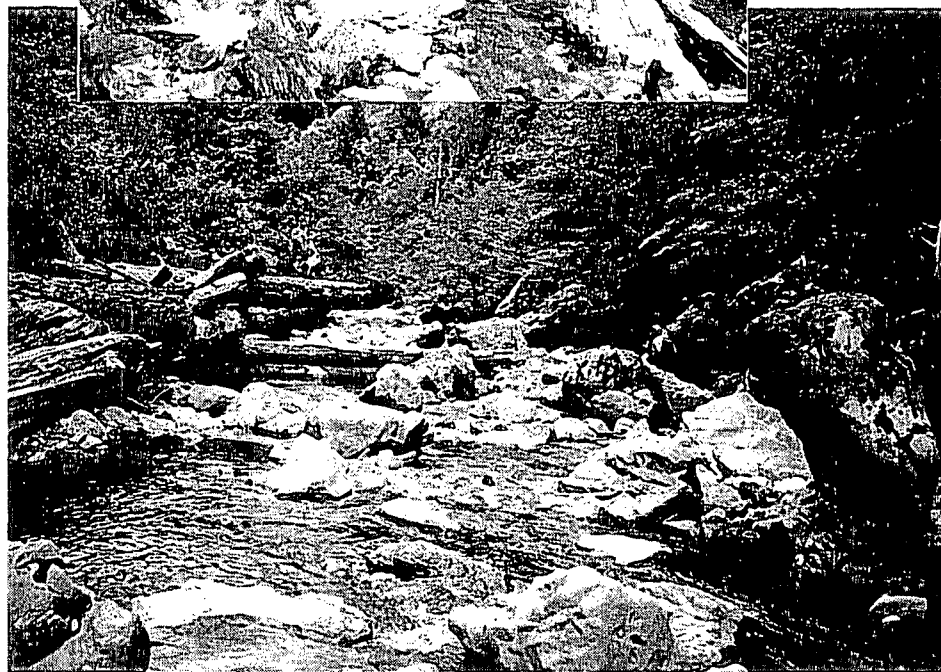
Typical stream section
— 1 mile below powerlines

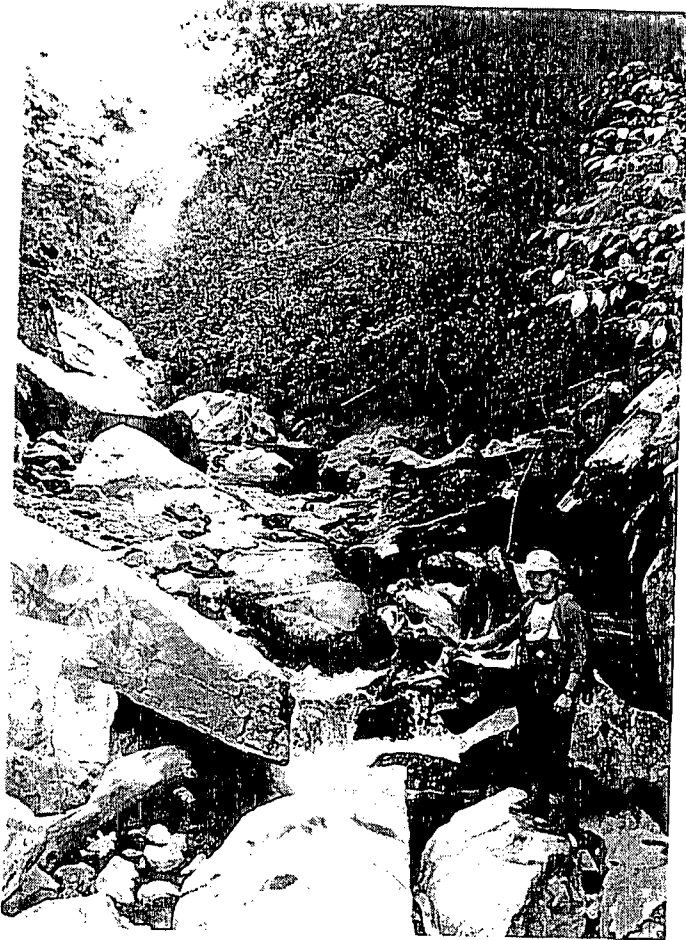
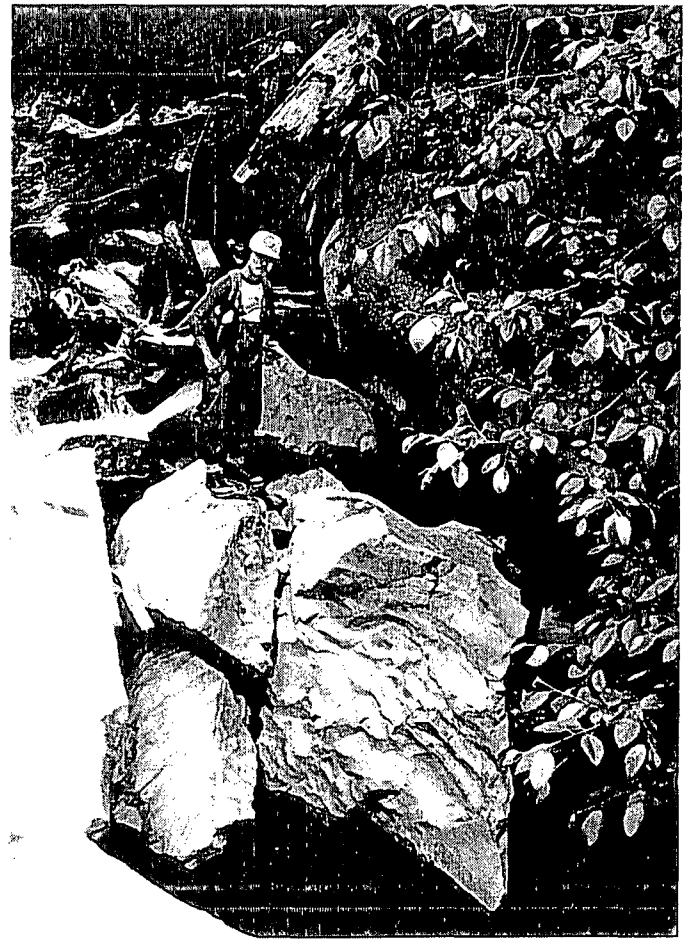
About 2500' above Pardee Creek was the beginning of a boulder roughs section that was about 1500' long. In the upper 1000' of the roughs the channel narrowed to about 40' w and the gradient increased to approximately 15%. Boulders ranged from 2' to 20' and averaged 10'. The falls ranged from 2'h to 10'h and averaged 4'h. Pools averaged 4'd, 15'w, 25'l. The flow cascaded over boulders from pool to pool. In the lower 500' of this roughs section the gradient decreased to about 6% and boulders decreased to about 3'. The roughs was a probable barrier to salmon but not to steelhead. There are two possible low flow barriers in this section.

Begin boulder roughs section 2500' above Pardee Cr.
Photos were taken with Esquivel (pictured) standing on
same rock. Not a Barrier.

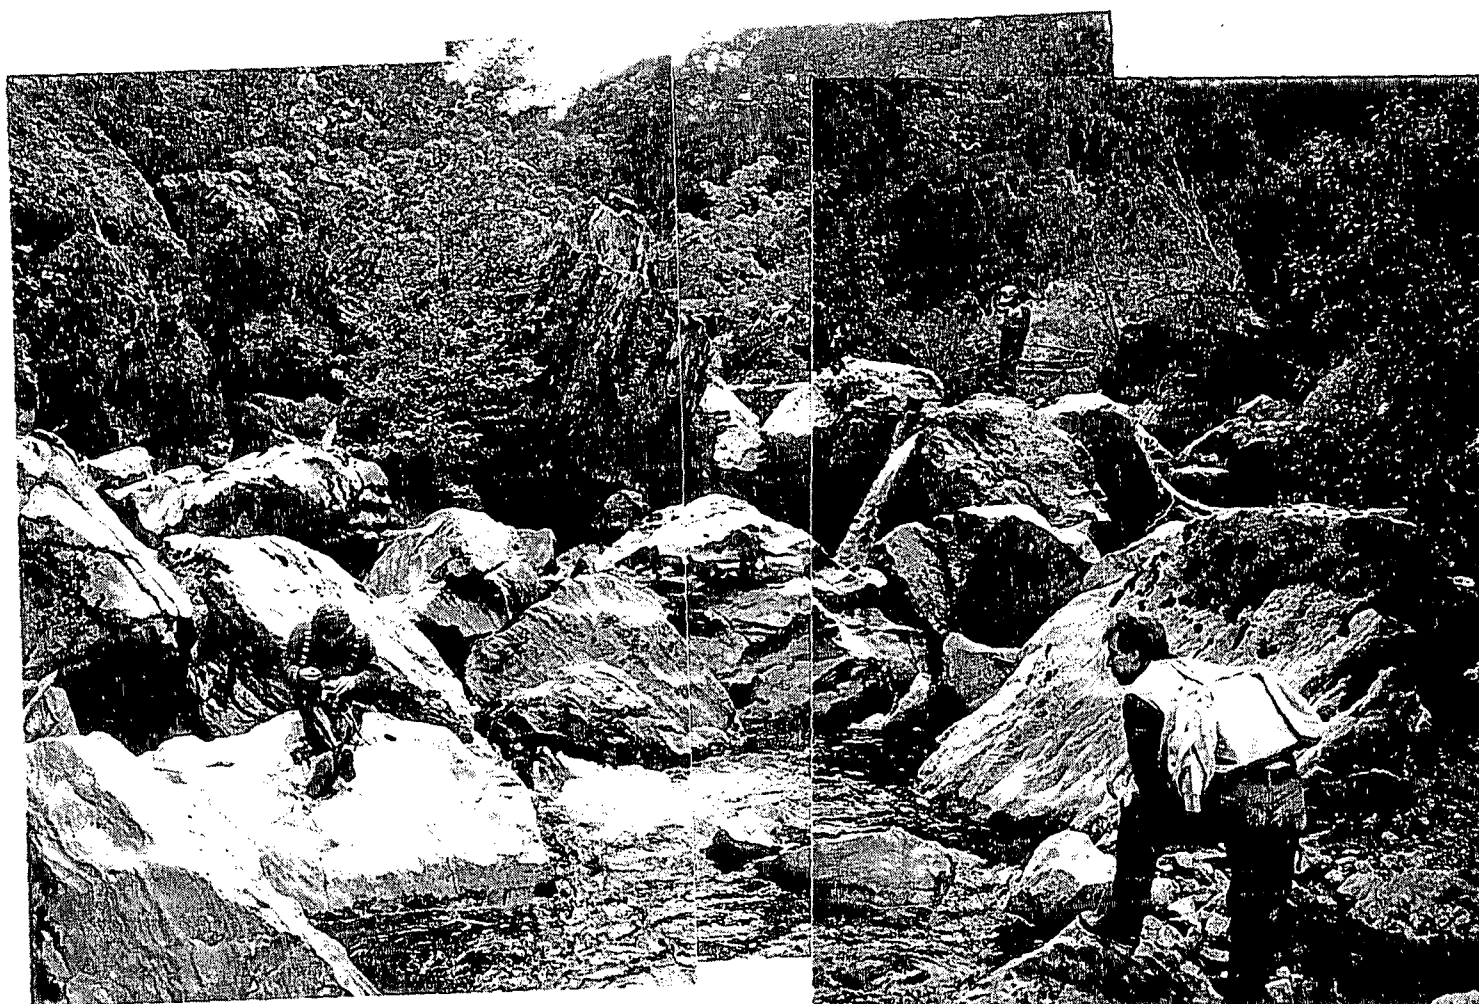
The boulder roughs section about 2500' above Pardee Creek, described in the text above, may be a barrier to salmon but not to steelhead. There is a 45' cascade, falls barrier mentioned in a 1972 survey around the section line between sections 10 and 15, T4N, R4E.

10' Boulder falls 2500' above Pardee Cr.
Probable Barrier to salmon

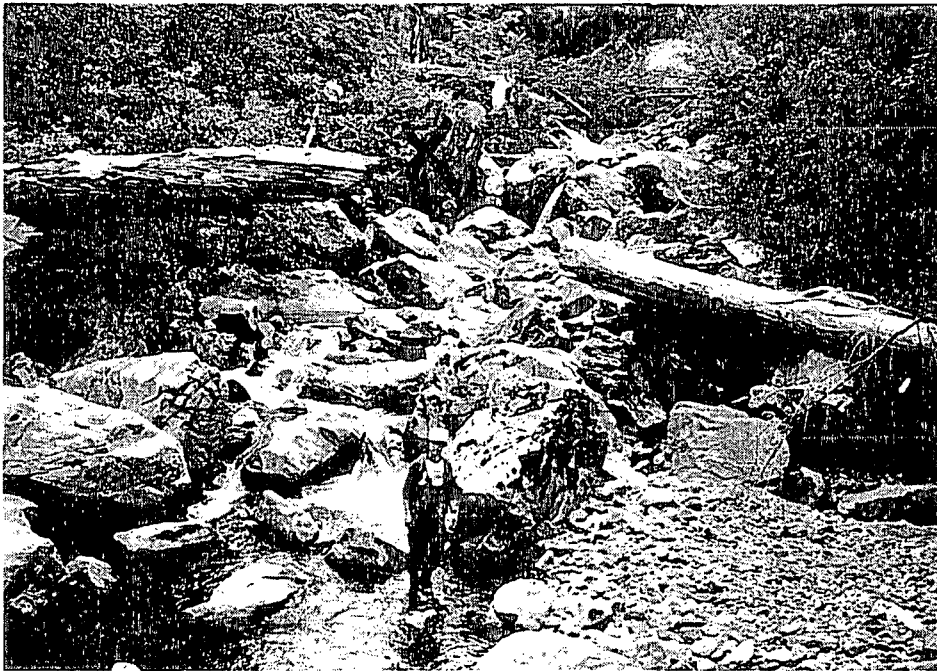
10' boulder falls shown in background.
"X" shows boulder pictured below.

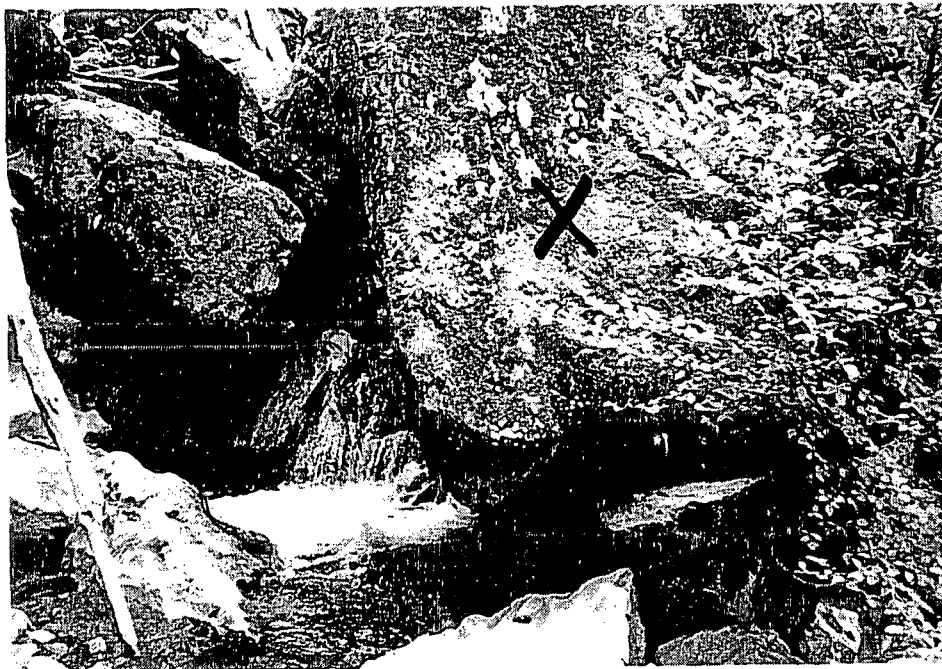
downstream view of 15' long chute on
left side of boulder. Alternate route around
falls.

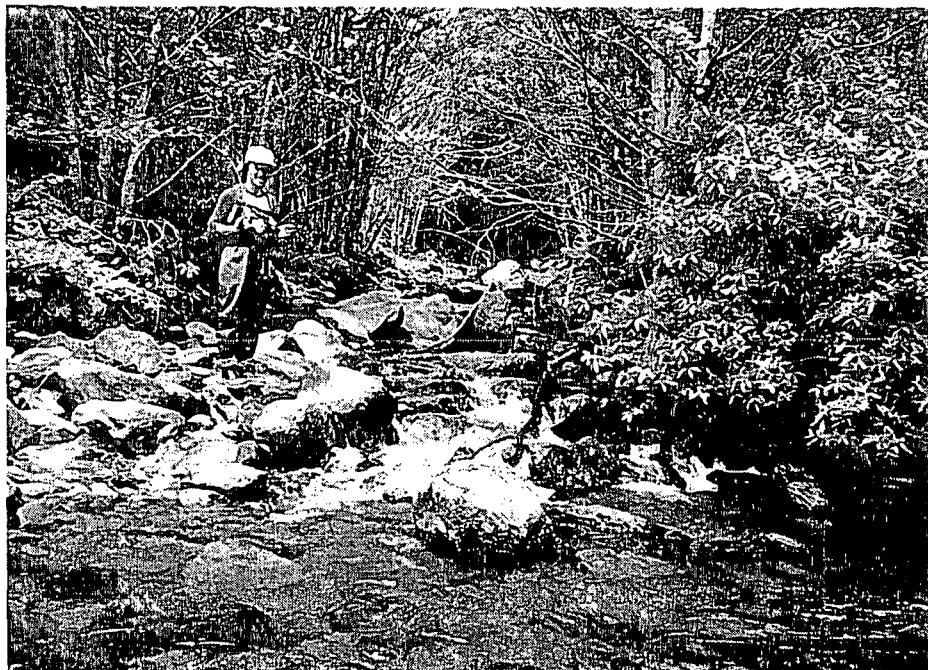
— Mouth of Bradford Cr.

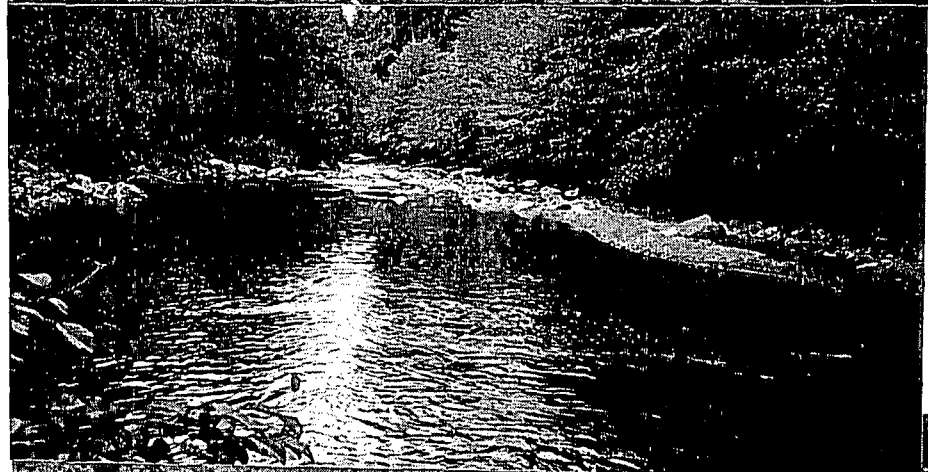
The stream channel alternates between low gradient riffle sections and narrow bedrock, boulder sections with cascading flow from pool to pool. There were many pools in this section and they ranged from 1-5'd, x 2-20'w, x 3-60'l. These pools provided good rearing habitat and spawning gravel was also good in this section.

Pool below the mouth of
— Bradford Creek.

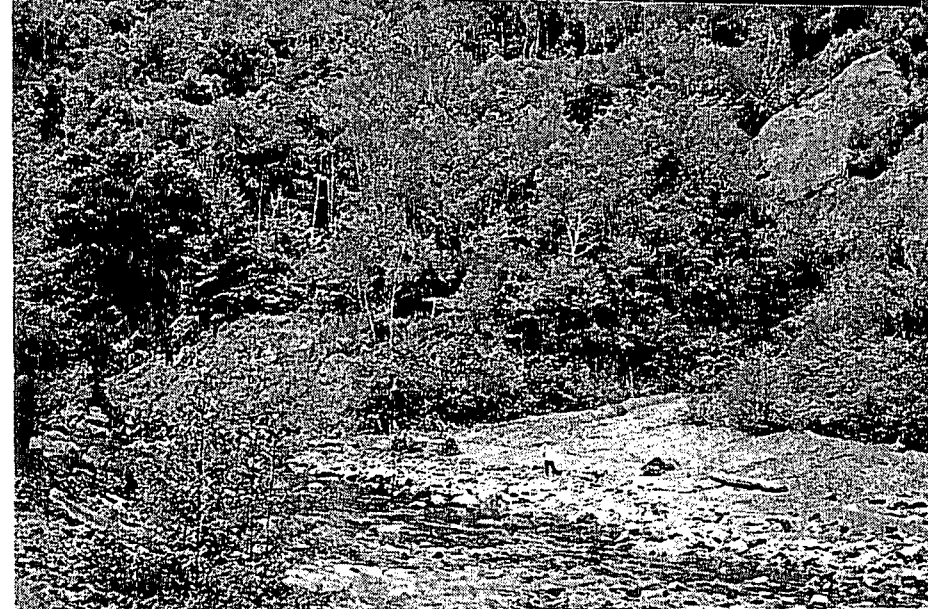
The second major slide in this section was located on the left bank about 1500' below the Ayers Cabin in section 7. It was about 200'w at base x 300'h. The toe was located about 125' away from the streambank. There was a alluvial fan of slide material that ran from the toe of the slide to the stream. This material is beginning to revegetate. The slide is contributing fines to the system.

Slide 1500' below
— Ayers cabin on right
bank

Redwood Creek should be managed as an anadromous stream. Slide stabilization and pool cover should be considered as high priority stream enhancement projects for this portion of the stream.

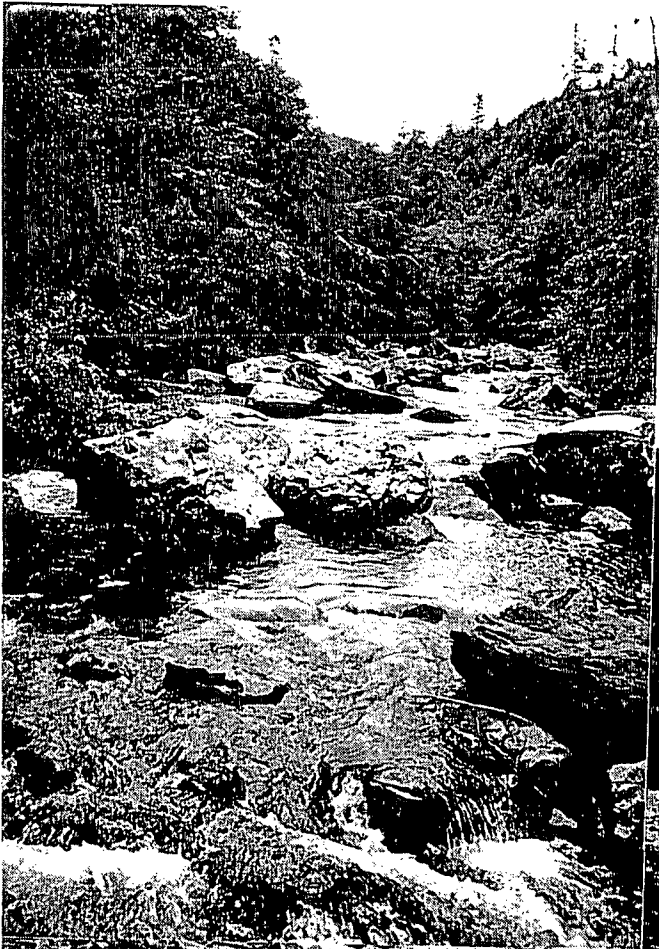
Typical stream section upstream
of Cool Spring Cr. in section 6.

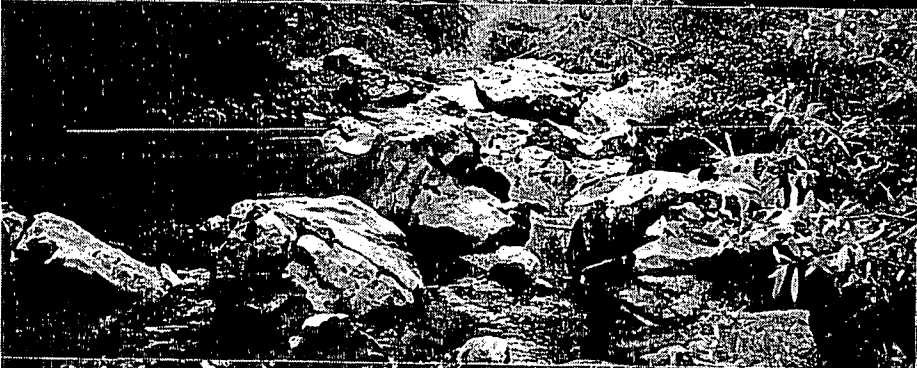
Typical boulder section
above Noisy Creek showing
slide on right bank.

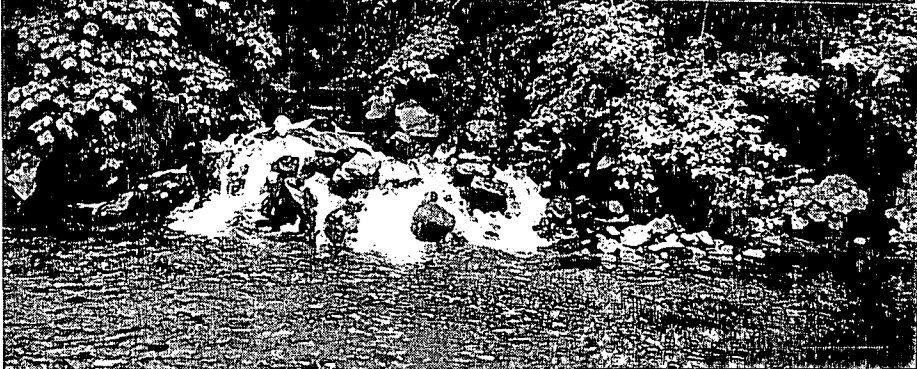
Mouth of Noisy Cr.
