STREAM CLEARANCE PROJECT - COMPLETION REPORT
NOYO RIVER, MENDOCINO COUNTY^{1/}

GERALD HOLMAN and WILLIS A. EVANS
Region 3, Inland Fisheries

^{1/} Submitted April, 1964.
Inland Fisheries Administrative Report No. 64-10.

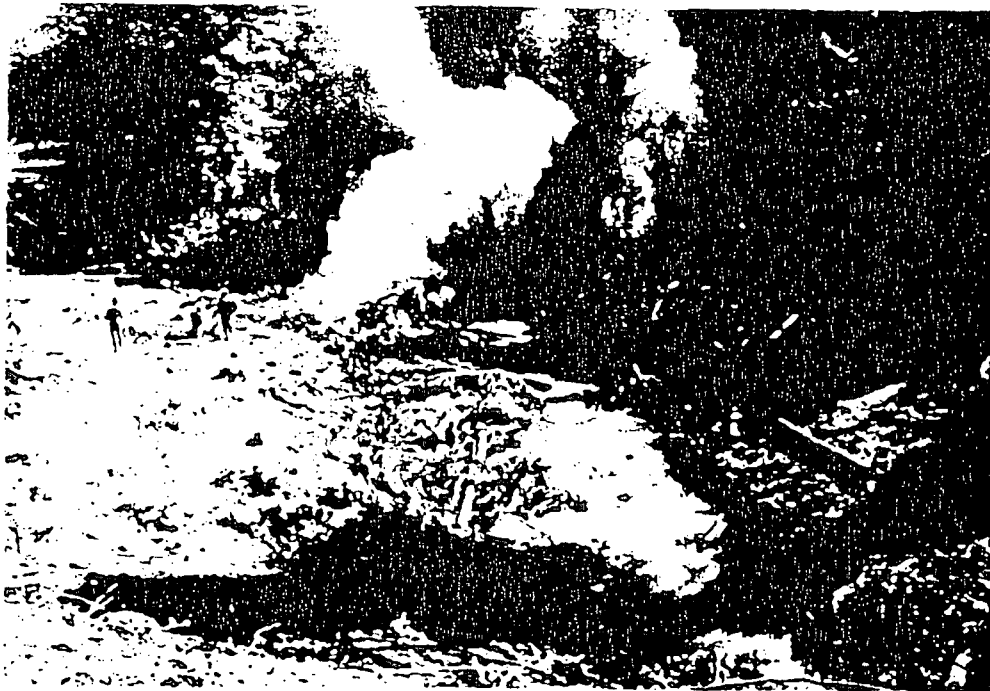
FIGURE 8. Crews clearing debris from Olds Creek, 1/2 mile above mouth. Photo by Gerald Holman, January 6, 1960.

It was found that large log jams could be removed readily using hand labor to start several fires on top of the jam. Small debris was added to the fires until they became well established. Attention by a few members of the crew was necessary to maintain the fires, but vast volumes of wood material were removed in this manner.

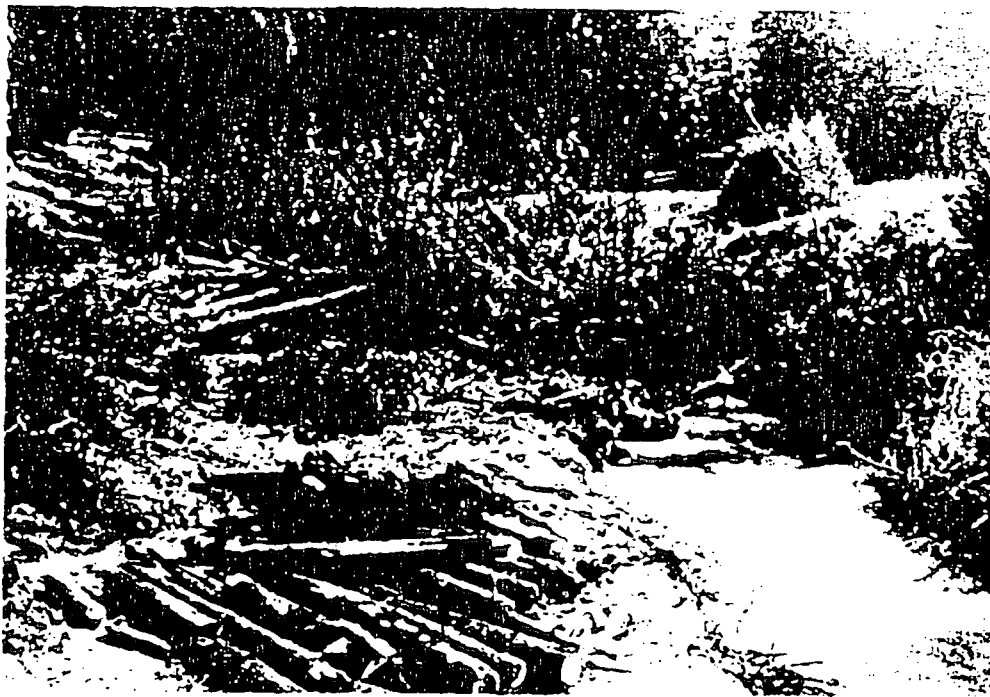
FIGURE 9. Contrast between cleared and uncleared area of Olds Creek, approximately 1/2 mile above mouth. Photo by Gerald Holman, January 6, 1960.

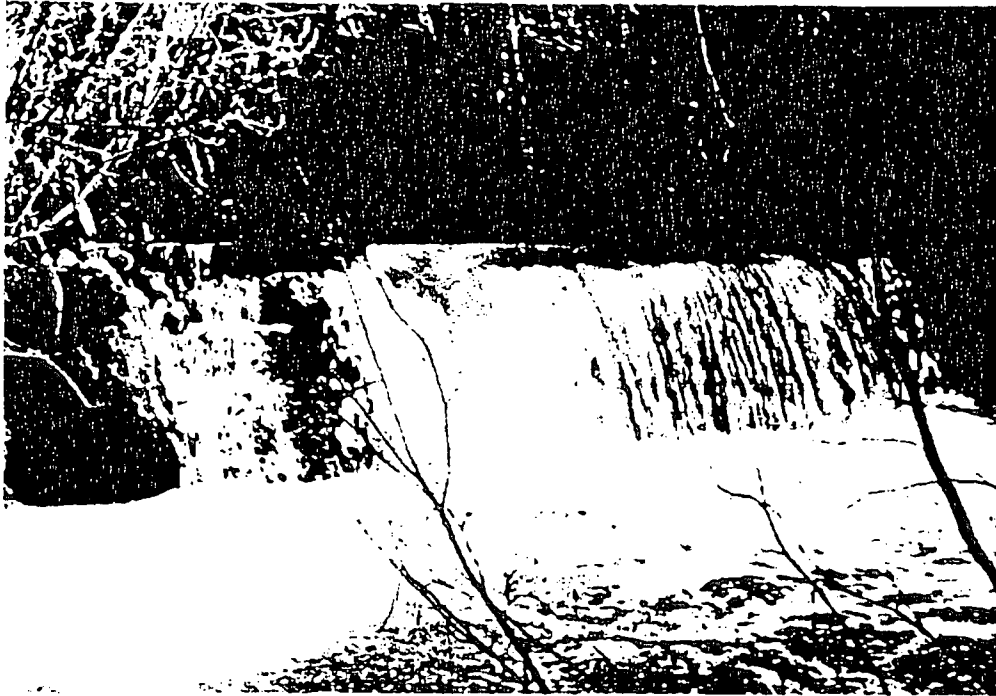
The abandoned six-foot high concrete dam on Olds Creek once served a sawmill at Irmulco. Only under certain flow conditions could silver salmon or steelhead ascend this dam.

FIGURE 10. Abandoned dam on Olds Creek, 1/4 mile upstream from mouth prior to correction. This was a partial barrier to upstream migration of fishes. Photo by Gerald Holman, January 6, 1960.

Barriers - There are many log jam barriers throughout the 3-mile section none of which can be considered fish barriers. Near the mouth exist a concrete dam with a vertical drop of approximately 6 feet which can be considered a barrier except during higher flows.

1. Removal of the concrete dam.
2. Removal of all log jams and debris to approximately 1/2 mile above the Irmulco Road crossing. By this removal the heavy overburden of gravels and silt will be allowed to flash downstream and the streambed will become more stable.
