A STUDY OF SOME WATER QUALITY  
CHARACTERISTICS AND POSSIBLE LOGGING  
INFLUENCES ON A SMALL STREAM ON THE  
NORTH COAST OF CALIFORNIA

A Thesis

Master of Science Graduate Program  
in Watershed Management,  
Humboldt State College, June, 1972.

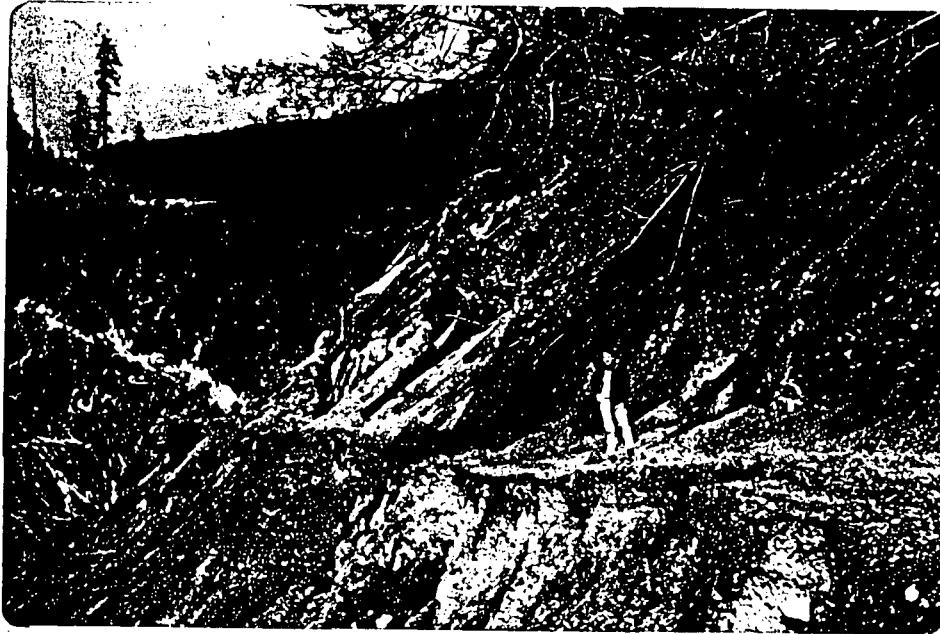
PHOTOGRAPH NO. 13

SLUMPED OUT PORTION OF MAIN ROAD

Photograph No. 13 shows another view of the main road. It can be seen that the road has almost entirely slumped into the stream channel. Removal of vegetation which holds soil in place on steep slopes may set the scene for disaster. Underground water and surface runoff then saturate fill material and soil. The soil can no longer support the weight

of the water it is holding, and mass movement occurs. This phenomenon may occur without removing vegetation.

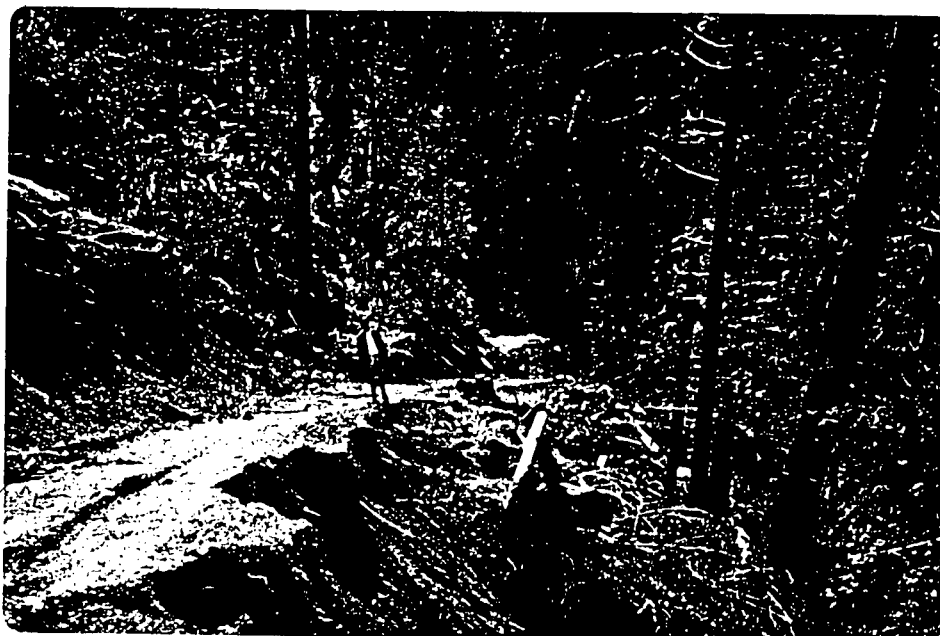
PHOTOGRAPH NO. 16

TREES BEING PUSHED OVER BY SOIL MOVEMENT

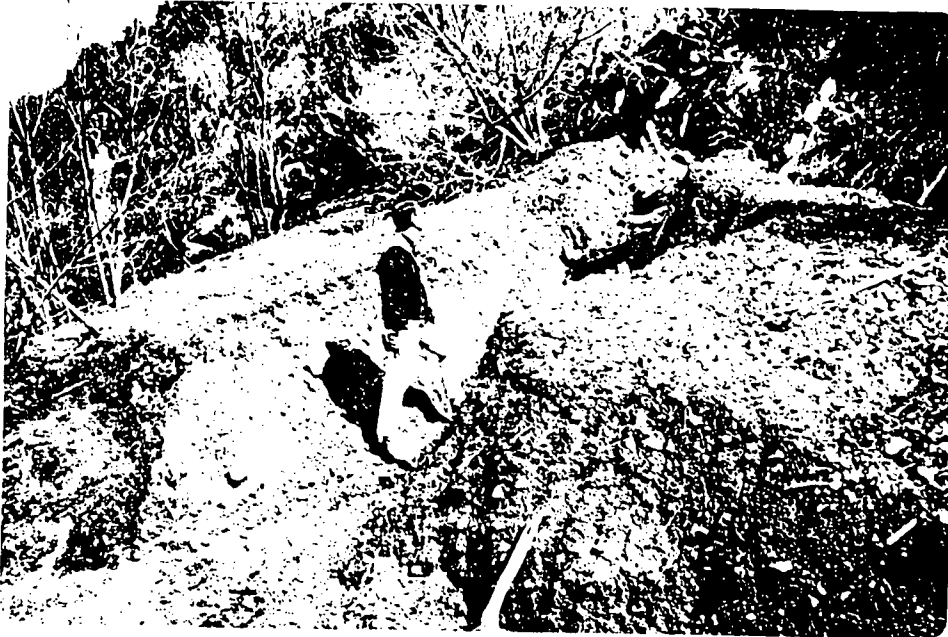
PHOTOGRAPH NO. 17

DEBRIS CONTRIBUTING TO TURBIDITY. MATERIAL IS WASHED OUT AND PILED IN DEBRIS CONES AT THE BASE OF SLOPES. THIS MATERIAL IS EVENTUALLY WASHED INTO JACOBY CREEK.
