Santa Rosa Creek Bacterial Contamination Investigation Report

**City of Santa Rosa, Sonoma County Environmental Health Department, and North Coast
Regional Water Quality Control Board**

December 2001

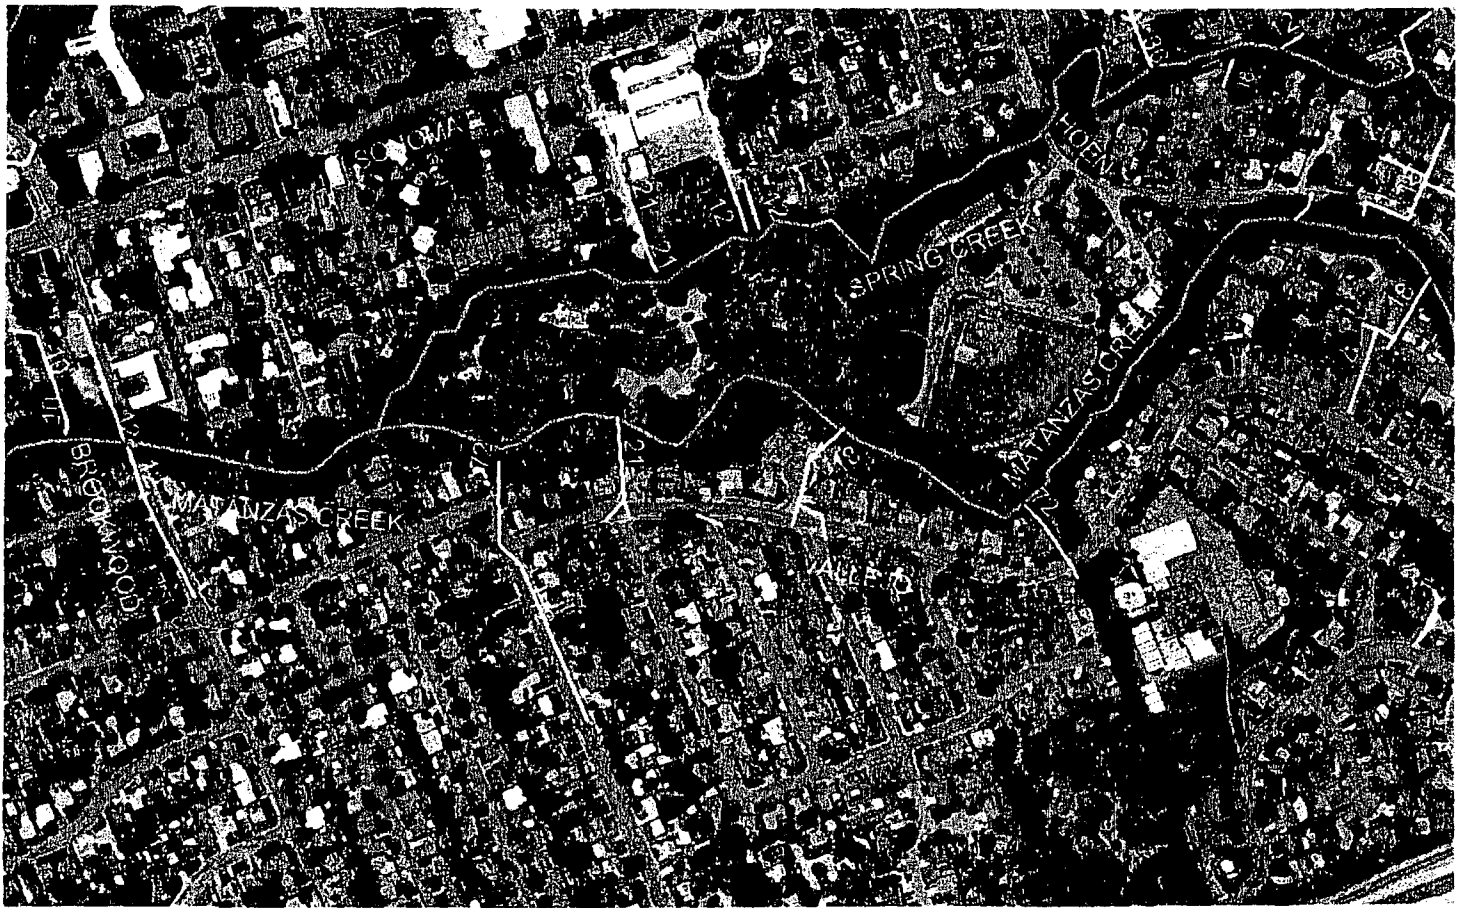
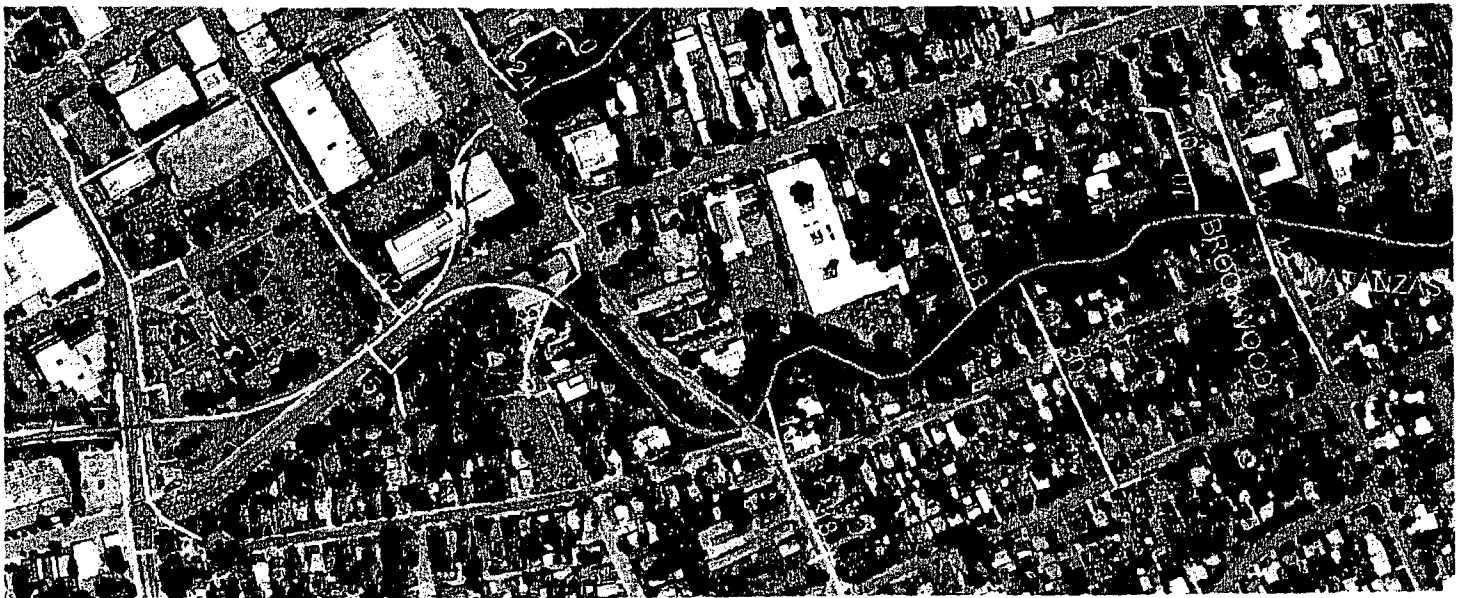
(Figure 4)

The field investigation for Matanzas Creek and Spring Creek from "E" Street to the upstream end of Doyle Park was conducted on July 31 (see Figure 4). The significant sources of bacterial contamination that were found included five incidences of animal fecal matter and two incidences of human fecal matter.

On August 14, several catch basins that drain into Matanzas and Spring Creeks were inspected by Alistair Bleifuss and Zephan Fischl. All catch basins inspected were either dry or had some moisture in them but none of them had flowing water.

MATANZAS CREEK "E" Street to Hoen Avenue

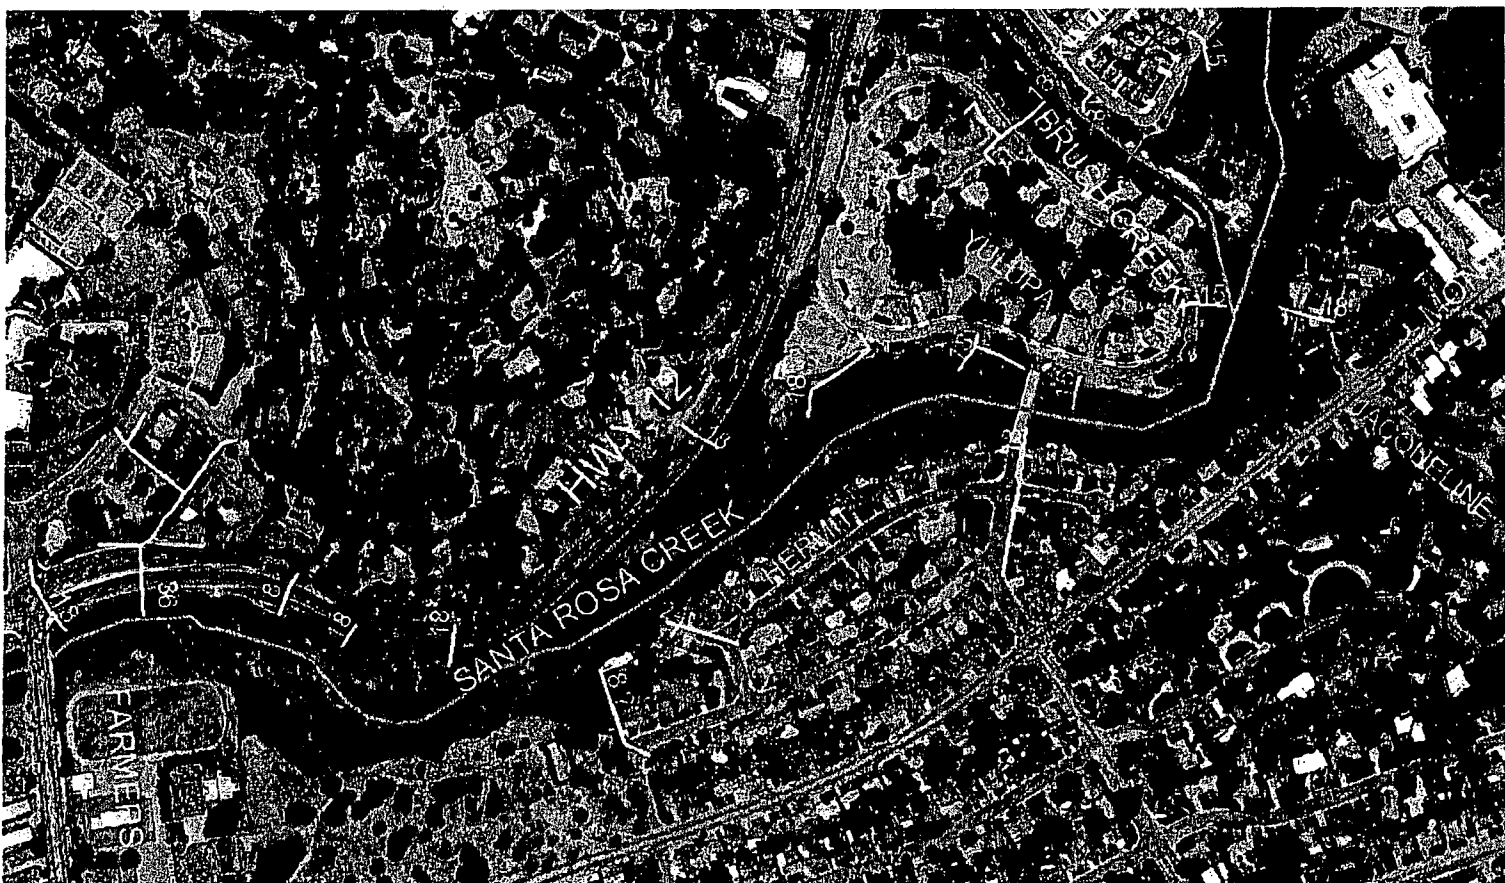
SANTA ROSA CREEK
Farmers Lane to Mission Blvd.
(Figure 5)

On July 27, Alistair Bleifuss, accompanied by Mark Mahre from the City of Santa Rosa Police Department, took water samples from Santa Rosa Creek above Farmers Lane (see Figure 5). Several homeless encampments are situated along this reach. Earlier that morning the City and County had conducted outreach to residents of encampments along this stretch of creek. Sampling was conducted upstream and downstream of the encampment area, with a third sample taken from mid-reach in an area identified by Mahre as the "bathroom area". The samples in this reach did not show elevated bacteria levels for any of the parameters tested except for enterococcus. The results, were lowest downstream of the encampment area and were lower than those found in the Greenway (see Table 1).

The actual field investigation for Santa Rosa Creek from Farmers Lane to Mission Boulevard was conducted on August 7. There were several incidences of toilet paper on the bank and a fecal odor was persistent in the "bathroom area" situated mid-reach. Conventional water quality constituents (pH, temperature, dissolved oxygen, and specific conductivity) were recorded at various sites and are included in the field notes. The investigation was called off approximately 1000' west of Mission Blvd. due to an injury incurred by one of the police escorts.

Since most of the outfall pipes in reach 4 were difficult to locate from the active channel, an additional investigation was conducted from the top of bank on August 13 by City employees Alistair Bleifuss and Zephan Fischl. They found that only one out of twenty-five outfall pipes had water flowing from it. On August 23 the City sampled this outfall which was a 24" storm drain line behind the Shadow Creek Apartments (Structure 35, City Storm Drain Map II-29-07). Bacteria levels were below California Department of Health Services guidance levels (See Table 1.)

The remainder of the Reach 4 investigation took place on September 24. There were several encampments situated along the remainder of this reach. The encampment underneath the Mission Blvd. bridge was rather elaborate with a garden area, shower, and a plastic bucket containing human waste. There was also an area nearby with some dense foam floating on the surface of the water that seemed to be unnatural. Water quality parameters were taken at this and other sites along the reach and are included in the field notes. On September 27 the City sampled the area with the dense foam and found that it exceeded some of the applicable standards but not to a large

On September 24, the 24" storm drain behind Shadow Creek Apartments was found to still be flowing at approximately 5 gallons/minute. After a thorough investigation, the City of Santa Rosa's Water Conservation Department found an irrigation leak at the Shadow Creek apartments and, by working with the apartment supervisor, was able to eliminate this significant discharge from the 24" storm drain.
