DEPARTMENT OF PARKS AND RECREATION

RE: Virgin Creek Sewage Spill

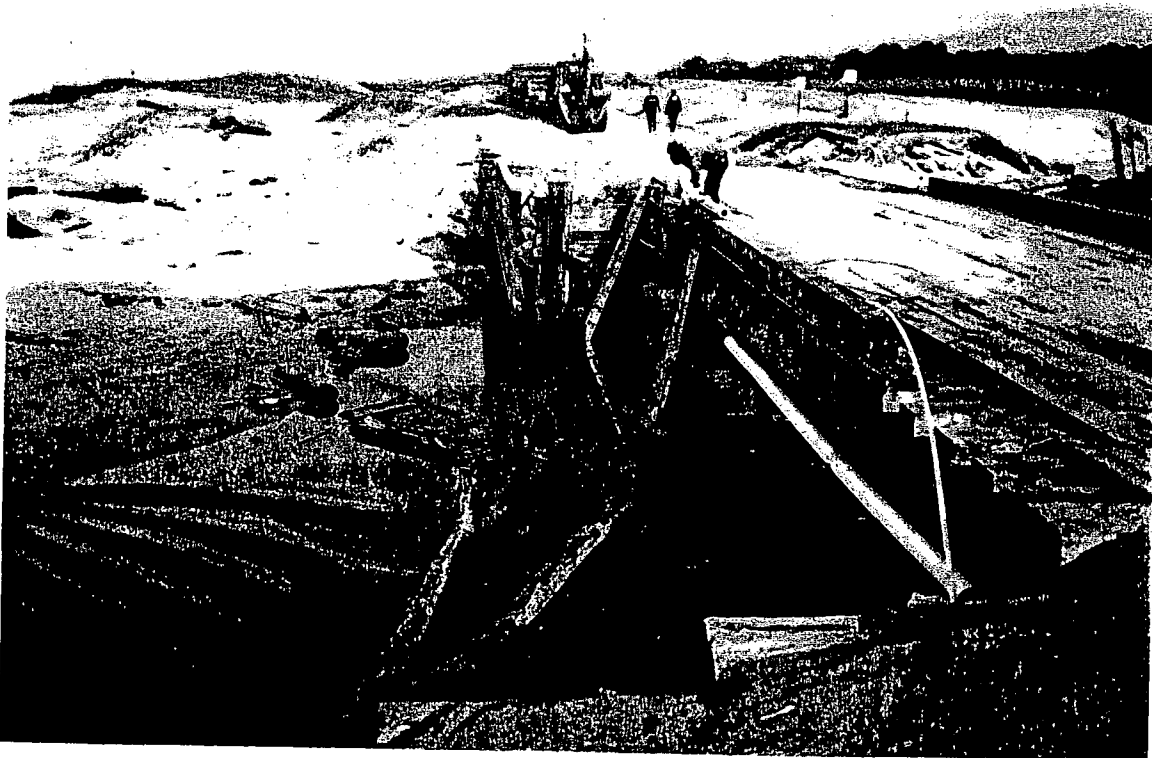
Virgin Creek, MacKerricher State Park. Site of broken sewer force main.
(Looking north)

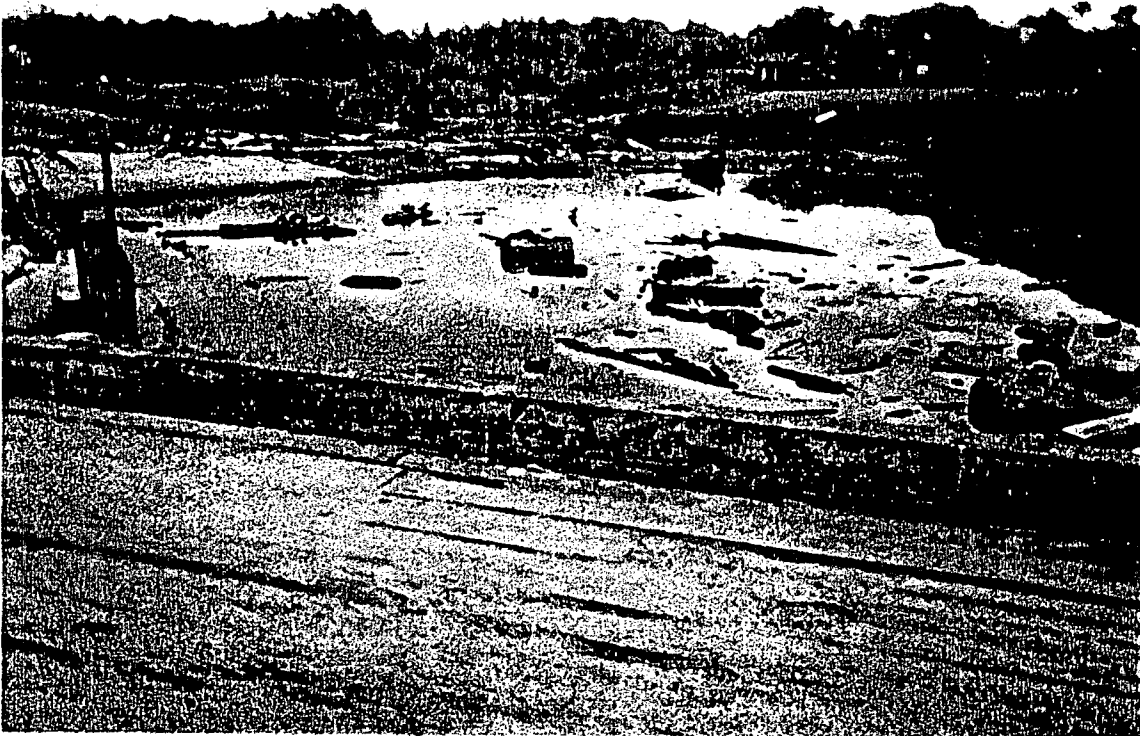
View to the east from Wooden bridge across Virgin Creek.

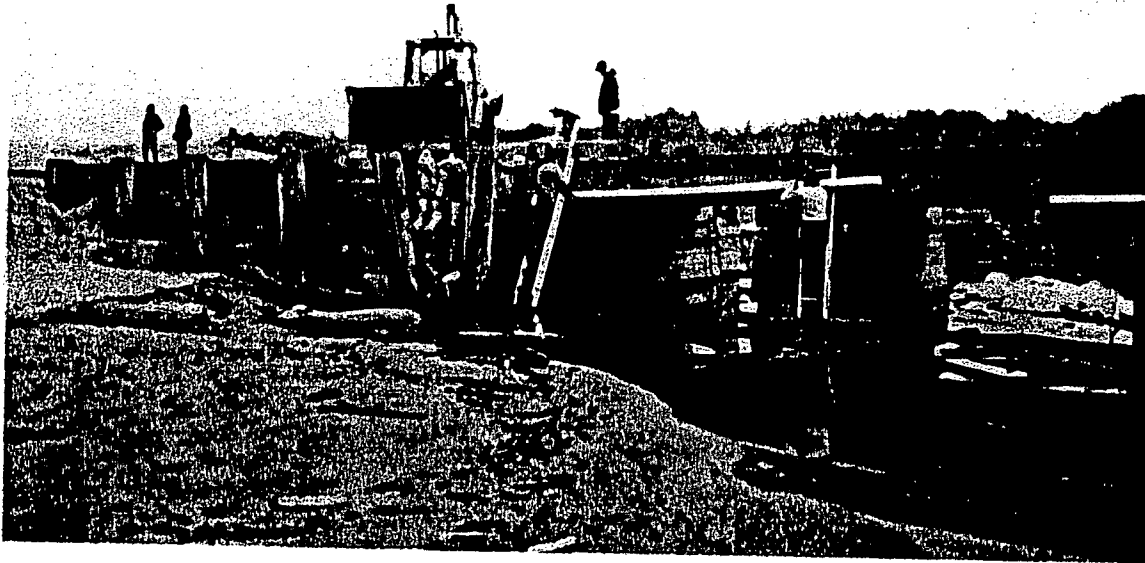
Park Maintenance employees replacing broken section of 4-inch PVC sewer force main at MacKerricher State Park.

On Wednesday morning, December 27, 2,000 samples of Virgin Creek water, were collected according to directions from Charles Reed of the Regional Water Quality Control Board and submitted to Alpha Analytical Laboratories in Ukiah. Repairs to the force main were completed that afternoon and the lift stations returned to normal operation. Additional work on the force main included securing it to the bridge framework. Also, the repaired section of force main was not encased within a metal pipe, as before. Instead, the main was encased in a wooden box made of 4"x 8" redwood boards to protect it.

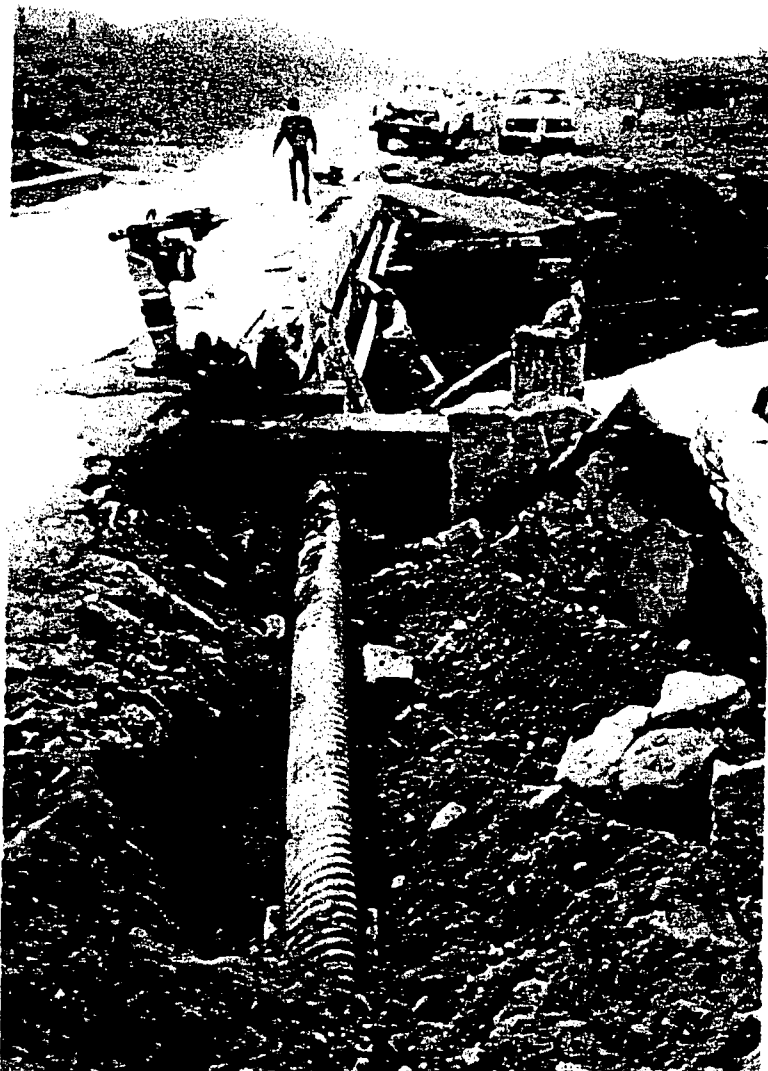
View, looking south, of sewer main repairs in progress. Section of corrugated metal pipe in foreground that encased force main where it crossed bridge.

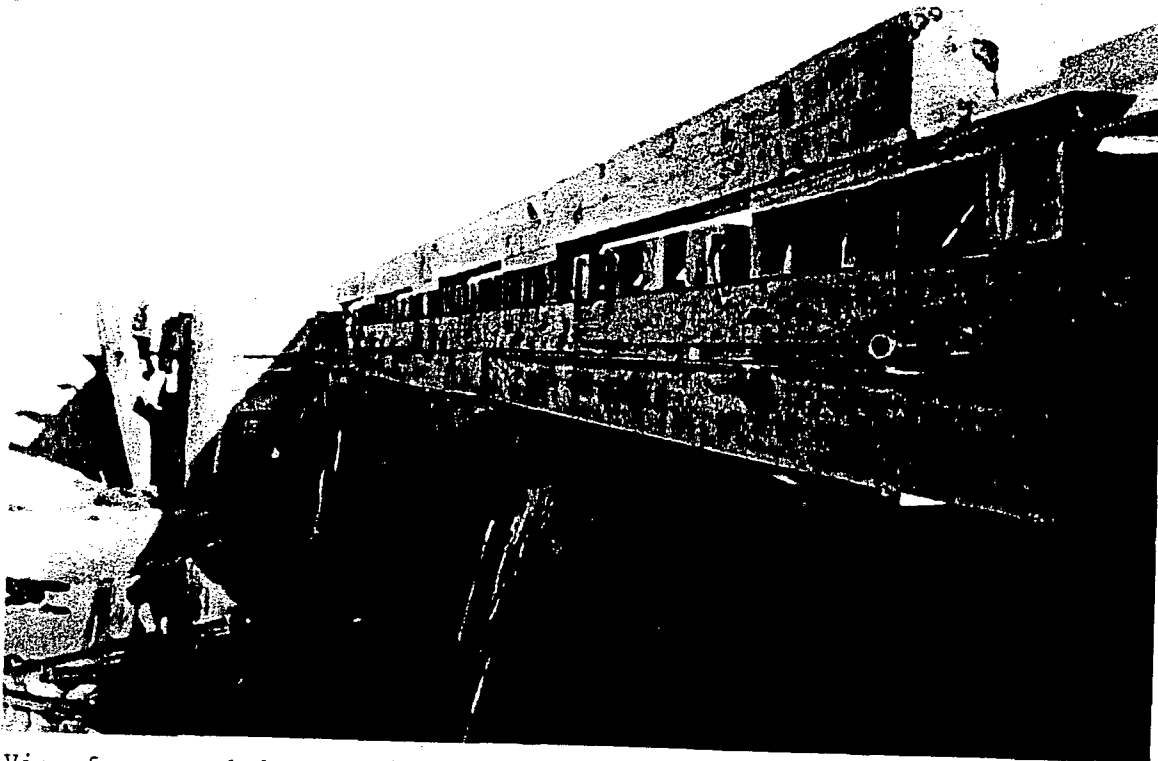
View from creek bed of 4"X 8" boards encasing repaired 4-inch pipe.
