CHRISTMAS FLOODS 1964

A Reprint From California Highways and Public Works Magazine

The Redwood Highway

By JOHN ROBINSON

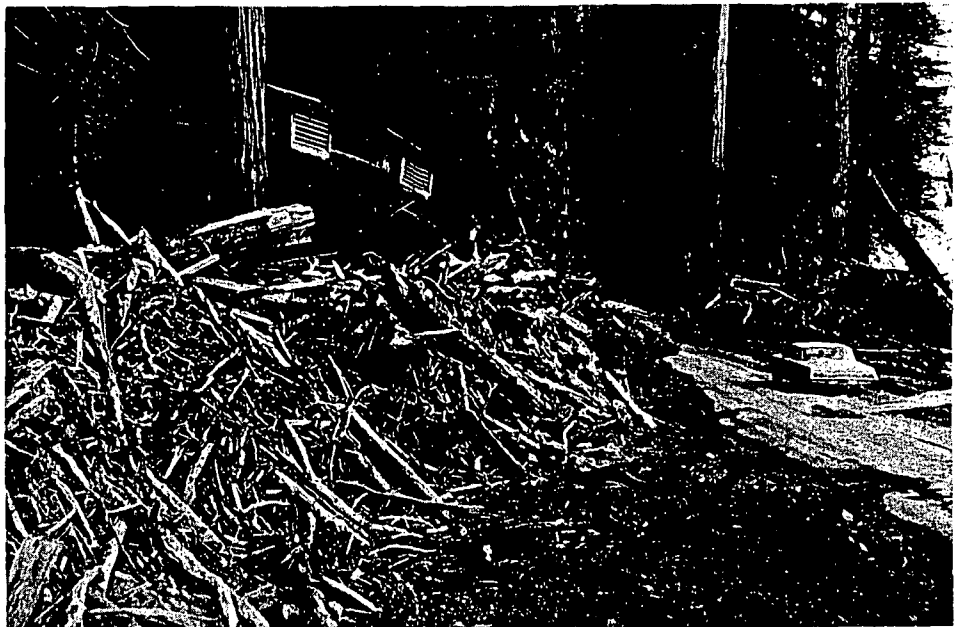
Eel River in full flood, site of town of Pepperwood in foreground. Highway 101 passes across photo about quarter of the way up. Town was destroyed, with many buildings caught in groves of trees amidst debris seen in picture. (Photo courtesy of Eureka Newspapers, Inc.)

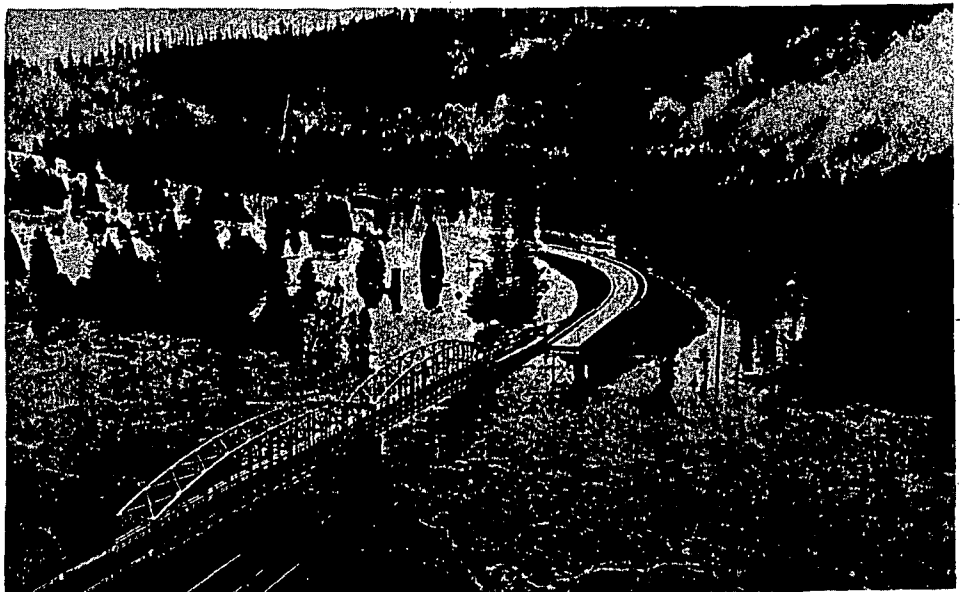
ABOVE: Debris deposited by flood on US 101 in redwood groves just upstream from Pepperwood. Barn with cupolas came from site across river and several miles upstream. BELOW: Downstream bridge of pair on Redwood Highway at South Scotia was also flood victim. Older bridge at left of through-truss design, survived flood because it was high enough to avoid debris which collected on truss below deck of newer bridge now missing at right. (Photo courtesy of Eureka Newspapers, Inc.)

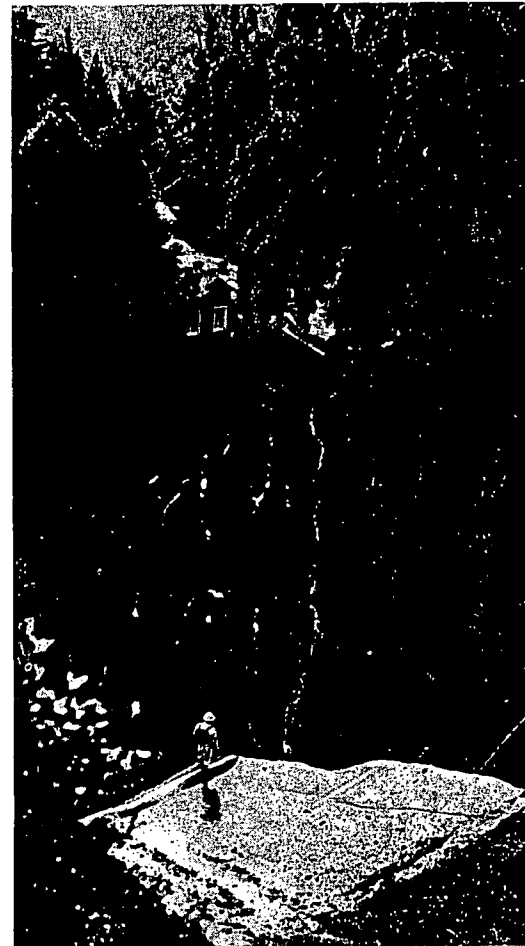
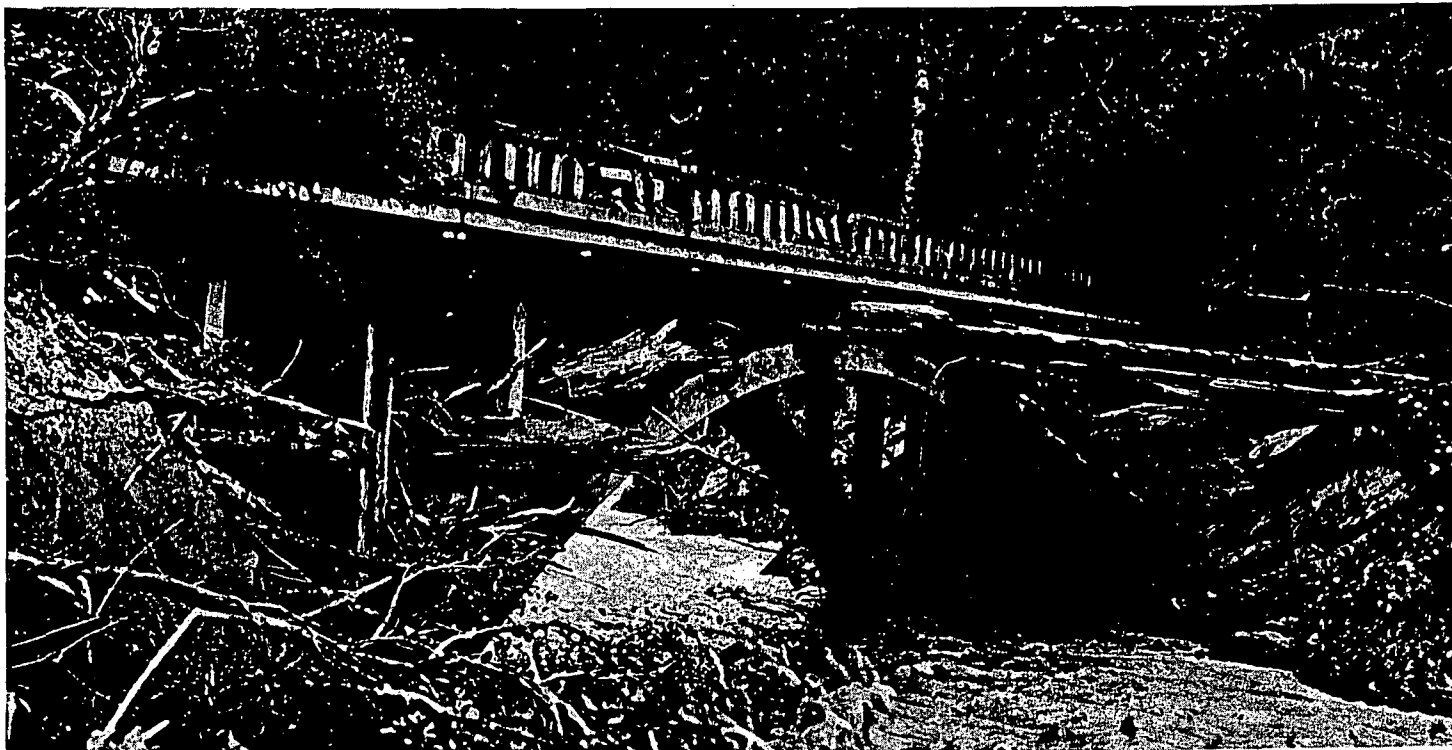
ABOVE: Squaw Creek, cascading down the steep slopes at Cummings on the Redwood Highway, tore this gap in the road. BELOW: This concrete arch bridge on US 199 above Crescent City withstood the flood, despite obvious pounding. Note debris lodged in every opening, and battered conditions of railing.

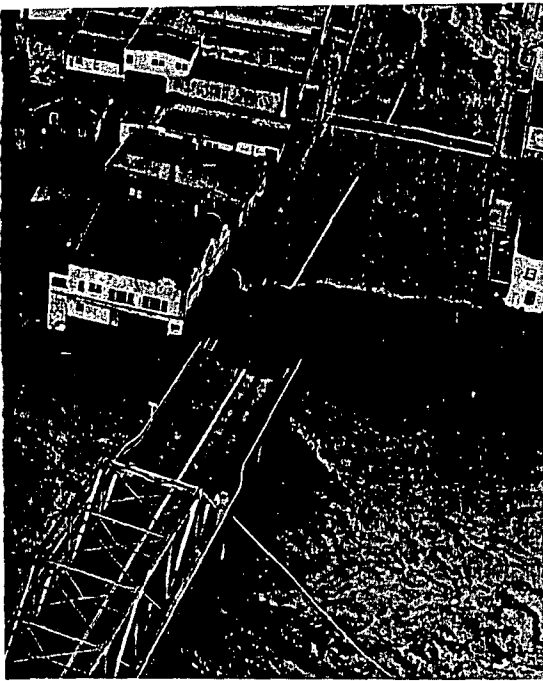
ABOVE: North abutment of North Scotia Bridge at Rio Dell torn out by force of Eel, here shown partly in flood. Building at left of broken bridge end is now gone. (Photo courtesy of Eureka Newspapers, Inc.) BELOW: Looking south along US 101, the Redwood Highway, with the town of Klamath in the foreground, and washed-out bridge in the background. (Photo courtesy of Eureka Newspapers, Inc.)

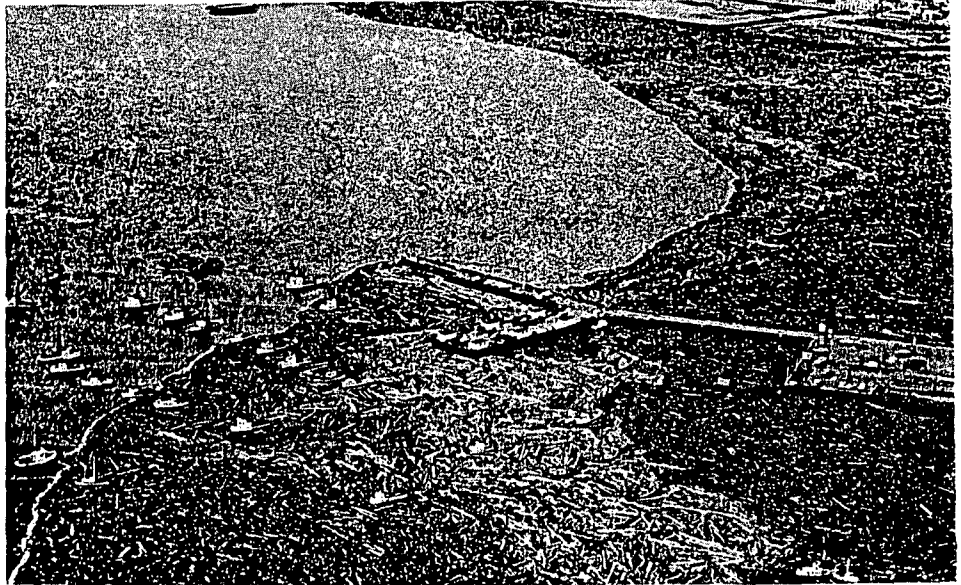
Logs from mills' storage and other debris carried down by rivers and washed into Crescent City harbor. Cut logs are worth about \$100 apiece.

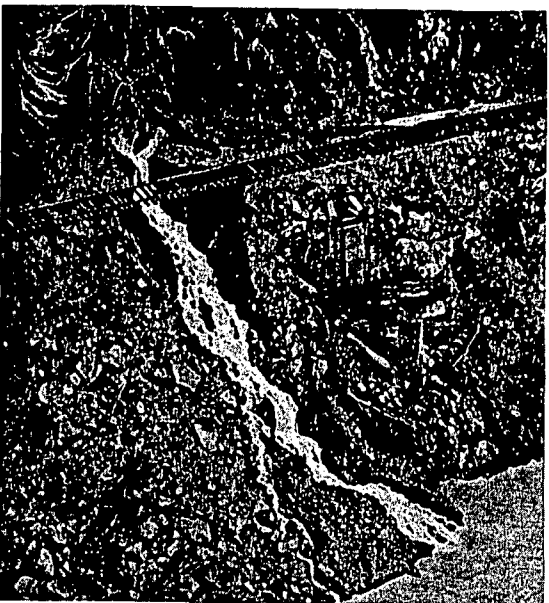
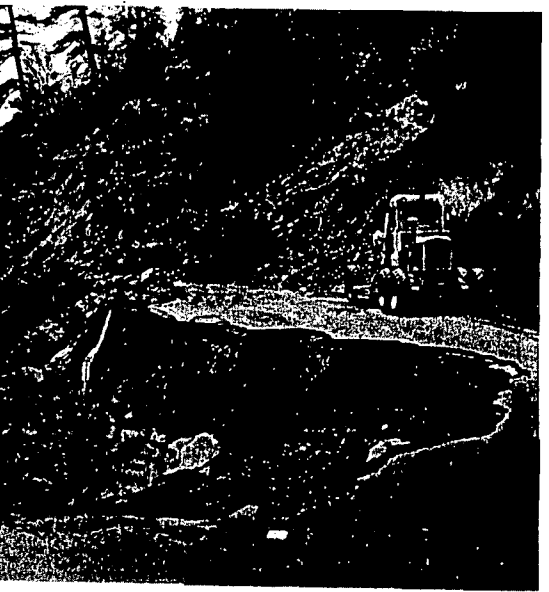
ABOVE: In this photo of roadbed destruction on Northwestern Pacific Railroad debris washed down the slope has filled the culvert and the stream has cut a new bed. (Photo courtesy of Northwestern Pacific Railroad.) BELOW: Destruction here is by slipout, or, in other words, a slide of the supporting slope below the roadbed.

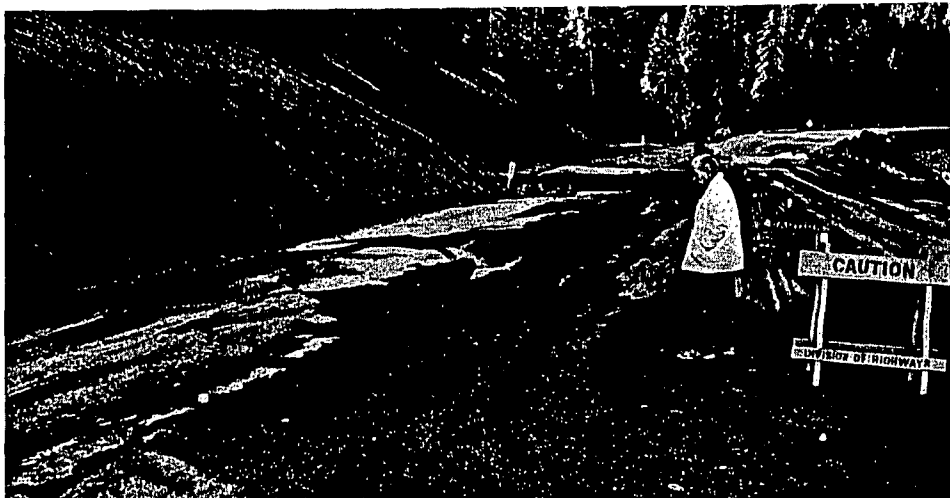
Another kind of damage occurred when underground waters, seeping through fill, washed out part of road foundation.

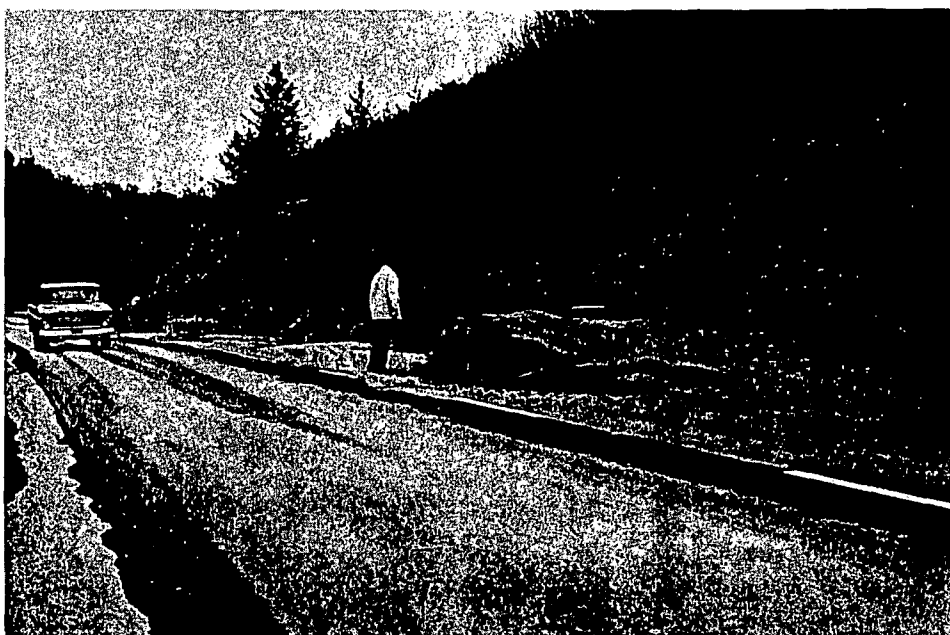
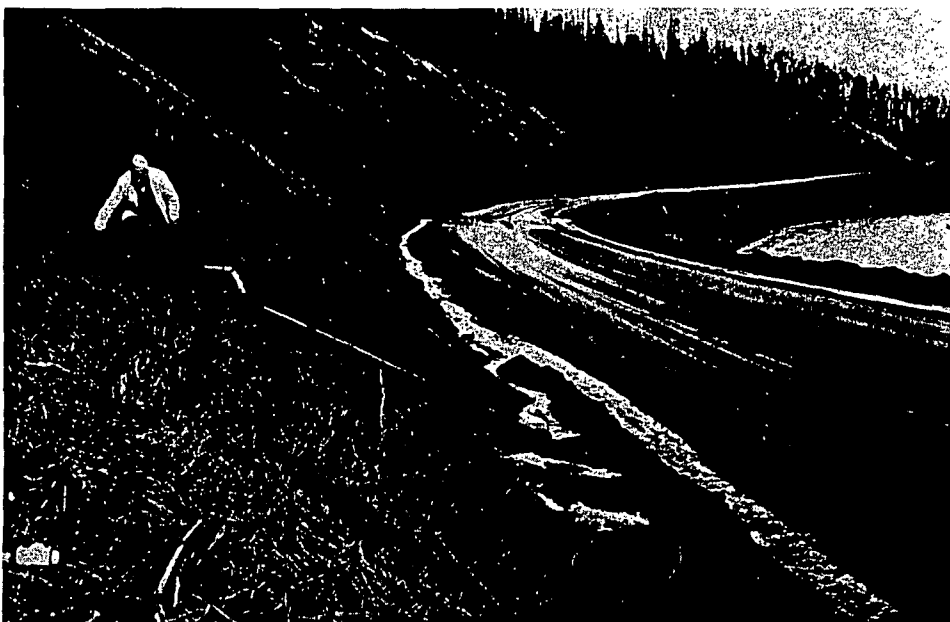
ABOVE: This paving damage was caused by pressure of sliding material on slope at right, forcing its way between road surface and foundation. BELOW: Man in photo has right hand at high-water mark which South Fork of Eel reached here near Phillipsville. This stretch of freeway, recently completed, was constructed five feet above high-water line of 1955 flood.

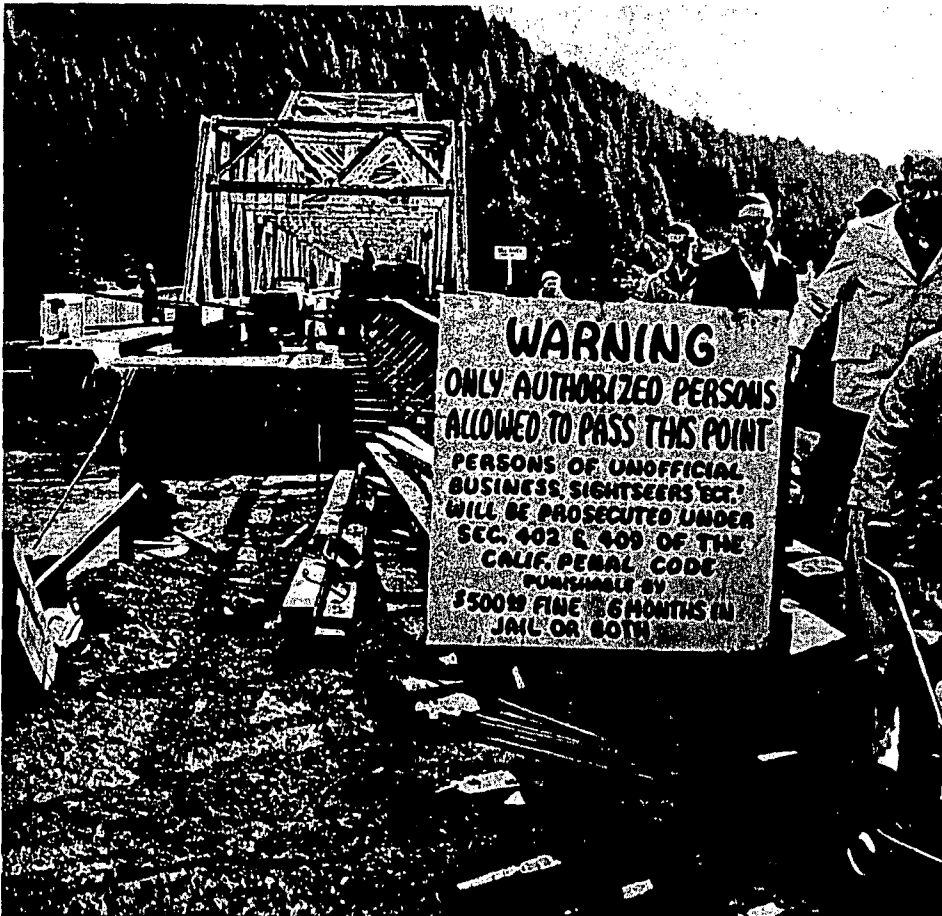
ABOVE: Temporary one-way bridge of wooden piles, beams, and planks built across break at north end of Scotia-Rio Dell Bridge carried legal loads for several months. BELOW LEFT: Footbridge was first span over gap and served many needs for two weeks. Requirements of sign were strictly enforced by civil defense officials. BELOW RIGHT: The footbridge, a simple suspension design, being built by Pacific Lumber Co. and P.G. & E. employees. (Both lower pictures Eureka Newspapers, Inc.)

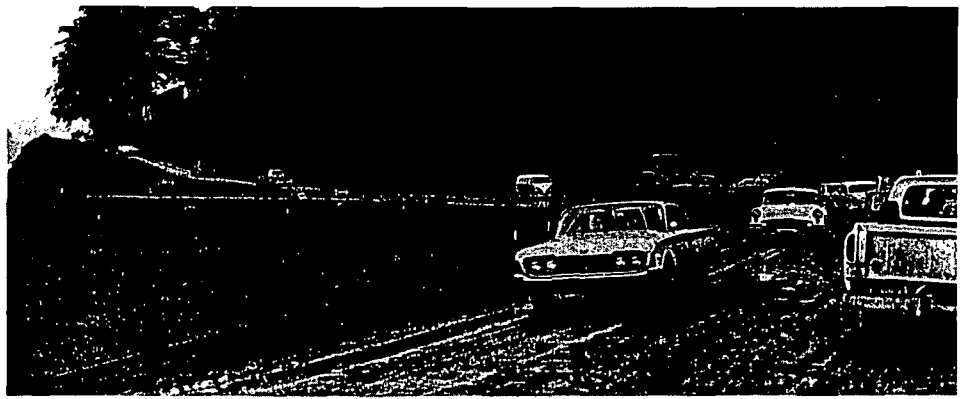
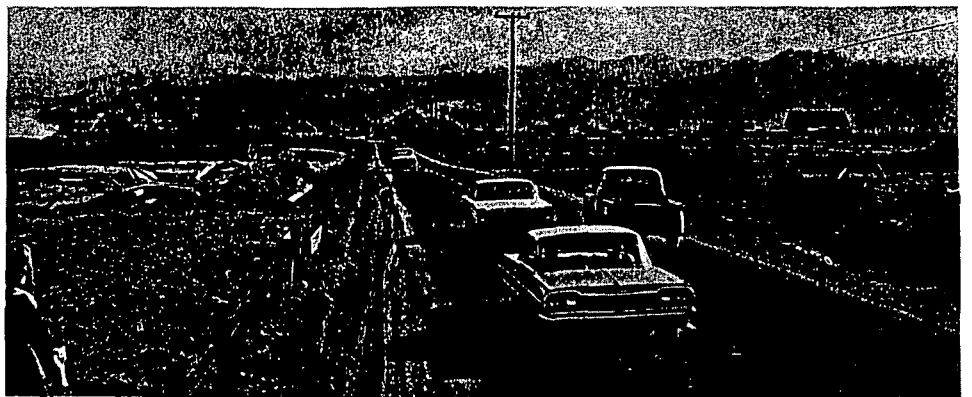
Five photos this page show steps in development of Blue Slide Road detour on Redwood Highway. Upper left is view of road on January 4 after flood; top is traffic moving in one-way convoys above cliffs before lower section repaired; directly above is filling operation on same section as shown in upper left. Directly below, about three weeks later, lumber trucks moving over this section; and bottom, same detour road where it crosses the floodplain, photographed March 17 after asphalt paving laid.

At first, traffic was forced to use an ancient, slippery, one-lane route which traversed the edge of cliffs above the Eel, while the Blue Slide section along the river was being rebuilt. Working from both ends, with 16 trucks hauling fill on the south end, and several DW-21's hauling riverbed gravel on the north, the crews had replaced the road base and had it carrying traffic in less than two weeks. Since the freeway sections through

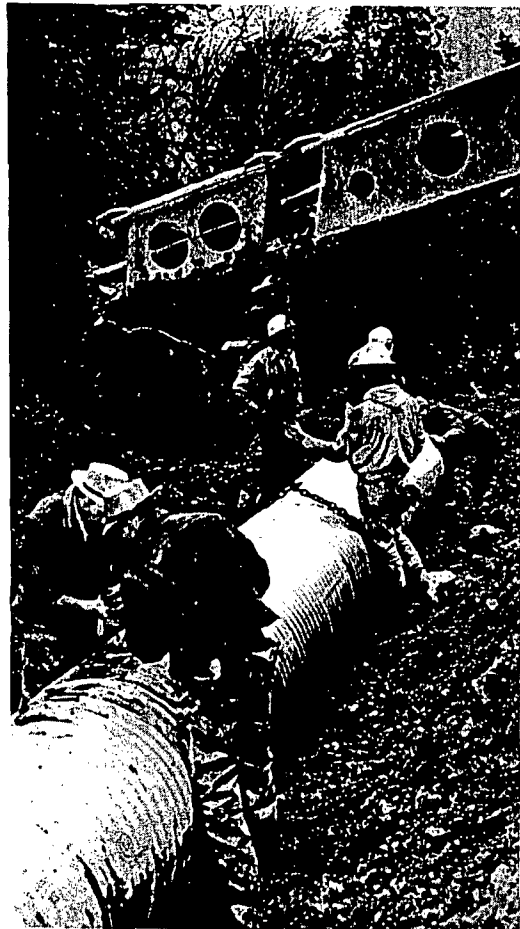
Boom of backhoe is used as crane for lifting sections of culvert into place while repairing washout near Richardson Grove.

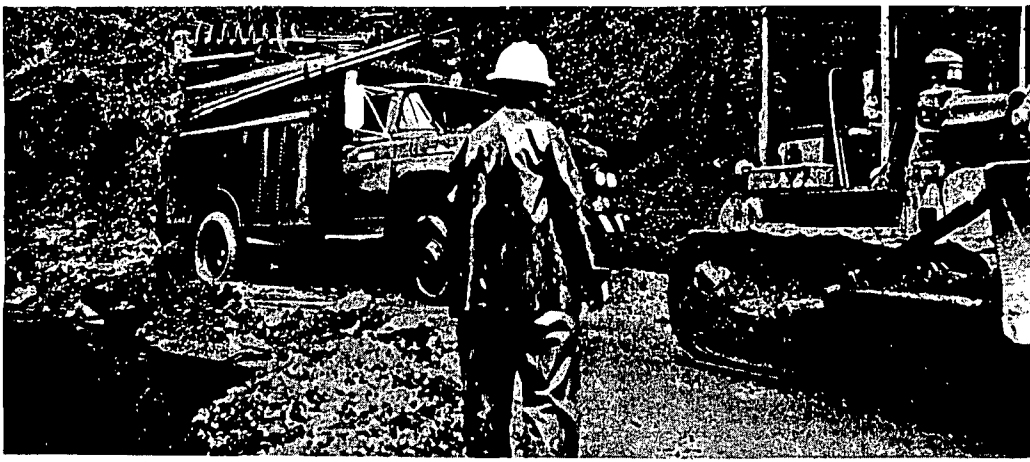
Tractor tows public utilities repair truck around bad spot at slipout on Redwood Highway. This was on December 27, 1964, during first phase of recovery from flood.

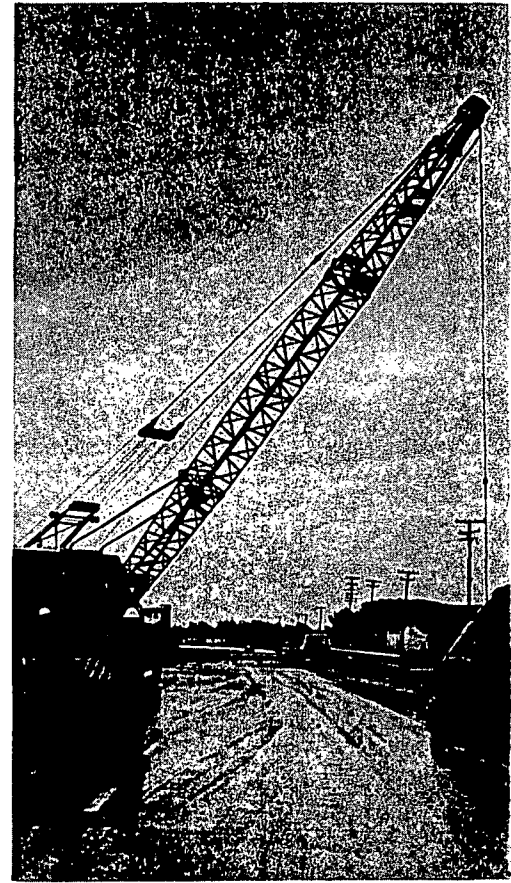
Crane removes logs washed up on undamaged section of county road near Ferndale in order to use it for detour for Redwood Highway.

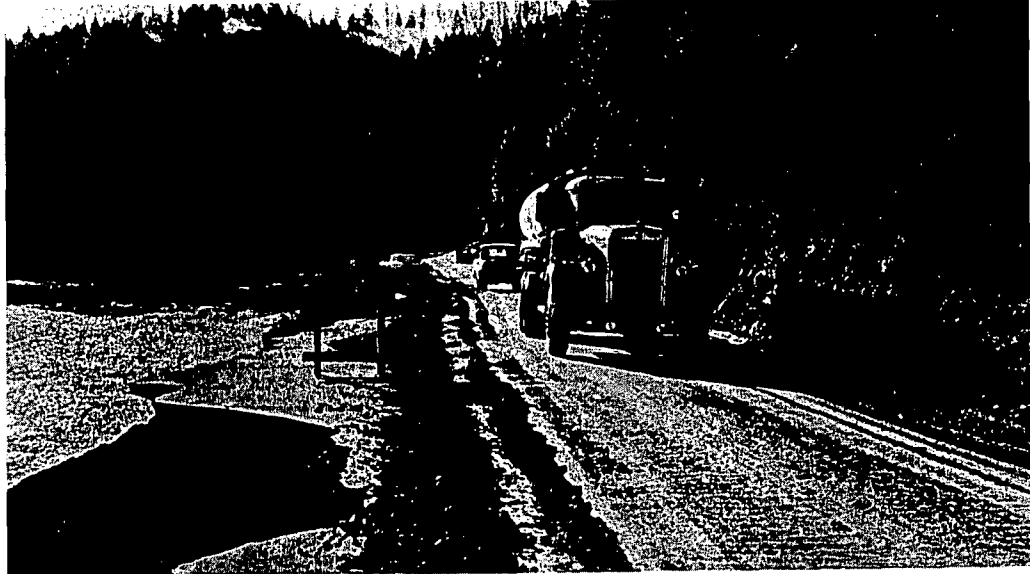
Section of Redwood Highway south of Pepperwood, along main Eel River as it appeared on January 12, 1965. Dirt ridge was used like this wherever paving was destroyed to delineate safe driving area.

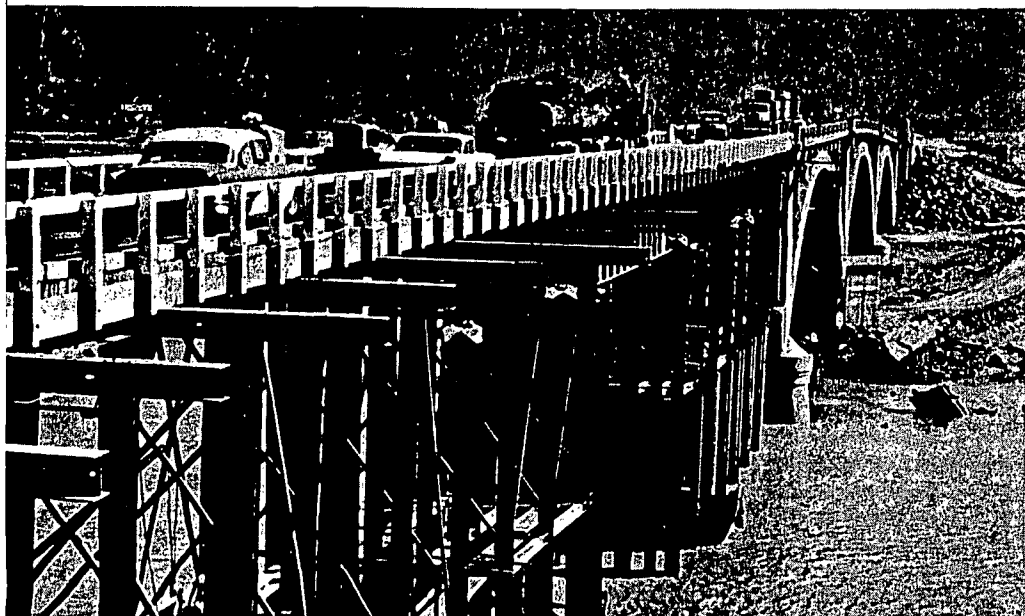
Klamath River Bridge with temporary repairs, opened to traffic on March 14, 1965.

When the pile structure filling the broken gap on the Klamath Bridge was opened March 14, the ferry was retired after an estimated 5,527 trips across the turbulent stream. During its slightly more than two months of operation, it had carried nearly 30,000 vehicles.

Work was started on the 11th of January, and the crossing was opened to traffic on Sunday evening, March 14, after almost exactly two months elapsed time. Since the temporary structure is on piles, with close spacing, it is vulnerable to damage by drift should the river rise. A deflector or buffer of piles was placed upstream for protection.

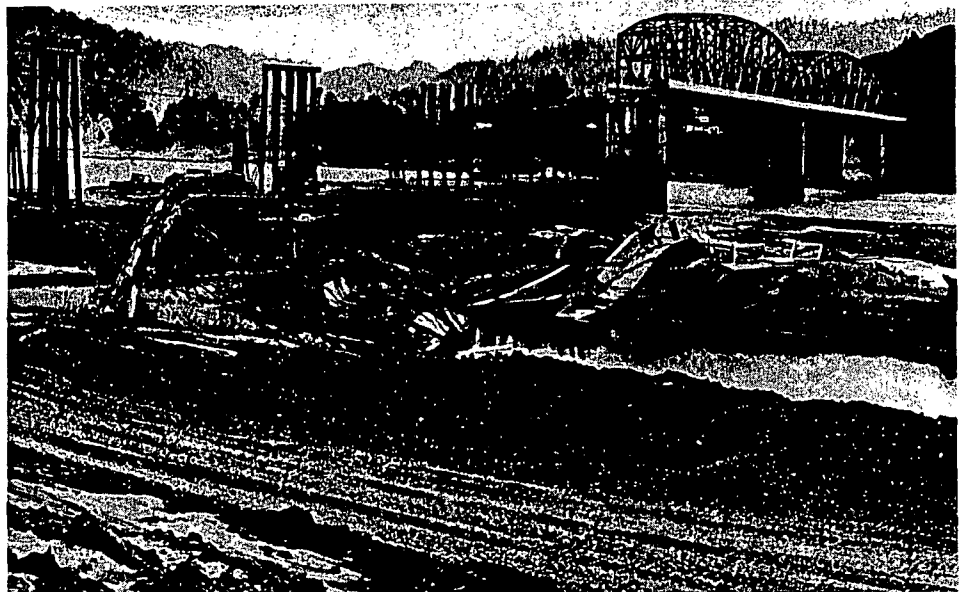
Repairs going forward on Robinson Ferry Bridge over the Eel. Crews gambled stream would not flood again this winter, and as payoff bridge will be opened to traffic in May. Wreckage of old spans lies in center foreground.

Permanent repairs to the Robinson Ferry Bridge. Estimated cost \$650,000 but emergency contract let January 5, 1965 on a cost-plus basis.

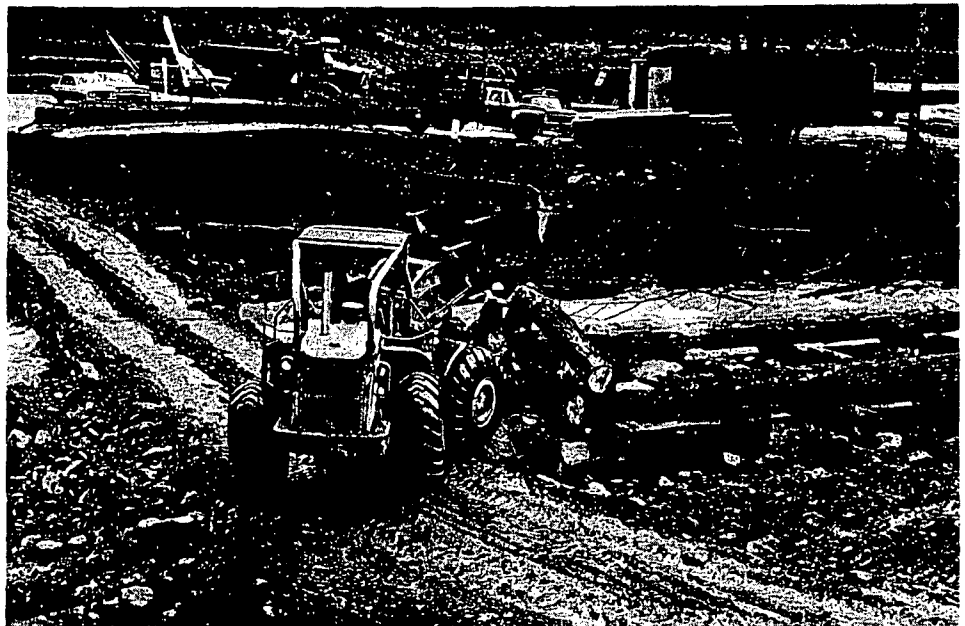
ABOVE: After first building low-level log bridge to move equipment in, contractor here, using front-end loader as crane, puts logs in place for abutment for higher level crossing. BELOW: The finished bridge, crossing Patrick's Creek, US 199.

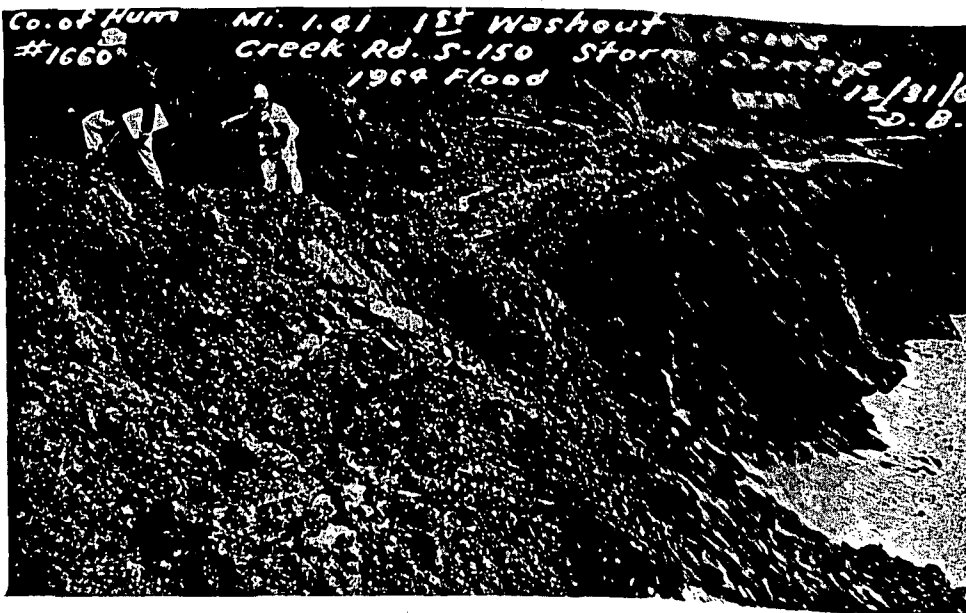
Engineers surveying damage on county road in Humboldt County, seeking route into Rio Dell, struggle through knee-deep mud along banks of the Eel River. This route is now being used temporarily as part of the Redwood Highway.

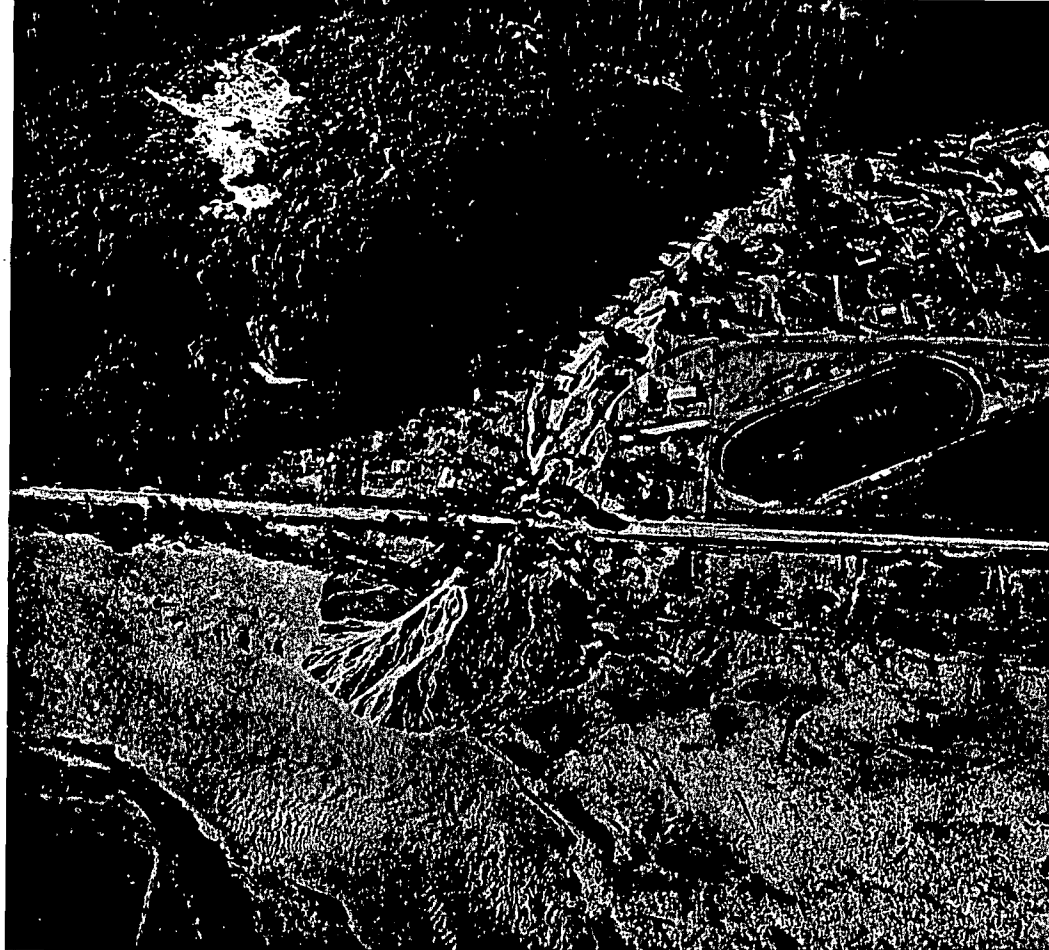
Hospital Creek on Trinity River near Hoopa brought down so much debris it filled channel, and covered highway with gravel several feet thick. This was a common type of damage in this storm, and required reestablishment of the channel in each case. Note creek "delta" in river.

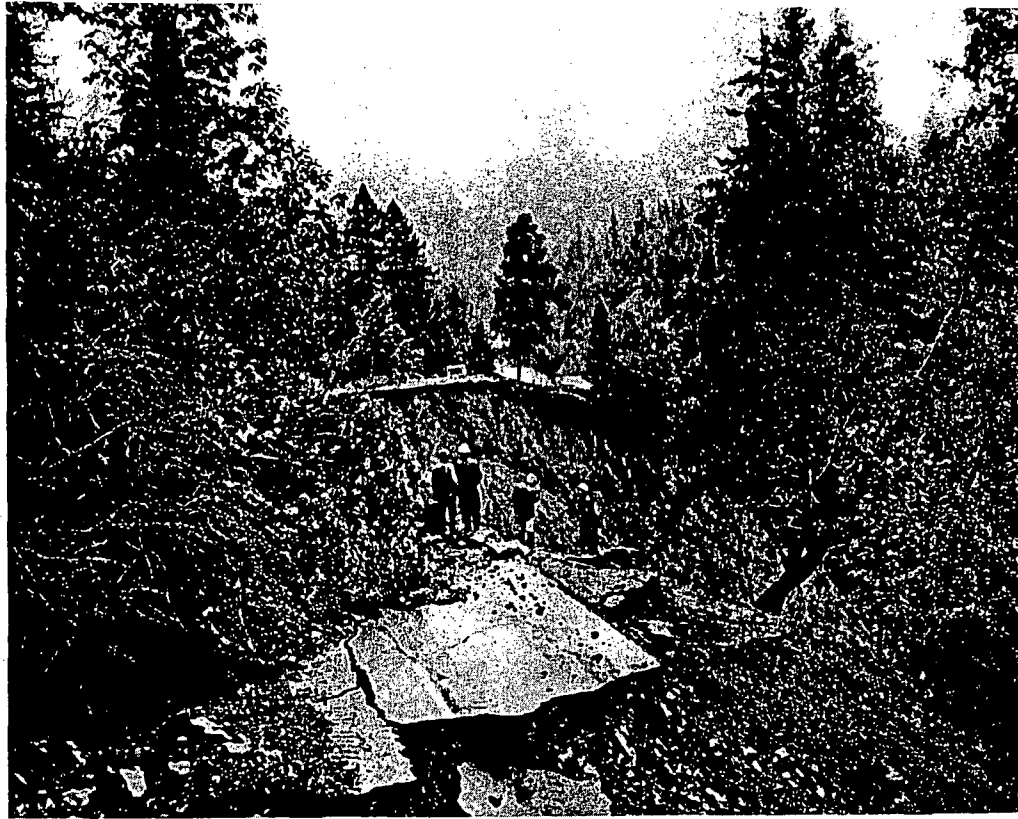
Gaping washout from what is normally an insignificant trickle of a stream is typical of damage throughout the several northwestern counties in the December 1964 floods. This is State Route 208 in Mendocino County, west of Leggett.

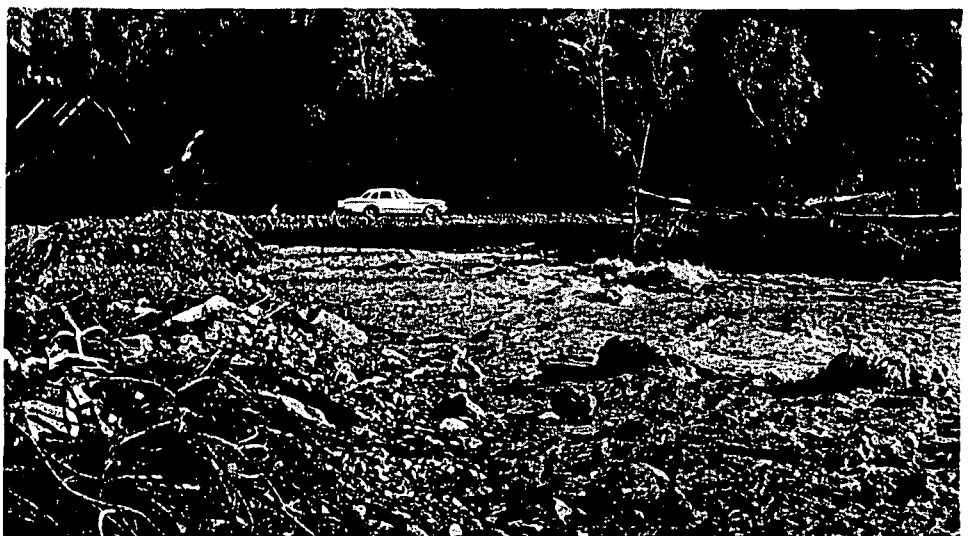
The log emergency bridge at Willow Creek on January 7, 1965. At upper left is collapsed bridge. Photo on opposite page made same day gives aerial view of this area.

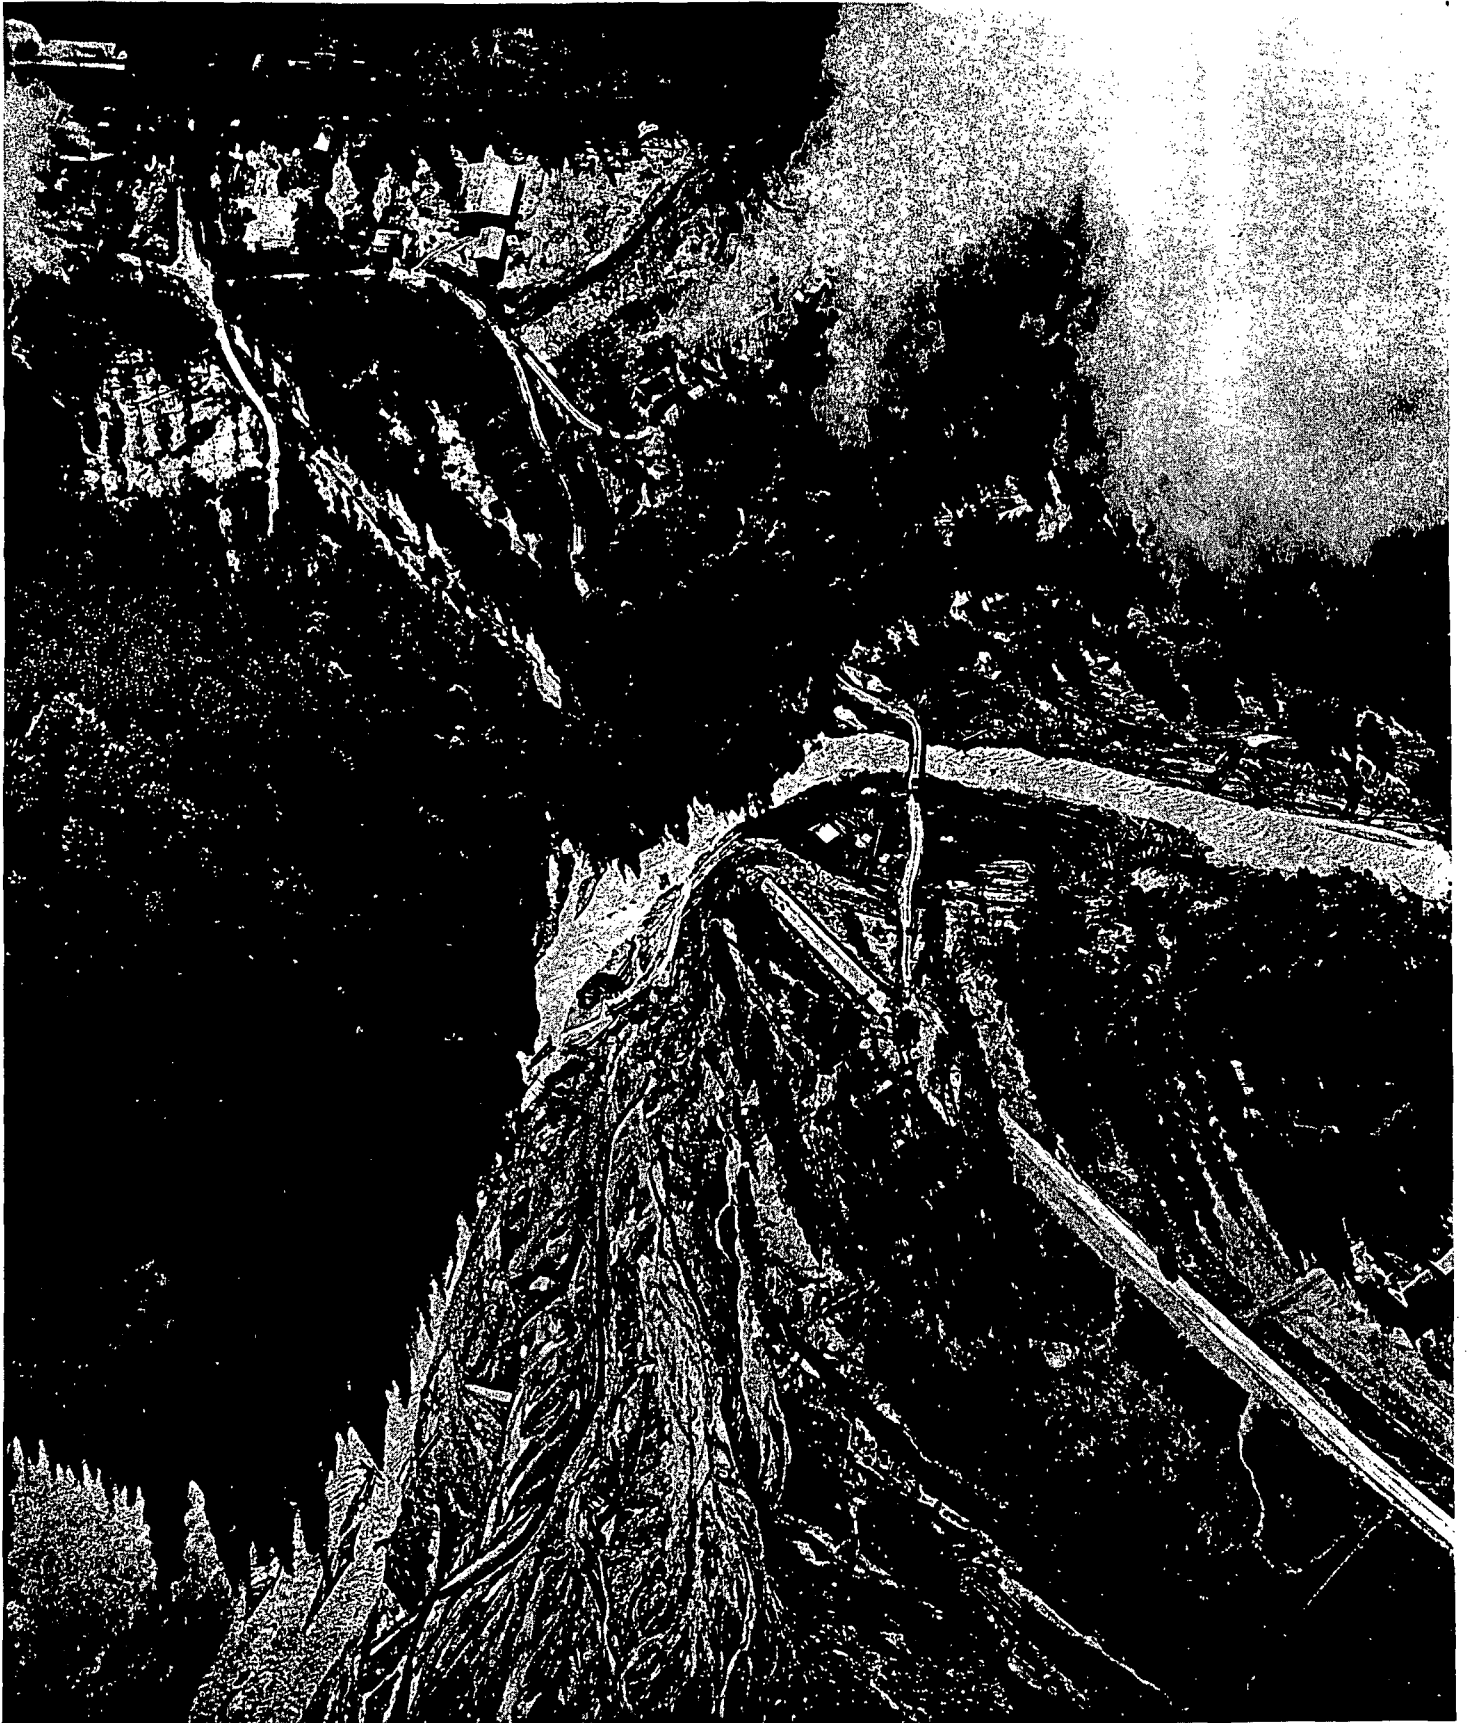
View from air of break at Willow Creek Bridge on State Route 96, emergency log bridge and collapsed bridge in center. Trinity River at lower left, town of Willow Creek and Route 299 top of picture.

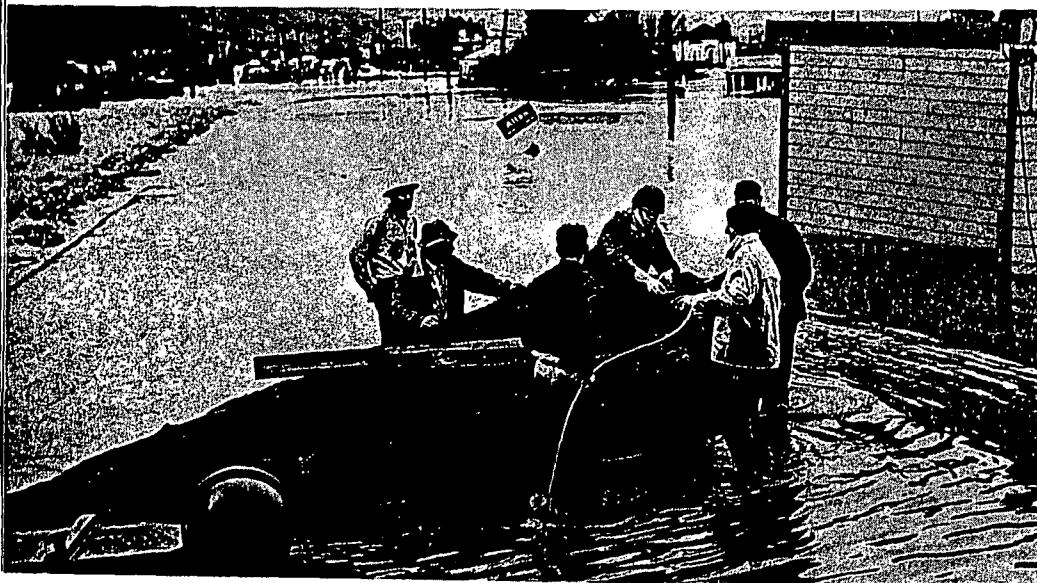
BELOW: Workers from various agencies clearing highway on Christmas Day. This is State Route 36 at Alton, near its western terminus. (Photo courtesy Eureka Newspapers, Inc.)

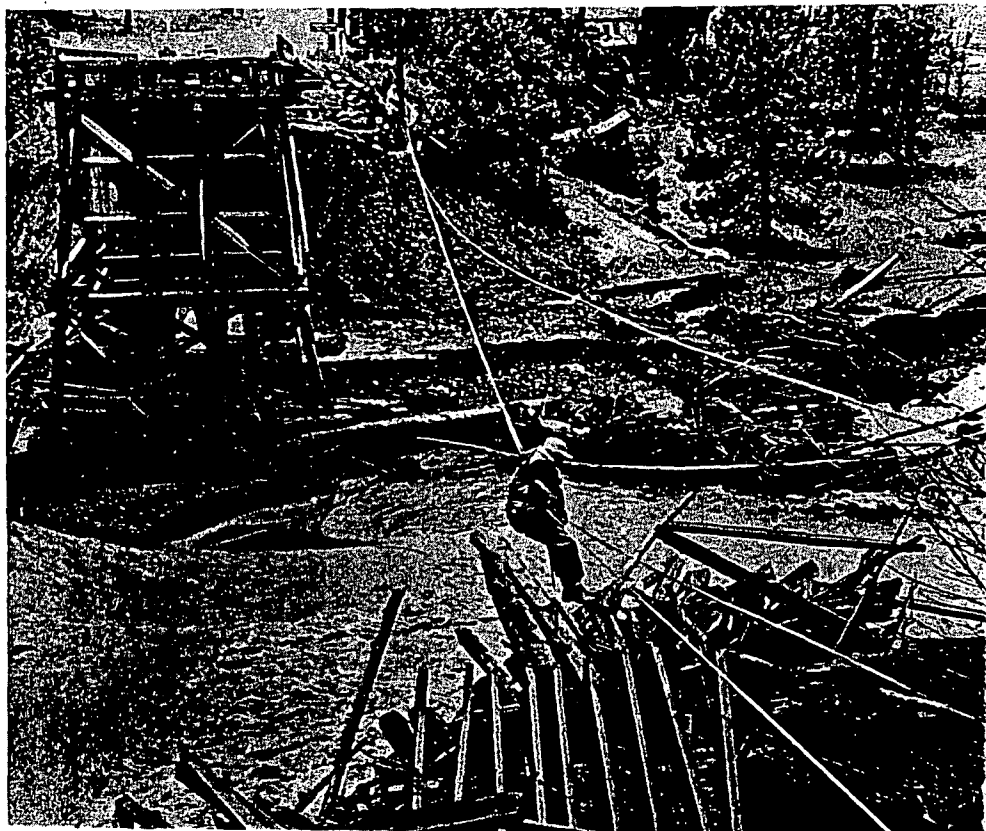
Breeches buoy rigged at Willow Creek Bridge to carry people across during first days of recovery after flood. Note debris and silt left by receding stream. (Photo courtesy of Eureka Newspapers, Inc.)

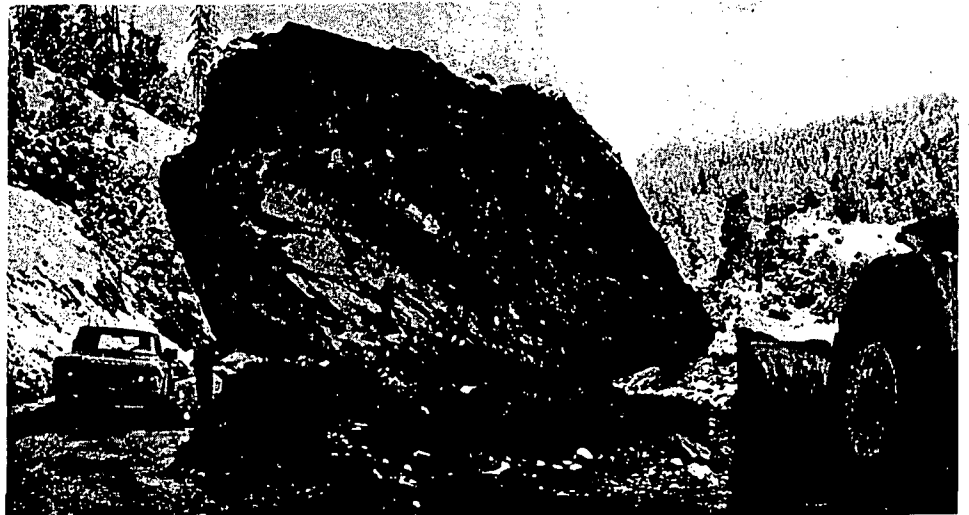
Boulder which slid down mountainside onto Route 299 must be broken up by blasting before removal.

just east of Grey Creek where another major obstacle, actually a double one, was encountered. Here, where the road travels a ledge along almost perpendicular cliffs several hundred feet above the Trinity River, a huge rock slide had completely covered the road, and the boulders were still dropping from the high cliffs above.

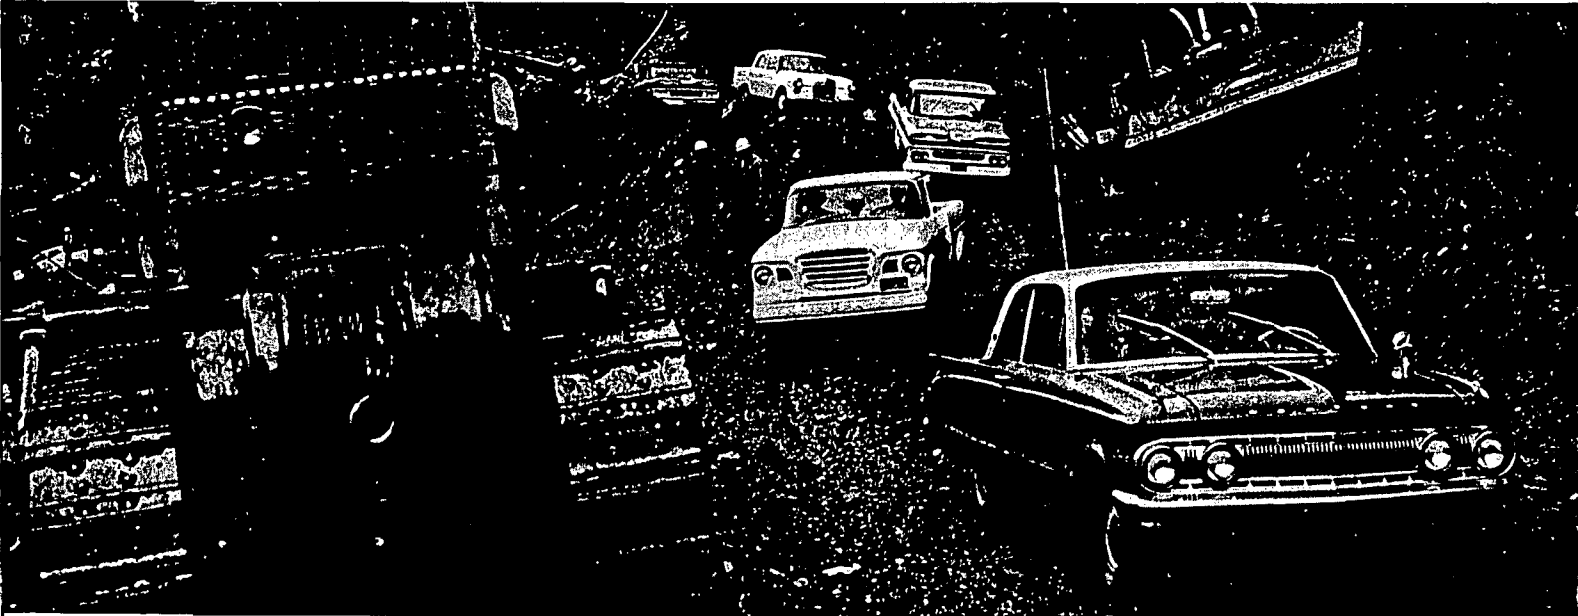
ABOVE: Convoy of evacuees working its way around detour on Route 299 at Junction City on December 28, 1964, over one-way bulldozer road. BELOW: Westbound convoy on Route 299 January 7, 1965, at Pony Creek. Note logs used as guardrails and delineators.
