CHRISTMAS FLOODS 1964

A Reprint From California Highways and Public Works Magazine

The Redwood Highway

By JOHN ROBINSON

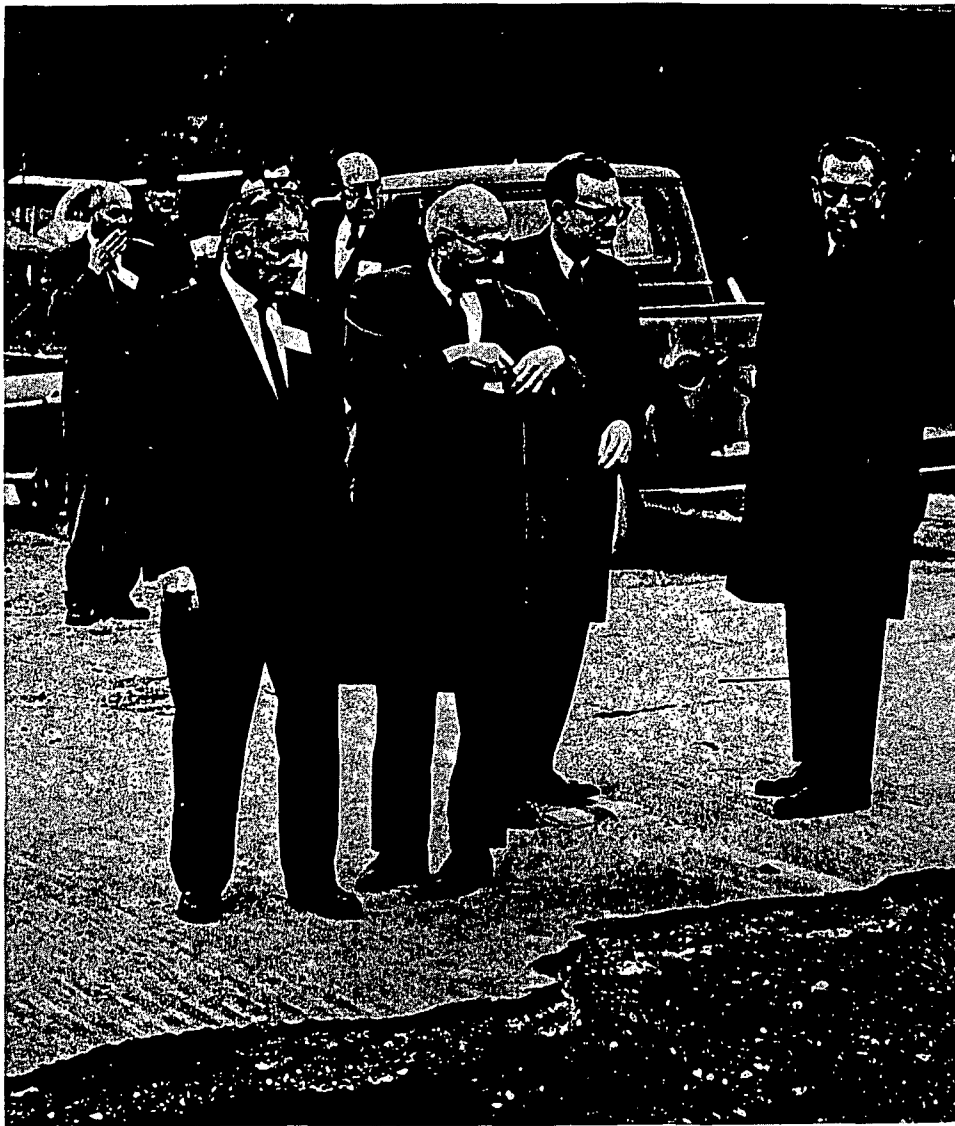
In foreground, left to right, Director of Public Works John Erreca and Highway Commissioners Abraham Kofman, Joseph C. Houghteling, and William S. Whitehurst look at gap in Redwood Highway north of Rio Dell.

BELOW: Four-span log bridge, built as temporary replacement for destroyed bridge in foreground, is carrying legal loads on State Route 36 just west of Bridgeville. Piers are log cribs filled with rock and gravel. Sections are held together with steel cable.

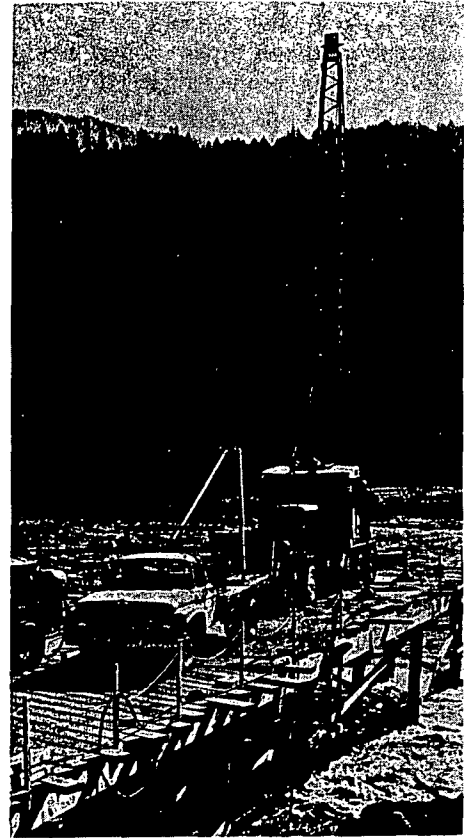
ABOVE: First stages in construction of temporary crossing over Klamath River to replace washed-out Orleans suspension bridge. BELOW: Construction stage on replacement bridge at Somesbar. With abutments and pier intact, girders were quickly positioned to replace truss which stream carried away.

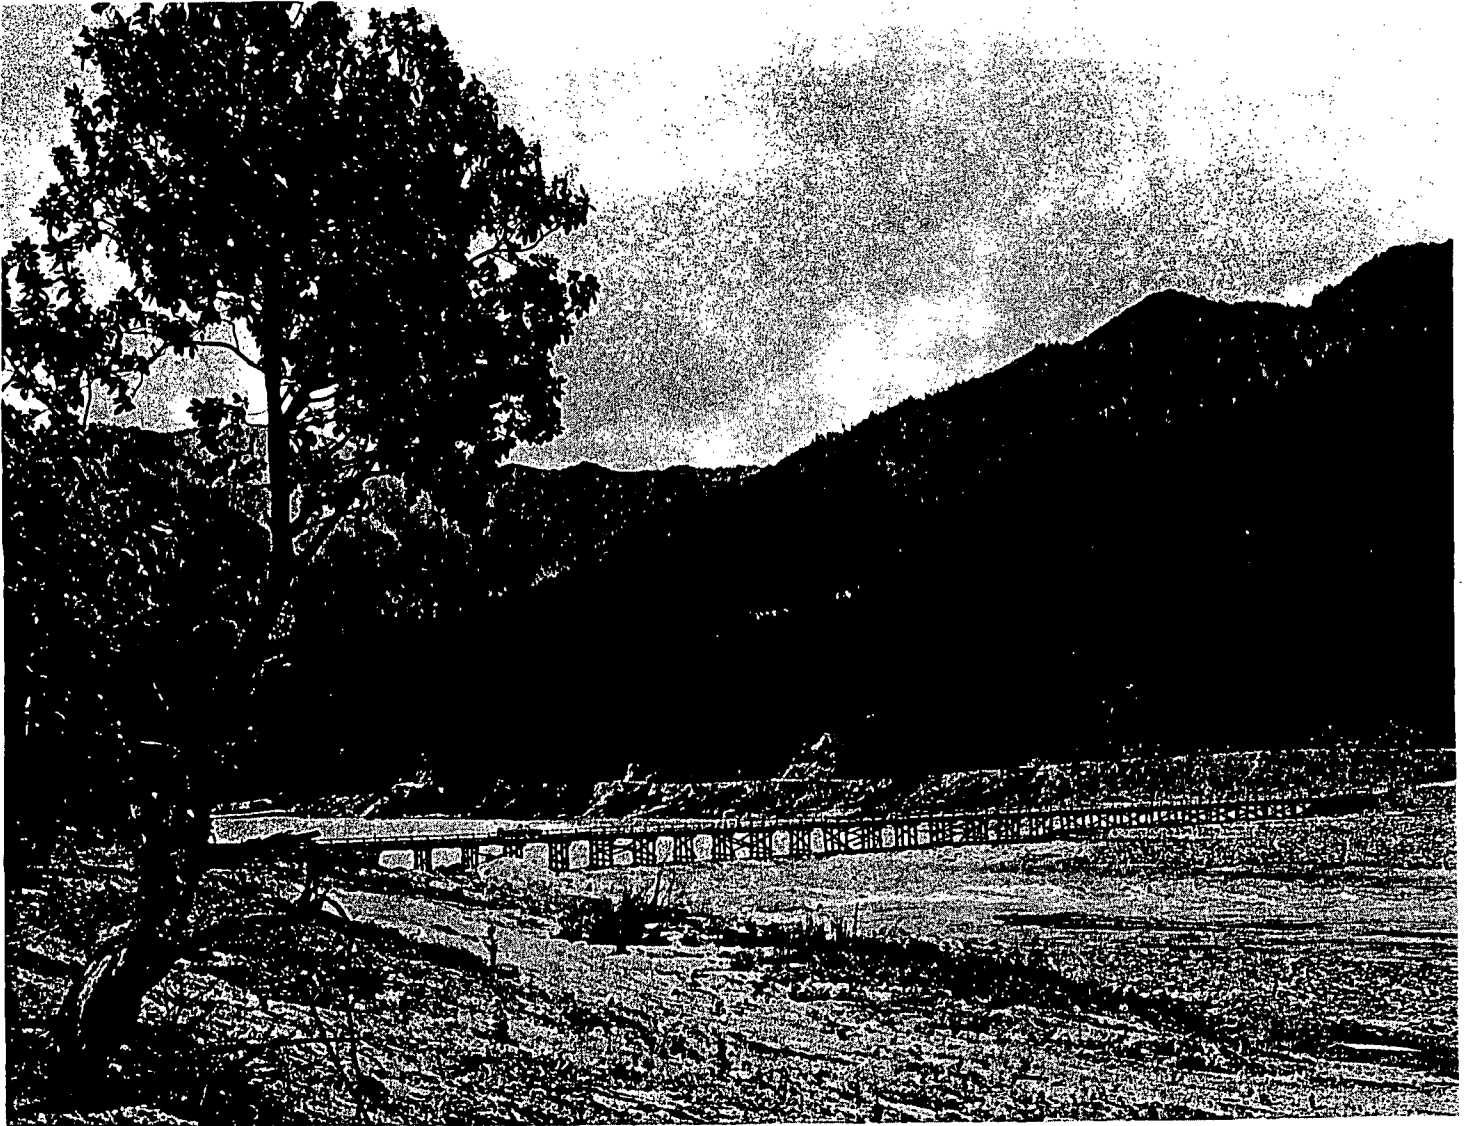
Temporary low-level bridge at Orleans to carry traffic while new bridge over Klamath is being constructed. This will be a major project.

This was partly remedied by replacement of the washed out truss of the Somesbar Bridge with plate girders and reopening of the bridge on March 4. A low-level, temporary bridge was opened April 1 at Orleans, and then Route 96 could be traversed its entire length.

A temporary low level bridge is in use on Route 96 at Orleans, to replace the structure destroyed by the Klamath River. Traffic can now move over this route freely, although it will be some months before all the damaged sections on this route are completely back to normal.
