**Oregon Department of Forestry  
Storm Impacts and Landslides of 1996:  
Final Report**

**Oregon Department of Forestry  
Forest Practices Monitoring Program**

**June 1999**

*Forest Practices Technical Report Number 4*

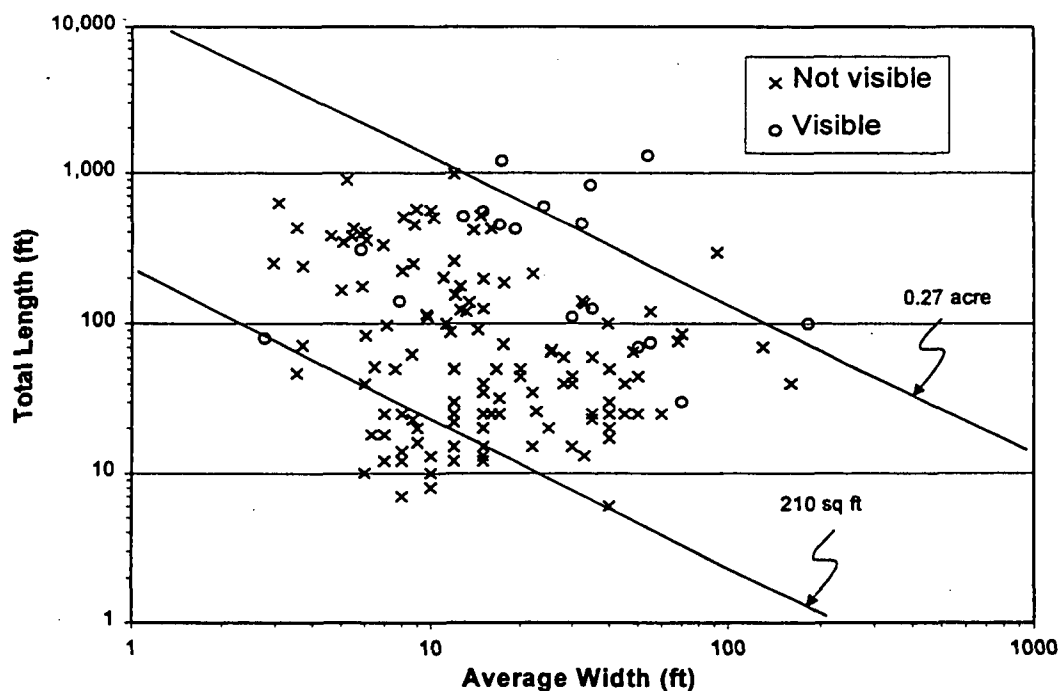
Figure 3. Visibility of non-road-associated landslides (n=143) in 1:6,000 air-photos plotted by total length and width (both initial failure area and debris flow). All non-road-related landslides in Mapleton, Vida, and Tillamook within the area covered by the air photo surveys in 30+ year-old forests are included here.

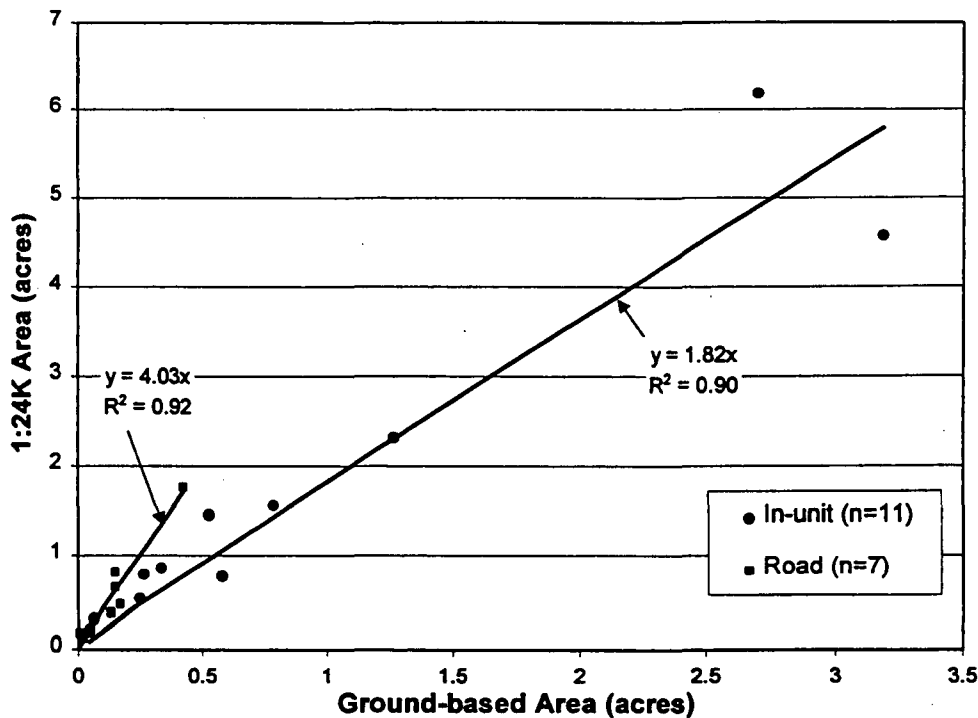
Figure 6. Comparison of landslide areas determined from ground-based measurements versus air photo measurements at 1:24,000 scale. All non-road-related landslides in Mapleton, Vida, and Tillamook within the area covered by the air photo surveys are included here.

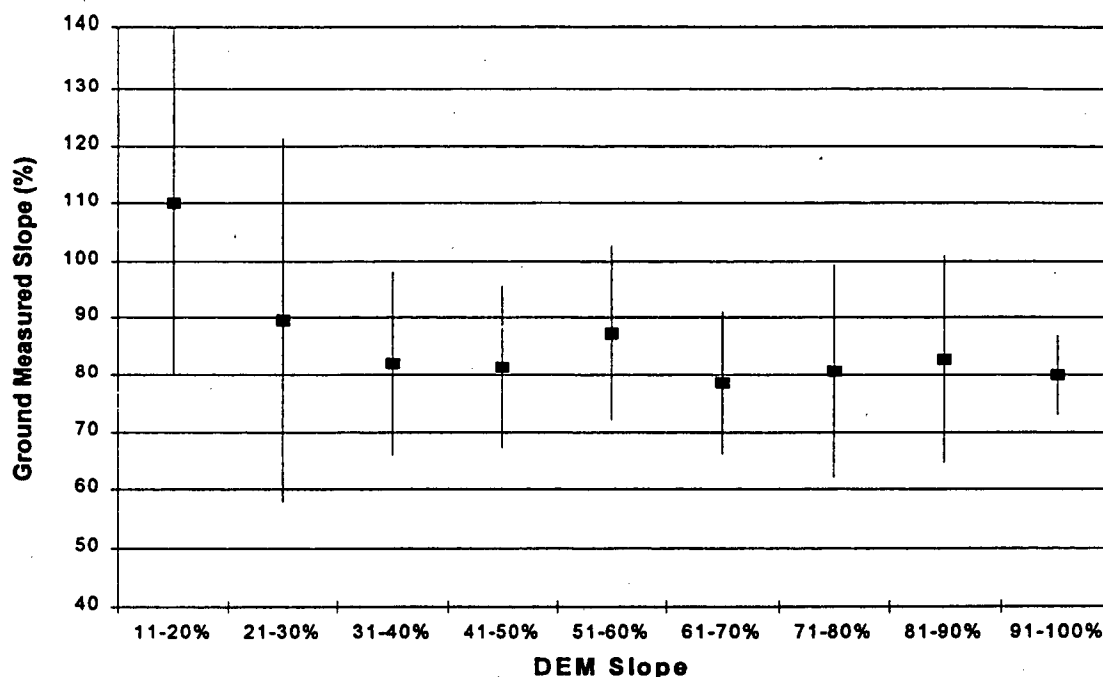
Figure 10. Slope measurements at landslide locations mapped with a GPS compared to slope measurements from the 30-meter digital elevation model (DEM). The box represents the average of the ground-slope measurements for all landslides corresponding to the DEM slope range. The bars represent plus or minus one standard deviation.

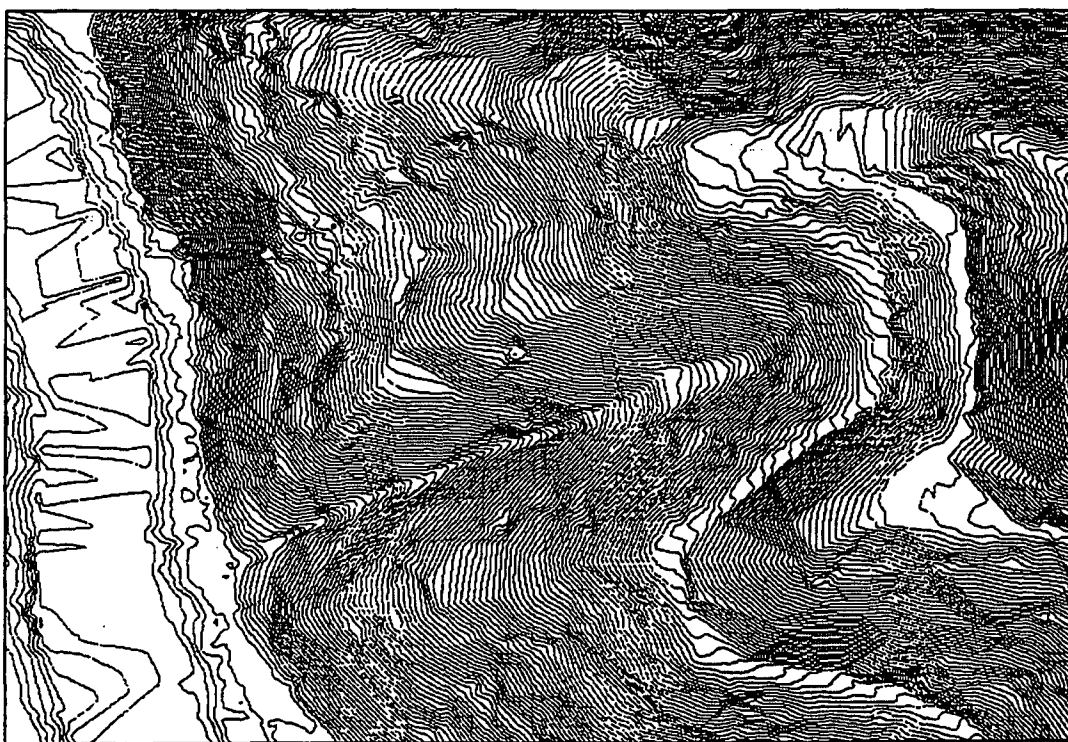
Figure 13. A portion of a one-meter contour interval map of the Scottsburg study area developed from a one-meter digital elevation model (DEM). This area is identical to that in Figure 11 & 12 (1 inch = 190 feet).

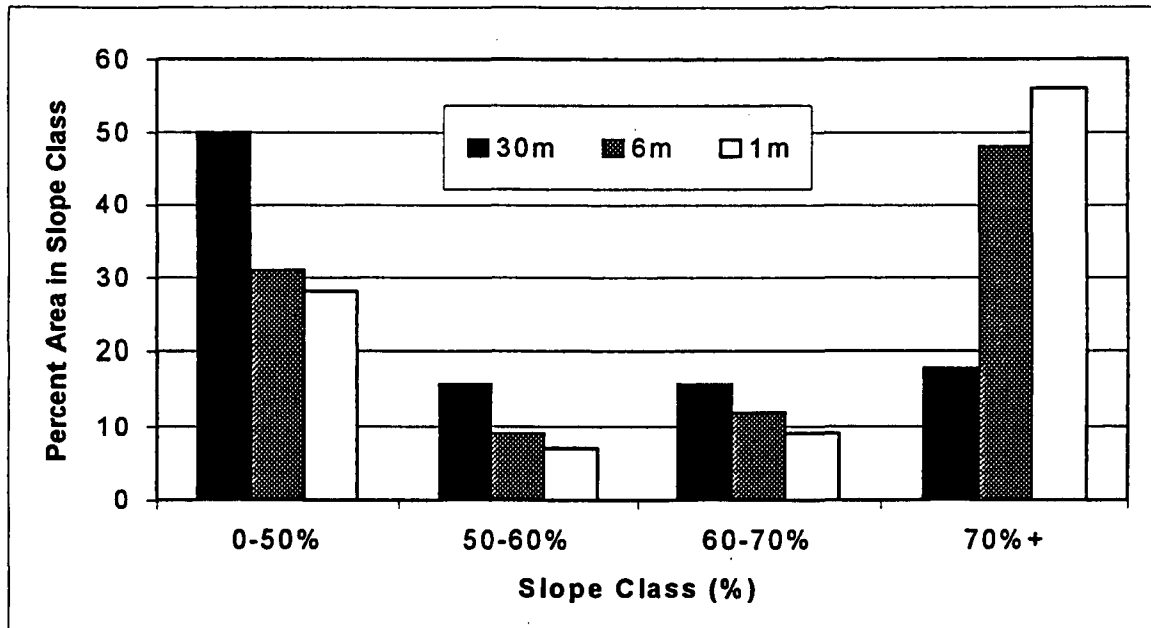
Figure 14. Percent of area in various slope classes for 1, 6, and 30-meter DEMs for a 1000-acre area within the Scottsburg study area.

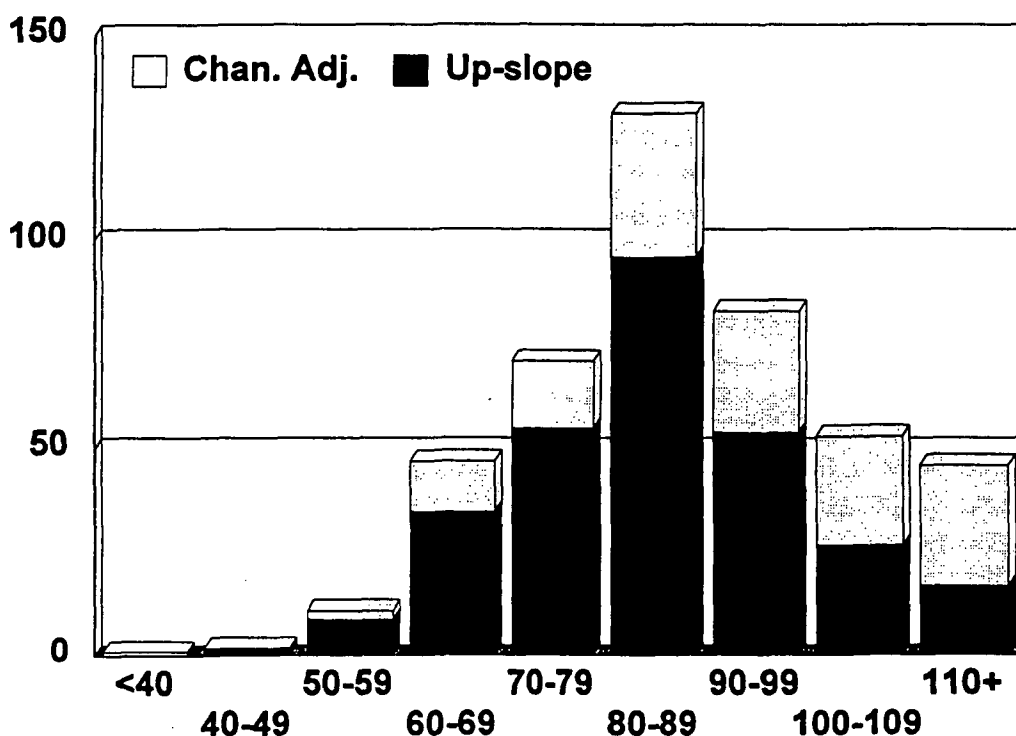
Figure 15. Frequency distribution of reconstructed slope steepness at the initial landslide both for channel adjacent and up-slope landslides (non-road associated).

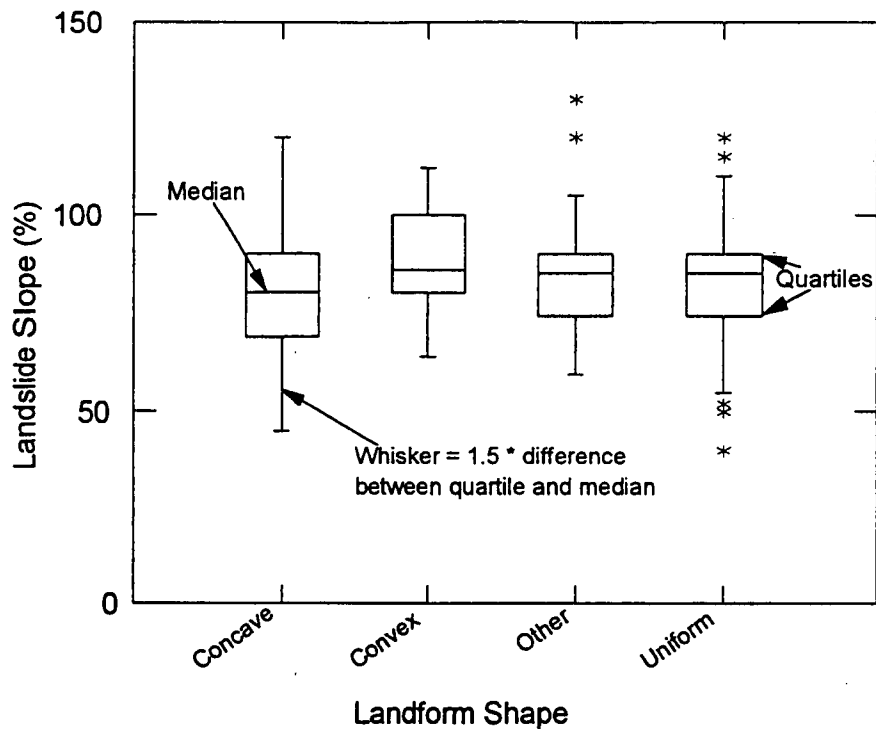
Figure 16. Graphical comparison of slope steepness distributions by landform type for up-slope landslides for all study areas. (A quartile includes 25 percent of the data.) There is a significant difference between the slope steepness of the concave and convex slopes, with an Analysis of Variance (AOV) p value equal to 0.008.

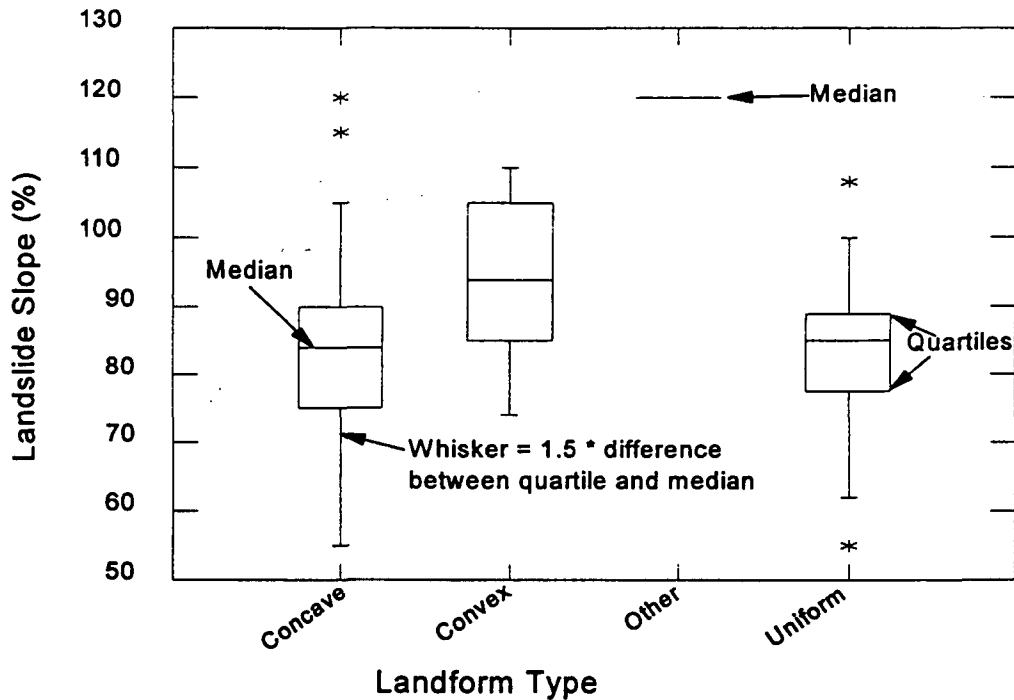
Figure 18. Graphical comparison of slope steepness distributions by landform for landslides in the igneous red zone study areas. AOV tests were conducted on both of these sets of distributions. In both of these cases, there was no significant difference in slope steepness between any of the individual landforms.

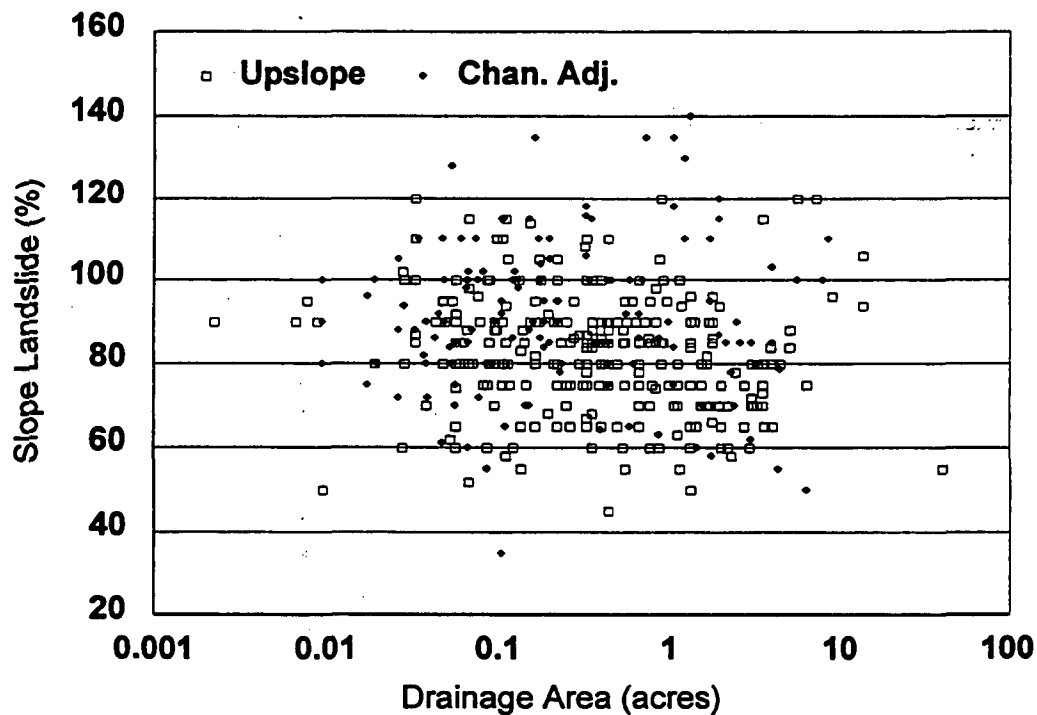
Figure 19. Scatter plot of basin area contributing to the landslide initiation site vs. slope steepness for both upslope and channel adjacent landslides.

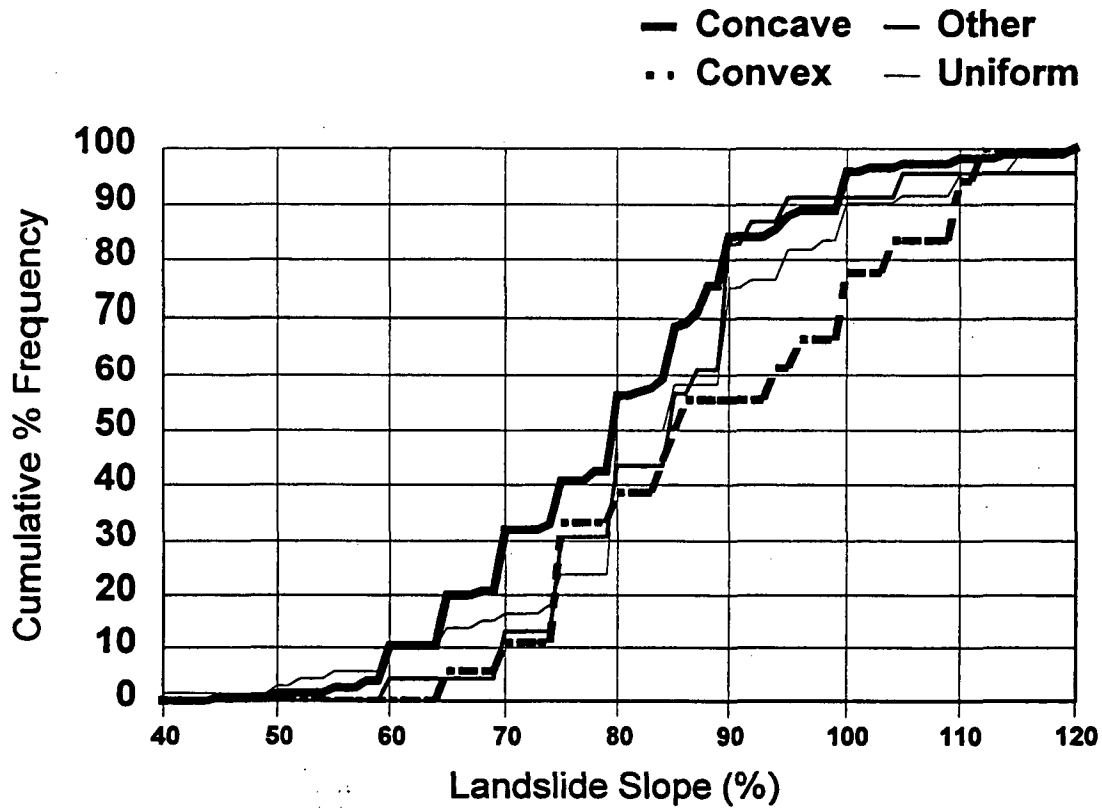
Figure 21. Cumulative percent frequency distributions of slope steepness by landform type for landslides in the Tyee red zone study areas.

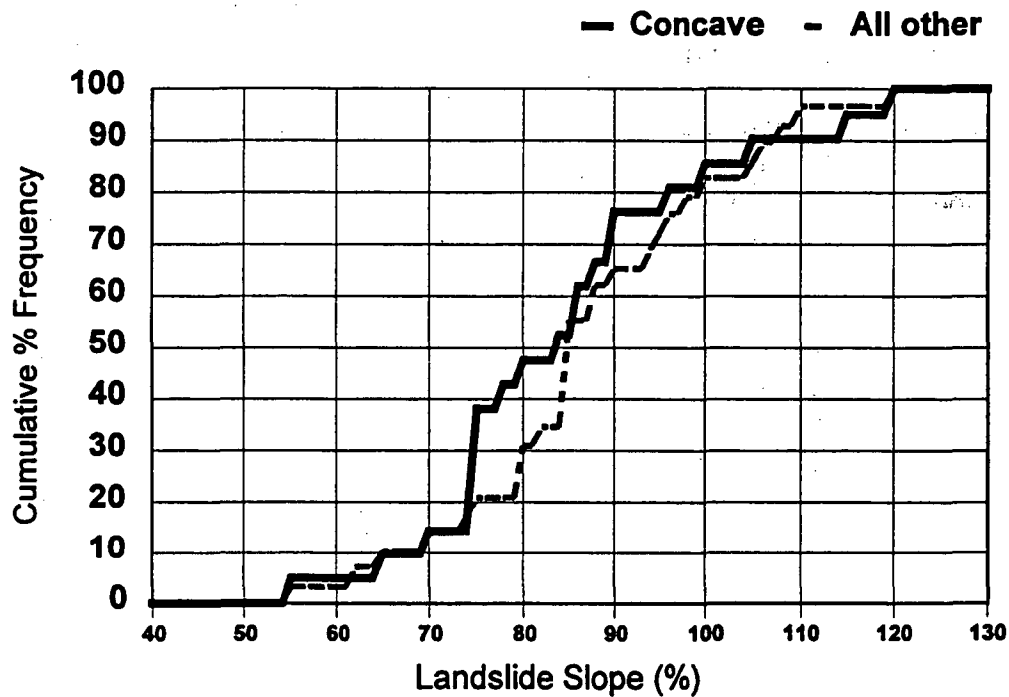
Figure 22. Cumulative percent frequency distributions of slope steepness by landform type for landslides in the igneous red zone study areas.

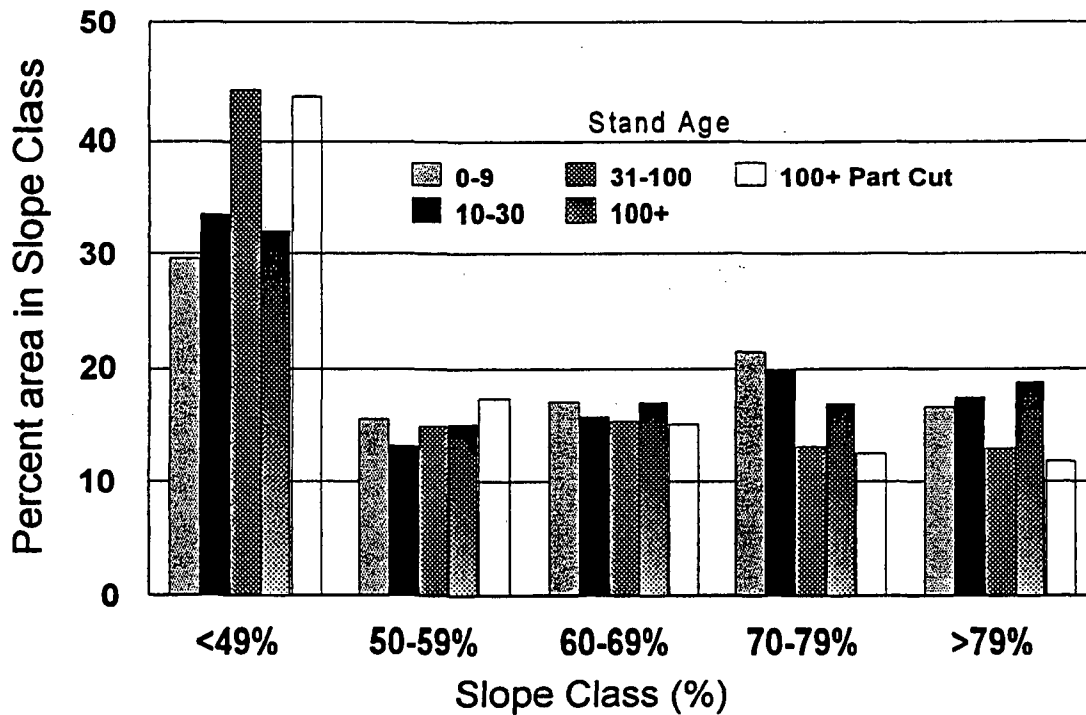
Figure 23. Slope steepness distribution by age class in the Elk Creek study area based on 6 meter DEM GIS coverage.

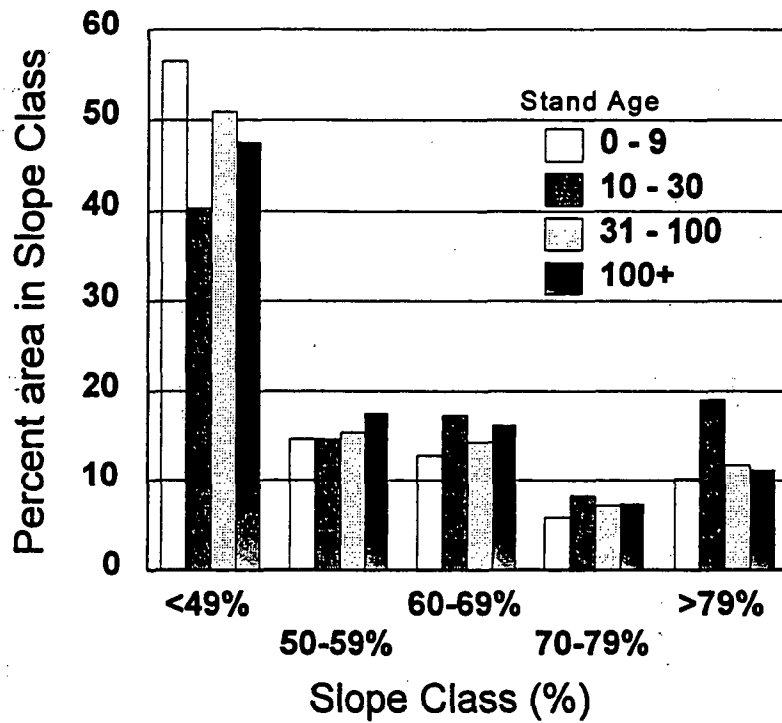
Figure 25. Slope steepness distribution by stand age class in the Mapleton study area based on 10 meter DEM GIS coverage.

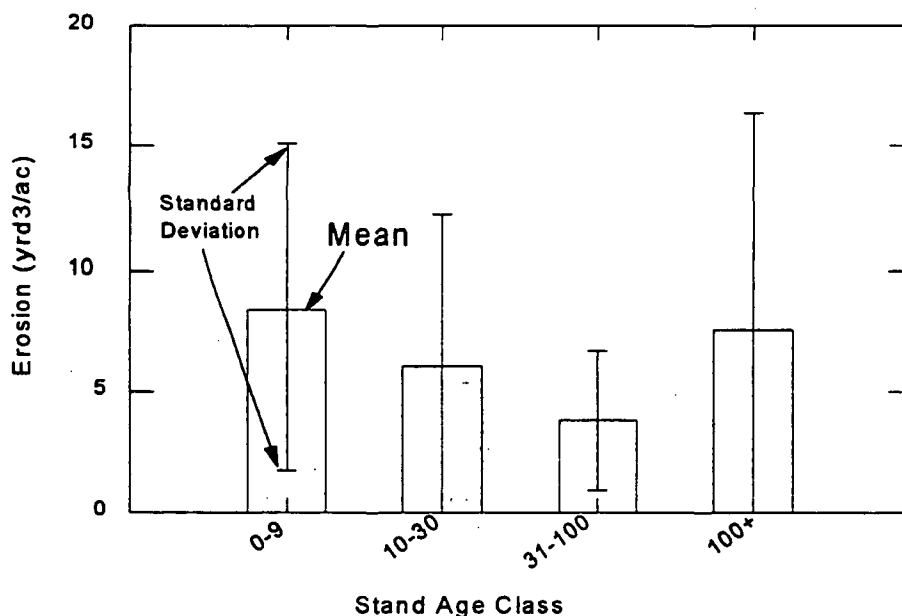
Figure 27. Bar graph showing distribution in erosion of the four multi-stand-age red zone study areas by age class.

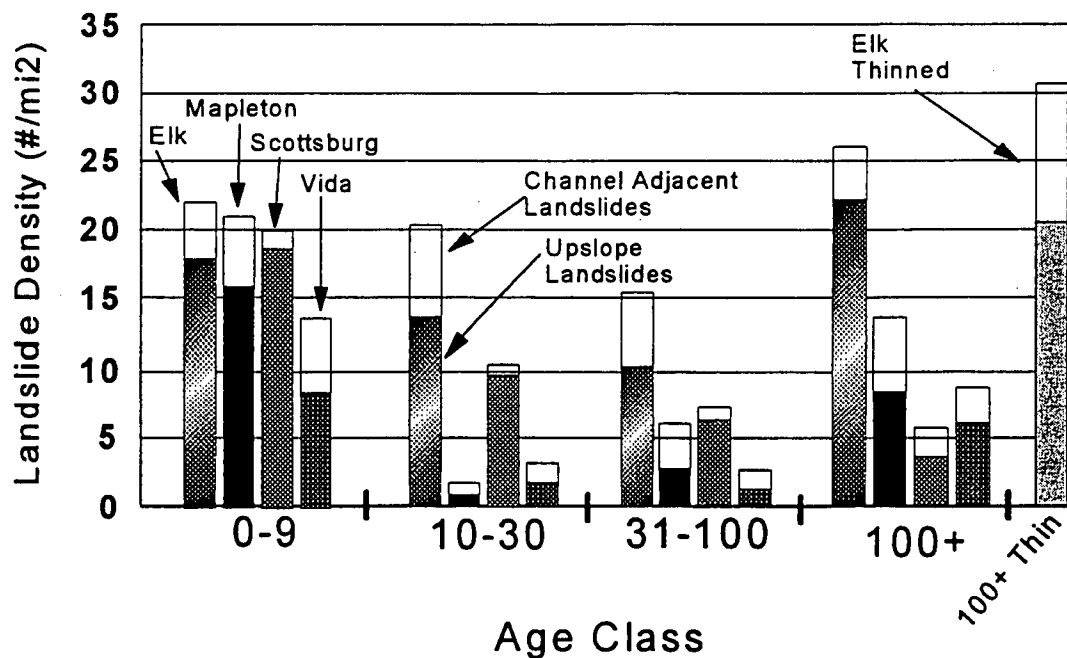
Figure 28. Stacked bar graph of landslide density for upslope and channel adjacent landslides by stand age class for the four red zone study areas.

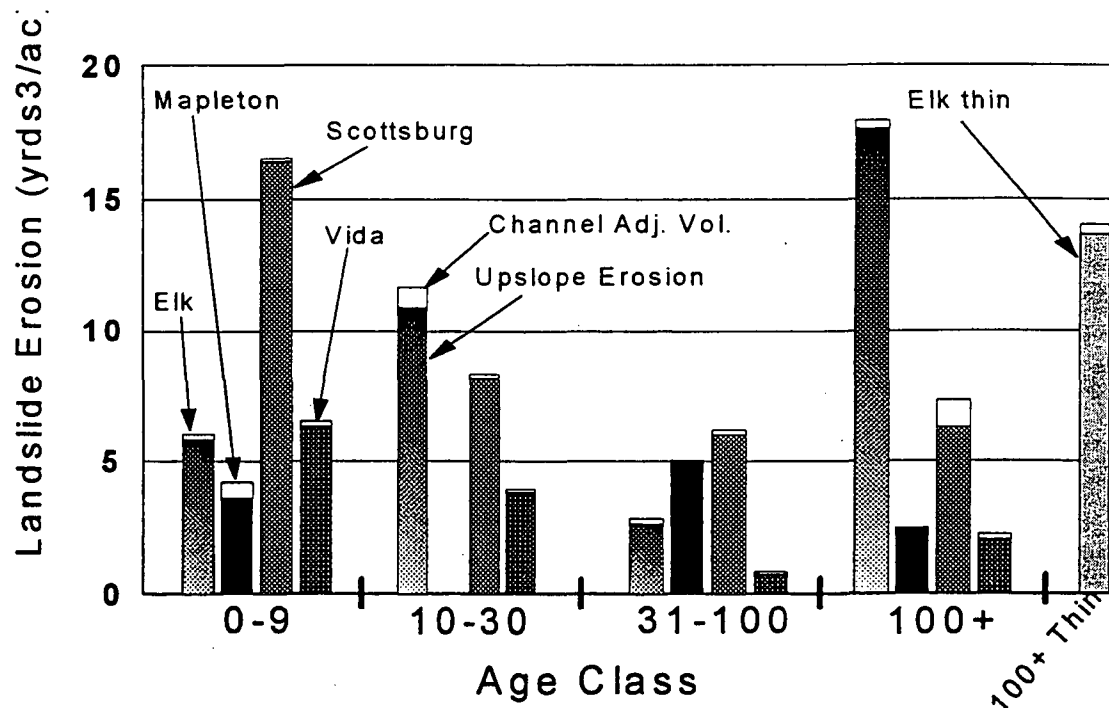
Figure 29. Stacked bar graph of landslide erosion rate for channel adjacent and upslope landslides by stand age class for the red zone study areas.

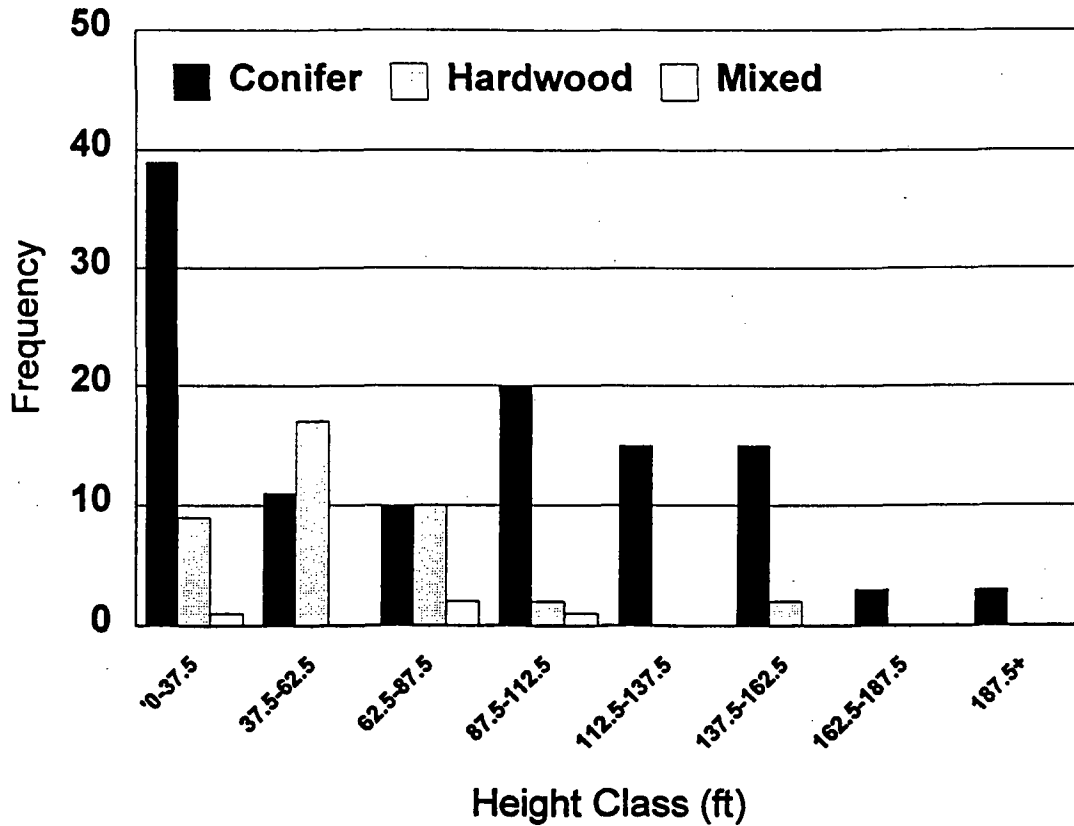
Figure 31. Vegetation type (conifer, deciduous, or mixed) around landslides that had dominant vegetation of various heights.

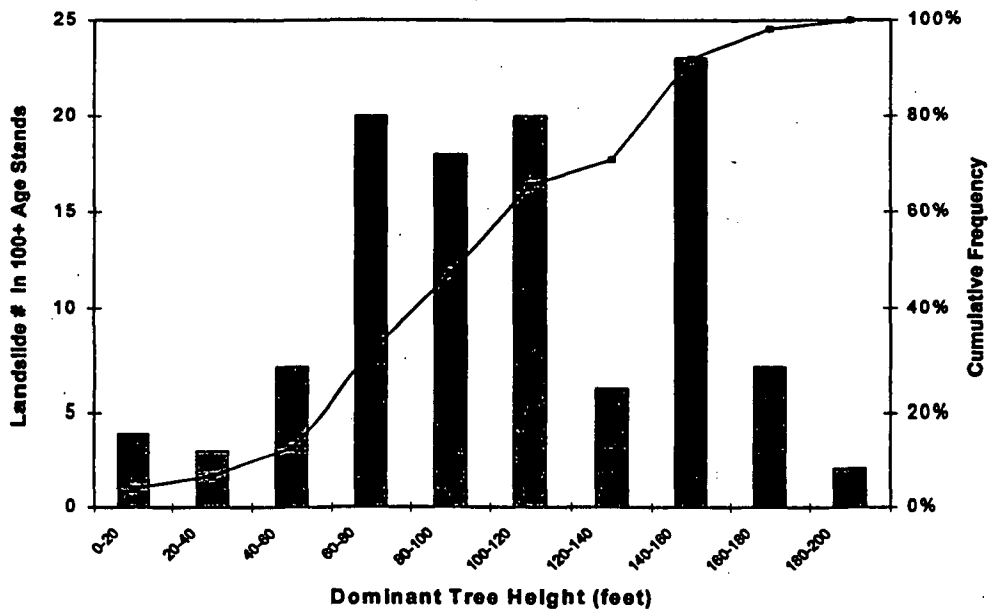
Figure 32. Frequency histogram of dominant vegetative height classes for red zone in mature (100 year-plus stand ages) forests.

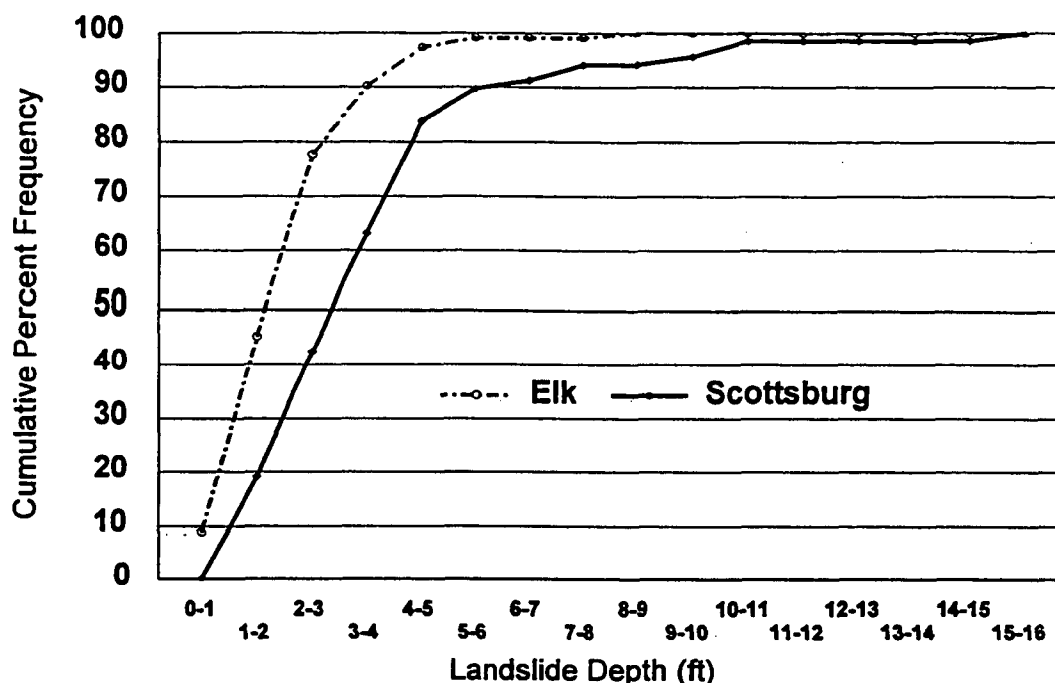
Figure 33. Landslide depth comparisons (via percent cumulative frequency distributions) between the Elk Creek and Scottsburg study areas.
