Greenwood Creek Watershed Project

1996 Road Survey Summary Report

**Greenwood Creek
Watershed Project**

**1996 Road Survey
Summary Report**

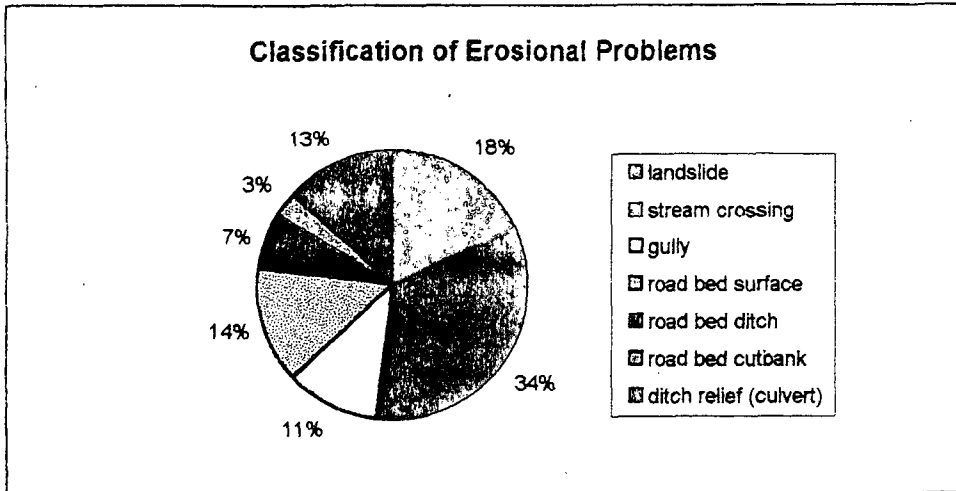
Figure 3.

The largest source of erosion problems were stream crossings (34% of all sites), followed by landslides (18%), road bed surface (14%), ditch relief-culverts (13%), gullies (11%), road bed ditches (7%) and road bed cutbanks (3%). Within each of these categories, more detailed information was collected, such as type of landslide or road failure or size of culvert recommended, requiring measurement of channel dimensions and channel gradient.

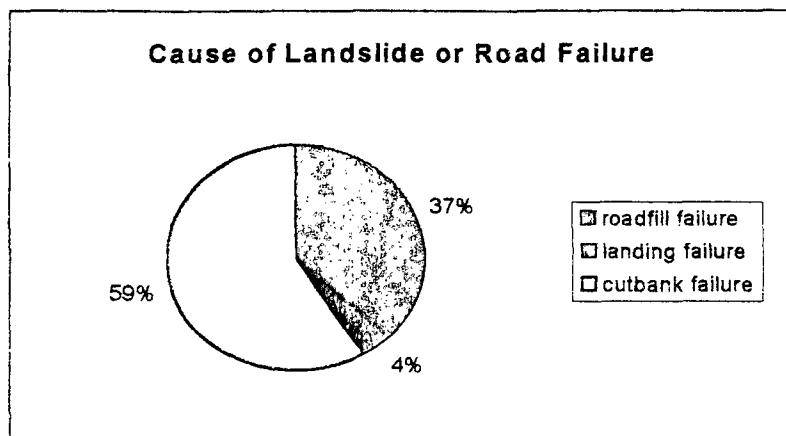
Figure 4.

Landslides were identified at 87 sites. Sliding due to road fill failures was noted at 32 sites (37%), three sites were attributed to landing fill failures (4%), and 52 sites attributed to cutbank slides (59%). Four of these latter sites were identified as deep-seated landslides. Of these 87 sites, 6% were on slopes of <30%, 28% were on slopes of 30-60% and not surprising, the majority, 66% were on slopes of 60% or greater. Distance from noted landslides to the nearest stream channel ranged from 10 feet to 250 ft., with an average of 72 ft. (Figures 4&5).

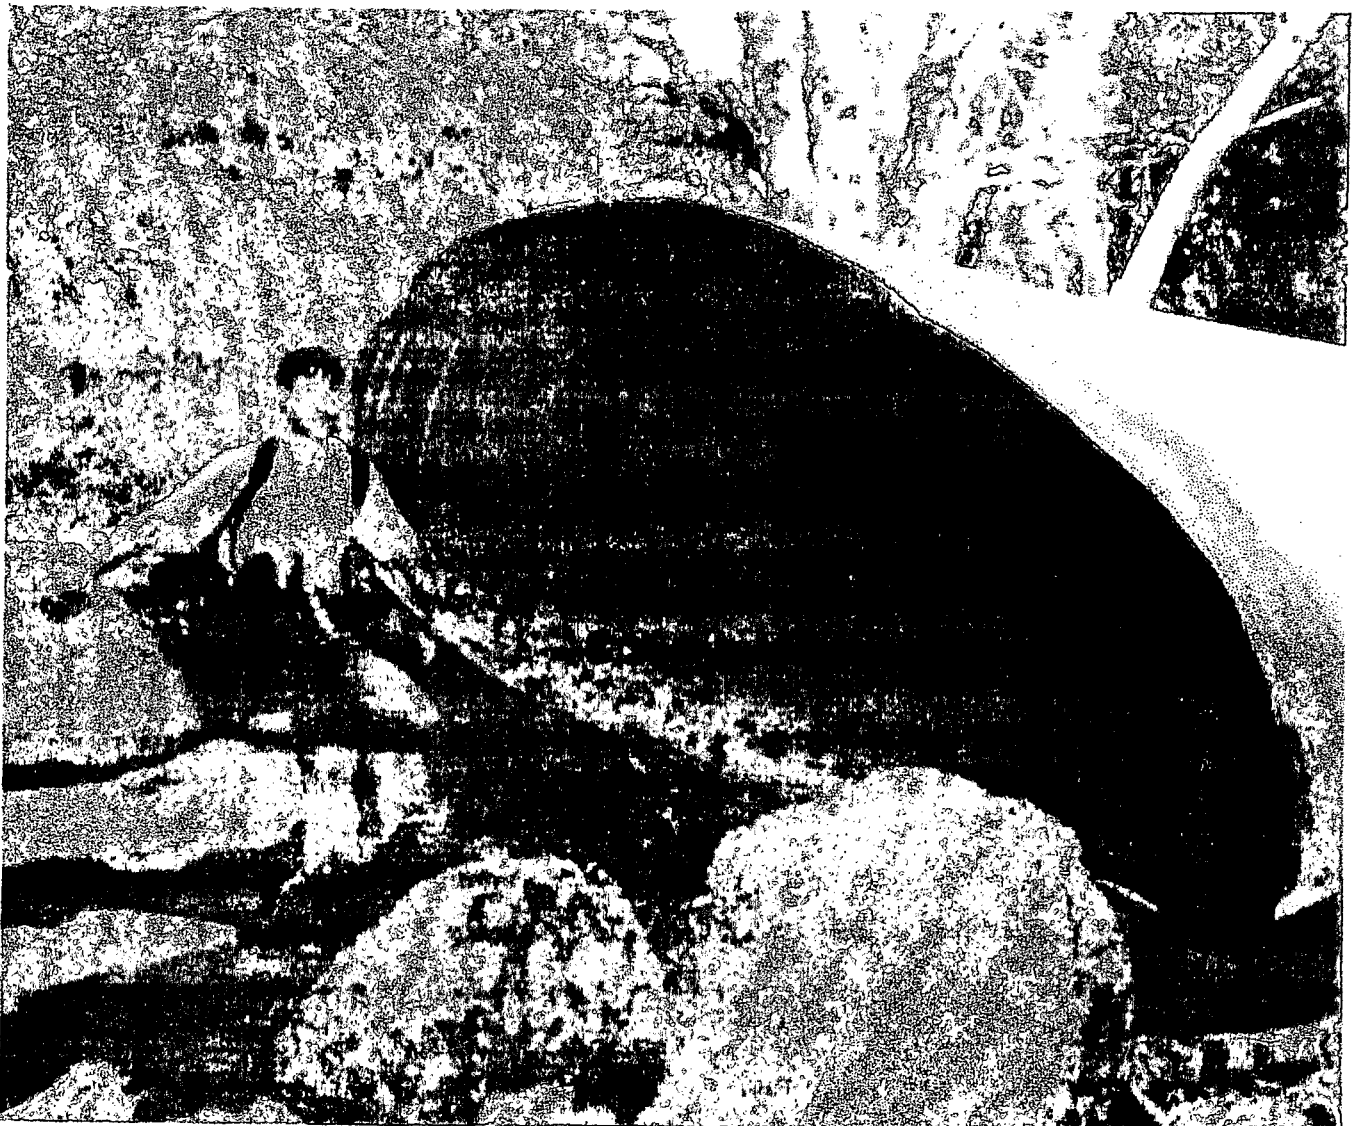
Road Survey 1996 - Priority Site 4
Jesse Russell (near blown culvert)
Summer, 1996
Photo by Dave Gurney

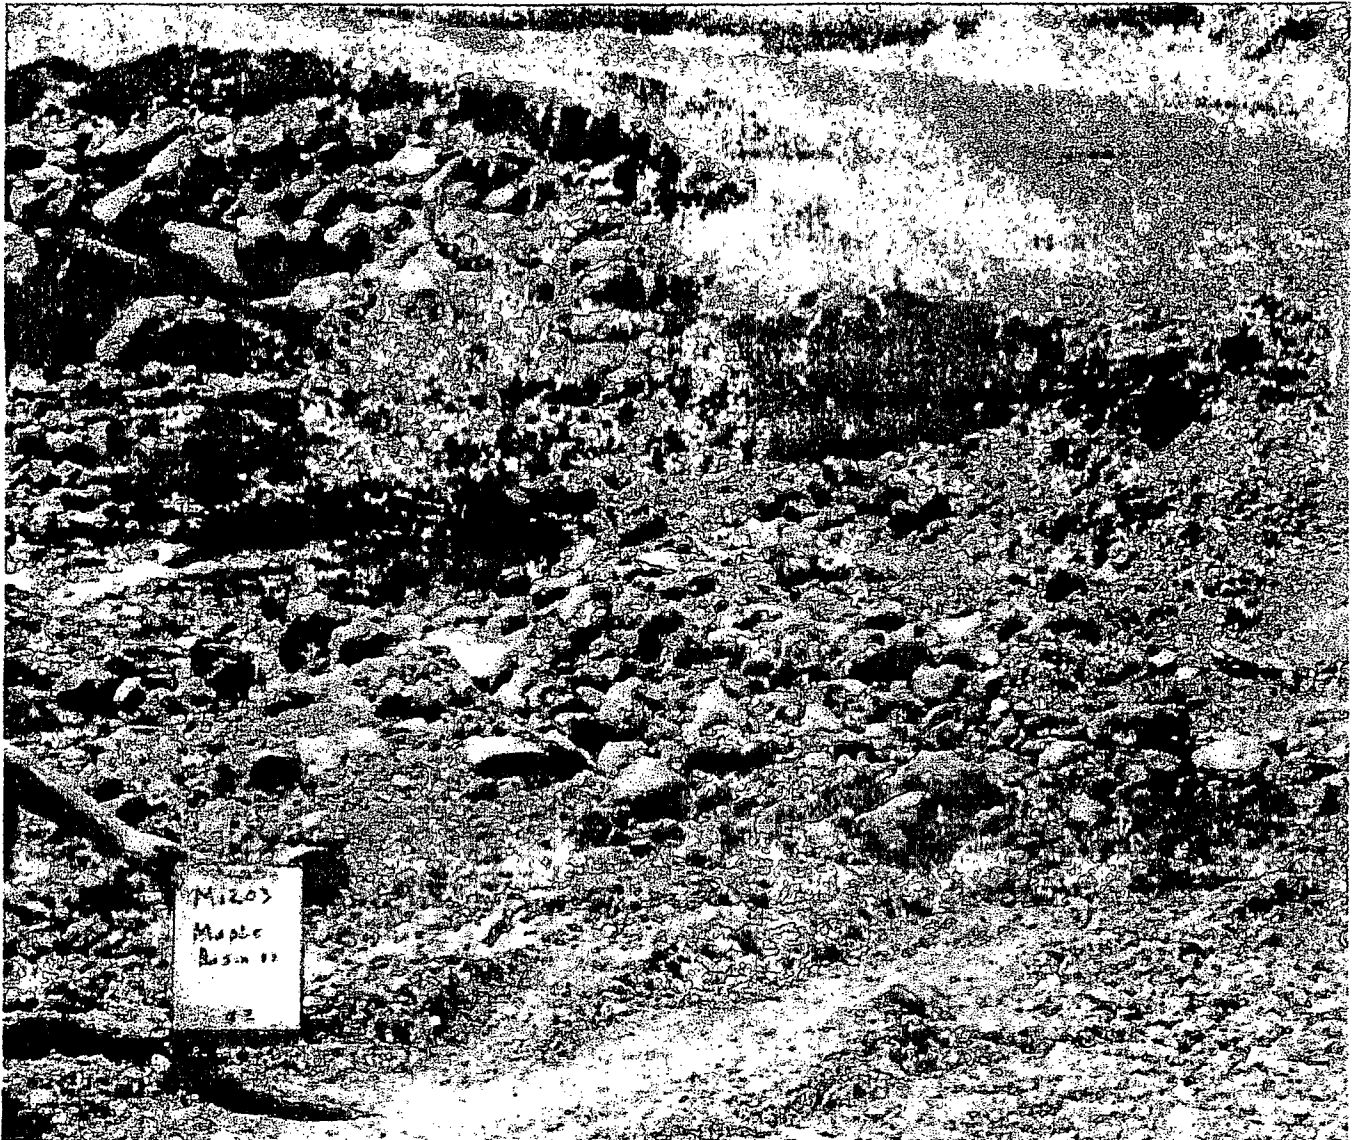
Road Survey 1996 - Priority Site 10
Coho Salmon Crossing
Photo by Dave Gurney
