# 1998 Redwood Creek Estuary Annual Monitoring Report

Redwood National and State Parks  
Division of Resource Management and Science  
Fish and Wildlife Branch

This is a summary of Redwood National and State Parks Fish and Wildlife Branch monitoring activities in the Redwood Creek estuary for the calendar year 1998. The purpose of the study is to determine utilization of the estuary by fish, monitor estuary water and sand berm elevations, and document breaching incidents. This report serves as the annual report for the Division of Resource Management and Science and the U.S. Army Corps of Engineers (Corps). An annual report is specified by special condition seven of Corps permit No. 21881N. The permit authorizes breaching of the mouth of Redwood Creek. The eight special conditions of the permit are addressed in this report. A copy of the permit is in Appendix I.

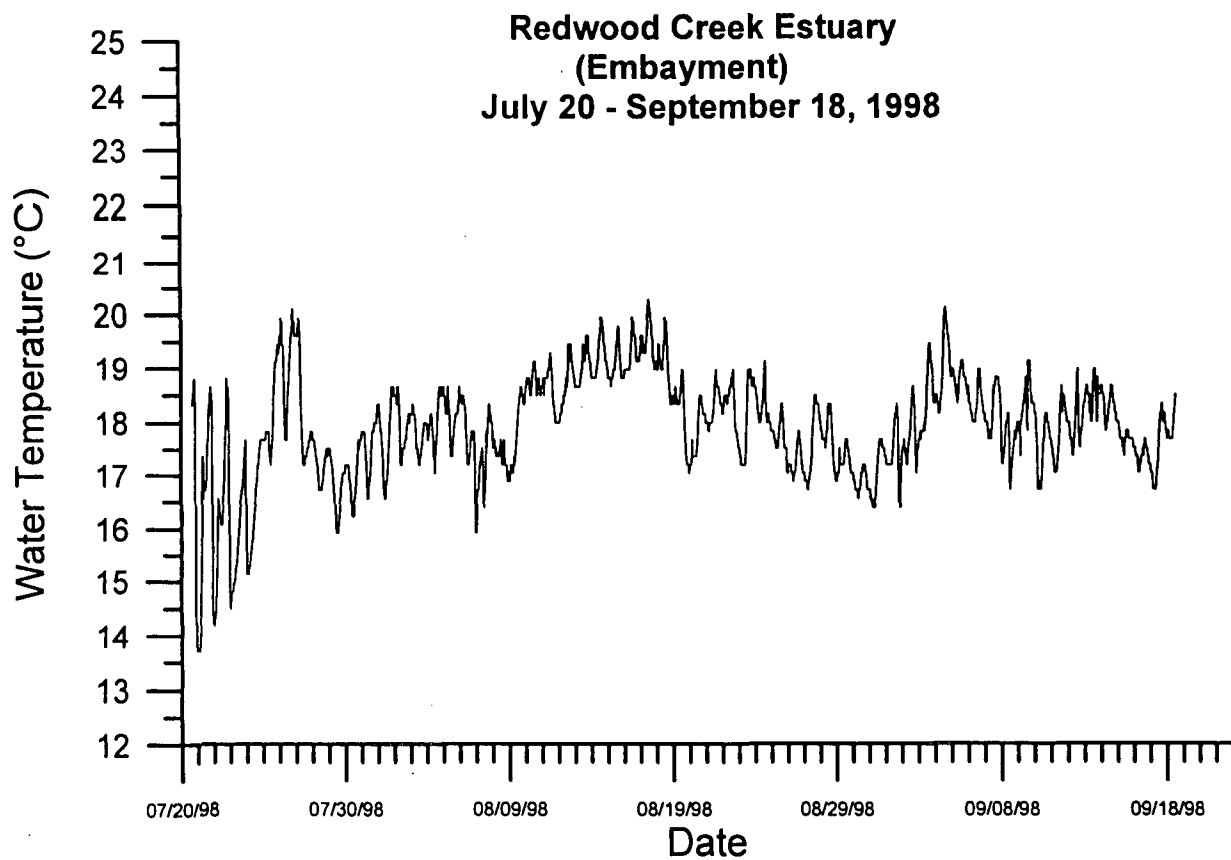
Figure 2. Redwood Creek estuary water temperatures (°C) measured by a HOBO temperature logger located in the middle of the Redwood Creek channel between the ends of the north and south flood control levees in the embayment. The temperature logger, located one foot from the bottom, recorded water temperature every 48 minutes from July 20 through September 18, 1998.

In 1998, water temperature (°C) was the only water quality parameter monitored in the Redwood Creek estuary. The HOBO temperature logger recorded water temperature every 48 minutes from July 20 through September 18, 1998 (Figure 2). The maximum and minimum water temperature were 20.2 and 13.7 °C. The average water temperature for the period of 60 days was 17.9°C. Though a logger was placed in the estuary on May 28, a laptop computer failure prevented the retrieval of the early data stored on the hard disk. It will be downloaded later and incorporated in a later report.

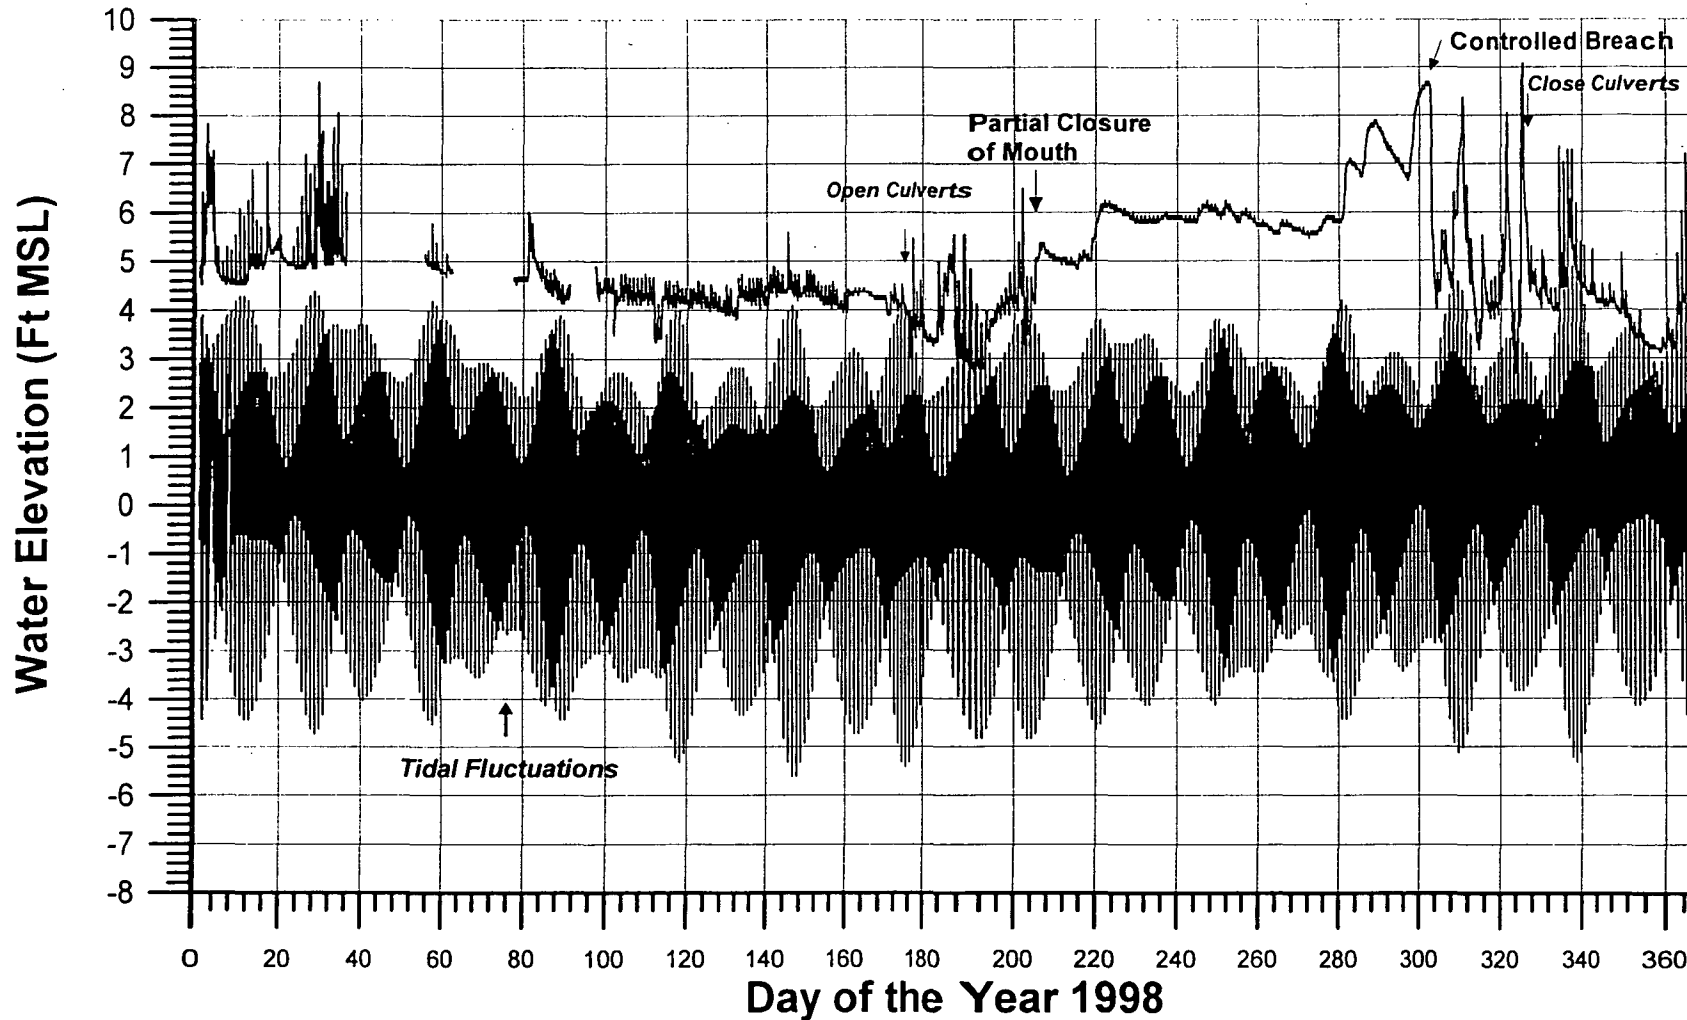
## South Slough Water Level Record and Tide 01/01/98 - 12/31/98

Figure 3. South slough water elevations (feet Mean Sea Level [MSL]) of the Redwood Creek estuary, Humboldt County for the period January 1 to December 31, 1998, excluding February 5 through 24, March 3 through 18, and April 1 through 7, 1998. Estimated tidal elevations are corrected for the coastal locality at the mouth of Redwood Creek and adjusted to feet MSL. A controlled breach occurred on October 29, 1998.

South Slough and South Levee Water Level Gaging - South slough water elevations (feet MSL) were recorded for the period January 1 to December 31, 1998, excluding February 5 through 24, March 3 through 18, and April 1 through 7 (Figure 3). A bad chip caused the latter two data lapses.

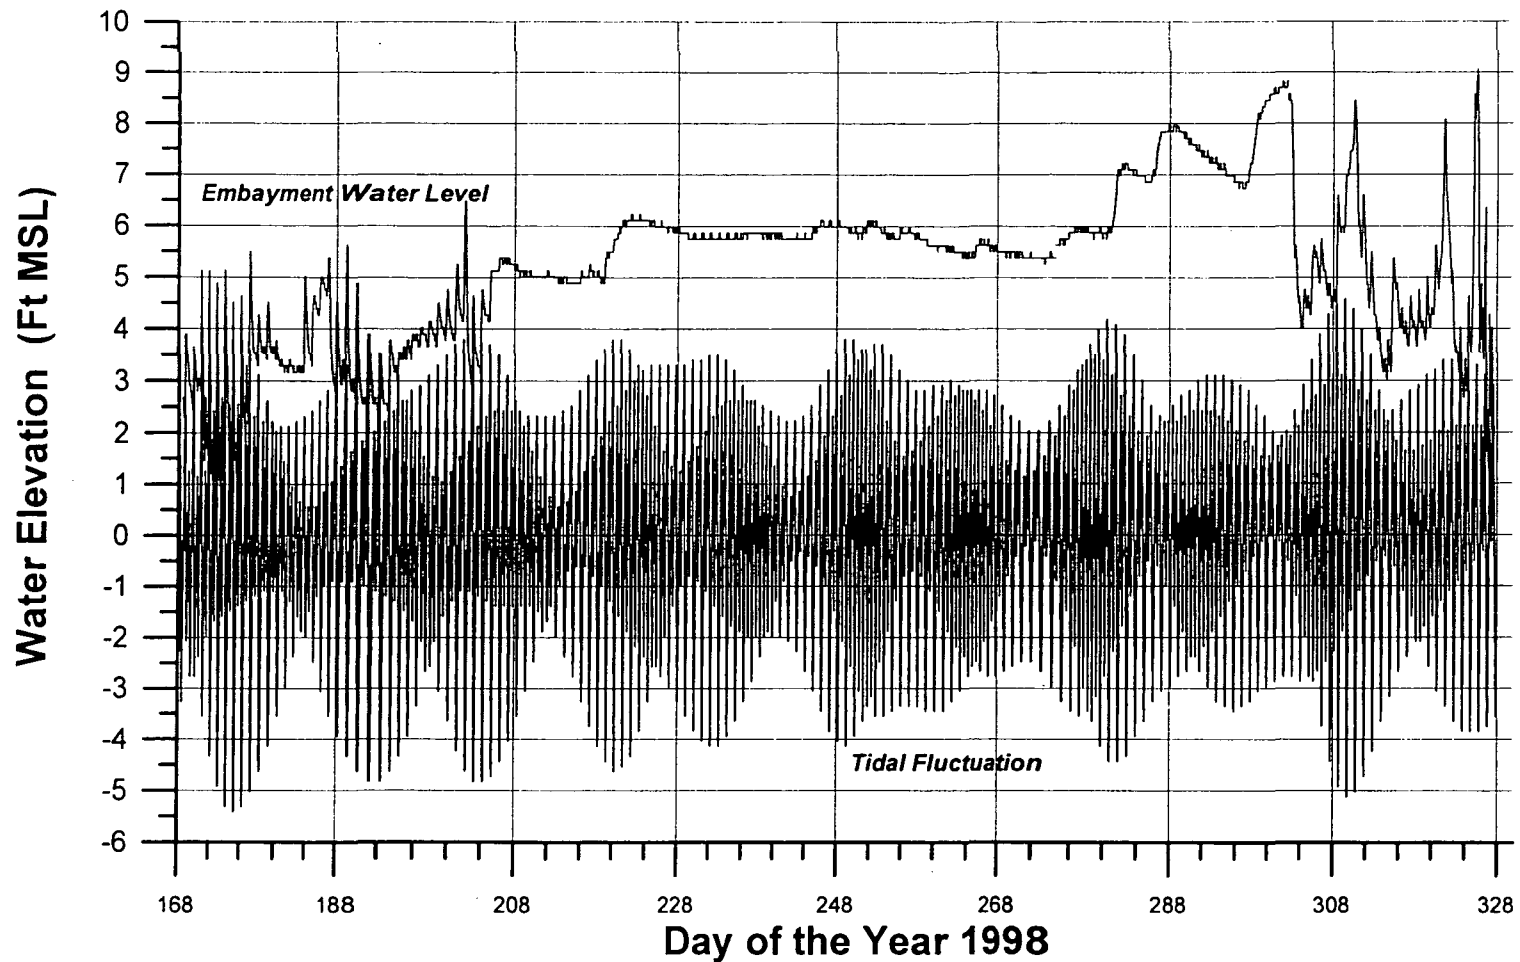
**Embayment Water Level  
Tides at Mouth of Redwood Creek  
06/17/98 - 11/23/98**

Figure 4. Embayment water elevations (feet Mean Sea Level [MSL]) of the Redwood Creek estuary, Humboldt County for the period the seasonal gage was in operation, June 12 through November 23, 1998. Estimated tidal elevations are corrected for the coastal locality at the mouth of Redwood Creek and adjusted to feet MSL. A controlled breach occurred on October 29, 1998.

The south levee gage measured embayment water elevations from June 17 to November 23, 1998 (Figure 4). Gaging was stopped after the November 21 35,500 cfs flow event to retrieve the ENMOS recording equipment before high flows, ocean waves, and driftwood being thrown on the south levee would damage it.

After the July 23 partial closure, the water level quickly rose to 5 ft MSL and maintained that elevation for 14 days, wherein the level rose to 6 ft MSL over 2 days. It maintained that level until September 14 when it started to decline and hover around 5.5 ft MSL (Figure 4).

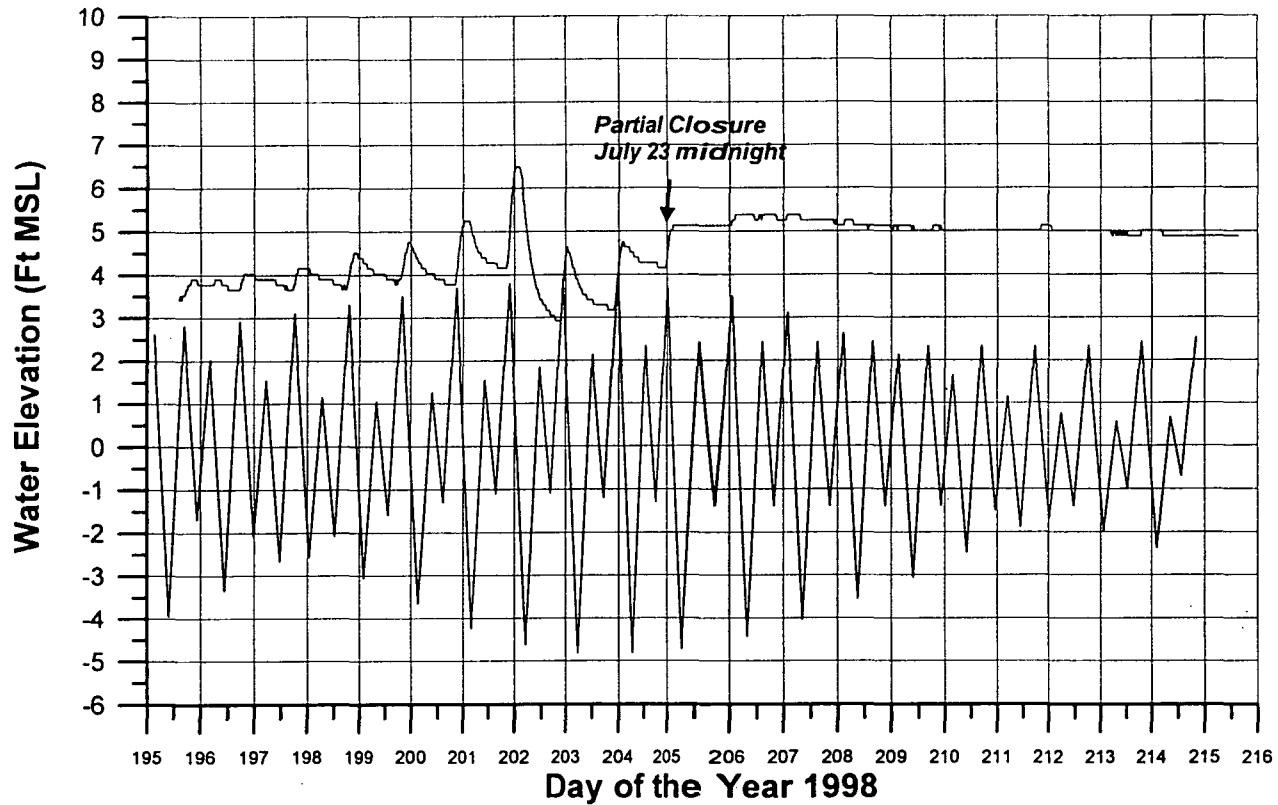
Embayment Water Level  
Tides at Mouth of Redwood Creek  
07/14/98 - 08/03/98

Figure 5. Partial closure of the channel of Redwood Creek estuary on July 23, 1998 at midnight.

The mouth of the creek partially closed on July 23 at midnight at approximately 4 ft MSL (Figure 5). It occurred at the peak of high tide, the wave overwash most likely filling in more of the small channel with sand. Tidal influence ended in the estuary, except from wave overwash over the berm.

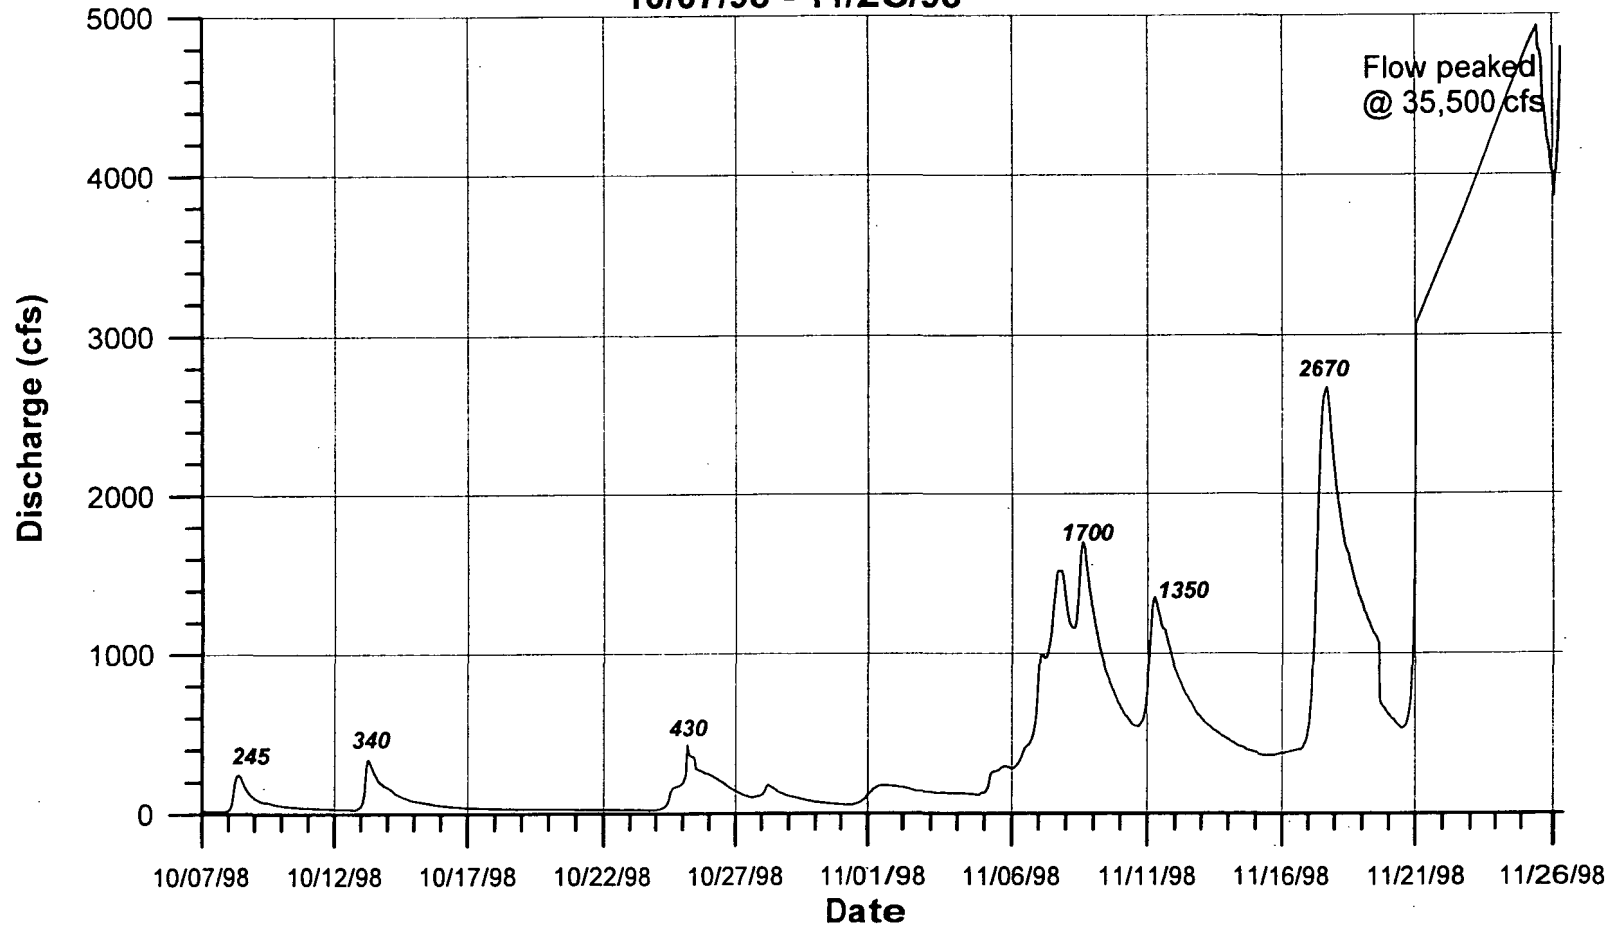
**Redwood Creek Flow at Orick (ORK)  
10/07/98 - 11/25/98**

Figure 6. Redwood Creek flow (cfs) at Orick (ORK) stream flow gage for the period October 7 to November 25, 1998. Data is clipped at 5,000 cfs. Peak flow on November 21, was 35,500 cfs.

Beginning on October 8, and responding to two small peak flow events of 245 cfs and 340 cfs (Figures 6), the water level peaked at 7.96 ft MSL on October 14, but again decreased to 6.73 ft MSL on October 23, 1998 (Figure 7). A peak flow event of 430 cfs on October 25 caused the water level to increase to 8.8 ft MSL on October 29 at which time a controlled breach was completed.

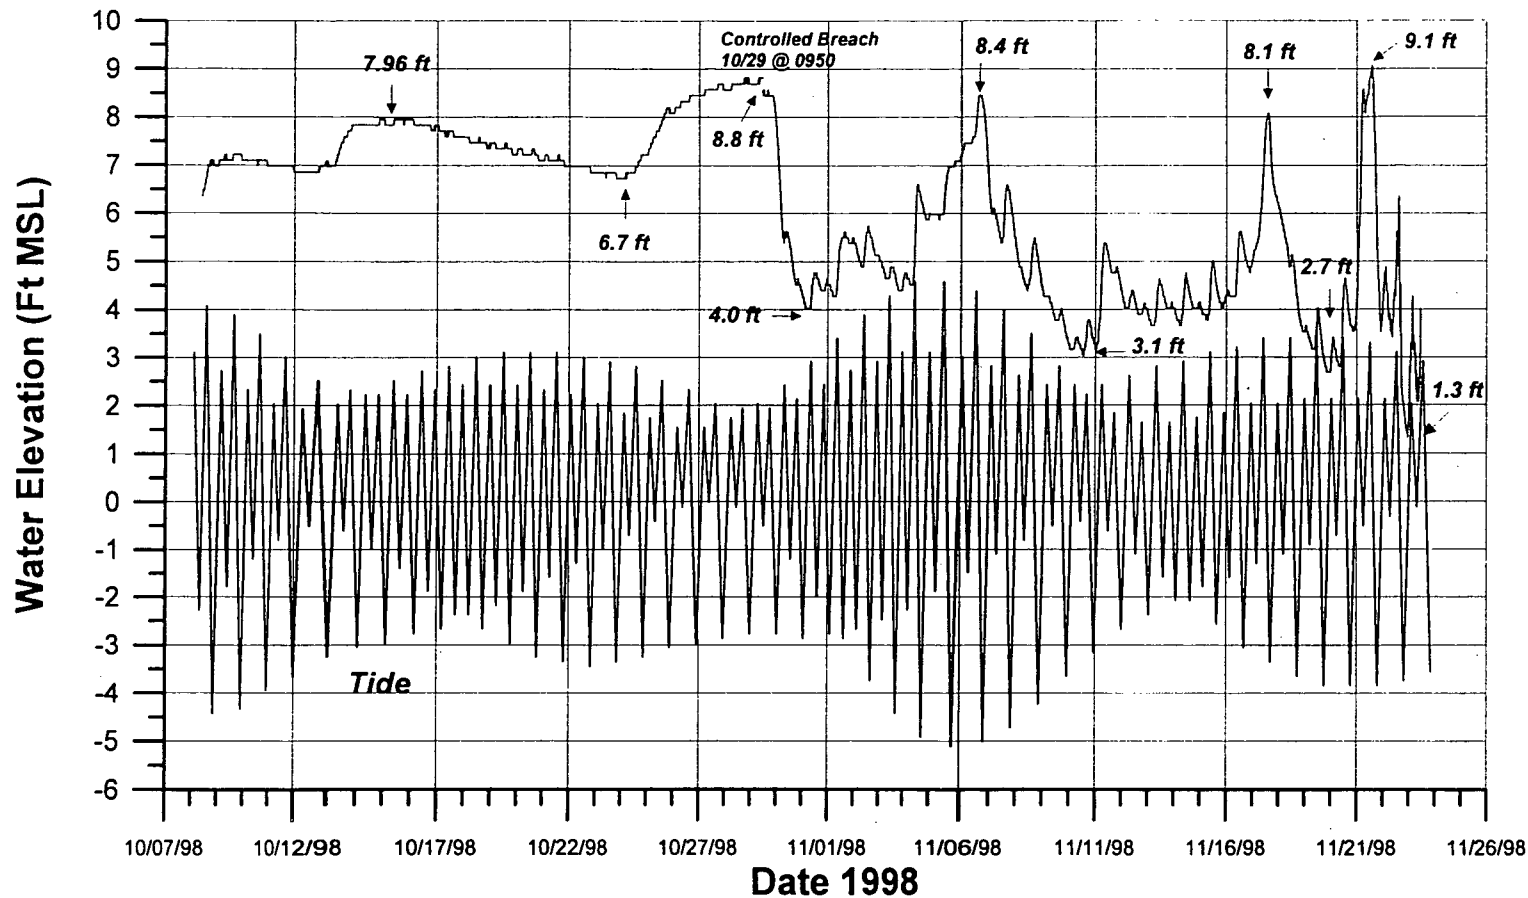
### Embayment Water Level and Tides at Mouth of Redwood Creek 10/08/98 - 11/23/98

Figure 7. Redwood Creek embayment water elevations and tides at the mouth of Redwood Creek in feet Mean Sea Level (MSL) before and after the controlled breach on October 29, 1998.

After the breach, the water level of the embayment decreased to 4.0 ft MSL on October 31, a decrease of 4.8 ft over 1.7 days (Figure 7). Based on embayment volume estimations, a 61% loss in volume (2,240,000 ft<sup>3</sup>) occurred. On November 6, the water level peaked at 8.4 ft, appearing to close briefly at the peak of a series of high tides. However a bimodal storm event peaking at 1,700 cfs naturally opened the mouth and the water level fell to 3.1 ft over 3.9 days.

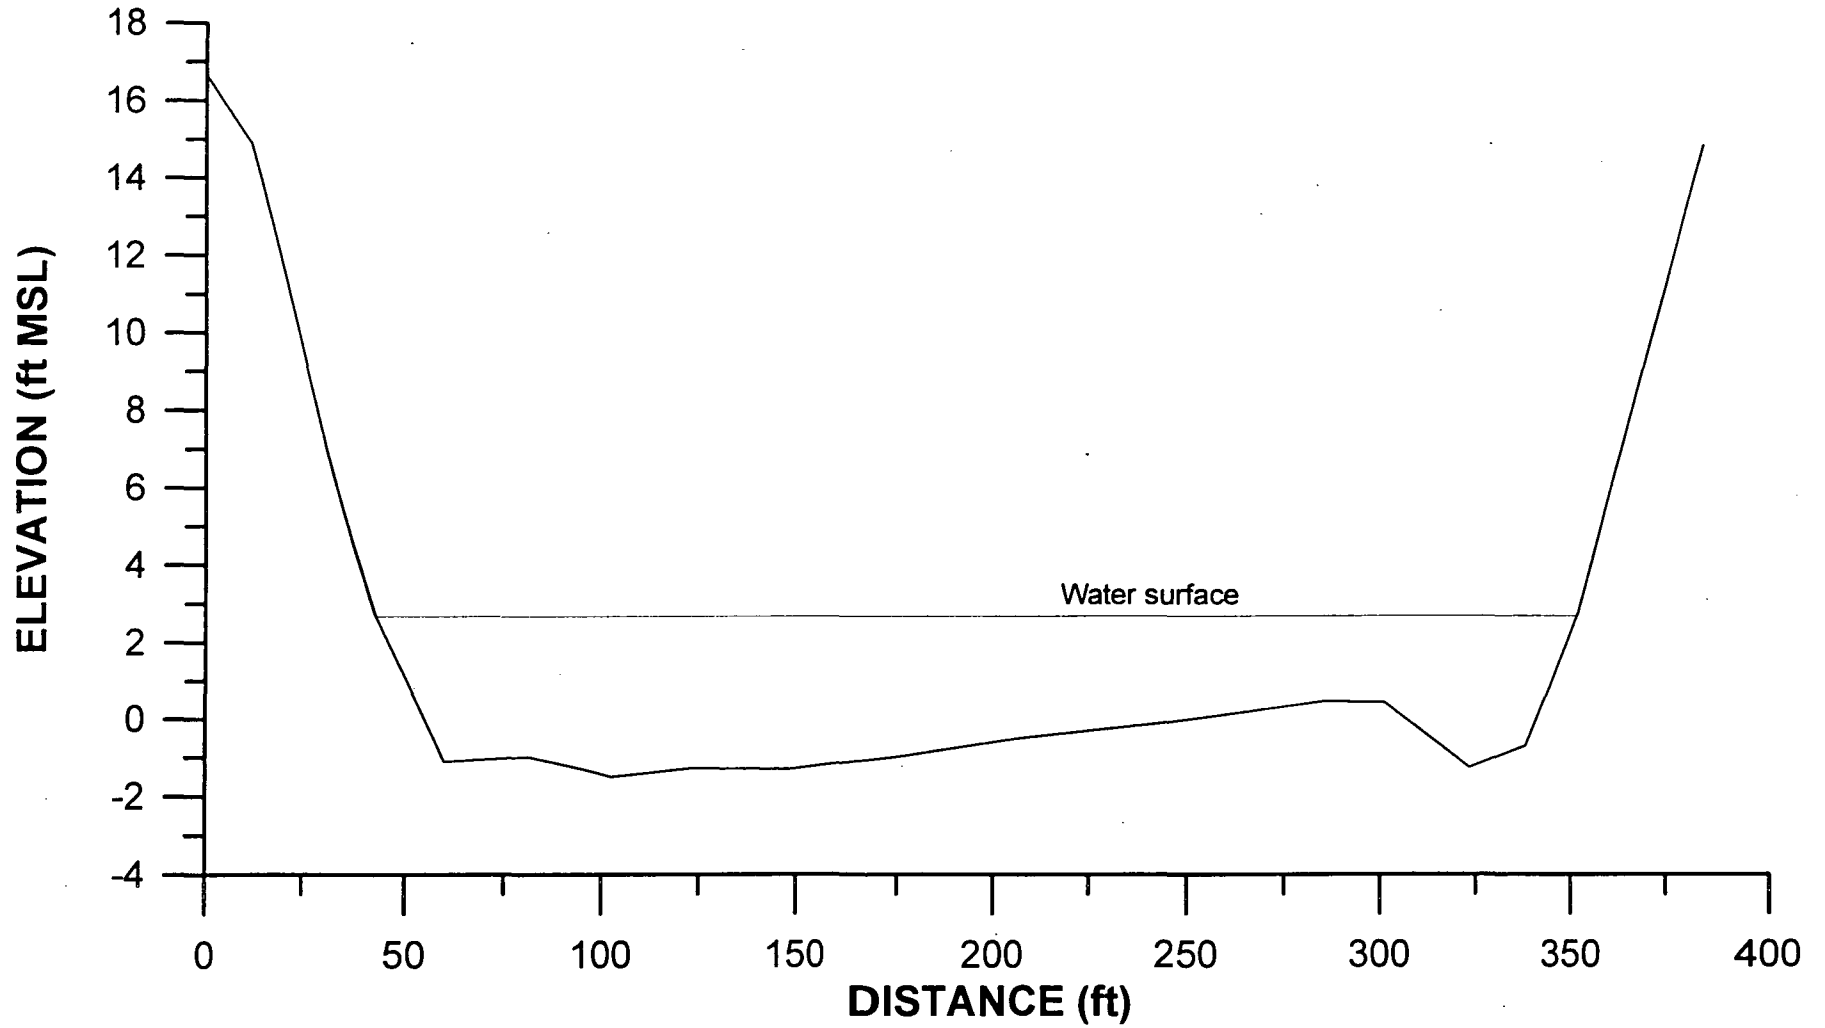
# ESTUARY CROSS SECTION E-1

Appendix III . The five permanent cross-sections in the estuary embayment perpendicular to the flow. Established and surveyed in June of 1998, each cross section was shot at a bearing of 169° from the north endpoints through the embayment to the sand dunes on the south. The parallel cross sections start between the ends of the levees with E-1 and end to the west with E-5 at the seawall adjacent to the berm. Zero on the x-axis of each graph represents the northside endpoint. The water surface was that at the time of the June 24 or 29, 1998 survey.

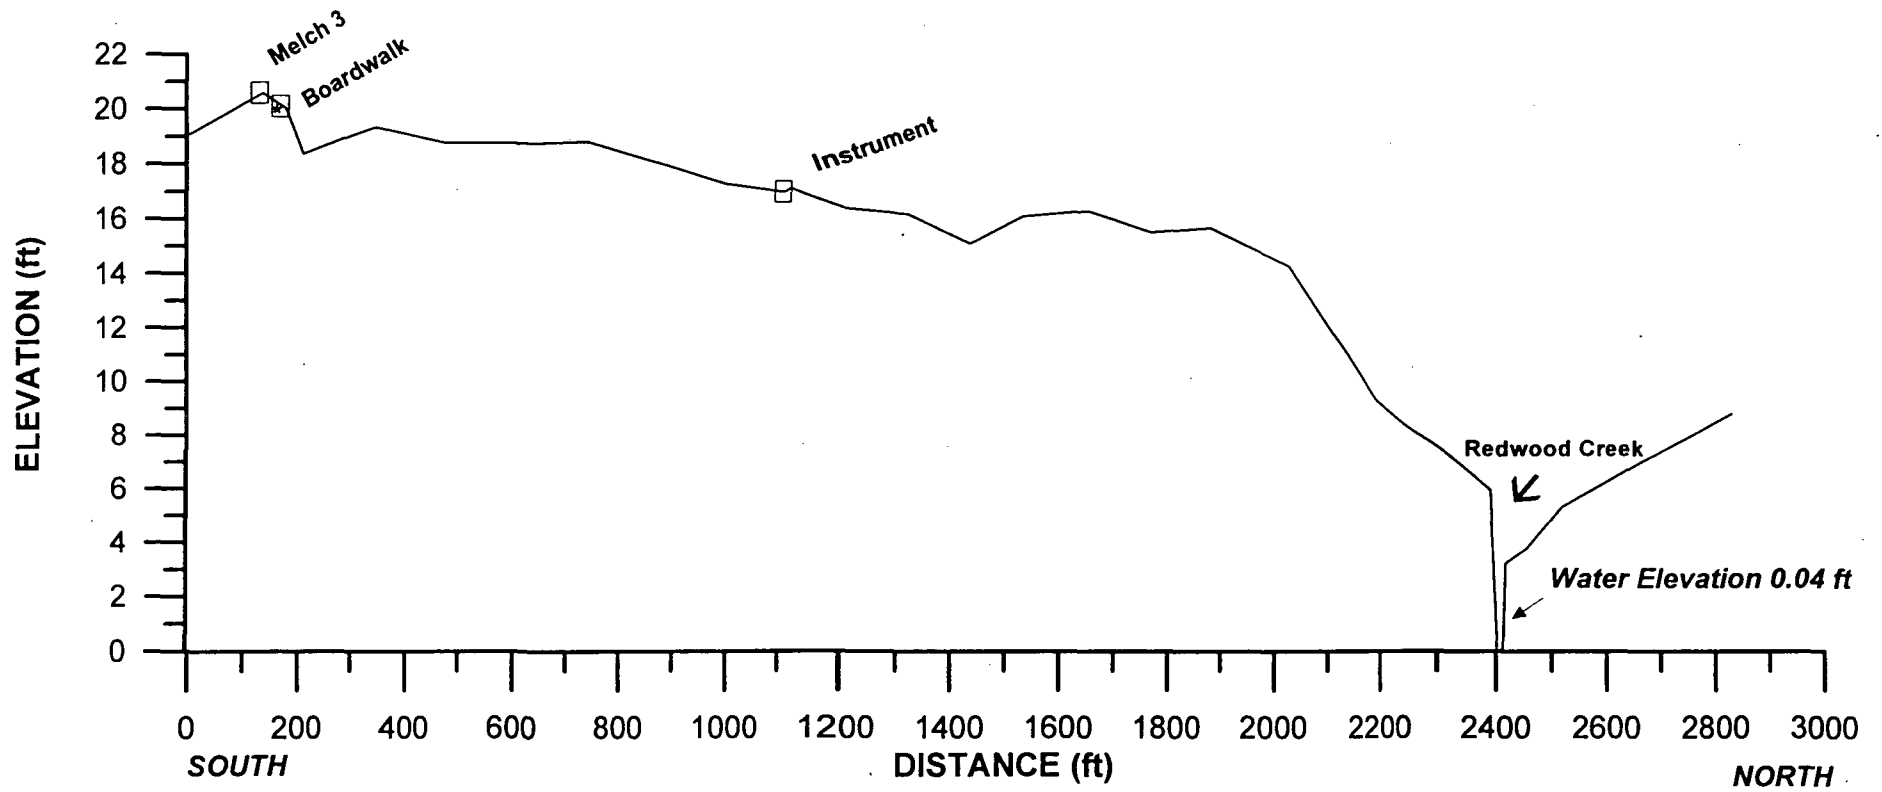
# RWC ESTUARY DUNE PROFILE 1

Appendix V. Longitudinal profiles of the sand berm along the highest ridge parallel to the shore and separating the estuary from the ocean for May 27, June 24, August 3, August 26, and September 21, 1998 (Profiles 1 through 5 respectively). The profiles extended from a minimum of 100 feet north of the estuary to 100 feet south of the Redwood Information Center (RIC). . Measurements were taken at breaks in slope along the sand berm. The elevations in feet MSL were referenced in the south to a permanent NOAA benchmark referred to as Melch 3 located west of RIC and to the end of the RIC boardwalk. In the north, they were referenced to a BLM benchmark, and the western most estuary cross section endpoint of E-5, RM2, a rock seastack. The winter storm berm, denoted as the high berm, and later in the summer, the summer swell berm, denoted as the low berm, were surveyed. The mouth was completely closed to the ocean on August 26 and September 21 surveys.
