FLOODS OF 18 JANUARY 1953 IN NORTHERN CALIFORNIA COASTAL STREAMS

PREPARED IN THE
OFFICE OF THE DISTRICT ENGINEER
CORPS OF ENGINEERS, U.S.A.
SAN FRANCISCO DISTRICT

JUNE 1953

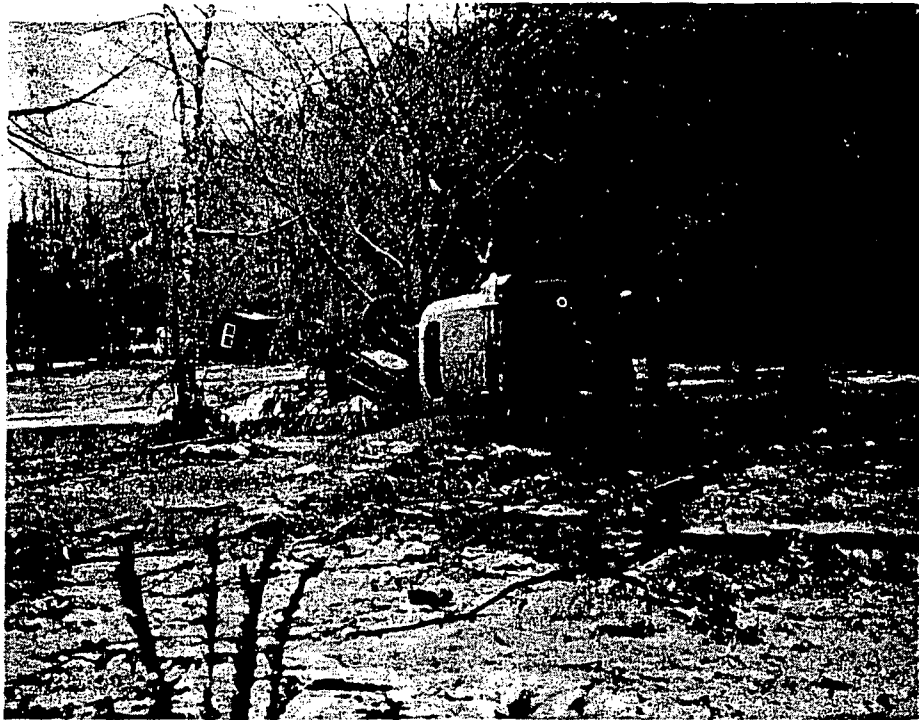
KLAMATH GLEN, CALIFORNIA, SHOWING AUTOMOBILES WASHED DOWNSTREAM BY OVERFLOW OF KLAMATH RIVER.

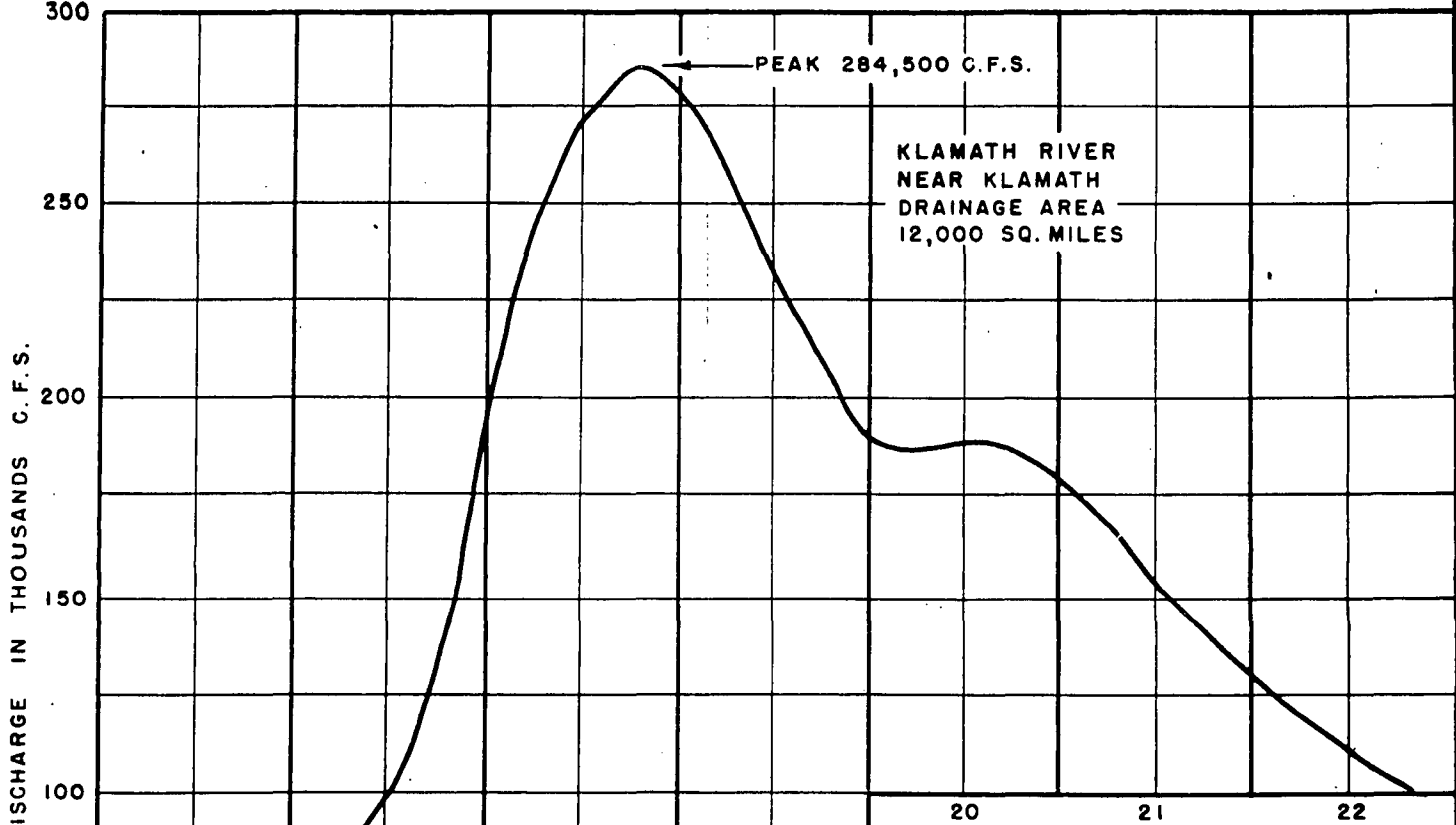
NOTE: HYDROGRAPHS ARE PRELIMINARY AND SUBJECT TO REVISION.
