**REDWOOD CREEK POOL SHELTERS  
FINAL REPORT  
FG-8451**

**1989-1990**

**TRINITY FISHERIES CONSULTING  
PO BOX 820  
ARCATA, CA.95521**

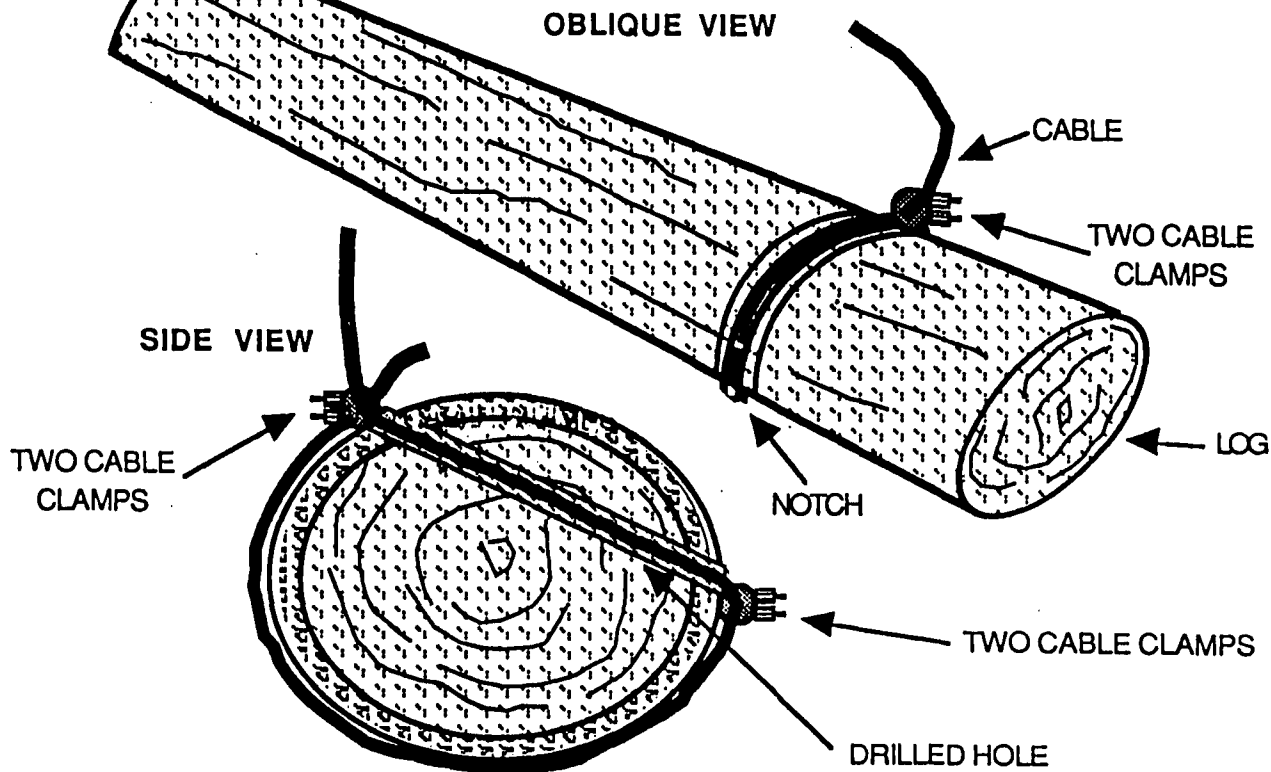
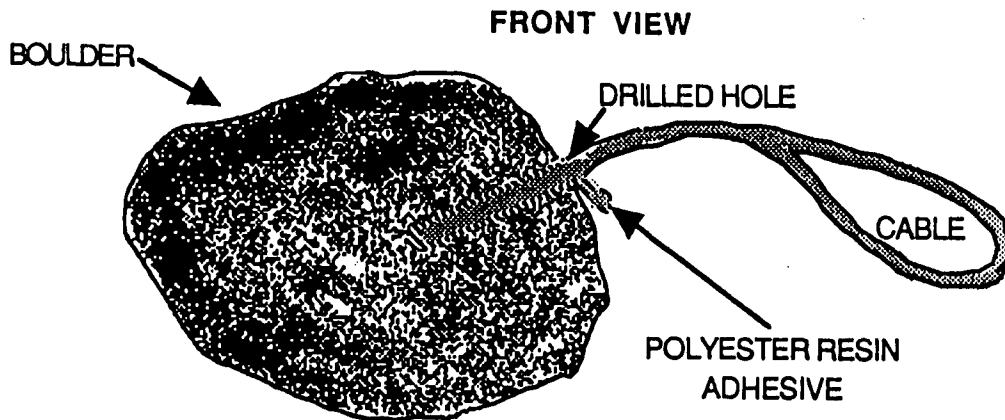
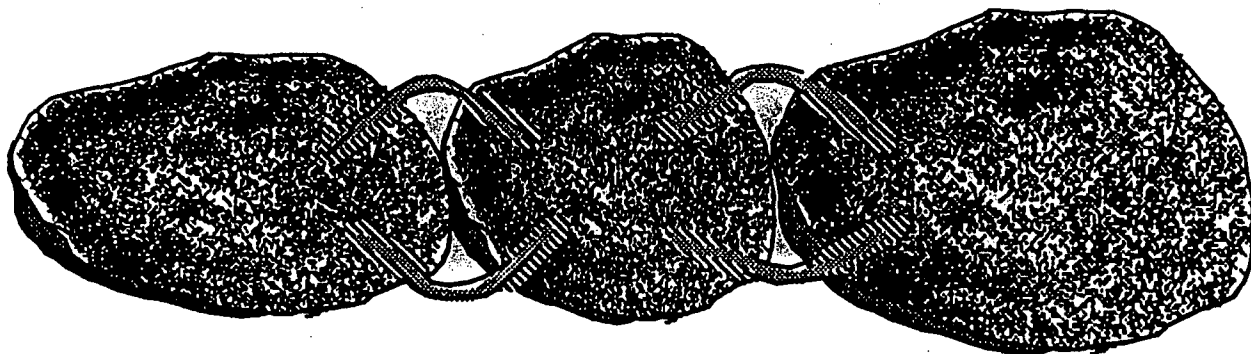
# CABLING

Large diameter steel cable is extremely stiff which resists bending. This can cause problems in creating tight enough anchor points. If cable is wrapped by hand around two logs and clamped together the cable will have slack. Slack creates flexibility at an anchor point, allowing the logs to twist and move. When this happens the cable can become frayed. Also, the cable can cut into the log creating additional slack, ultimately resulting in structure failure. To prevent this from happening the cable must be cinched tight. We have retrofitted standard cable clamps, welding hooks onto them (see picture #3) to provide a means of hooking a come-a-long to the cable ends. Clamps are attached to different places on the cable depending on the way in which the cable is wrapped. A come-a-long with it's yarding cable extended is hooked to one cable hook, wrapped around the logs and then hooked to the second cable hook. The come-a-long is then ratcheted in, tightening the cable. Before the cable is all the way tight two cable clamps can be put around the two cables where they are to be anchored. Leave the clamps loose so the cable can pull through them. Cinch the cable tight the rest of the way and then tighten down the cable clamps securing the anchor point.

The come-a-long can now be released and the cable will stay tight.
