CHANNEL CHANGES
AT CROSS SECTIONS
IN REDWOOD CREEK, CALIFORNIA

By
Nick Varnum

Redwood National Park
Arcata Office
Arcata, California 95521
October 1984

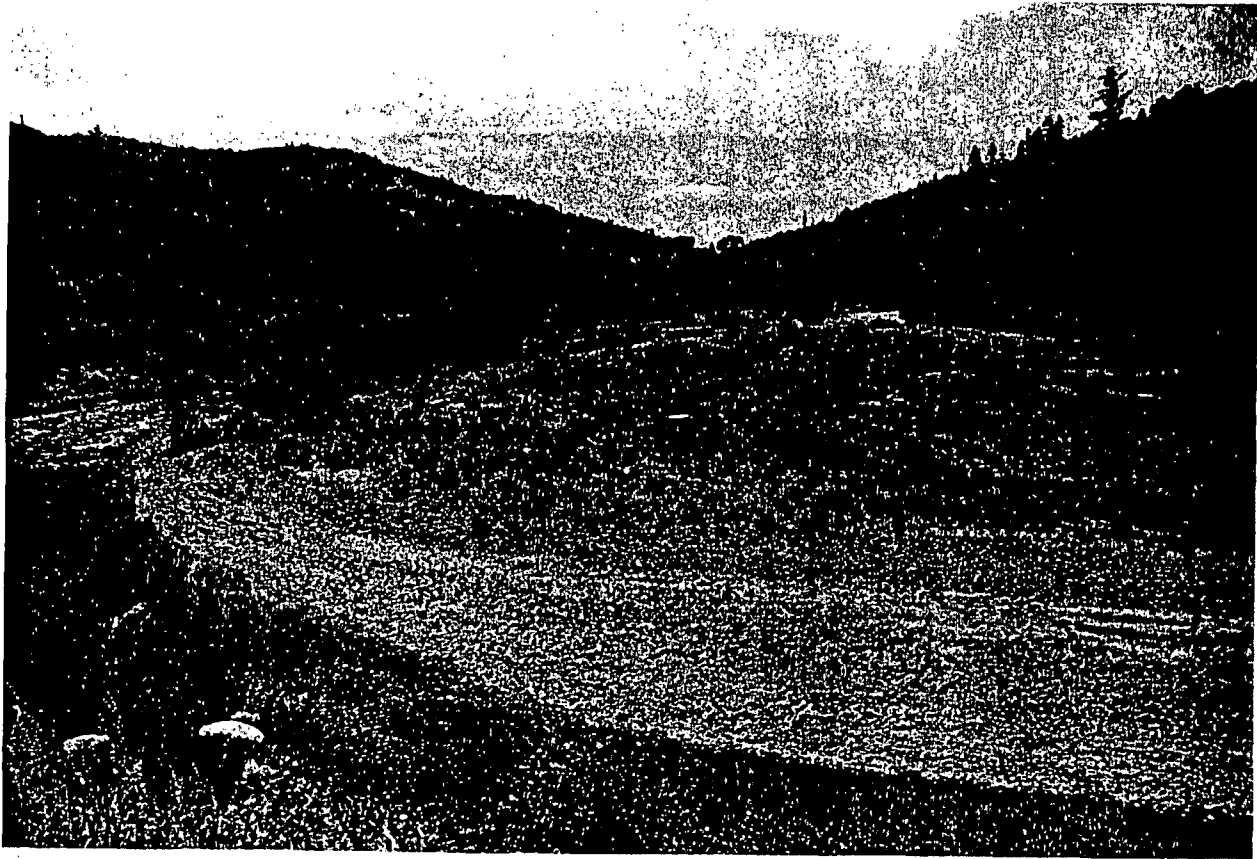
Figure 10: In Redwood Valley, channel widths up to 180 m are common and the streambed gradient is gentle. The lack of older vegetation on the storage bar indicates recent inundation by high flows.

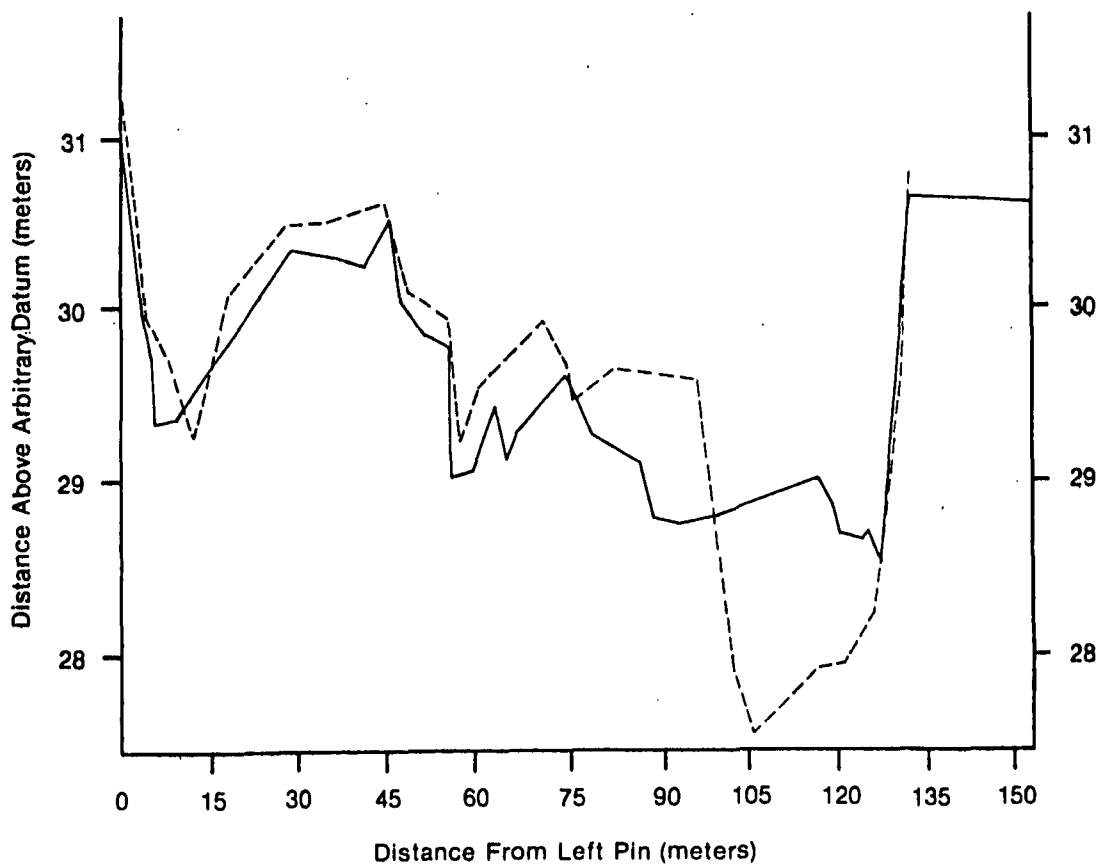
Survey Dates
7/7/82 - - - - -
8/5/81 —————

30x Vertical Exaggeration

Figure 11; Although this cross section showed a small net area change, there were major changes in thalweg shifting and thalweg elevation.

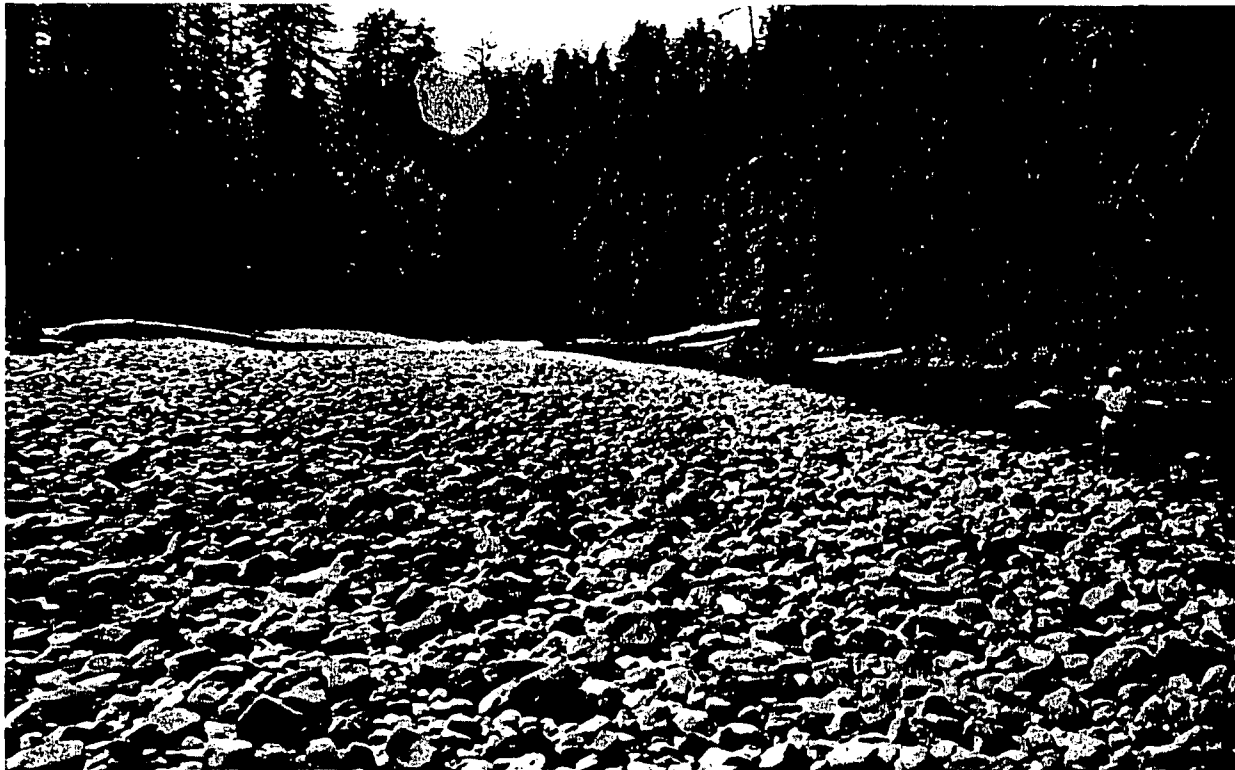
Figure 15: Downstream of the gorge, the riparian vegetation of Redwood Creek is typically old growth redwood forest. The streambed is also characterized by a wide alluviated channel. Between the base of the gorge and Bridge Creek, E_c values have been the highest recorded in the basin. Presently, the streambed is scouring here.

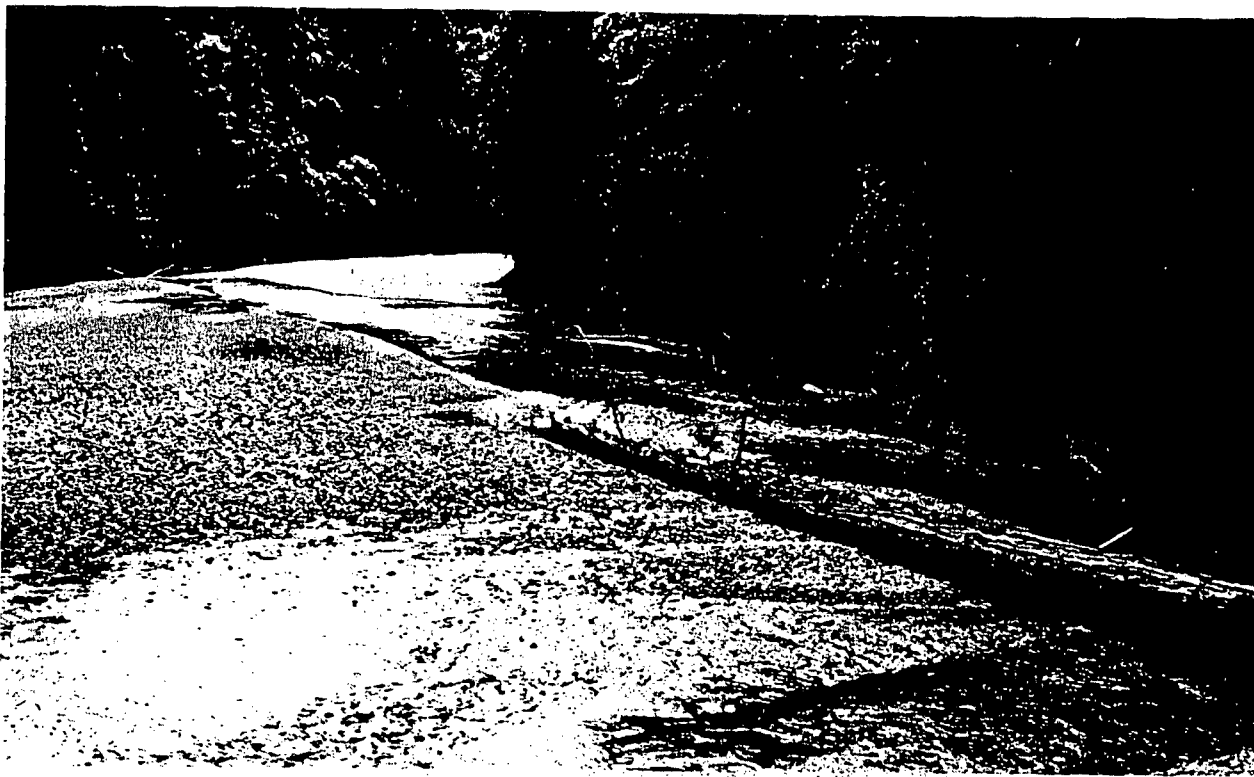
Figure 17: View downstream from Cross Section 20, located between Bridge Creek and the Tall Trees Grove. The fallen redwood tree on the right fell in WY 1981 as the result of effects related to streambed aggradation (see Figure 1).
