## Quartz Valley Indian Reservation

### **RE: 303 D Listing for Scott River Basin and tributaries**

## Comments requesting the State Water Resources Control Board to list the Scott River and Shackleford Creek as impaired by flow alteration

### **Comments requesting the State Water Resources Control Board to list the Scott River and Shackleford Creek as impaired by nutrients and bacteria**

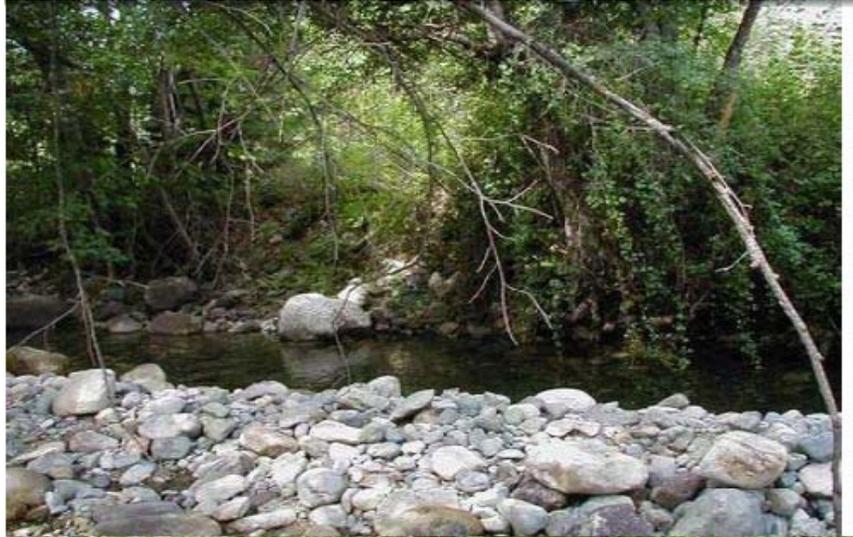
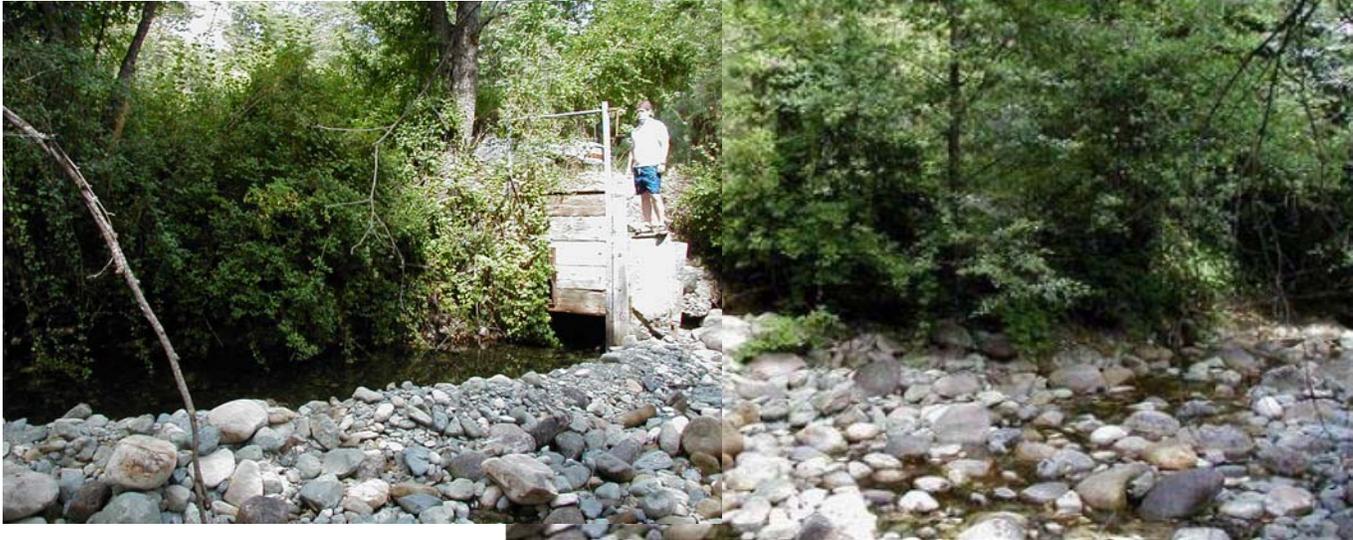
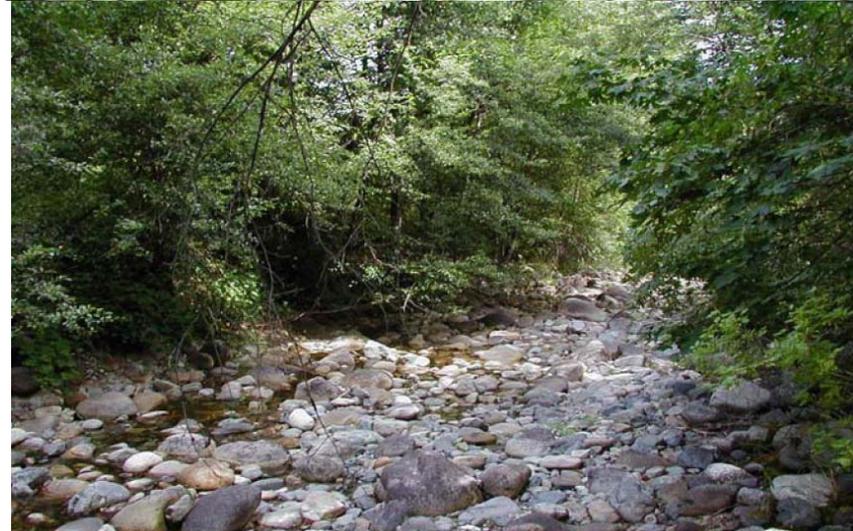
Figure 11. Jenner's diversion on Etna Creek: top photo—looking upstream of diversion, middle photos – at point of the diversion, and bottom photo – looking downstream of the diversion. August 2003. Lat/long coordinates: 41.43948, -122.89865. Photo by Bryan McFadin, NCRWQCB staff.

A single diversion on Etna Creek diverts almost the entire flow of creek (Figure 11).

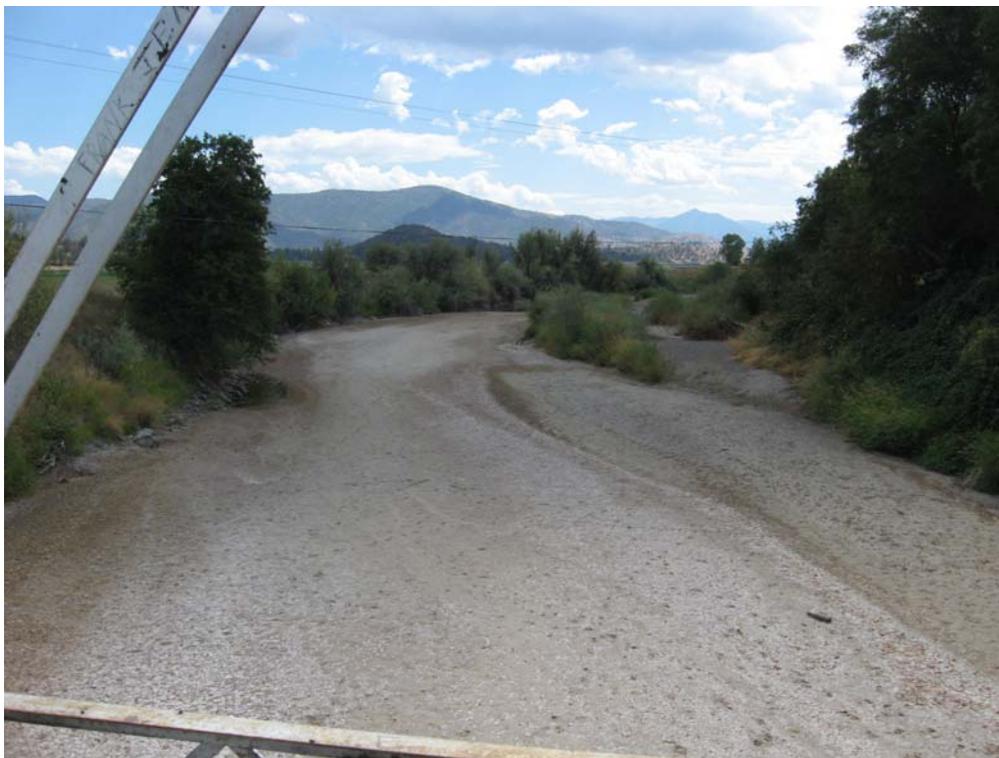
Figure 13. Photo of dry Scott River at Eller Lane, approximately halfway between Fort Jones and Etna. Lat/long coordinates: 41.51933, -122.8508. Photo by Bryan McFadin, NCRWQCB staff, August 30, 2007.

Available photographic evidence documents the drying up of the Scott River channel in 2002 (Figure 12), 2007 (Figure 13), and in 2009 across large stretches of the Scott Valley (Figures 14, 15, 16).

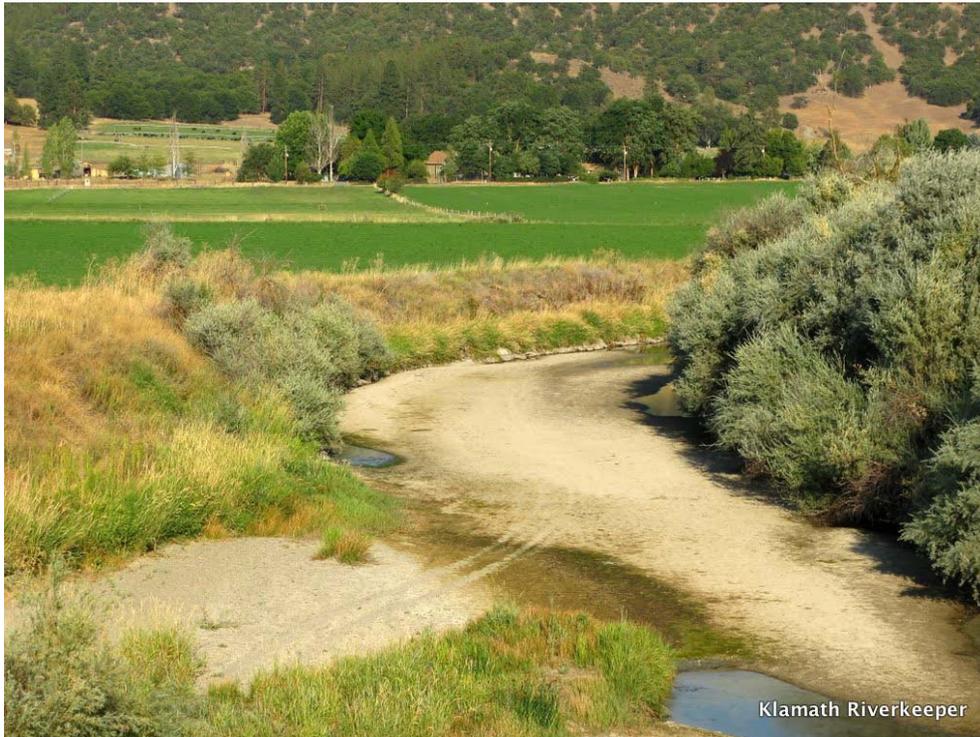
Figure 14. Mainstem Scott River at Highway 3 Bridge southwest of Fort Jones, August 23, 2009. Lat/long coordinates: 41.595474, -122.851547. Photo from Klamath Riverkeeper (<http://picasaweb.google.com/klamathriverkeeper/ScottAndShastaRivers2009FlowEmergency#5395238901042667954>)

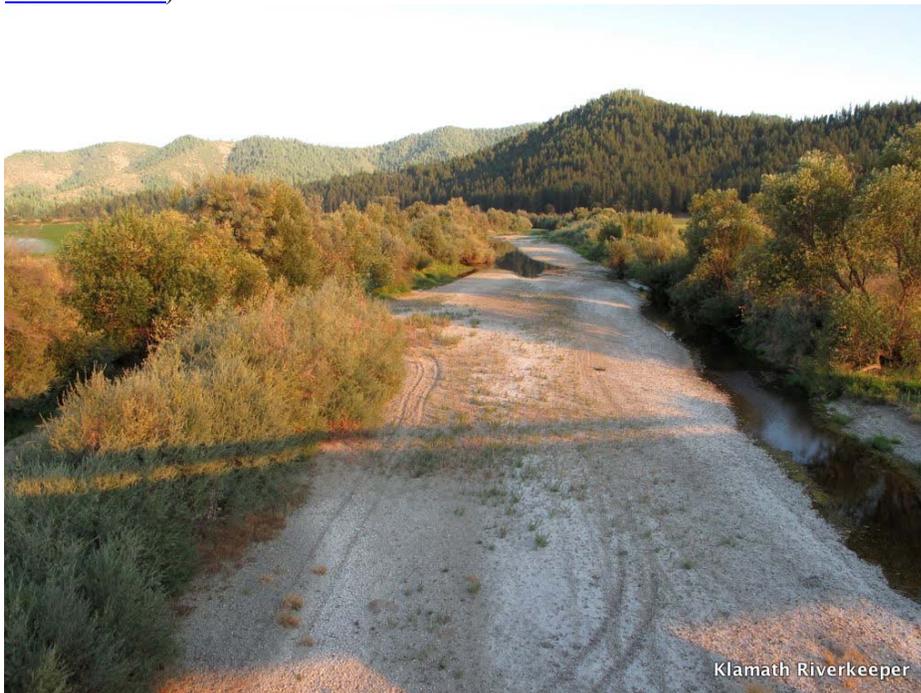
Figure 15. Mainstem Scott River at Quartz Valley Road, August 21, 2009. Lat/long coordinates: 41.629040, - 122.956978. Photo from Klamath Riverkeeper (<http://picasaweb.google.com/klamathriverkeeper/ScottAndShastaRivers2009FlowEmergency#5395238925999748034>)

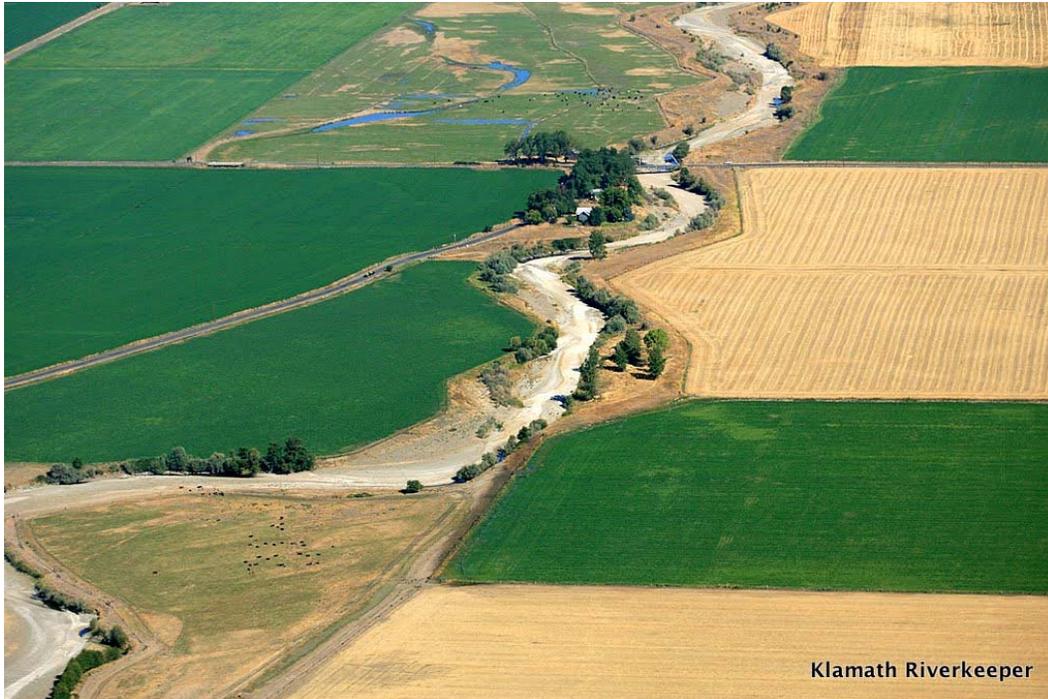
Figure 16. Dewatered Scott River, full irrigation ditches, and irrigated fields in central Scott Valley, Sept. 2, 2009. Lat/long coordinates: 41.496438, - 122.844658. Photo from Klamath Riverkeeper (<http://picasaweb.google.com/klamathriverkeeper/ScottAndShastaRivers2009FlowEmergency#5395238959214867394>).
