# **2009 Monitoring Report**

## **Araujo Fish Passage and Water Quality Improvements Project**

**SWQCB Agreement #07-541-550-1, Component #2.1**

**Shasta Valley Resource Conservation District**

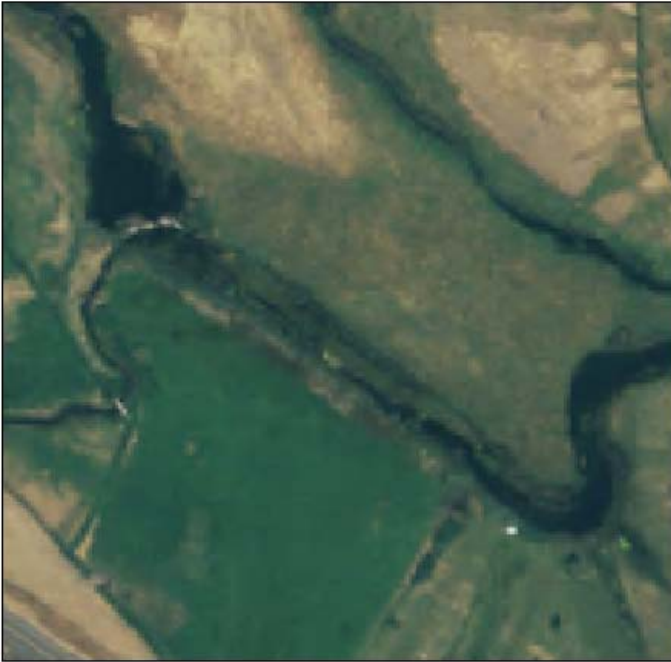
**Figure 5: Pre-Construction Aerial Photograph and Post-Construction Bare Earth LiDAR Image of Araujo Project**

An aerial photo taken in 2005 is shown alongside a LiDAR image taken in January 2008 (Figure 5). As discussed in the Methods section, technology differences must be kept in mind when comparing the two very different images. Other than the removal of the dam, no major differences in channel configuration are apparent from the pre- and post-construction image comparison.

2005 NAIP Aerial Photograph

2008 Bare Earth LiDAR image

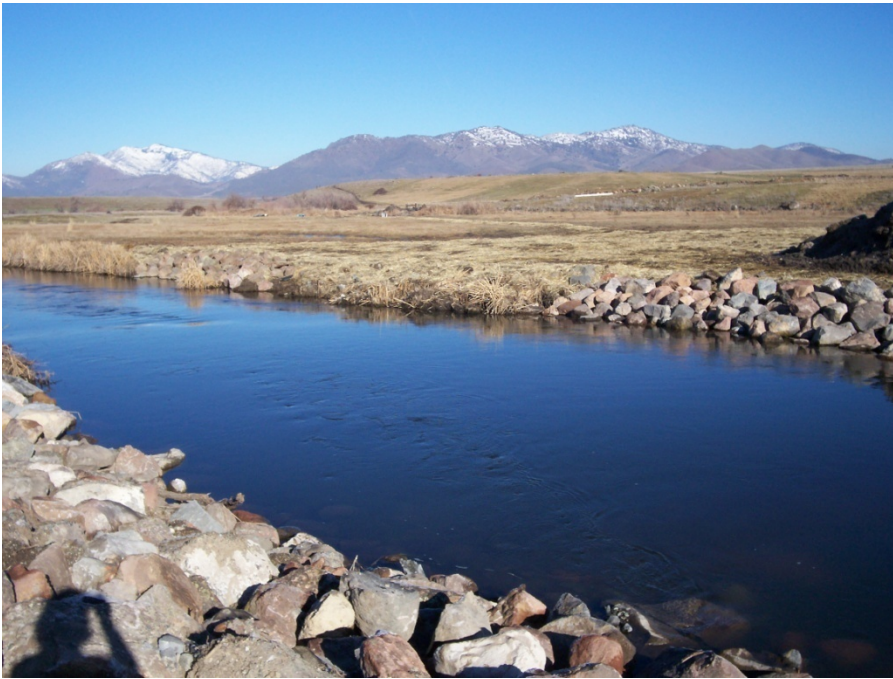
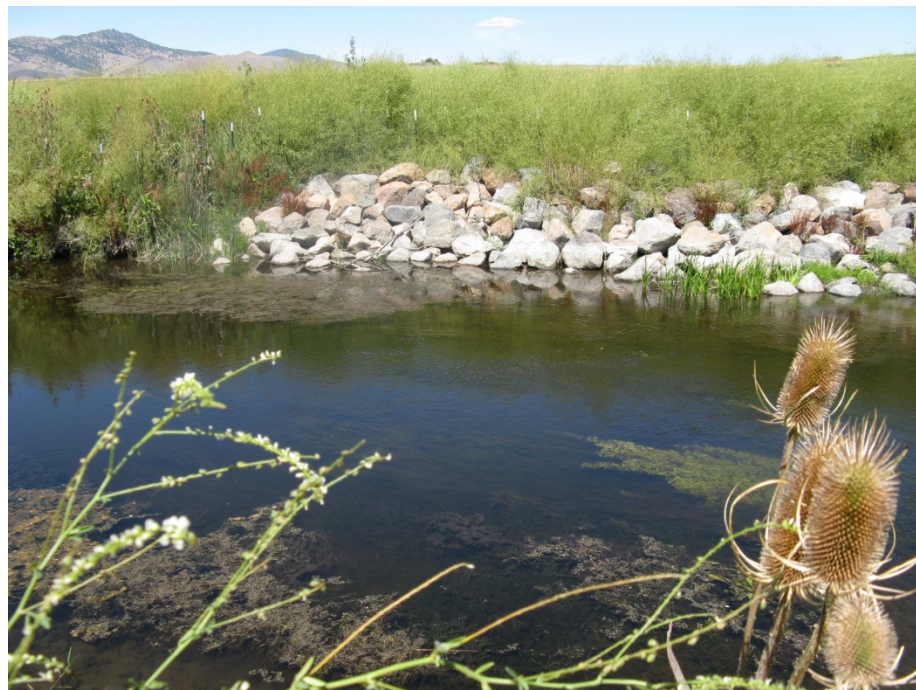
**Figure 6: Araujo Boulder Weir**

Digital photographs were taken upon completion of the boulder weir as well as during a period of low flow (20 cfs) to document that the weir structure provided a maximum jump height of twelve inches. These photos are shown in Figure 6.

**December 2007**

**August 2009**

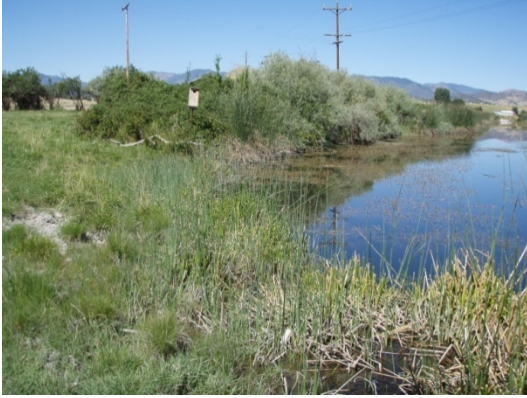
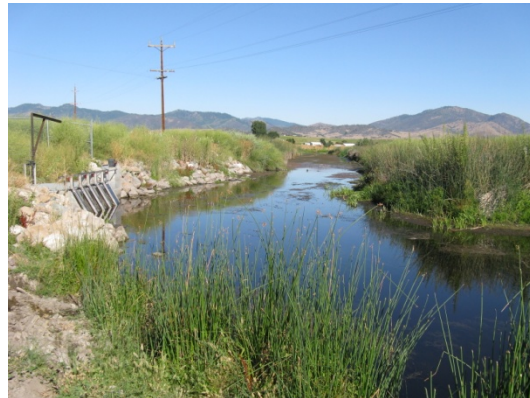
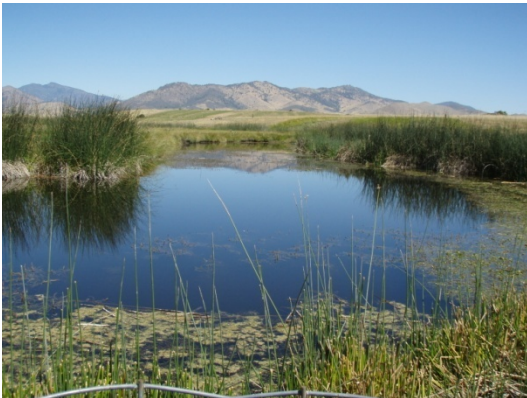
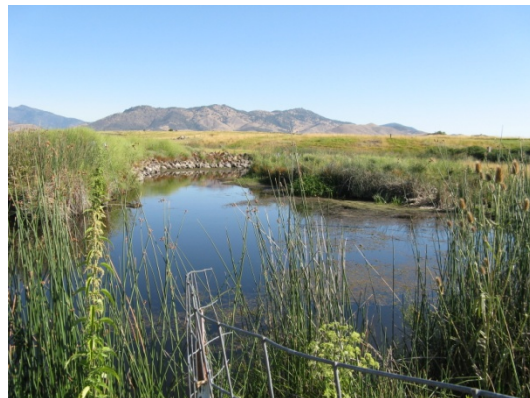
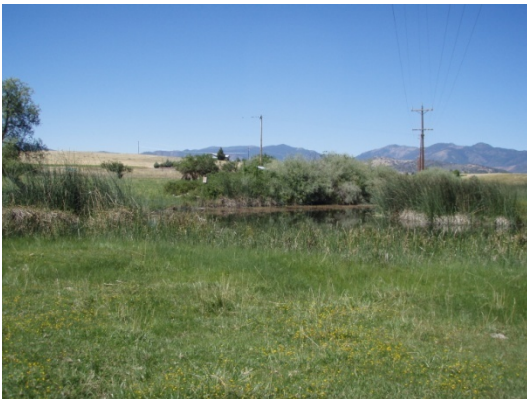
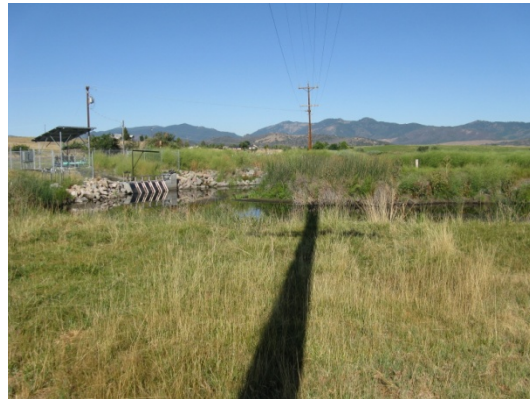
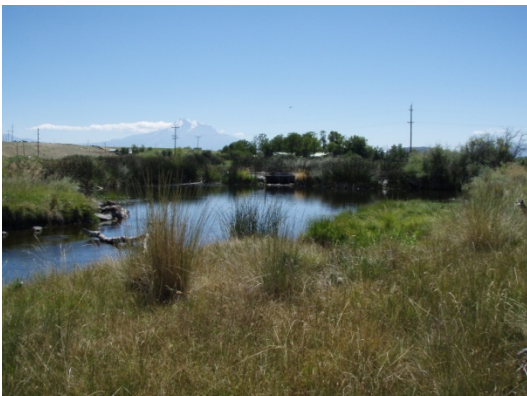
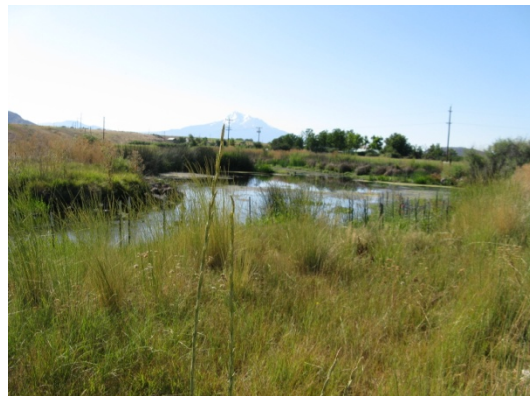
## Appendix D. Photo Monitoring 2007 and 2009

Post-construction photographs were taken from the established photopoints on August 5, 2009. Photos were taken both upstream and downstream. A pre- and post- construction comparison from three photopoints is shown in Appendix D. Visual documentation of the project site before and after construction is useful in determining post-construction changes in the channel configuration, flow characteristics, and vegetation growth.
