2009 Monitoring Report

Shasta Water Association Dam Demobilization And Water Quality Enhancement Project

Shasta Valley Resource Conservation District

**Submitted
October 2009**

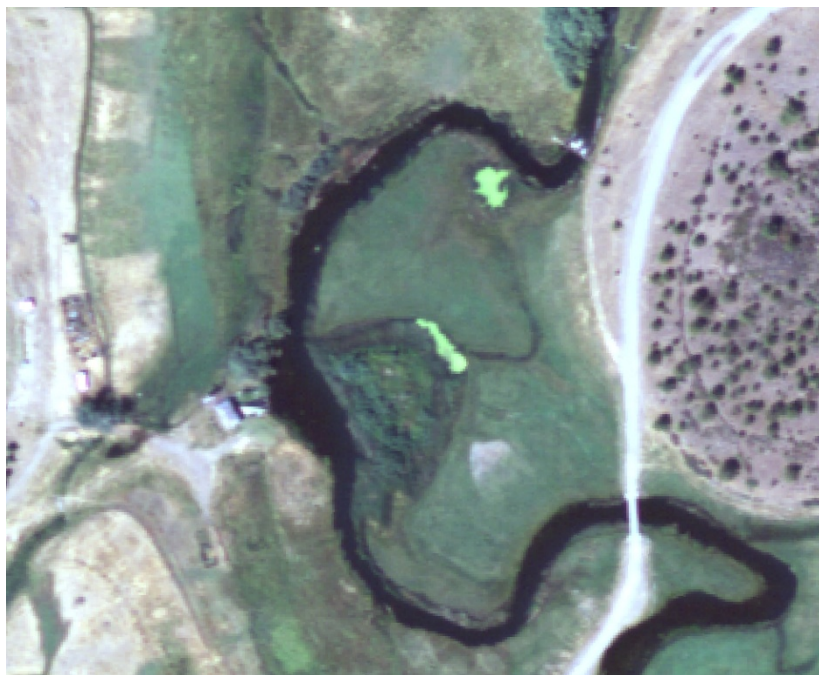
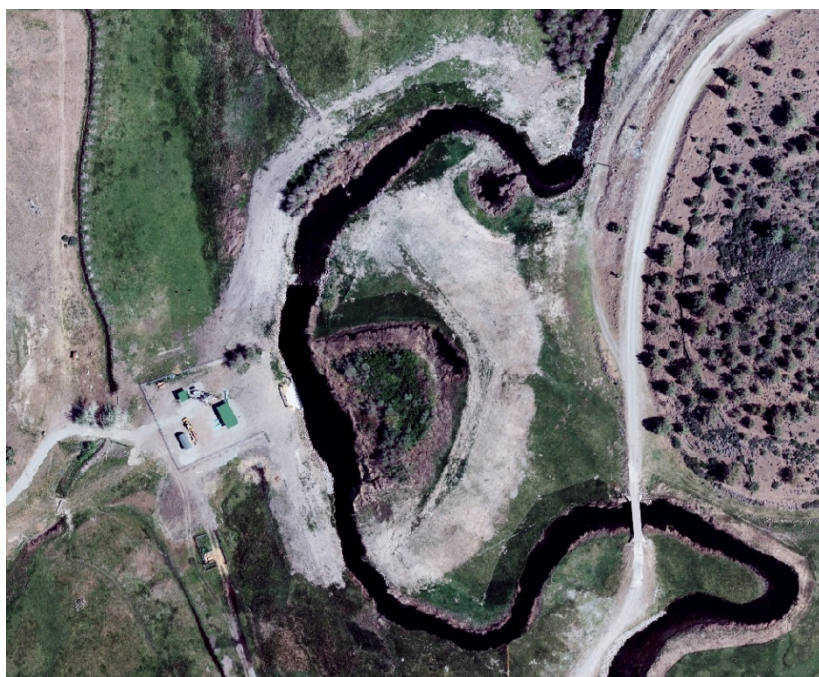
Figure 5. Pre-construction and Post-construction Aerial Photos

Aerial photos were used to visually examine changes in wetted channel as a result of the project (Figure 5). The pre-construction photo is from NRCS National Agriculture Imagery Program (2005). The post-construction photo was provided courtesy of the California Department of Fish and Game and Pacific States Marine Fish Commission. Direct changes to the channel due to the removal of the dam and project construction are apparent in those areas of the photos.

2005 NAIP Aerial Photograph

2009 Aerial Photograph

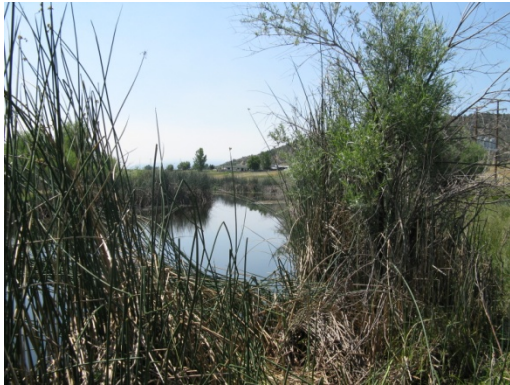
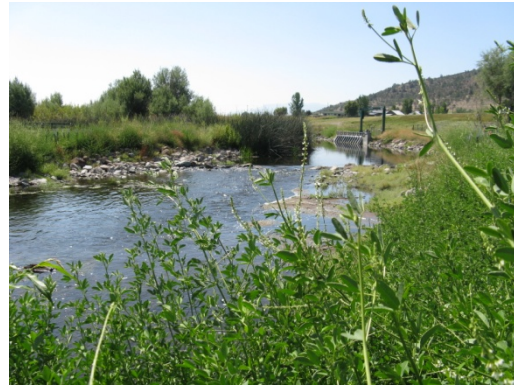
Photo Point 8: Upstream 2008

Post-construction photographs were taken from the established photopoints on August 15, 2009. Photos were taken both upstream and downstream. A pre- and post-construction comparison from three photopoints is shown in Figure 6. Visual documentation of the project site before and after construction is useful in determining post-construction changes in the channel configuration, flow characteristics, and vegetation growth.

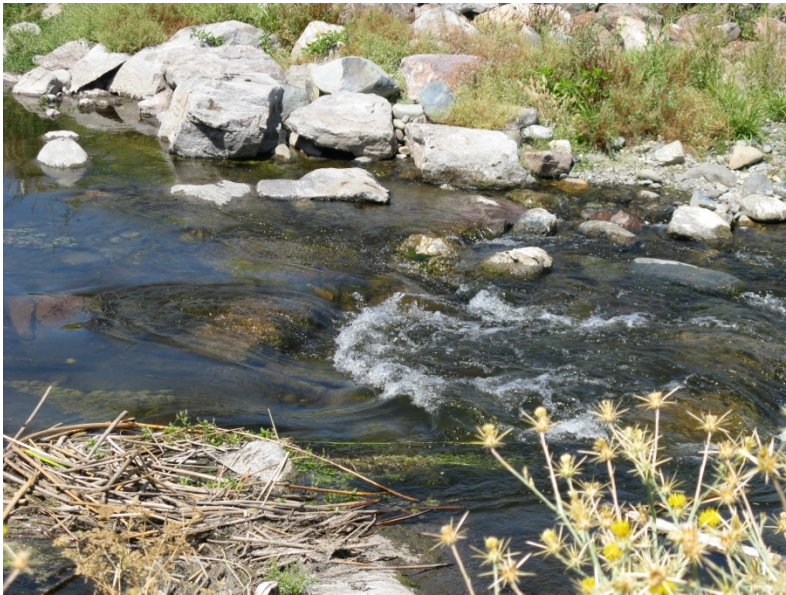
Lower Boulder Weir August 15, 2009

Digital photographs were taken during the construction phase of the two boulder weirs as well as upon completion to document a maximum jump height of twelve inches. Photos were taken on August 15, 2009 of the completed boulder weirs during a period of low flow (20 cfs) as shown in Figure 7.

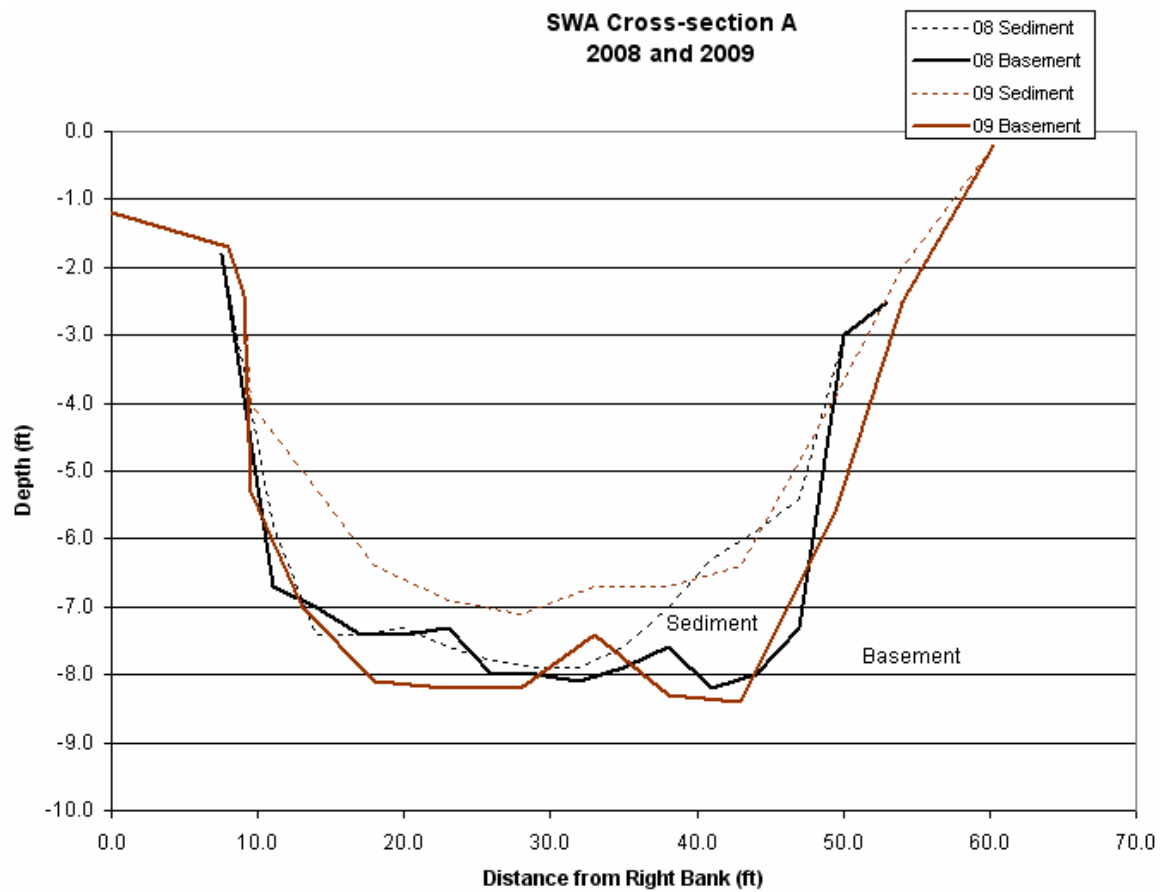
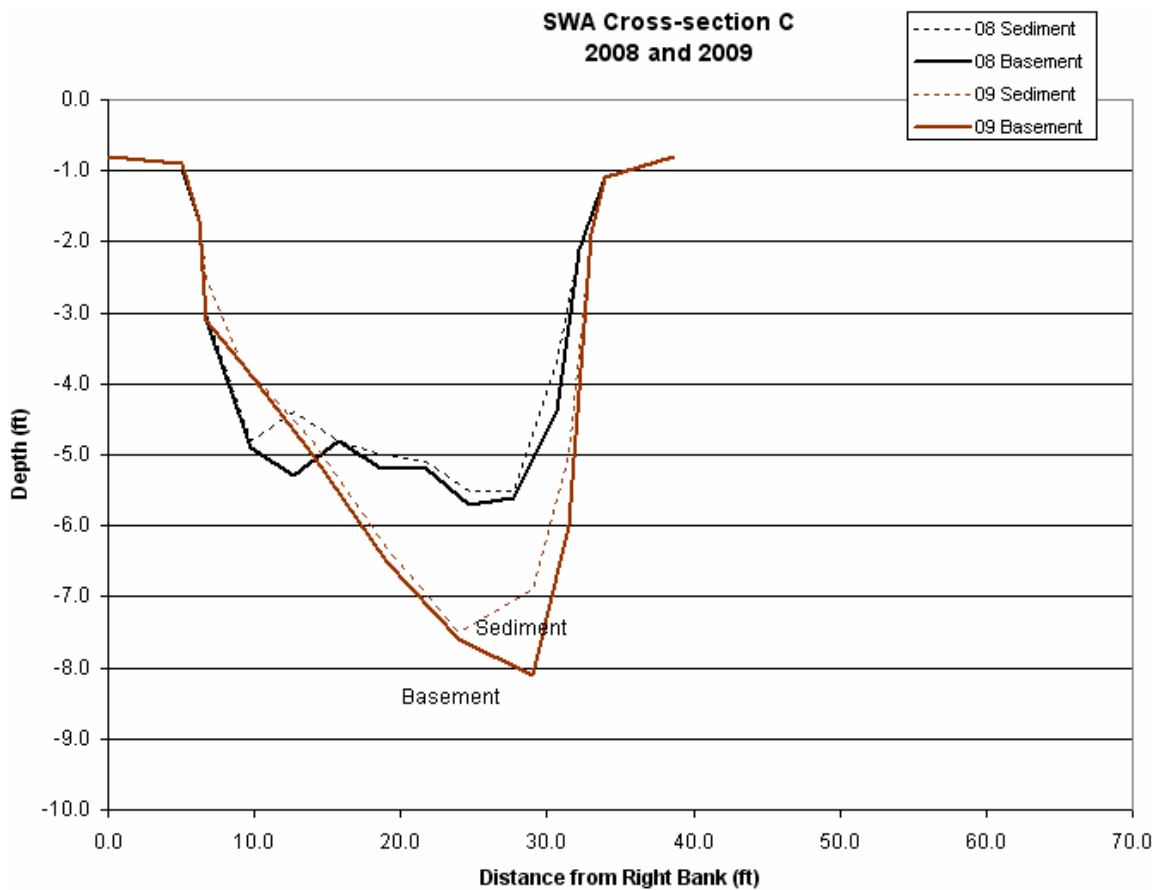
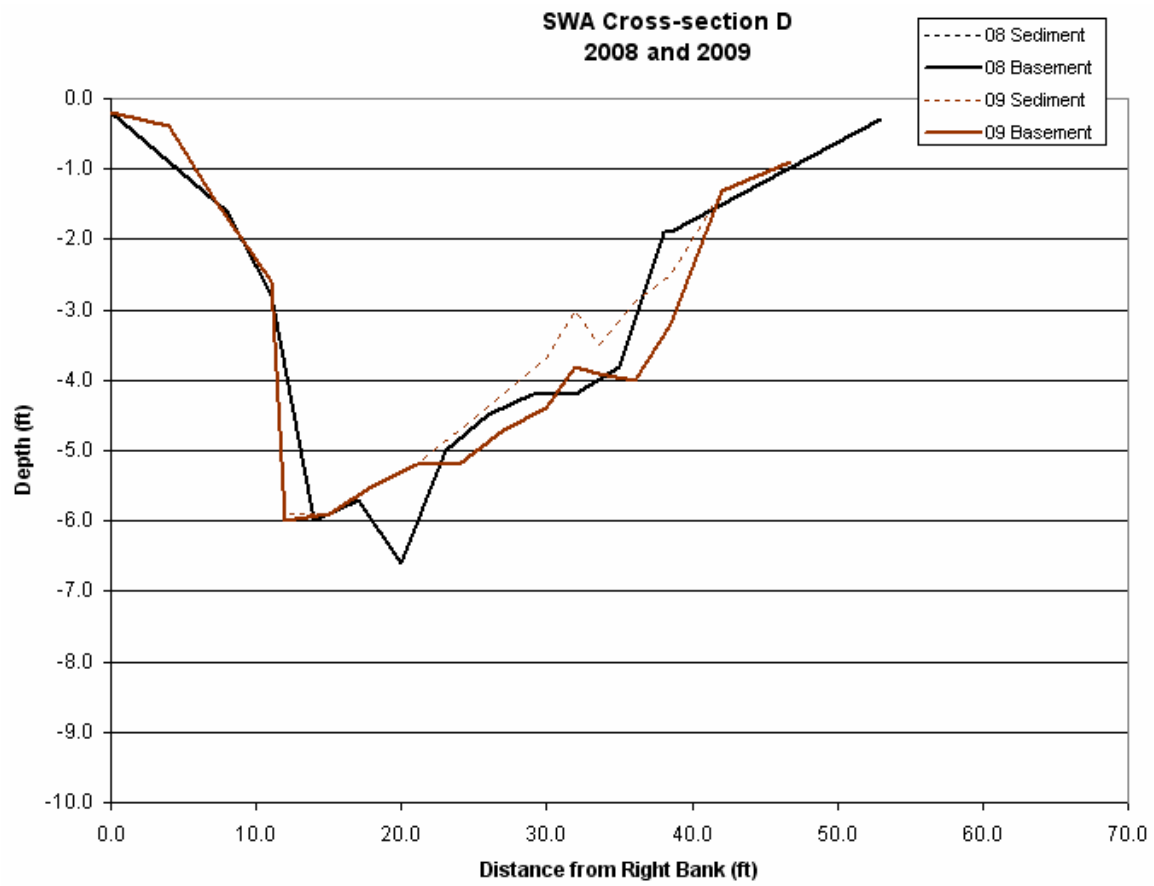
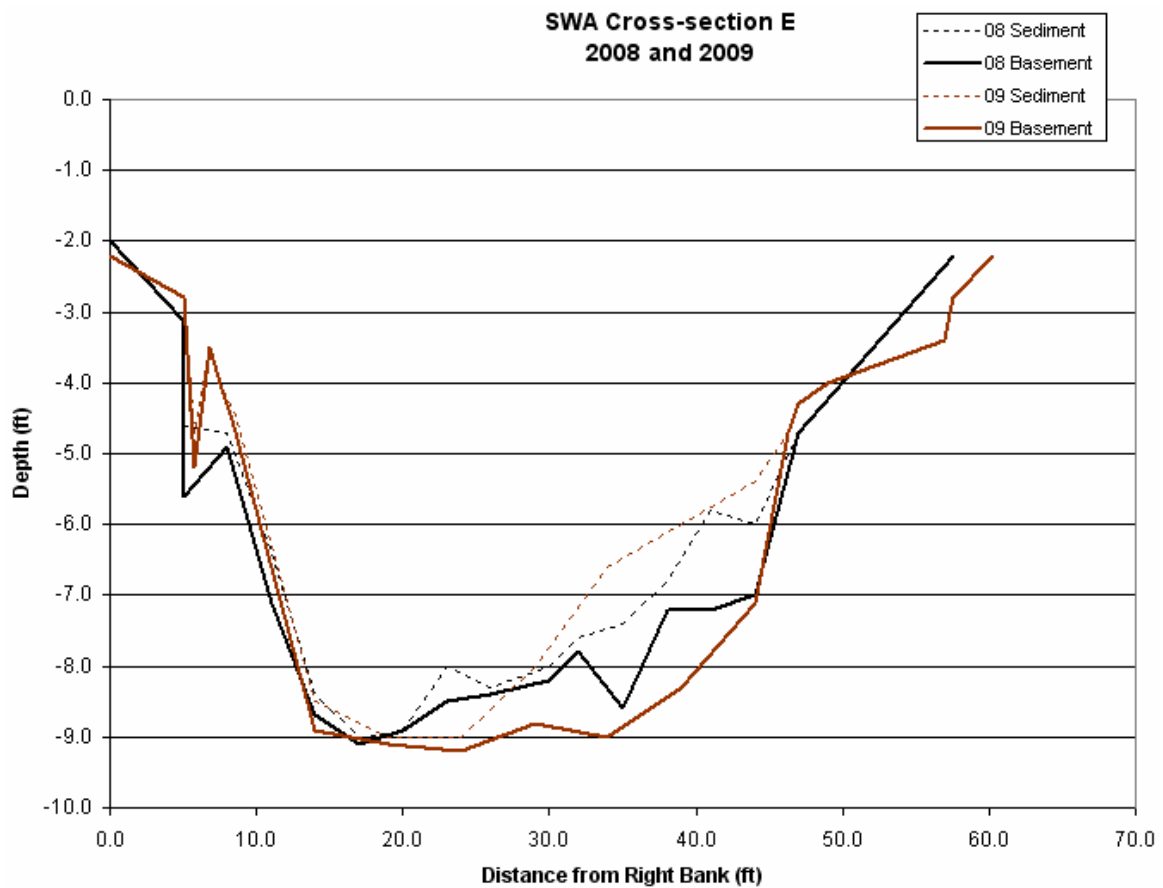
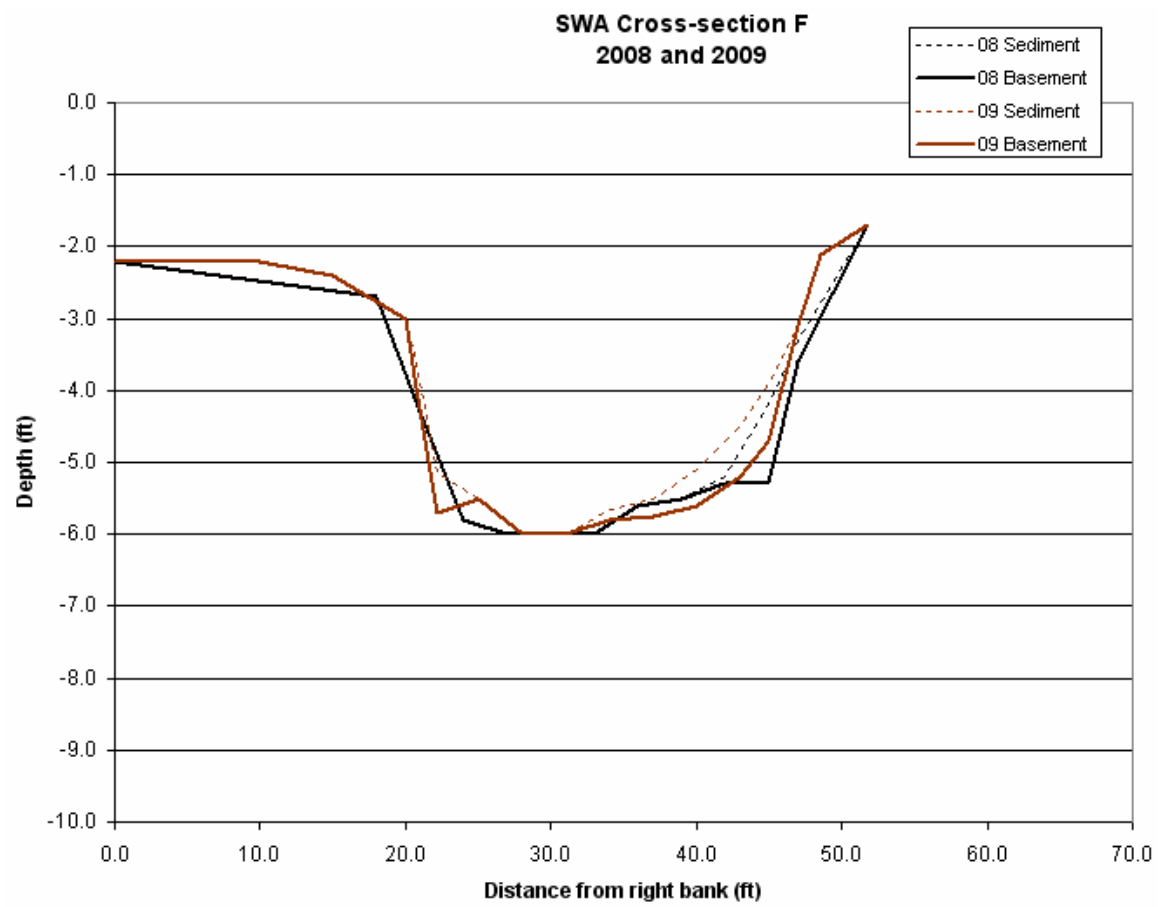
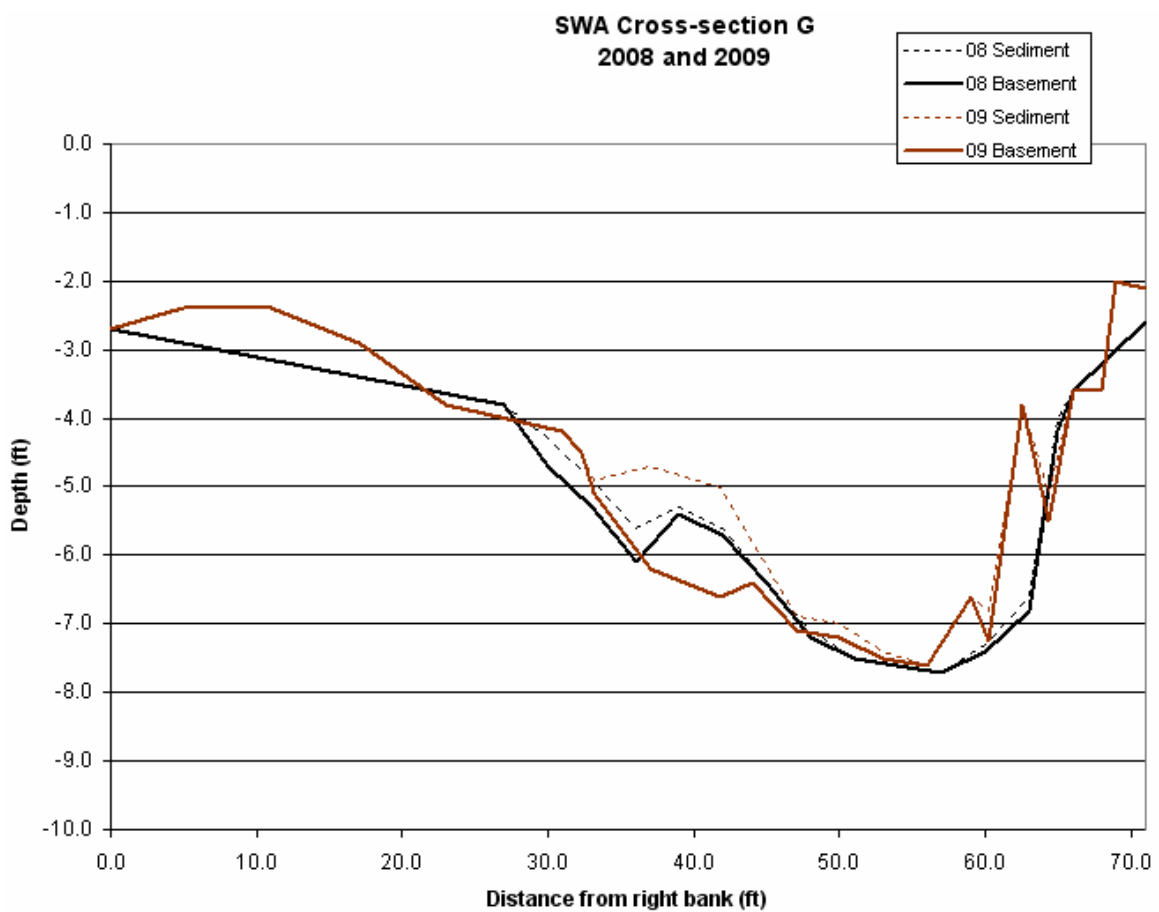
Appendix C. Cross Sections

Cross-sections of the river channel, including depth of sediment deposits, were measured in the summer of 2009 at six permanent locations throughout the project area. The resulting profiles of the riverbank were then graphed over the corresponding profiles measured in 2008 and are shown in Appendix C. An additional cross-section was measured in 2008, Cross-section B, which was not measured in 2009 due to its location within the pump station construction area. Measuring a change in width of wetted channel, or ponded surface area, will help determine whether a reduction in surface area available to aquatic vegetation and fine sediment, both of which reduce dissolved oxygen in the river, has occurred as a result of the project. However, the cross-section profile is only a snapshot in time and may not reflect long-term changes in the project area.
