# **2008 Monitoring Report**

## **Araujo Fish Passage and Water Quality Improvements Project**

**Shasta Valley Resource Conservation District**

**Submitted  
February 2009**

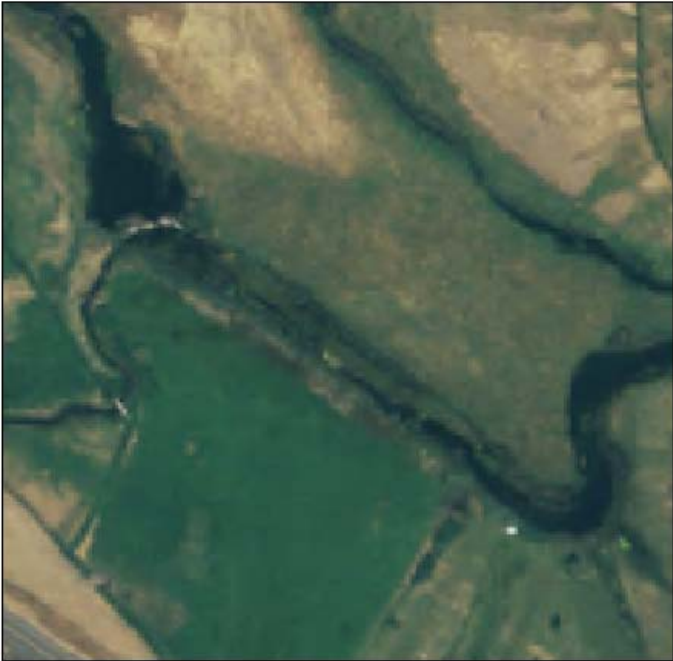
**Figure 2: Pre-Construction Aerial Photograph and Post-Construction Bare Earth LiDAR Image of Araujo Project**

Aerial photos were used to visually examine changes in wetted channel as a result of the project. A pre-construction NRCS National Agriculture Imagery Program (2005) photo was compared to a post-construction image obtained from 2008 LiDAR data. It is important to note that these two images are constructed from very different technology, as LiDAR is formulated from laser point data rather than photography. The LiDAR data that was used in the comparison shows only the bare earth surface without the vegetation component. The appearance of surface characteristics differs between the two images, and this difference should be considered when comparing the two images.

An aerial photo taken in 2005 is shown alongside a LiDAR image taken in January 2008 (Figure 2). As discussed in the Methods section, technology differences must be kept in

mind when comparing the two very different images. Other than the removal of the dam, no major differences in channel configuration are apparent from the pre- and post-construction image comparison.

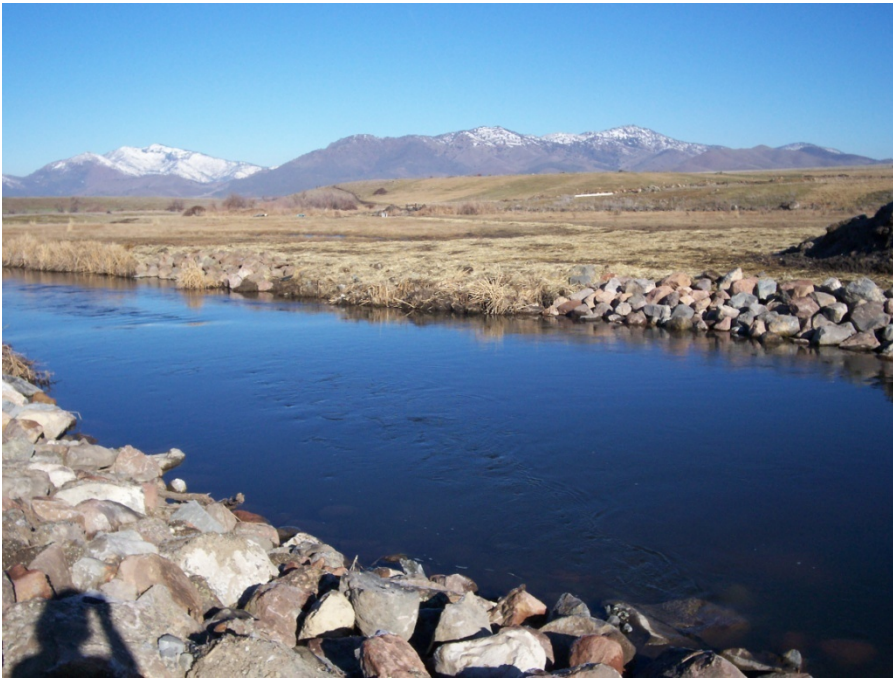
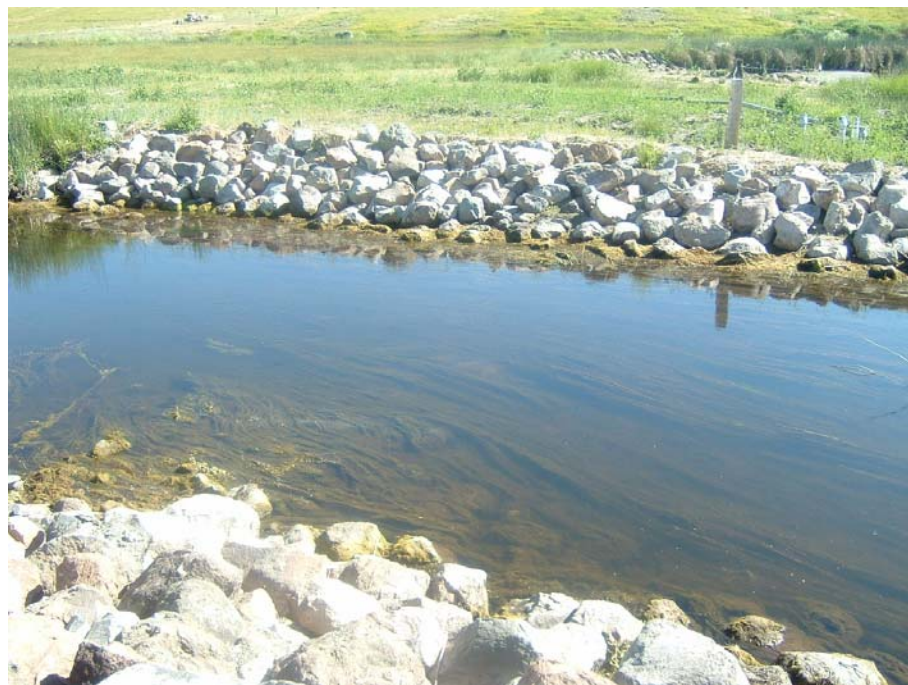
**Figure 3: Araujo Boulder Weir**

One of the major goals of the project was to remove a flashboard dam at the Araujo site in order to provide for improved fish passage. Project implementation plans included the construction of a boulder weir upstream of the old dam site to provide a minimum amount of ponding at the new pump and screen site to assure proper pump operation. Digital photographs were taken before, during, and after the construction phase of the boulder weir to document a maximum jump height of twelve inches.

Digital photographs were taken upon completion of the boulder weir as well as during a period of low flow (25 cfs) to document that the weir structure provided a maximum jump height of twelve inches. These photos are shown in Figure 3.

Digital photographs will be taken in 2009, including during low flows, to document whether any significant change had occurred at the weir structure, assuring a maximum jump height of twelve inches at the boulder weir.

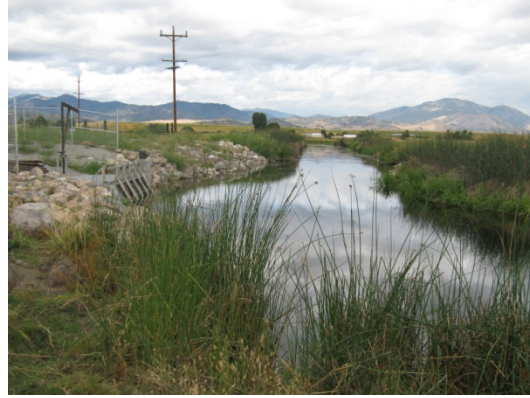
Photo Point 2: Downstream 2007

Post-construction photographs were taken from the established photopoints on August 20, 2008. Photos were taken both upstream and downstream. A pre- and post-construction comparison from three photopoints is shown in Appendix C. Visual documentation of the project site before and after construction is useful in determining post-construction changes in the channel configuration, flow characteristics, and vegetation growth.
