North Coast Watershed Assessment Program

Gualala River Watershed Assessment Report

March, 2003

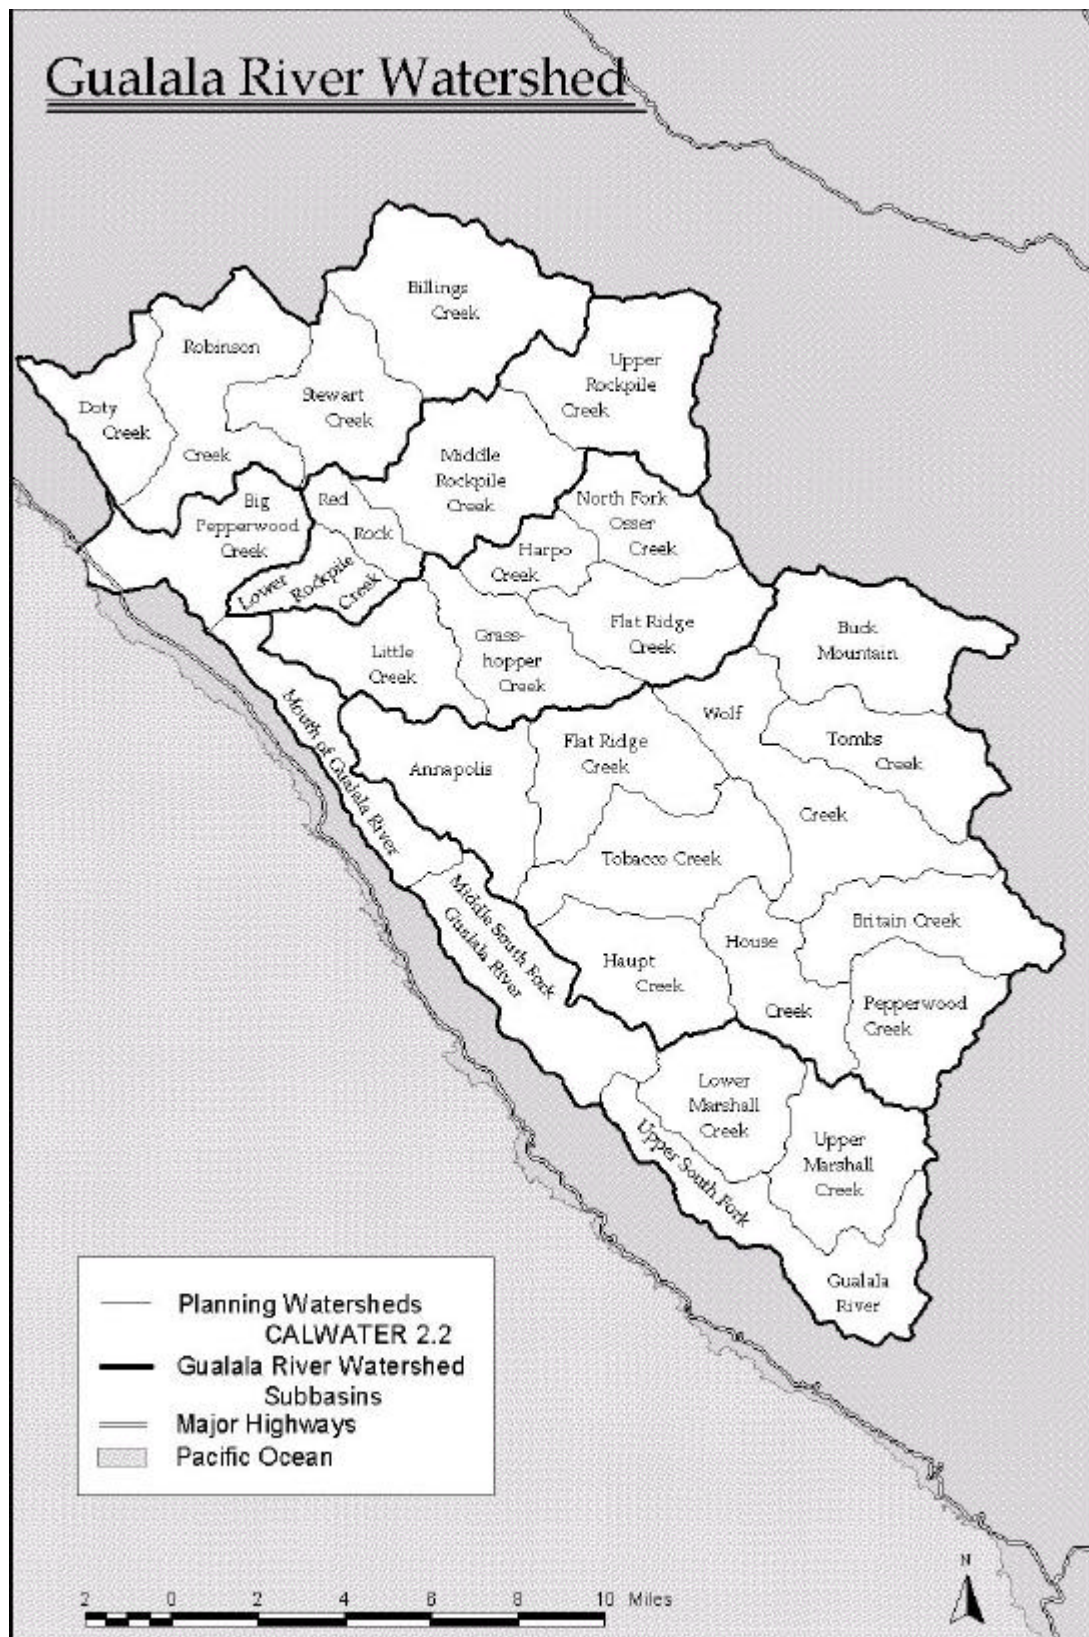
Figure ES-2
The Gualala River Watershed with NCWAP subbasins and Calwater 2.2a Planning Watersheds.

NCWAP's Gualala Team sub-divided the Gualala River Watershed into five subbasins for assessment purposes: North Fork, Rockpile, Buckeye, Wheatfield Fork, and the Gualala Mainstem/South Fork (Figure ES-2). Each subbasin has somewhat unique attributes that are generally common to the several CalWater 2.2a Planning Watersheds (PWS) contained within each subbasin. These PWS are approximately 3,000-10,000 acres and are used as planning and evaluation units for projects such as Timber Harvesting Plans submitted to CDF. These common subbasin attributes pertain to its geology, vegetation, climate, land use, streams, fisheries, towns and communities, access corridors, etc. The reader will encounter the term "blue line streams," which refers to those streams identified on standard U.S. Geologic Survey (USGS) topographic maps as solid blue lines.

Subbasins and their planning watersheds are used as the basis of the format of the assessment report. They also are used as the basis for display of the Ecological Management Decision Support system GIS images, geologic and landslide maps, landslide potential maps, potential restoration sites maps, and tabular data.
