These pictures are from cattle operations just above Pieta creek in Mendocino County. Cattle have access to almost a mile of the mainstem Russian River and cattle manure and consequently large thick algal mats are extremely prevalent along the shoreline of the River.

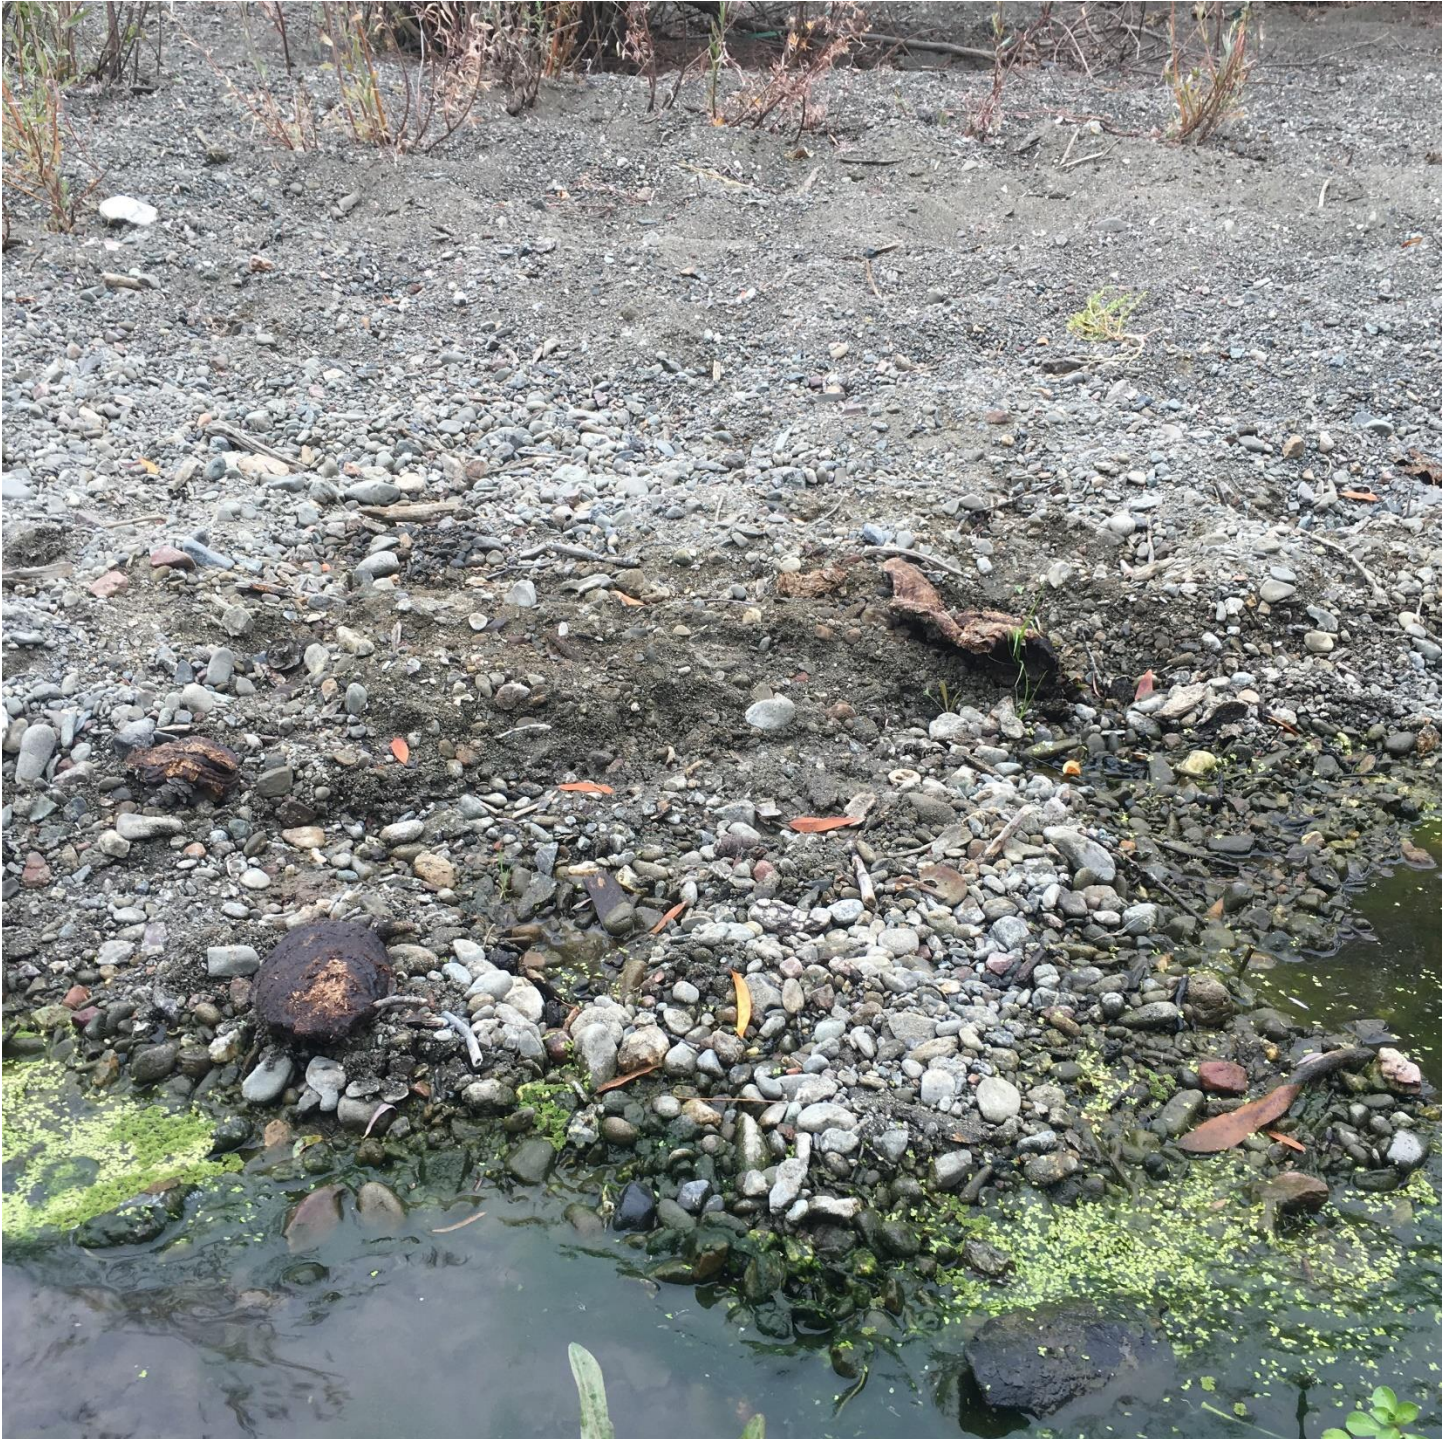
Photograph 1.

Date: 8/27/2016 Time: 954AM Location: Latitude 38; 56; 14.79 Longitude 123; 4; 45.59

Cattle manure directly in and at the river's edge contributing to nutrient impairment, WQS being exceeded (see data attached) and the diminishment of the Beneficial Uses of the mainstem.

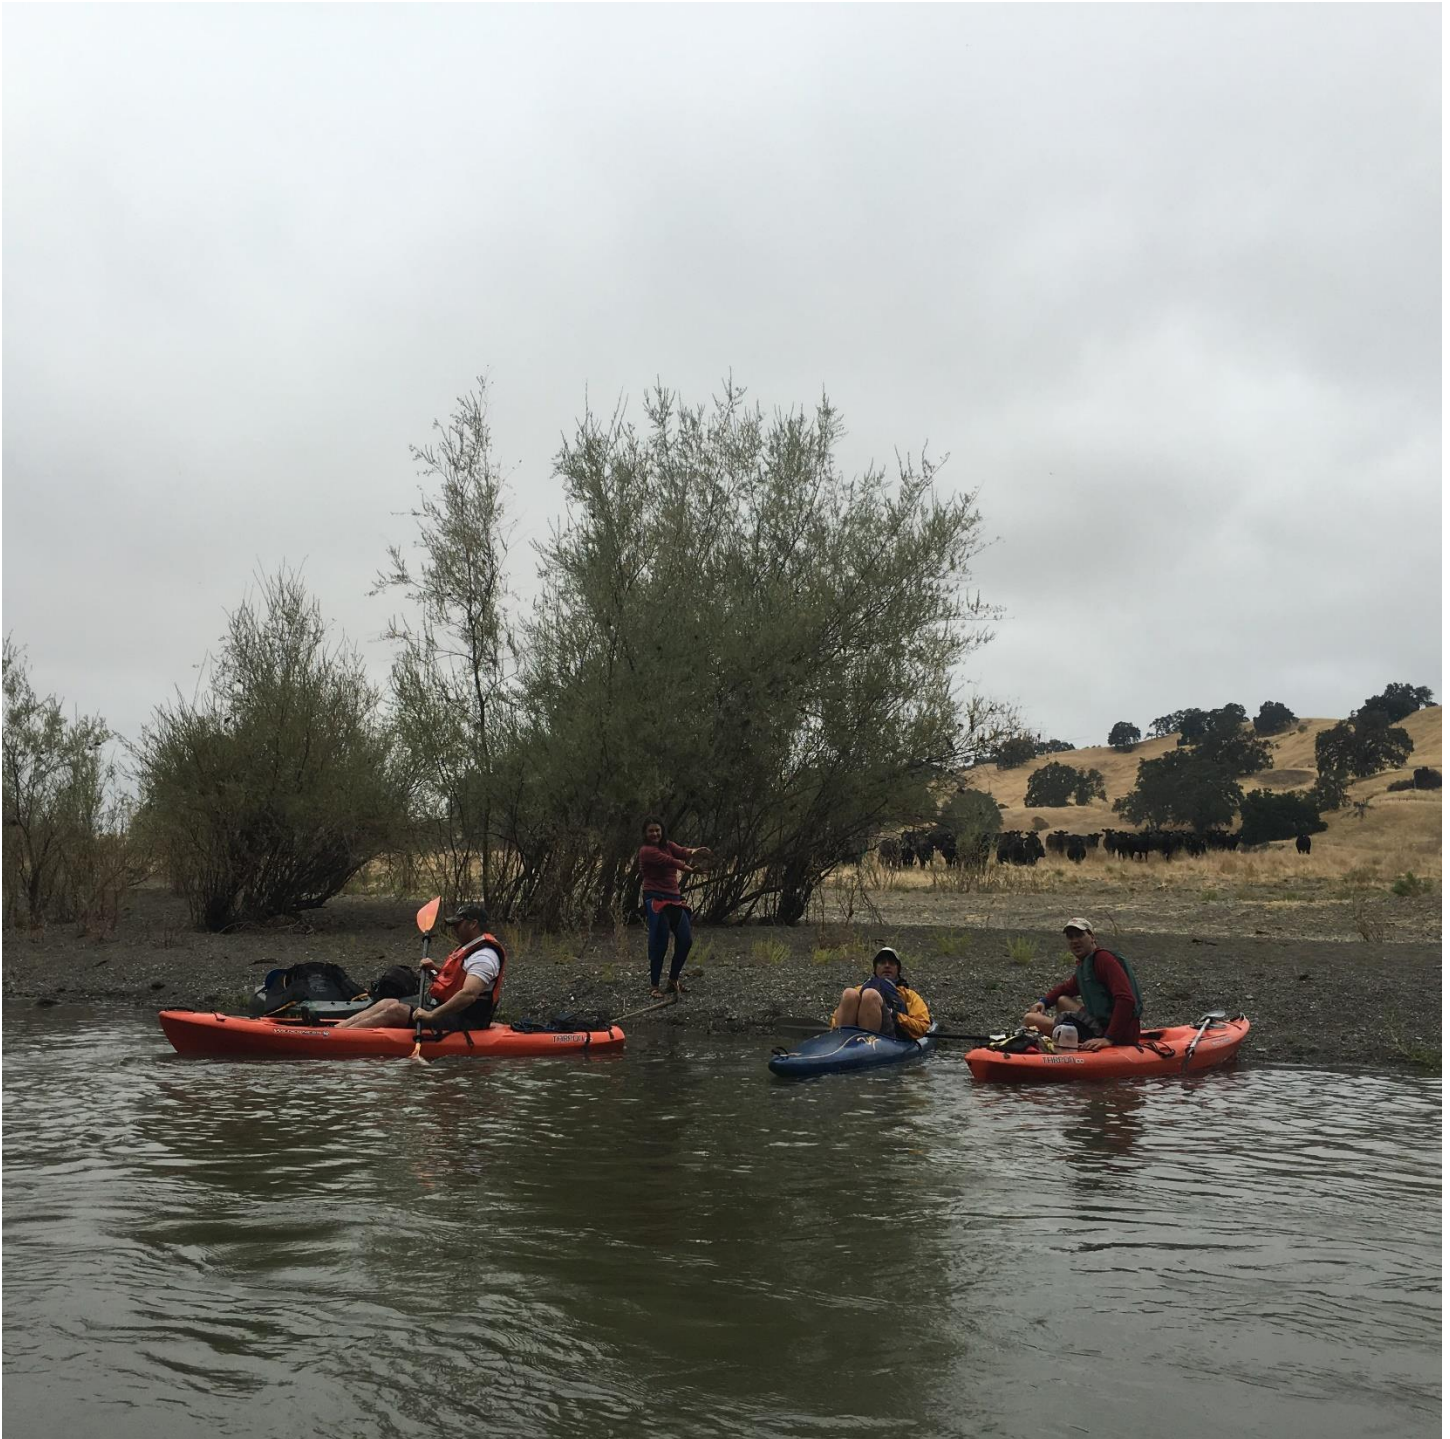
Picture 2.

Date: 8/27/2016 Time: 955AM Location: Latitude 38; 56; 14.739 Longitude 123; 4; 45.039

Picture 2 taken one minute after Picture 1 looking at just one of several herds of range cattle that have full, unimpeded access to the mainstem Russian River.

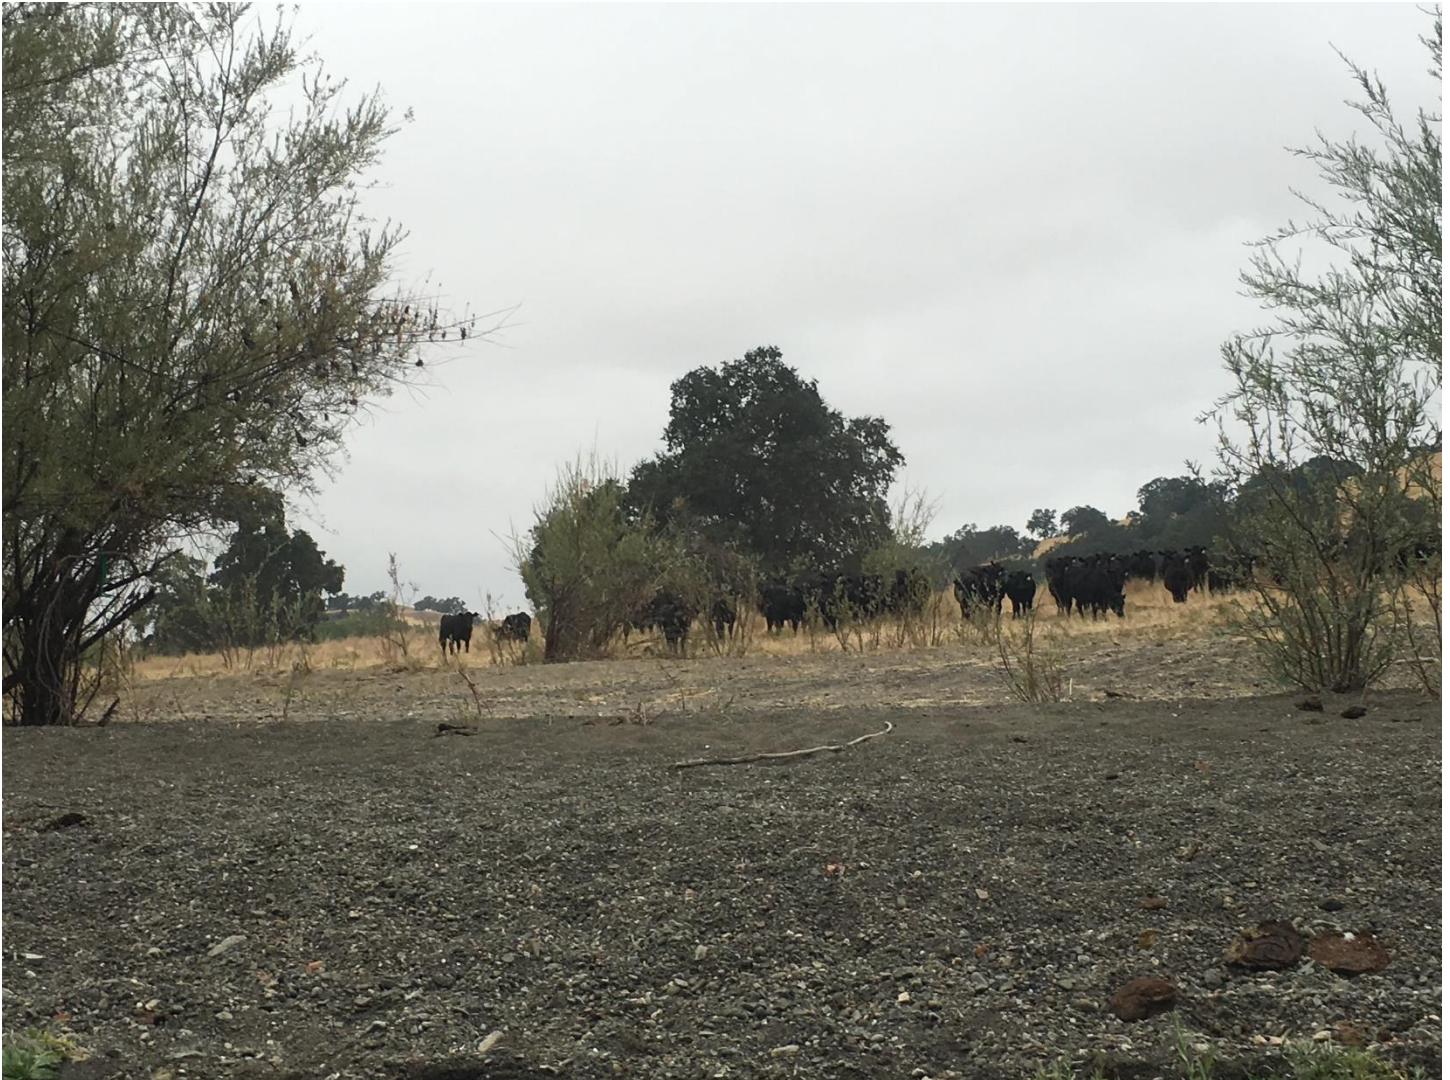
Picture 3.

Date: 8/27/2016 Time: 955AM Location: Latitude 38; 56; 14.70 Longitude 123; 4; 57

A close up of the herd in Picture 2. Note the cattle manure on the bank of the mainstem in the foreground (bottom right corner) of the photograph.

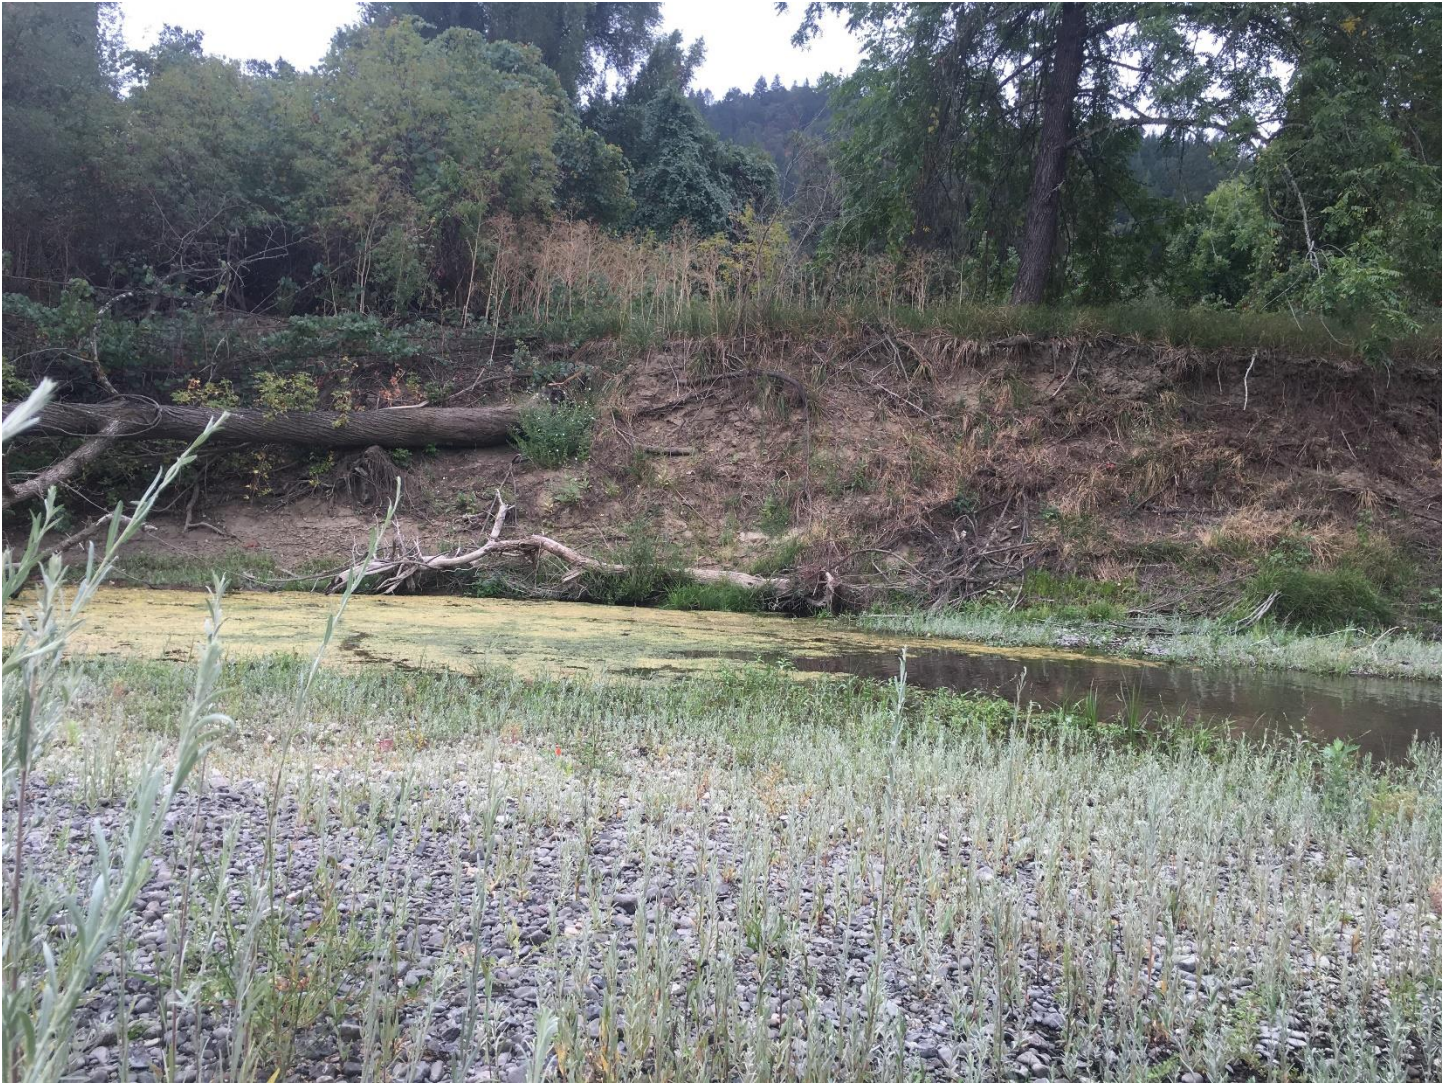
Picture 4.

Date: 8/27/2016 Time: 1013AM Location: Latitude 38; 56; 22.0 Longitude 123; 4; 21.749

The downstream effects of highly nutrient rich surface water in the Russian River as is evident in this side channel.
