Petaluma Watershed Enhancement Plan

An owner's manual for
the residents and landowners of
the Petaluma Watershed

Prepared by:
The Southern Sonoma County
Resource Conservation District
in conjunction with the people
of the Petaluma Watershed

July 1999

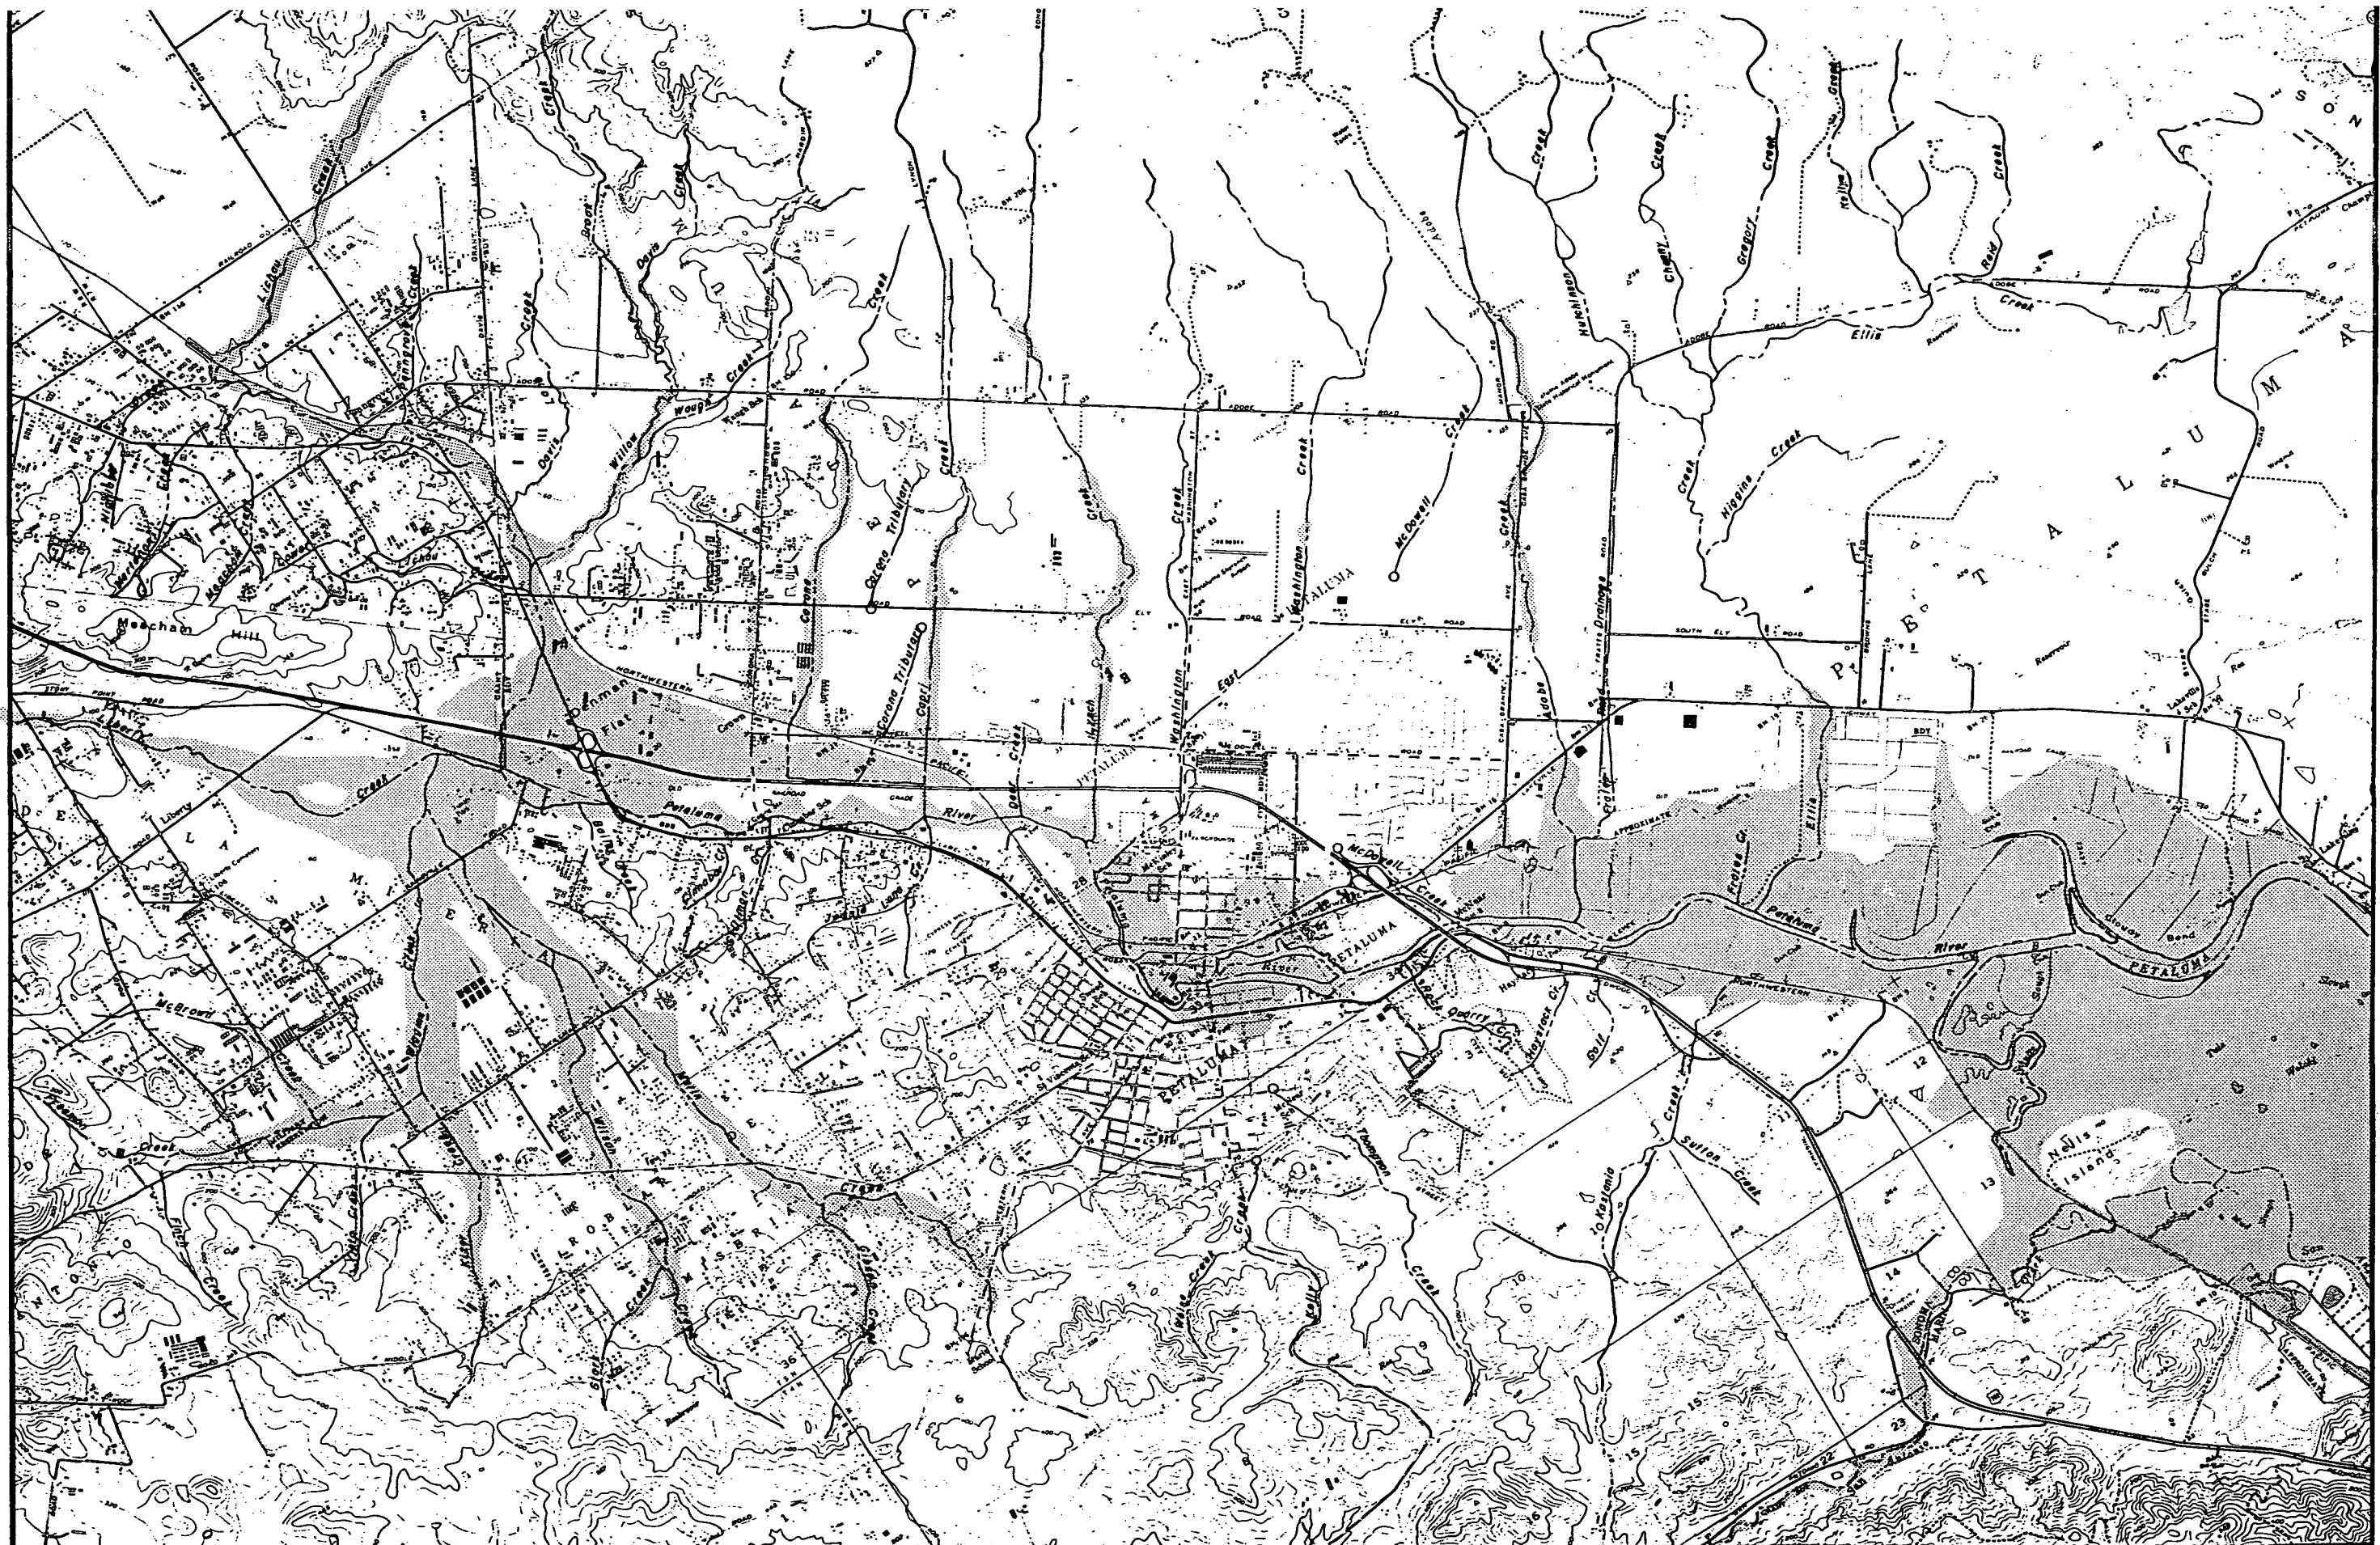
MAP NO.
2B

PETALUMA RIVER WATERSHED MASTER DRAINAGE PLAN
AREAS OF FLOODING - 100-YR FREQUENCY

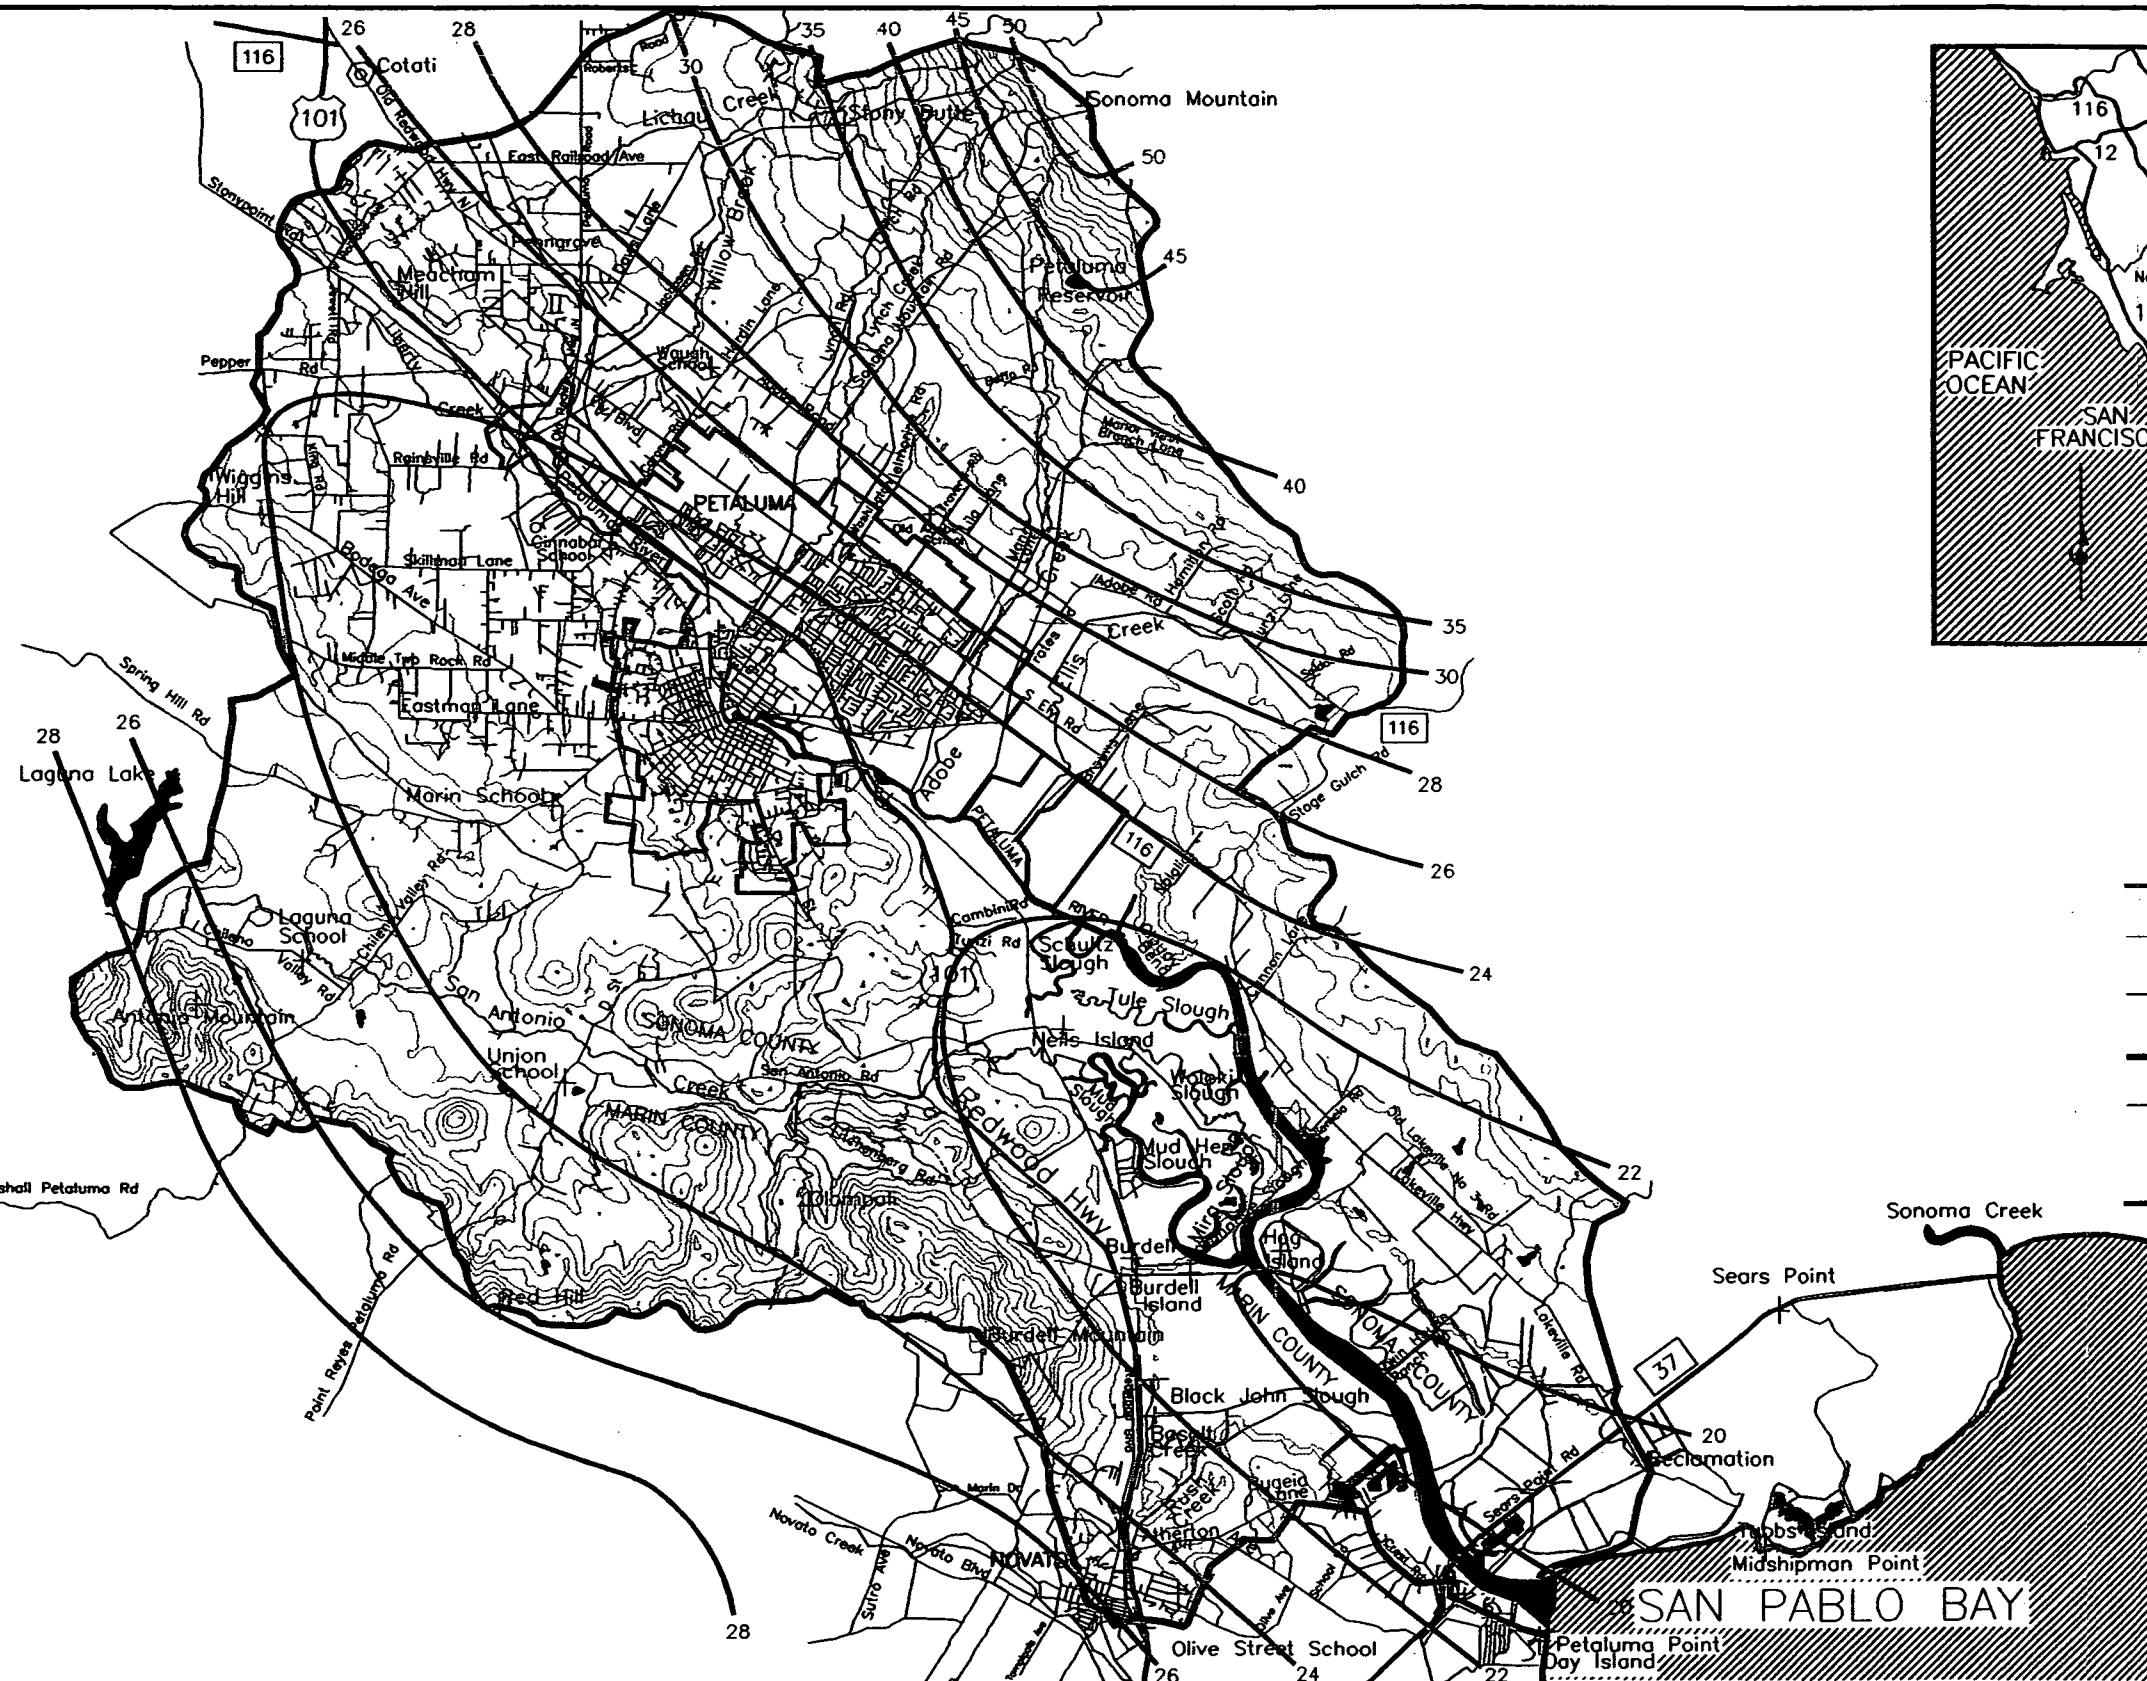
SHEET
1
OF 1

NORMAL ANNUAL PRECIPITATION FOR
PETALUMA RIVER WATERSHED

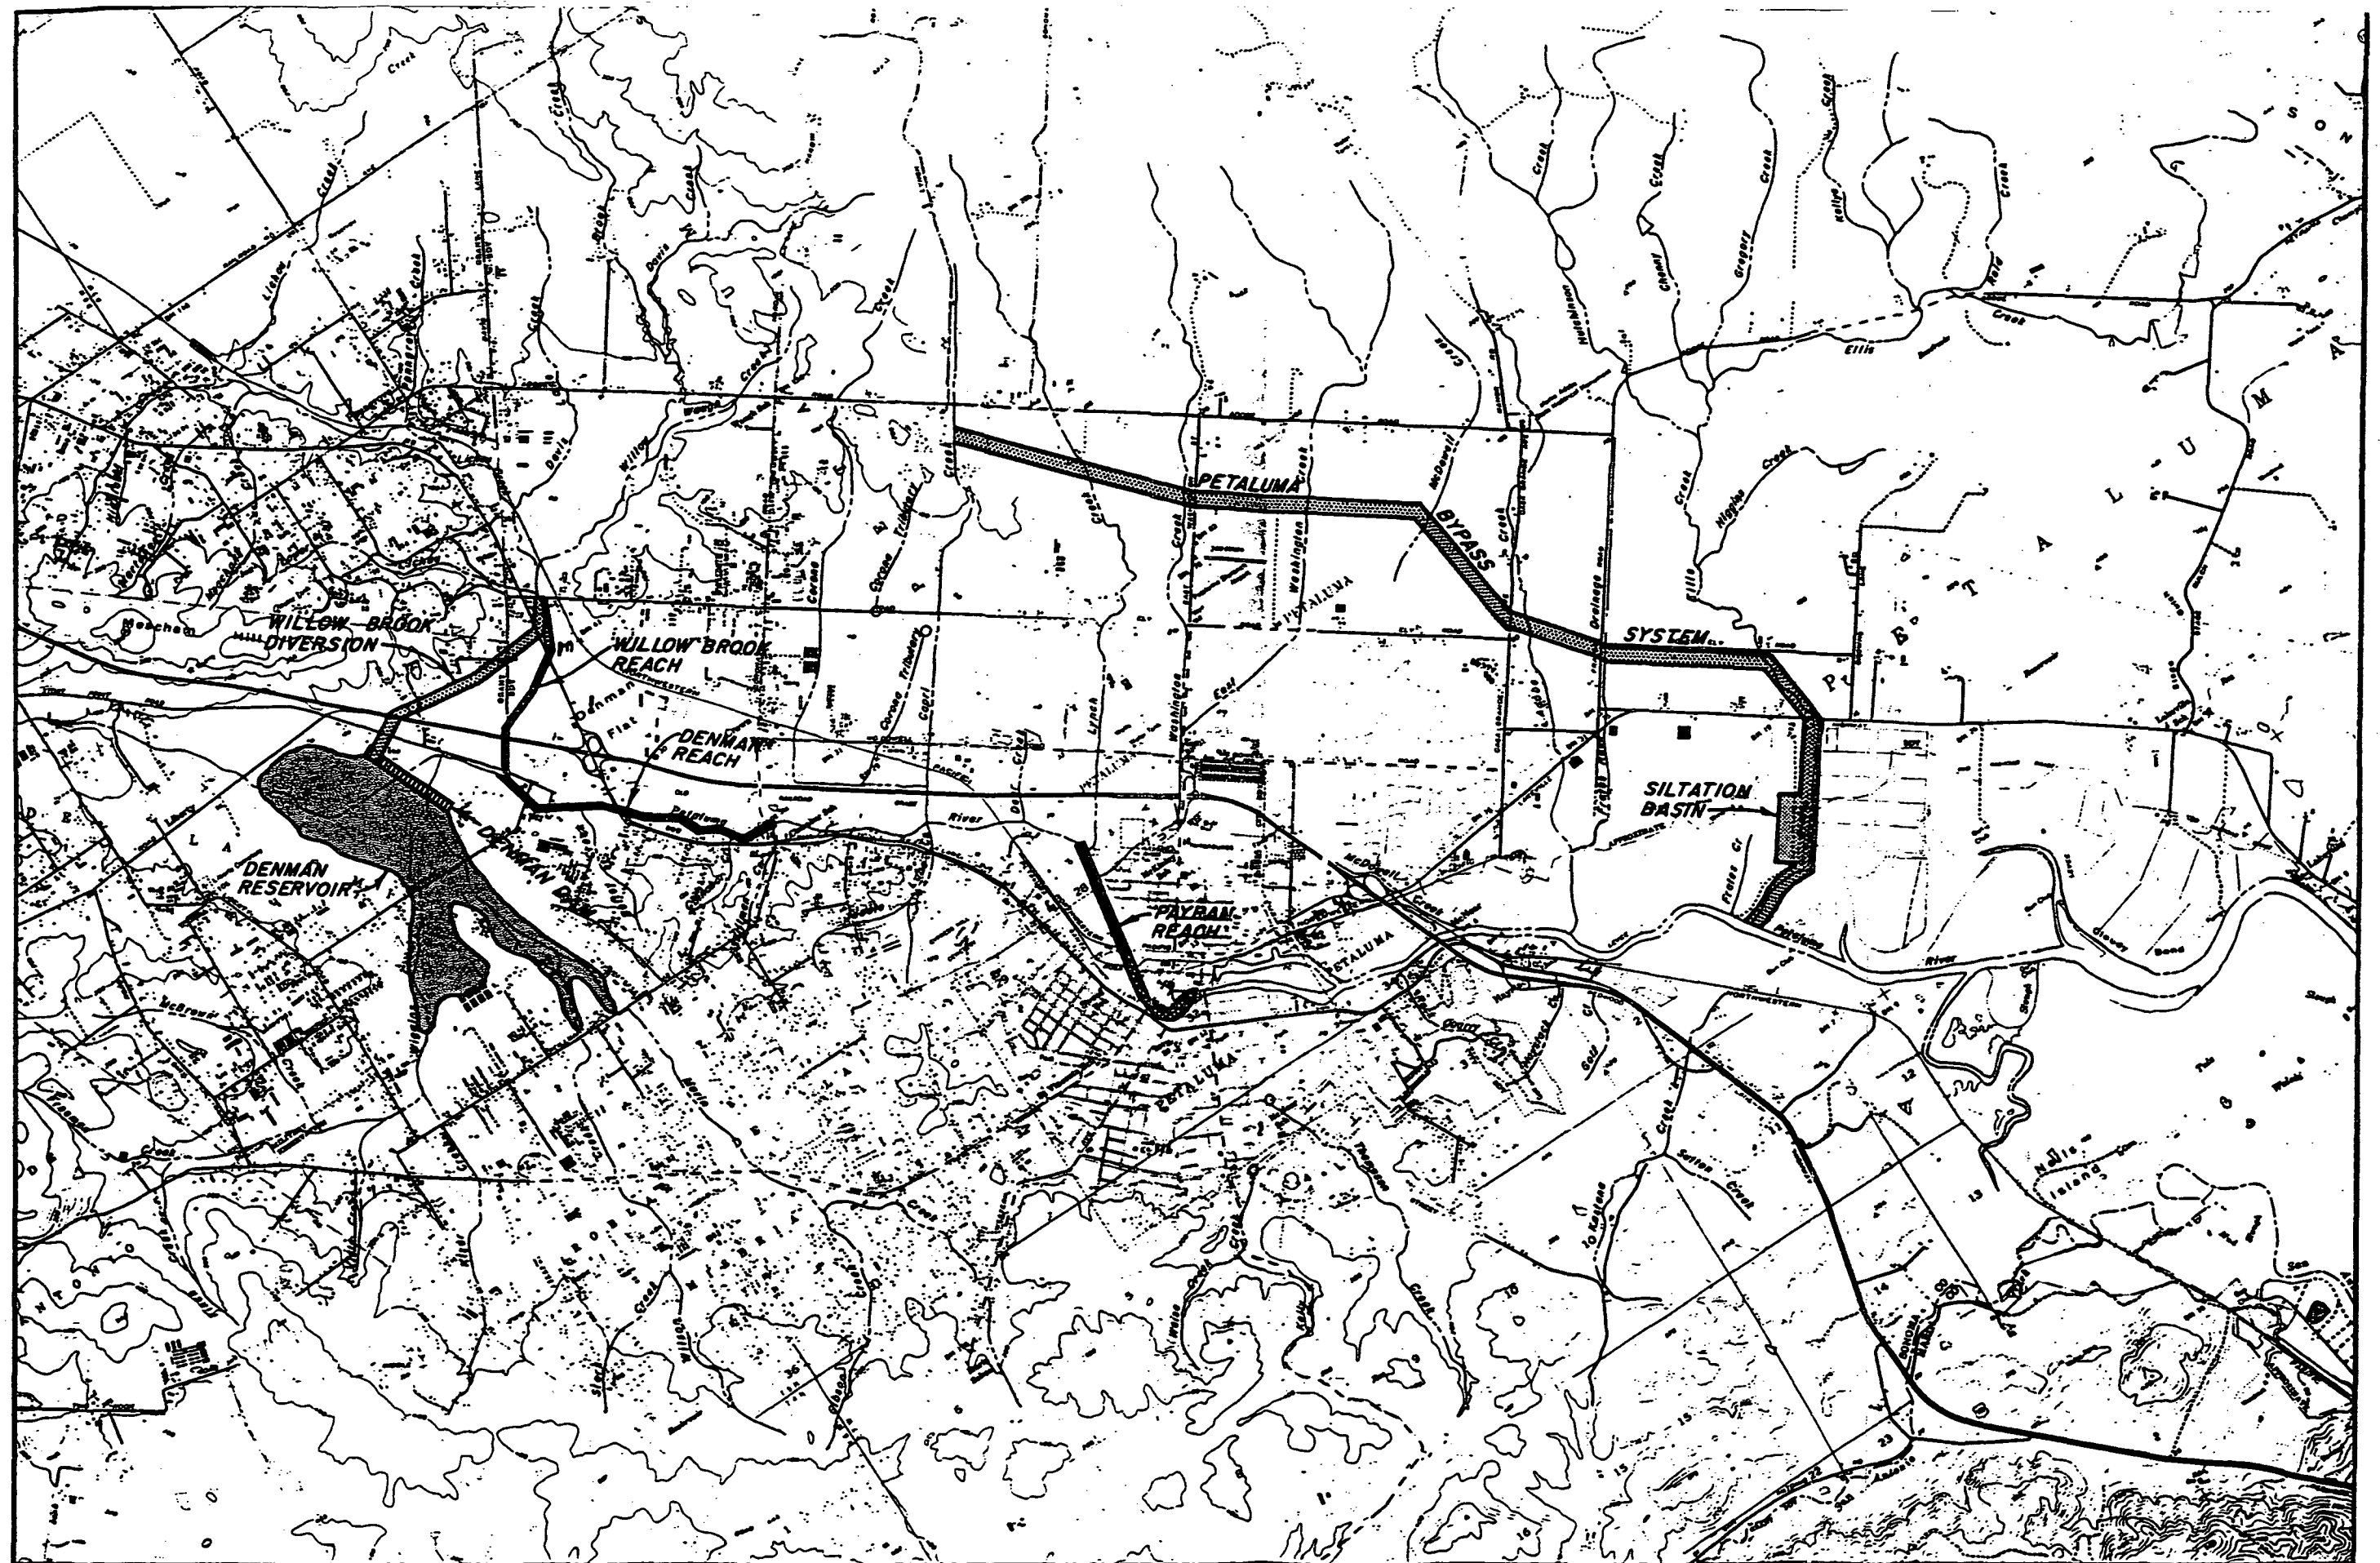
MAP NO.
3M

PETALUMA RIVER WATERSHED MASTER DRAINAGE PLAN
PETALUMA RIVER FLOOD MITIGATION ALTERNATES
