From Skeve Moore. SFB RWACB 2005.
 Peyton Slough Remediation -

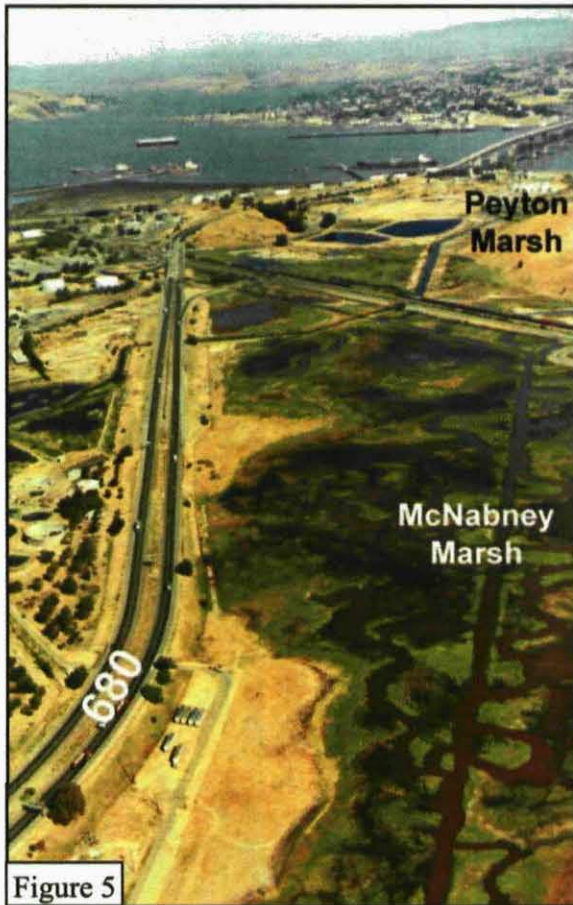
Figure 5

Key members in the Peyton Slough Technical Workgroup include representatives of the McNabney Marsh Management Advisory Committee (MMMAC). Peyton Slough is hydraulically connected to McNabney Marsh (Fig 5), and offers the only route by which fresh water can drain and saline water can flush McNabney Marsh. The MMMAC hopes that many of the compensatory mitigation features included in Rhodia’s mitigation package, such as increasing Peyton Slough’s channel capacity and enhancing the tide gate structure (used to control the upstream and downstream flow of water through the Slough), will ultimately improve the habitat of McNabney marsh.

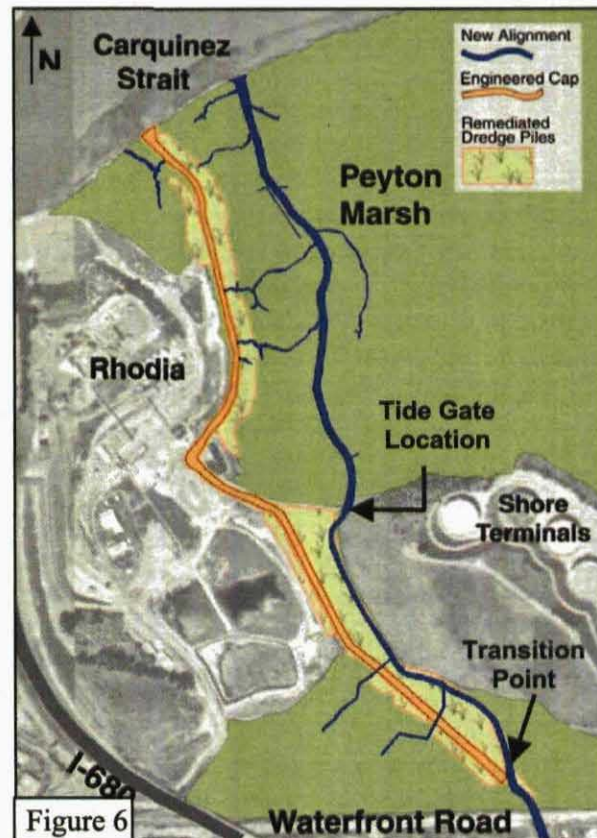
Figure 6

The Remediation Project involves several construction tasks. The first phase of construction, which has been completed, includes re-aligning the Slough to the east of its old alignment (Fig 6). The new channel is now located in relatively uncontaminated wetland habitat. The final moment of channel excavation is shown in Figure 7, where the last “plug” of earth is being removed. Water now enters the new alignment at the transition point, located at the southern boundary of the project site, near Waterfront Road. Water then flows north through the tide gate, eventually discharging at the Carquinez Strait (Figs 6 & 8).

Over the duration of the wet season, both the old and new channels will remain open. In summer 2005, Rhodia will begin the second construction phase of the Project, placing an engineered cap over the old channel (Fig 6). This will effectively contain the contaminated sediments in place so they are no longer

exposed to the environment. Much of the cap will be brought to marsh plain elevation and managed as wetland habitat. The final construction year may involve additional work on the cap, as well as confirming surface elevations necessary to promote the regrowth of native vegetation. Post-remediation monitoring will take place for a ten-year period following the completion of construction.
