Dylan Porter  
2152 Graydon Ave.  
Monrovia, CA 91016  
626-429-4219  
dporter@usc.edu

Peck Road Park Lake  
Id: 4053000

The observations were taken on November 5<sup>th</sup>, 2006 from 11:30am to 12:30pm. The weather was reported as 88° F, with clear skies no rain for at least three weeks. My observations are divided into four sections, each representing a different shoreline of the lake.

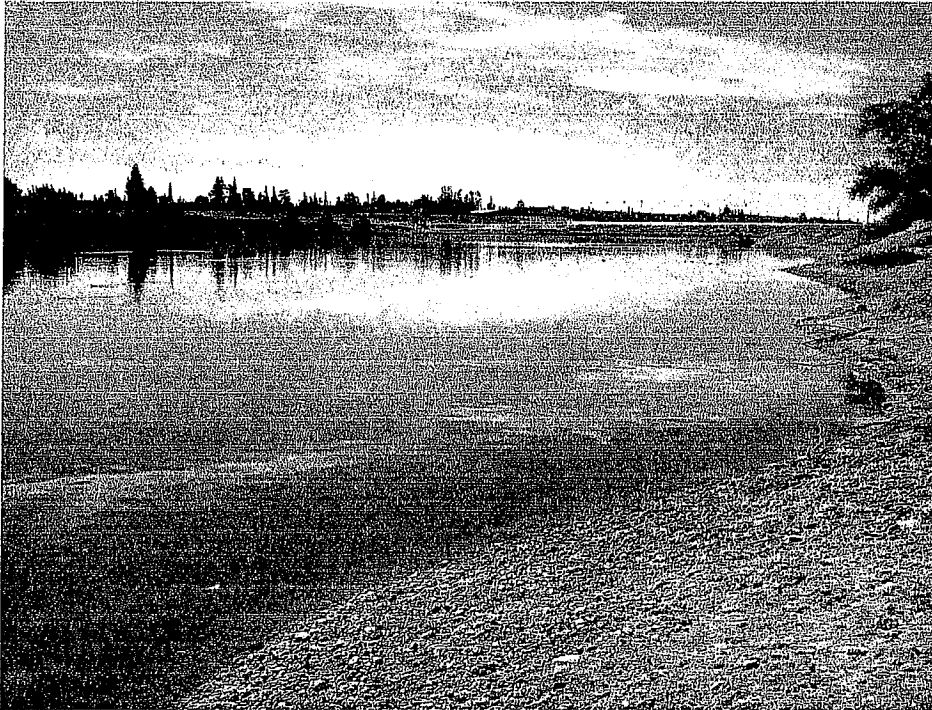
Figure 3: Northern Shore.

Trash, including human induced waste such as styrofoam cups and coolers, baby strollers, and various other household items along the shoreline of the reservoir. Within

the water styrofoam was visible, along with aluminum cans, cigarettes, and a shopping cart. The turbidity of the water along this edge was very high, with algae and suspended solids visible along the shoreline.

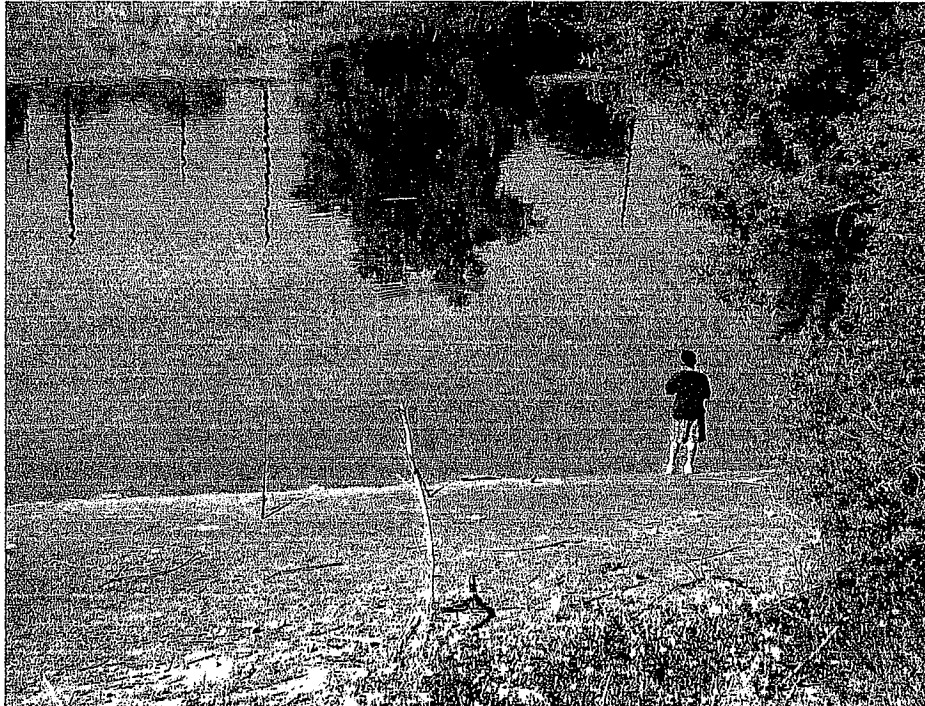
Figure 4: Man Fishing on Eastern Shore.

Observations were similar to the other two sites around the reservoir. Trash was visible floating along the edge of the water, with animal feces found along the southeastern edge of the reservoir. Again the water was turbid, with no way of seeing much deeper than 6 to 12 inches. There were also 8 people fishing from a variety of sights along these stretches of the reservoir. I was not able to see if they had caught any fish.

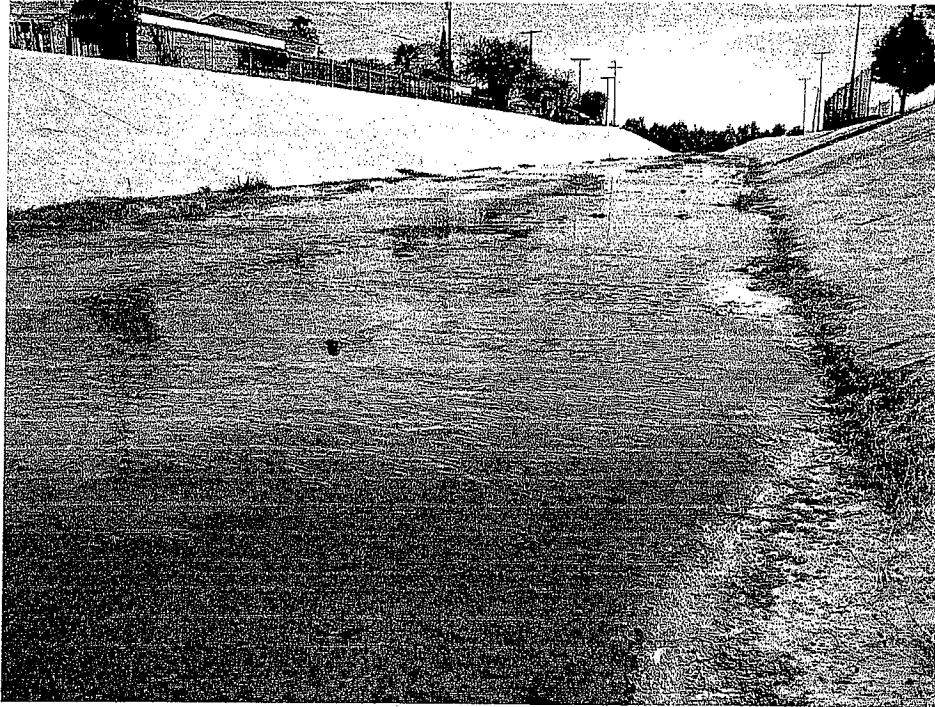
Figure 5: Santa Anita Wash inlet.

Algae covered approximately 80% of the wash bottom entering the reservoir, with water levels at about ½ inch deep and very low trickle of water movement. Animal waste was also visible along the upper portions of the reservoir, which would easily be washed into the lake water during the first heavy rain.
