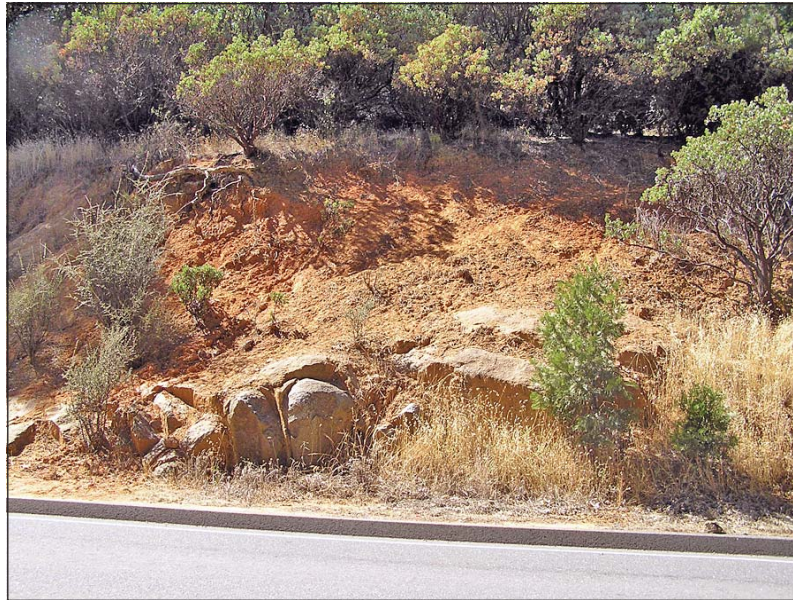
Weathering zone in granitic rock with rounded boulders emerging from bedrock joints at the base of the weathering zone. Sediment eroded from the site enters the roadway and is delivered to Sullivan Creek. Location is along Phoenix Lake Road downhill from Bellevue Creek Road.

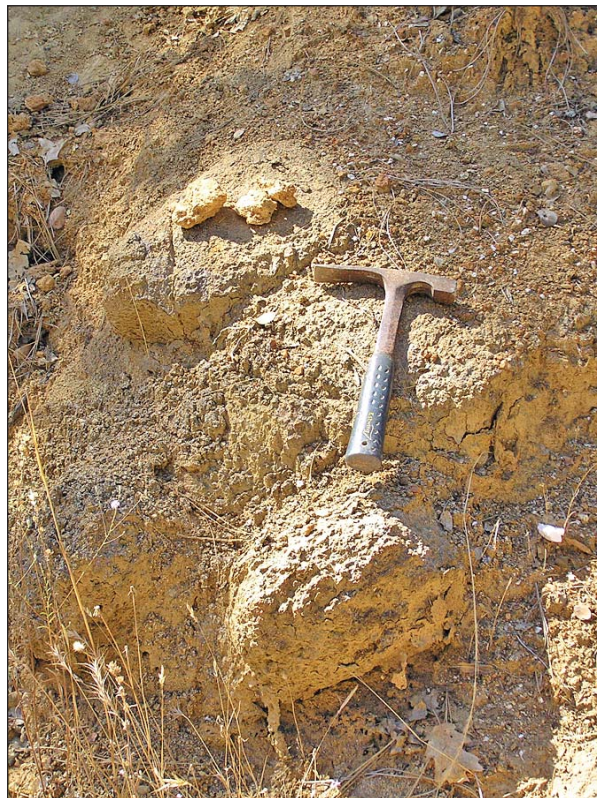
Close up view of weathered granitic boulder from exposure in the previous photograph.

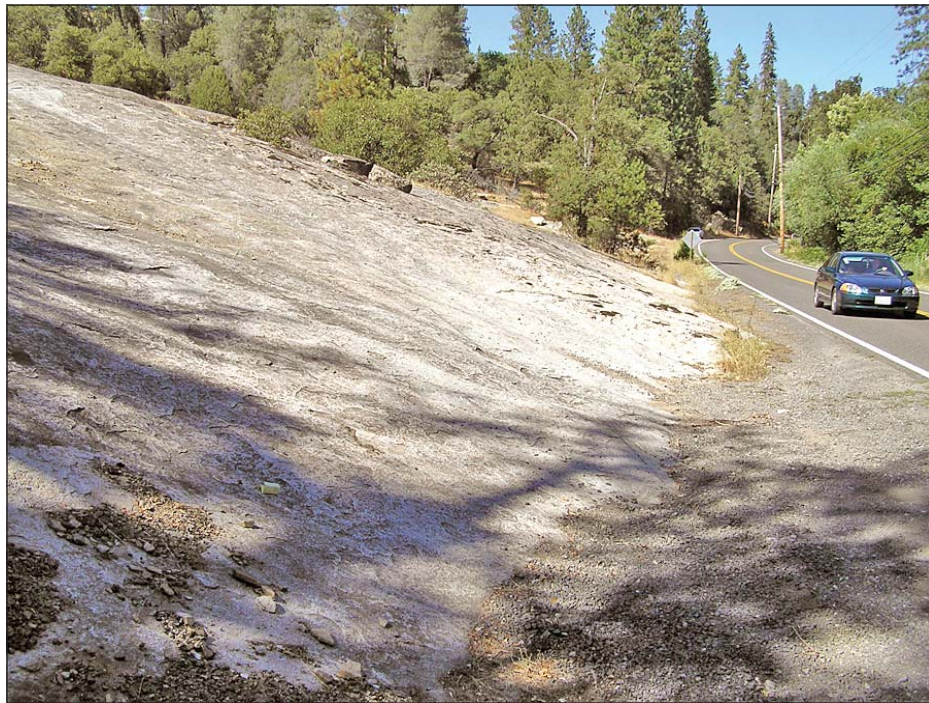
Lower portion of the granitic exfoliation surface shown in Figure 4-4. Sediment is delivered to Phoenix Lake Road and then to Sullivan Creek. Weathered zone in Figure 4-1 is across from the telephone pole.

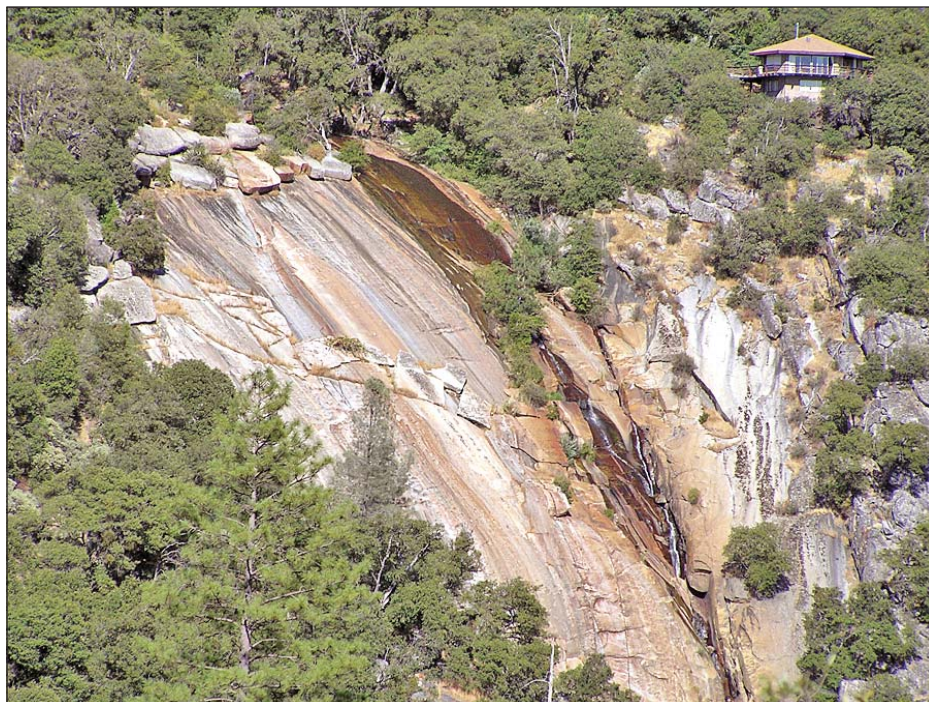
Granitic exfoliation surface along Sullivan Creek in vicinity of Crystal Falls Drive. View is from Phoenix Lake Road.

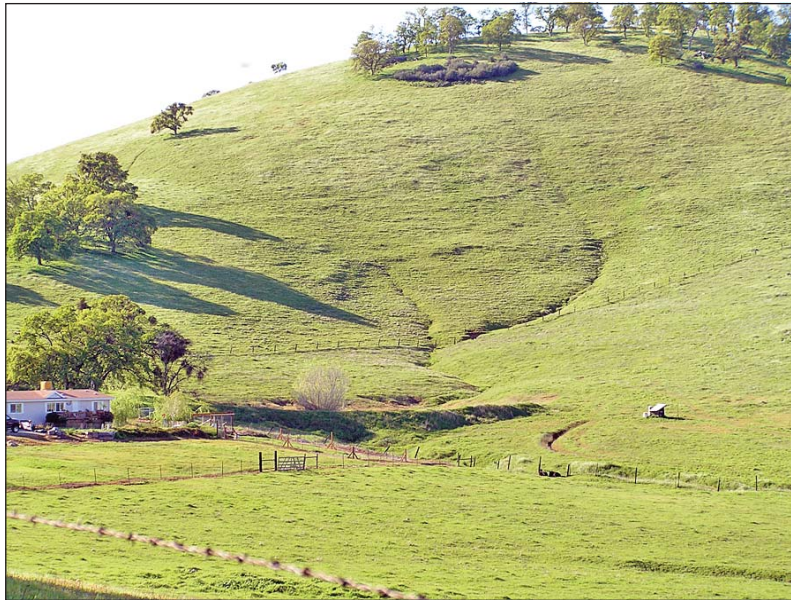
Shallow soils on moderate gradient slopes in the lower watershed metamorphic zone. Minimal soil erosion and minimal sediment delivery occurs except in localized and shallowly incised stream channels.

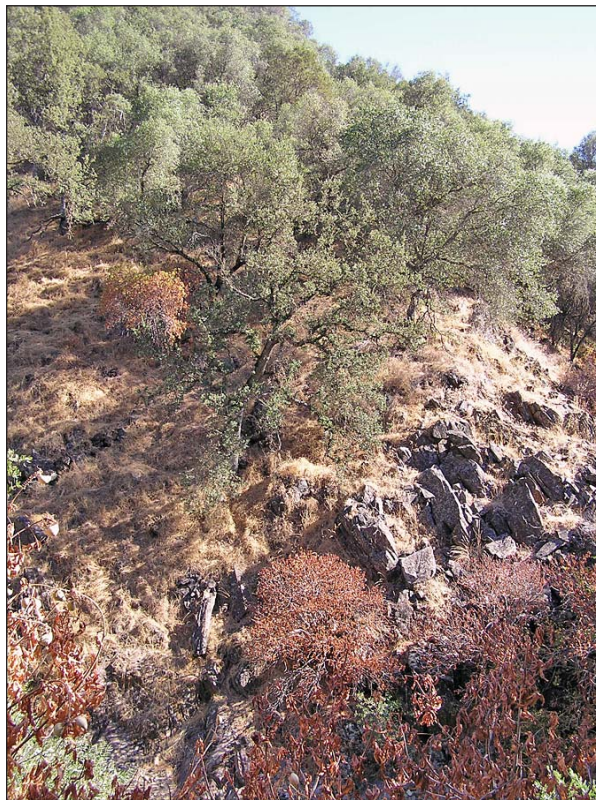
Shallow soils and physical weathering of bedrock in the lower watershed metamorphic rock zone. Site is a canyon along lower Curtis Creek (GPS point in Figure 4-9).

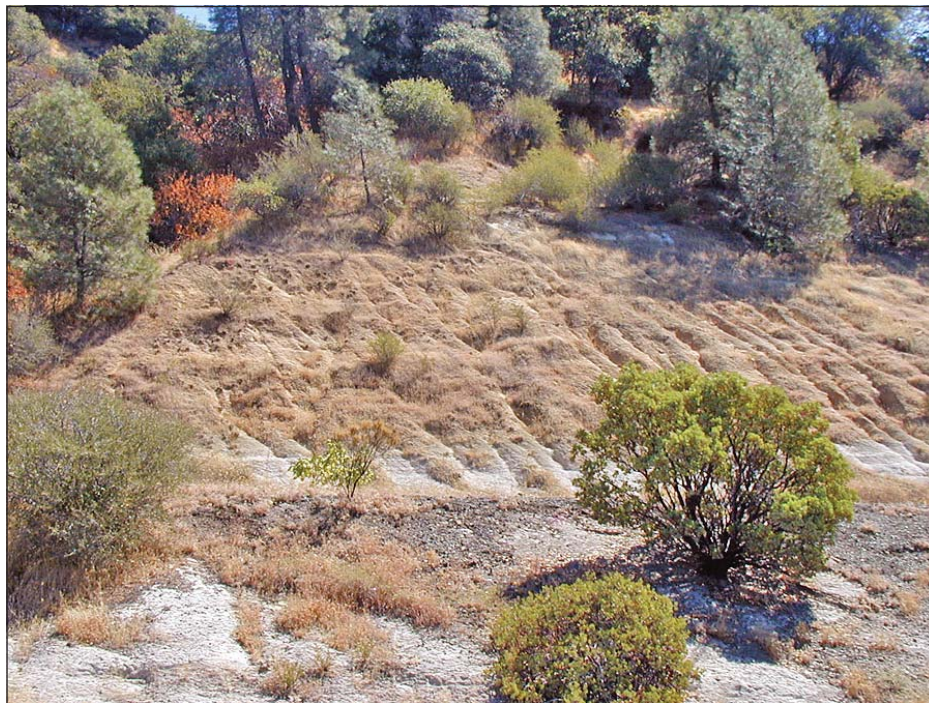
Rills developed in Mehrtens Formation along Highway 108 in Twain Harte.

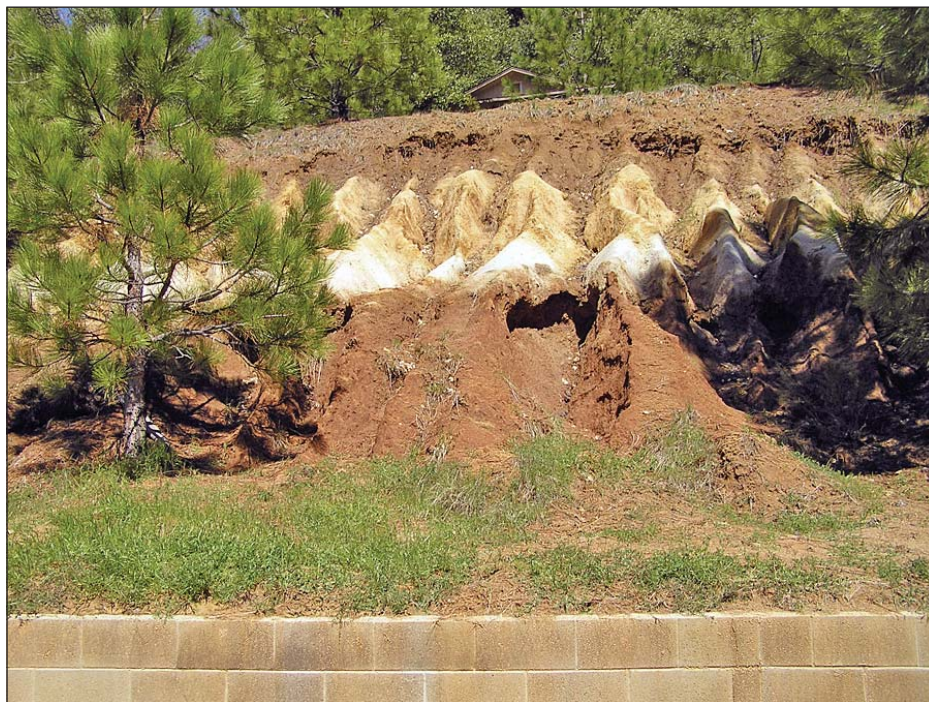
Weathering zone in granitic rocks in Twain Harte behind a commercial parking lot. Deep rills deliver sediment to parking lot and then to storm water system and then to Twain Harte Creek.

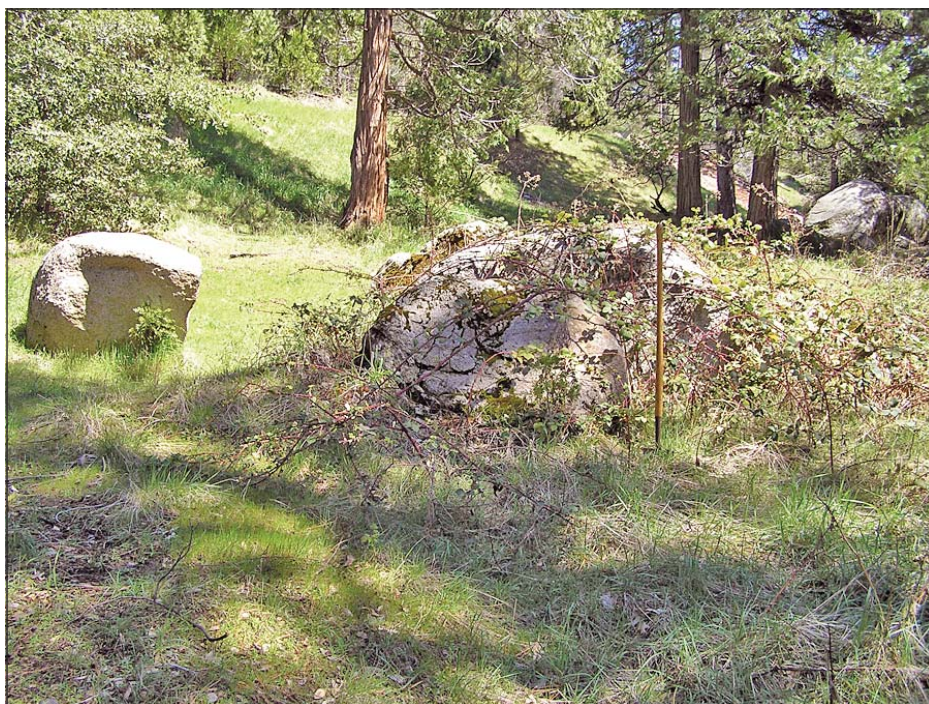
Remnant boulders being eroded from the same weathering zone shown in the previous photograph. This site is just below the base of the overlying Mehrten Formation.

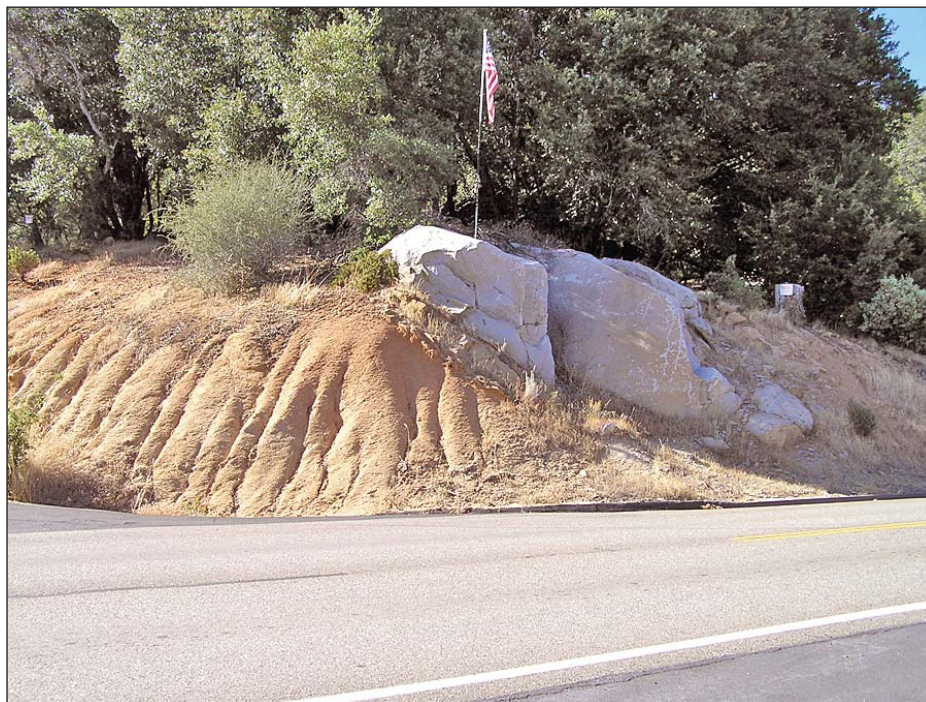
Boulder remnant within granitic weathering zone along Phoenix Lake Road near Oakhaven Lane. Rills deliver eroded sediment to roadway and Sullivan Creek.

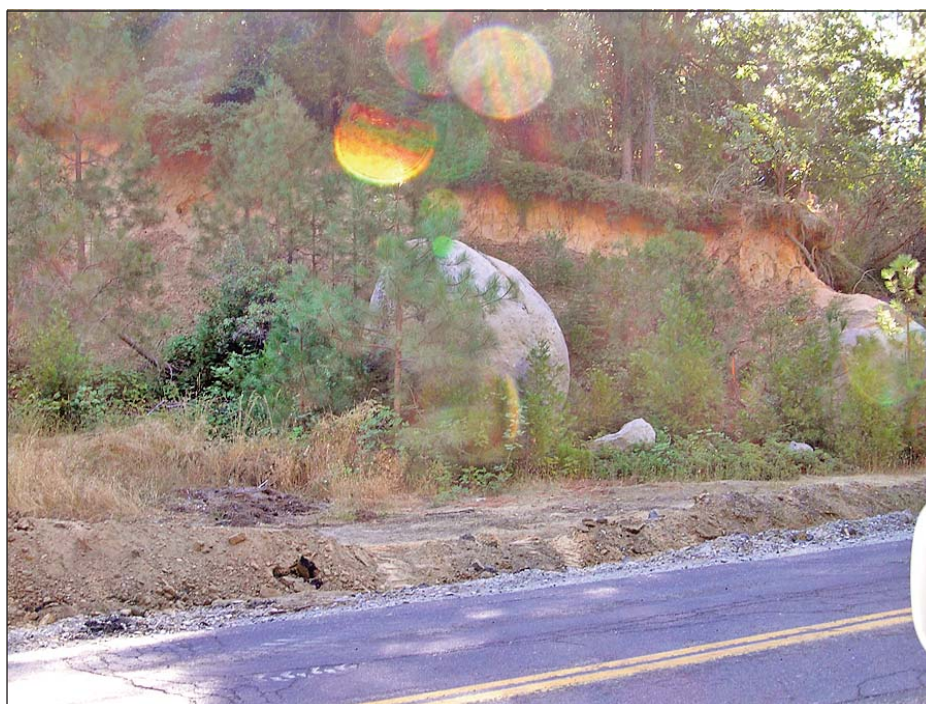
Two large boulder remnants from the granitic weathering zone along Middle Camp Road near Pinewood Lane in the Upper Sullivan Creek watershed.

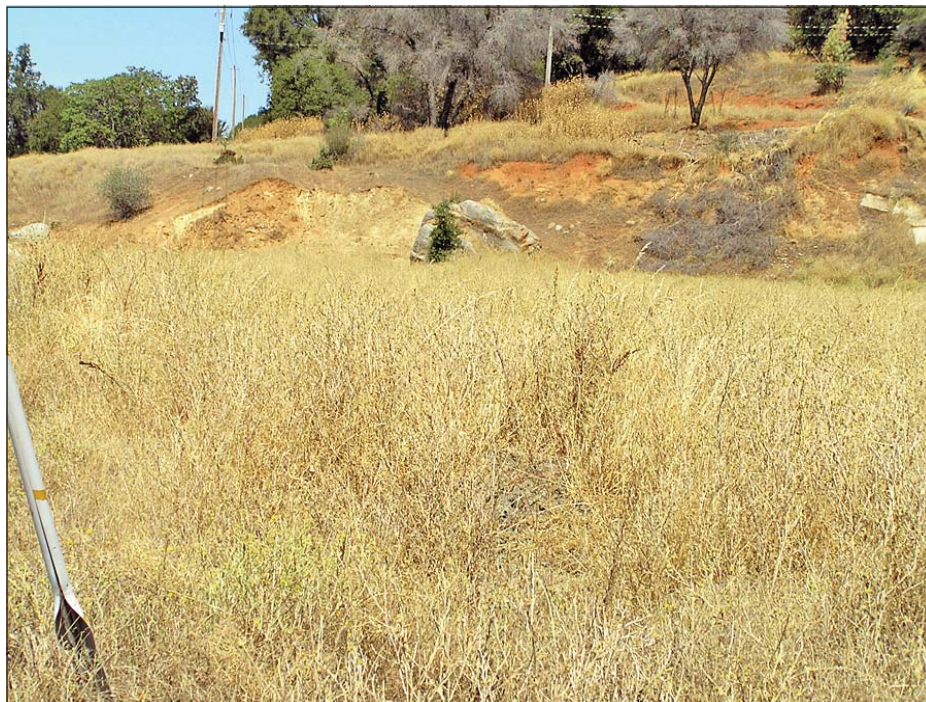
Deeply weathered granite and emerging boulder at Standard along Camage Avenue. The site is adjacent to Curtis Creek and similar large boulders are found along the creek.

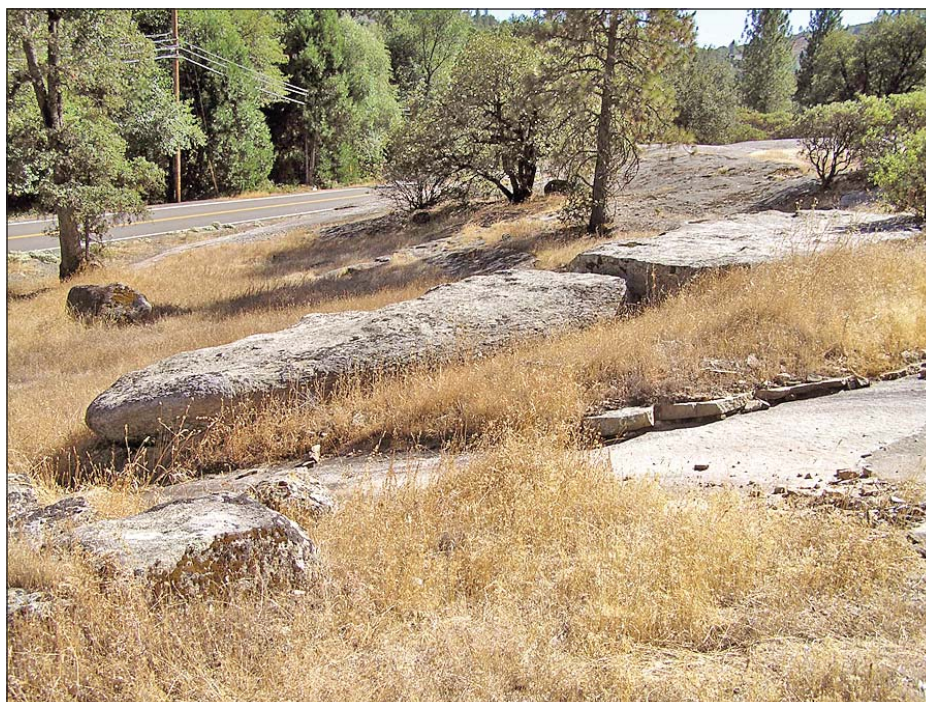
Exfoliation surface and sheets in granitic rocks with remnant soil and remnant weathered material. Site is along Phoenix Lake Road where it crosses Sullivan Creek.
