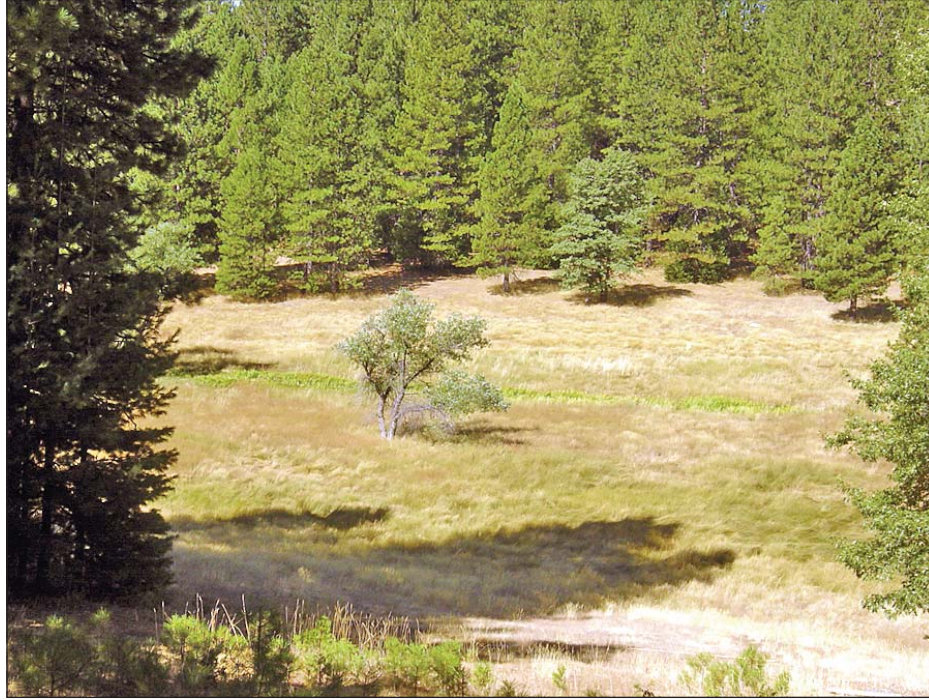
SCR-6. A small tributary to Sullivan Creek. Passes through an upland valley a few miles downstream of the Sullivan Creek headwaters.

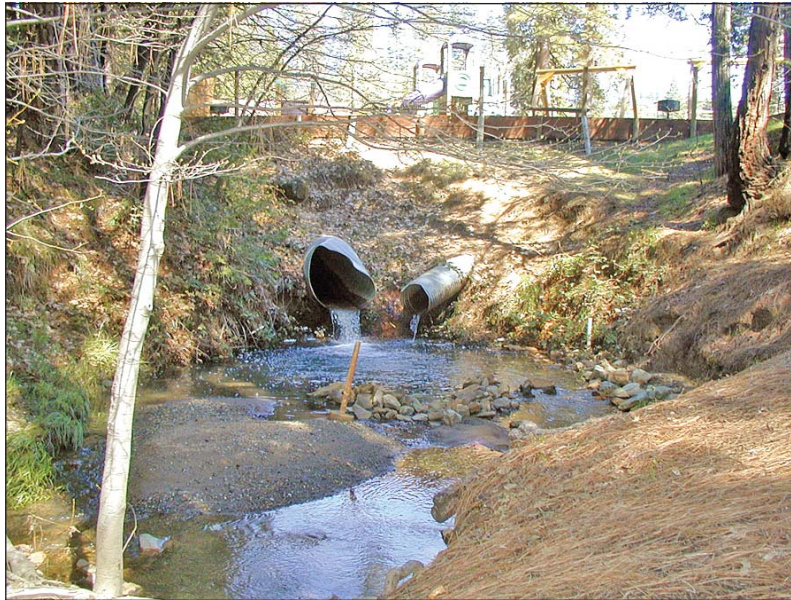
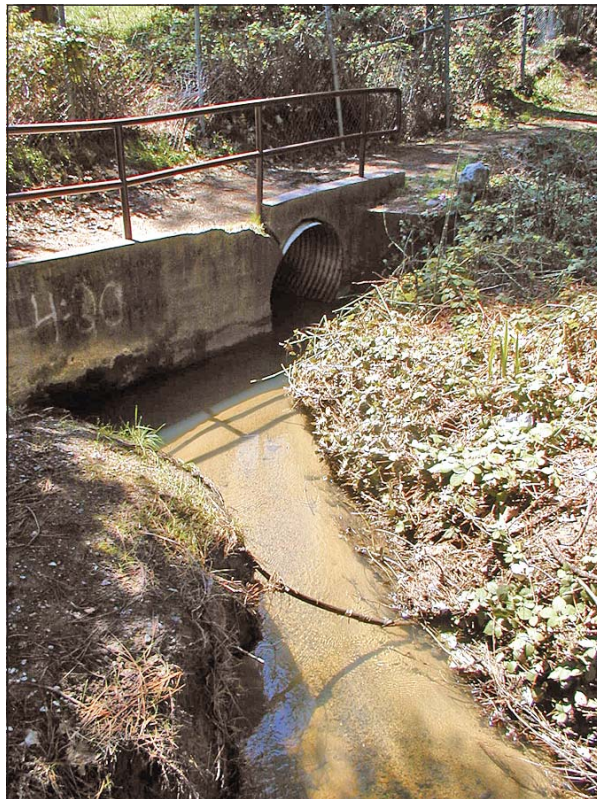
TWH-1. Small reach of Twain Harte Creek parallel to Epscol Park. Upstream end (top) is fed by two large culverts; downstream end (bottom) is backed-up by another culvert under the footpath. Morphology is highly altered, significant accumulation of sand within this reach and evidence of recent bank erosion and channel incision.

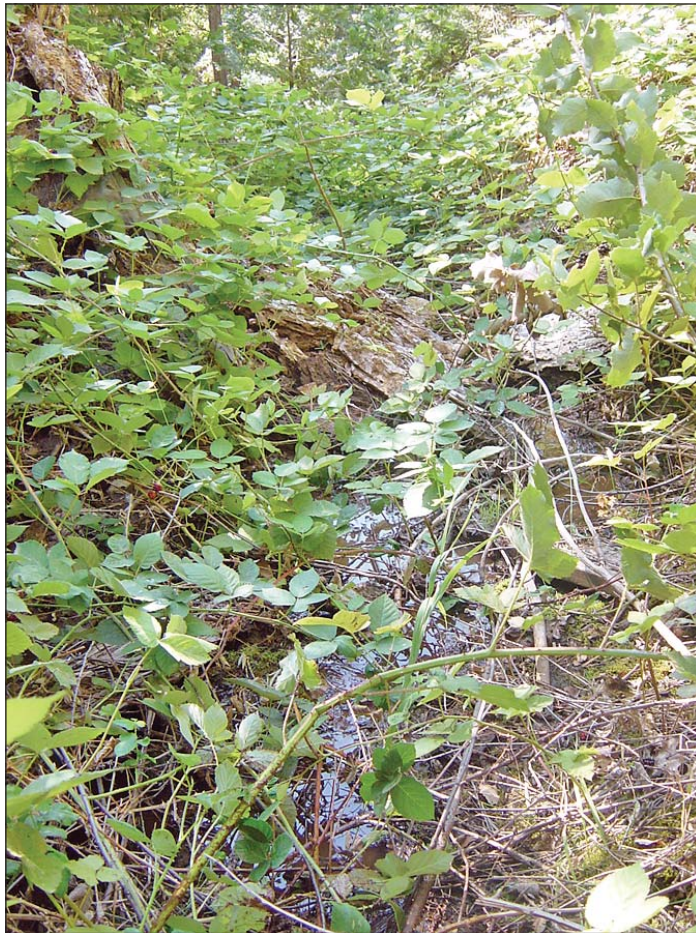
SCR-5. Looking downstream, cascade/step-pool morphology typical of the headwater channels draining the northern half of the upper Sullivan Creek watershed. Channel is heavily vegetated and is likely a transitional form between a colluvial and alluvial channel. Much storage of fine (clays and silts) sediment, likely a net storage of sediment over short time scales but flushed periodically by large flows.

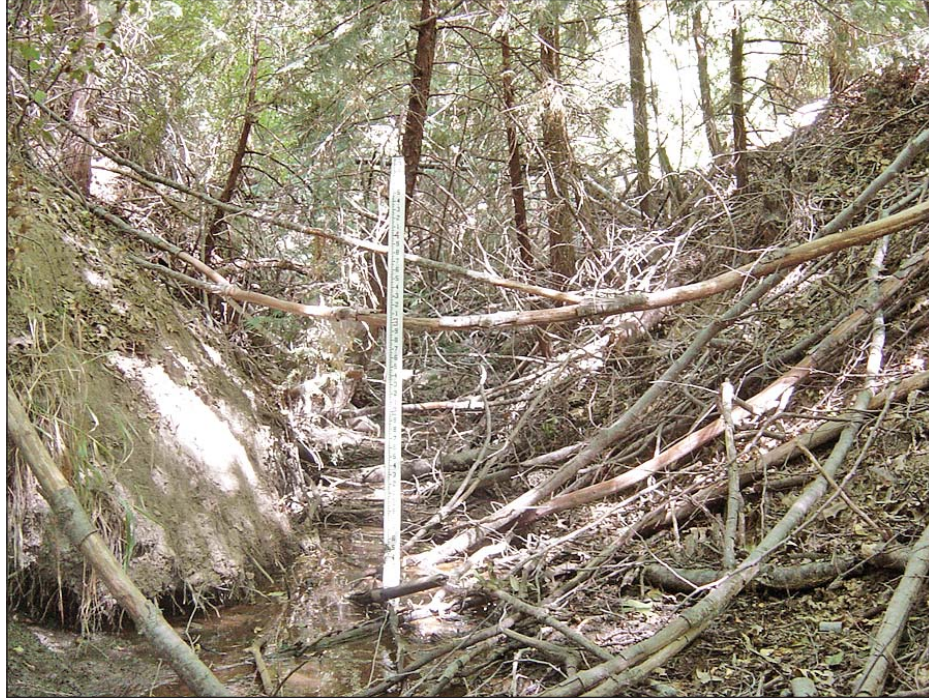
SCR-7. Small tributary to Sullivan Cr., this particular reach passes through the Lazy Z Resort property. Highly entrenched channel, severe bank and bed erosion and bank stability issues (note all the relatively young trees falling into the channel). Channel has cut down into highly erodible valley-fill, or terrace material, and a large amount of sediment has been scoured from this channel over time.

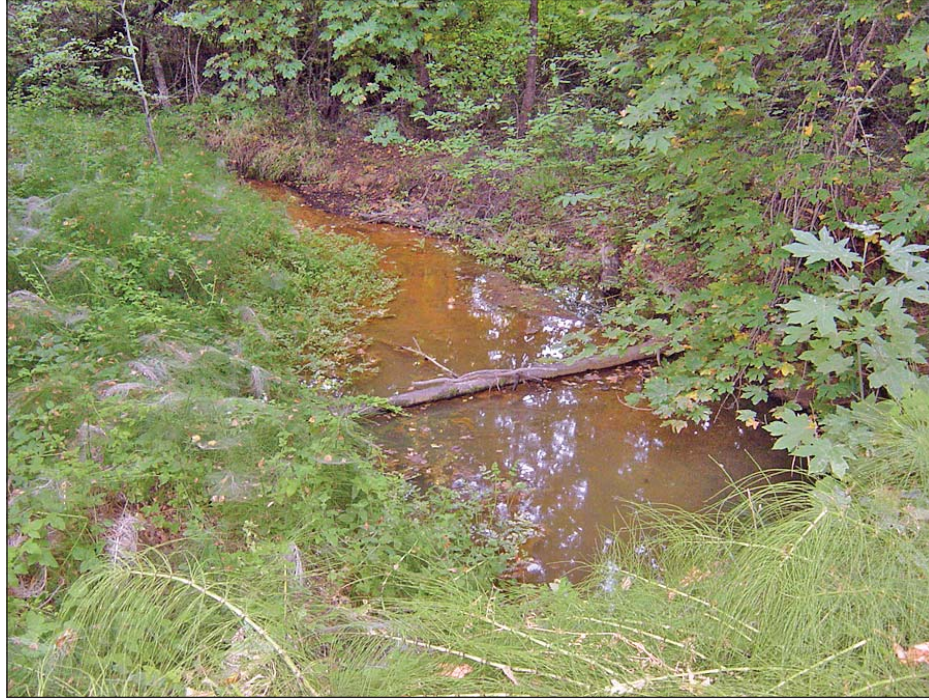
SCR-3. Fairly non-typical, headwater channel, in that this upper reach falls within the MEDIUM slope (2-8%) category (vs. HIGH slope category). Morphology is more typical of the lower gradient, mainstem Sullivan Cr. However, much more clay, silt, and organic material accumulation.

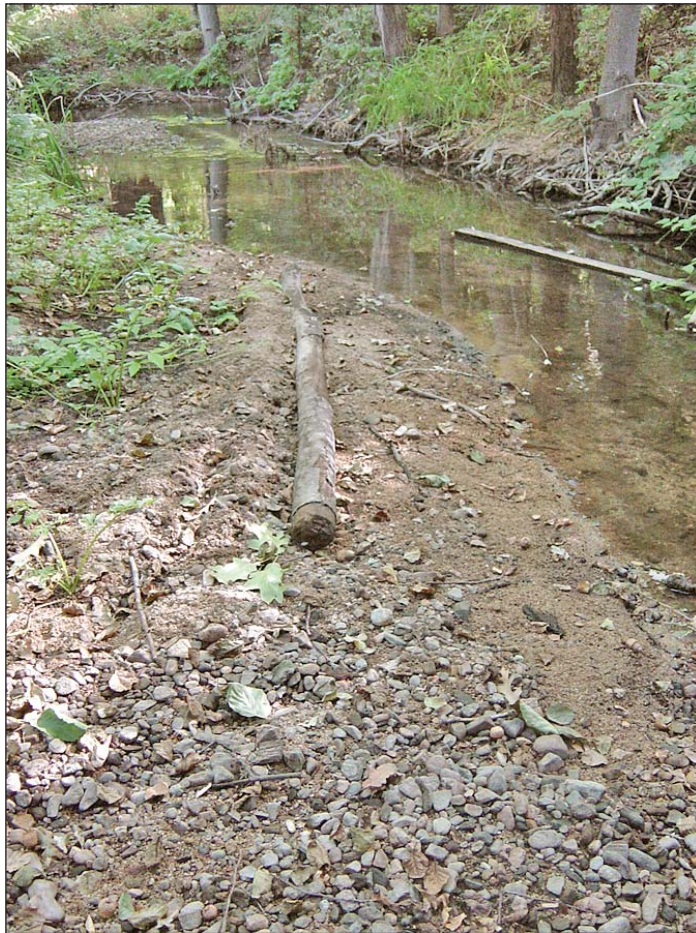
SCR-2. Looking downstream, low gradient reach of mainstem Sullivan Creek. Bar formation and sand accumulation suggests channel is generally more transport (vs. supply) limited. Poorly sorted bar material, note delineation between the gravels and sands. A pebble-count was conducted at this station.

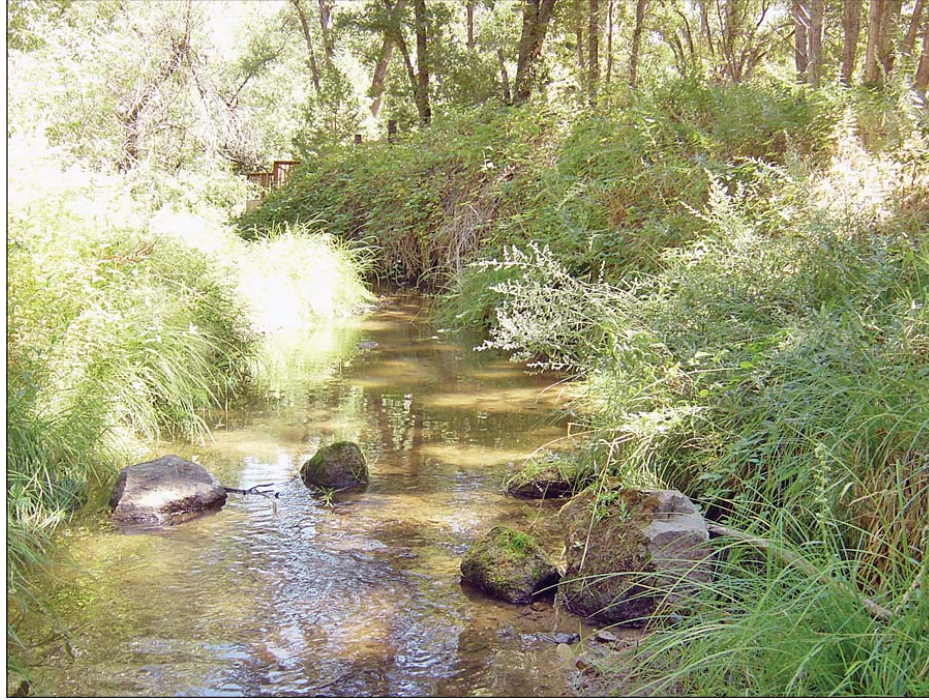
SCR-1. Looking upstream toward eventual benchmark. Low gradient and morphology is pool-riffle. Mobile, sandy bed-forms form layer over relatively immobile cobble bed, suggests reach is transport-limited. A cross-section was surveyed and a pebble-count was conducted at this station.

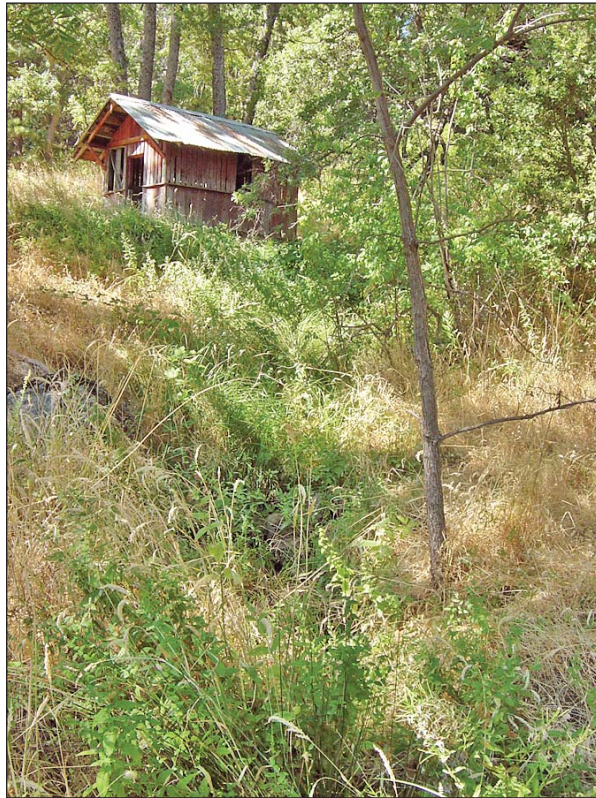
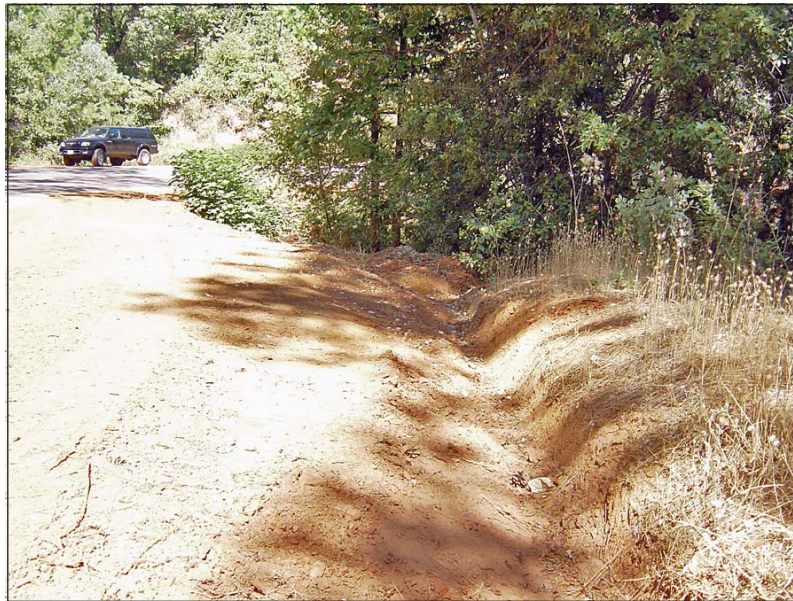
SCR-18. Small tributary to Powerhouse Creek (which drains to Phoenix Lake and then to lower Sullivan Creek). Looking upstream (top), small cascading (could be colluvial) channel typical of the steep headwater streams draining the northern half of the Upper Sullivan (or Phoenix Lake in this case) watershed. Roadside ditch (bottom) delivering weathered material (likely mostly clays, silts, and fine sands) to the hillslope and channel.

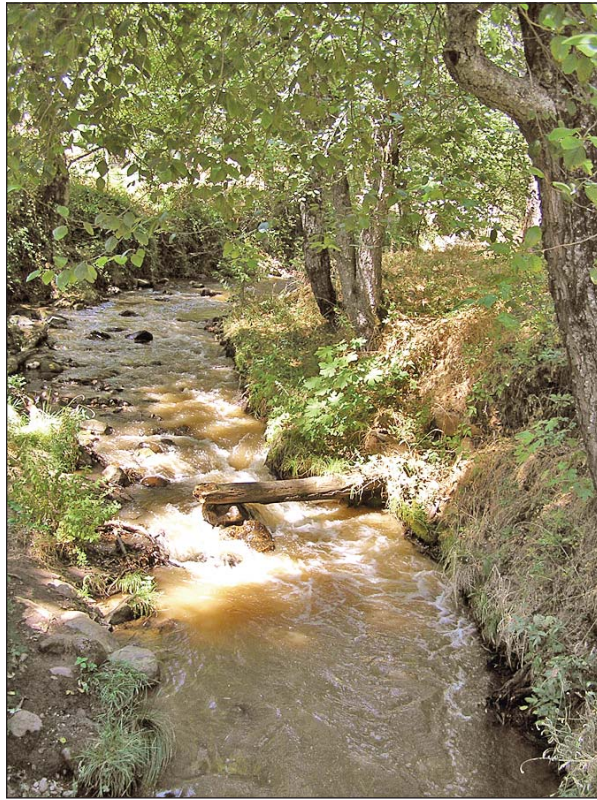
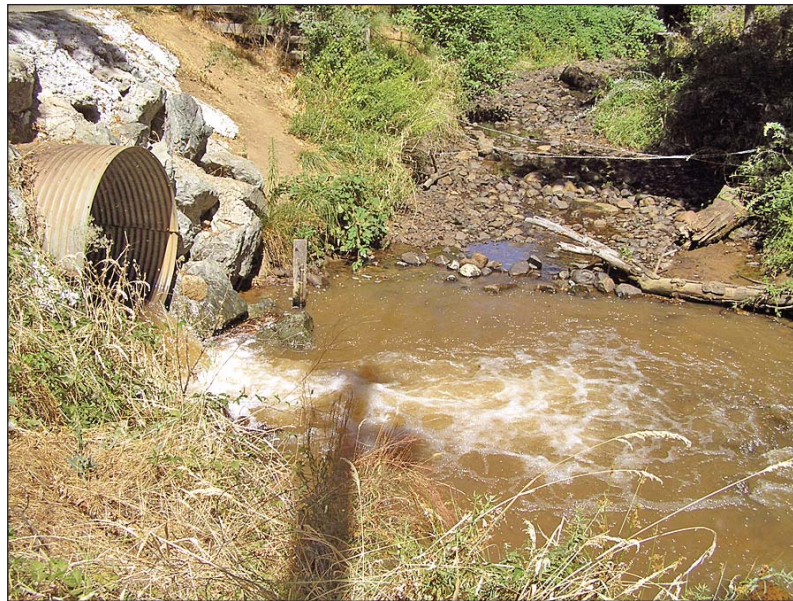
SCR-9. Looking upstream (top) from road, much more flow relative to other tributaries. Morphology appears to be plane-bed, or gentle cascade. Note the turbid nature of the water. Large culvert (bottom) is just upstream of reach in the top photo, it drains a tributary that comes in from the northwest and passes just to the west of the power station. The power station is likely using the water from the Penstock ditch (canal, etc.) and the effluent is diverted back into this tributary.

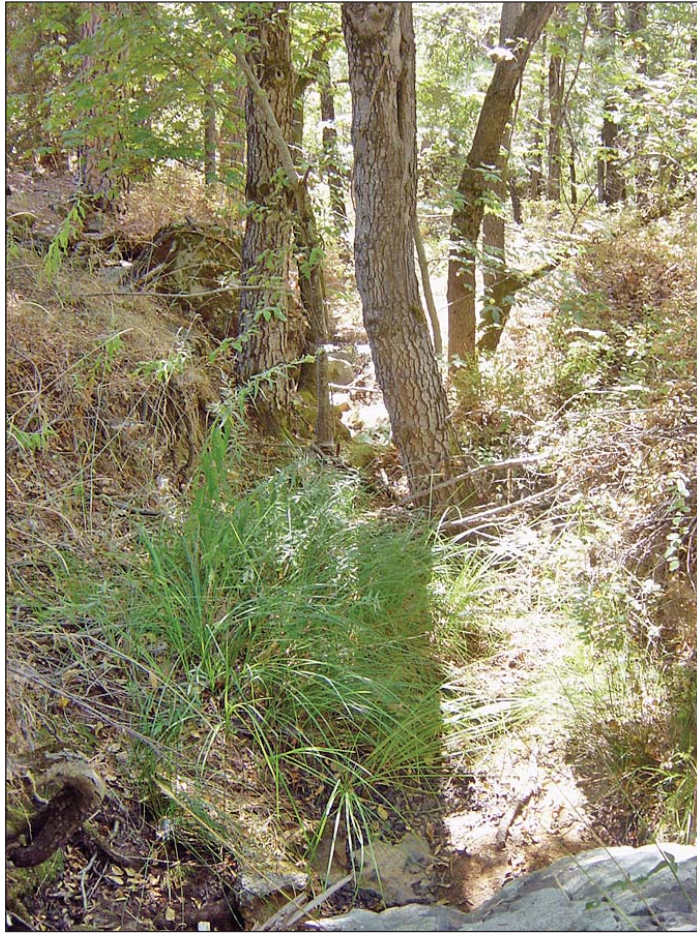
SCR-10 (the Outdoor School property). Looking downstream, morphology is cascade/step-pool and the channel cuts through a narrow valley of large remnant boulders. Large amounts of sediment stored behind channel obstructions (i.e., boulders).

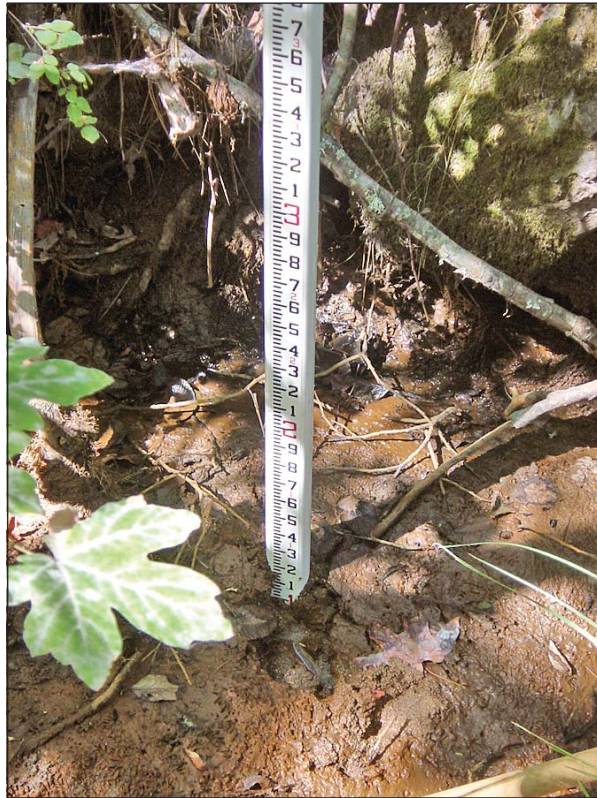
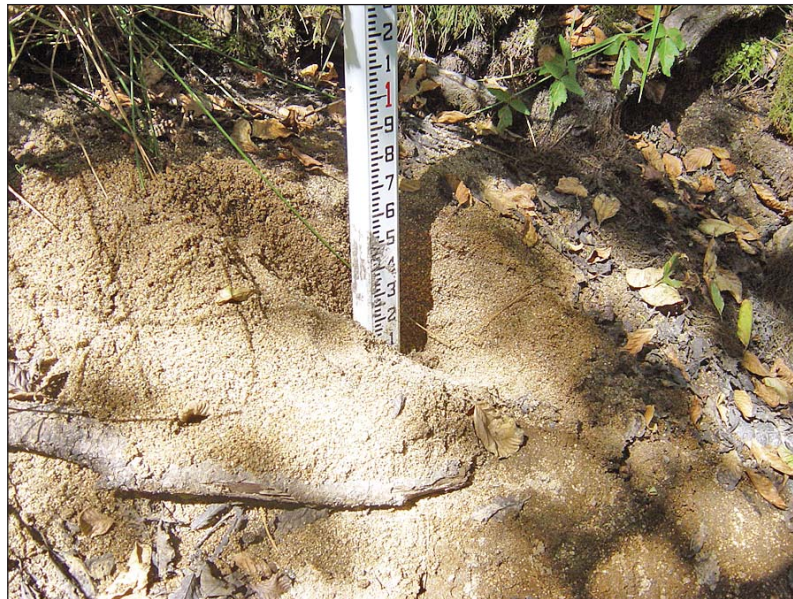
SCR-10 (the Outdoor School property). Close-up view of silt and sand (top) and sand and small gravel (bottom) accumulation within the channel (upstream of local obstructions). Such accumulations were fairly typical of the headwater streams draining the northern half of the upper Sullivan and Phoenix Lake watershed. The residence time of such sediments in the entire system is unclear, yet these are likely flushed out of local storage every year or so.

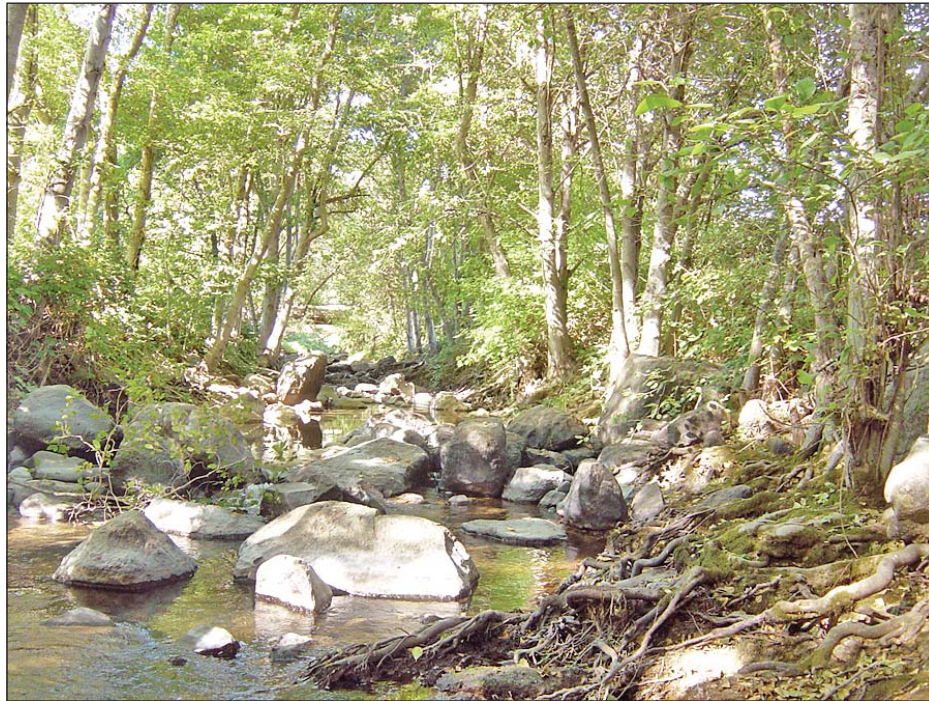
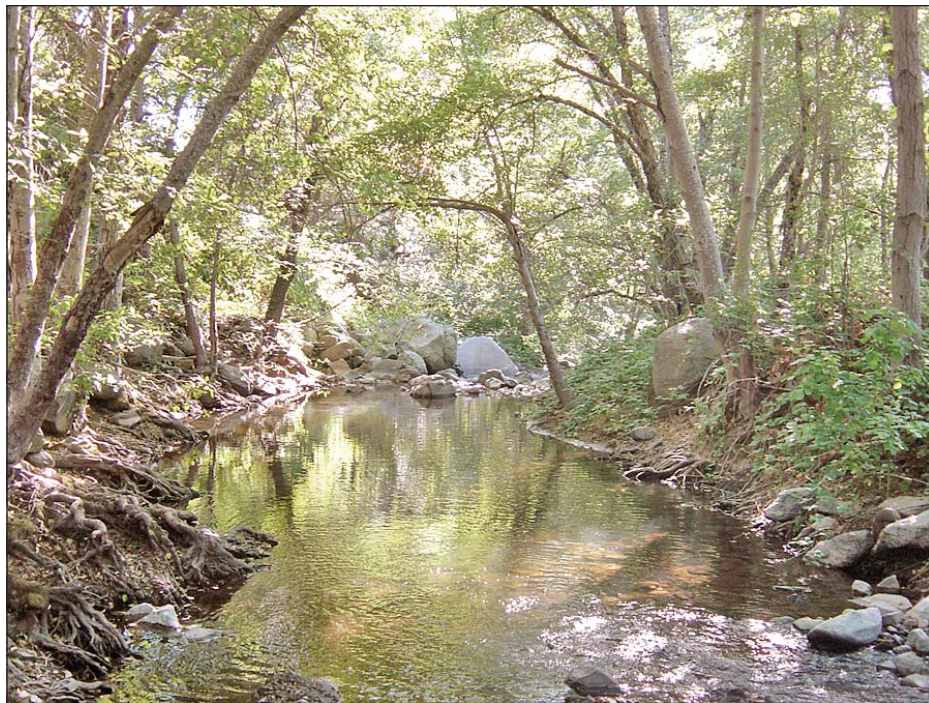
SCR-11. Sullivan Creek just over two miles downstream of Phoenix Lake, looking upstream (top) and downstream (bottom) from the same point. Morphology is step-pool and pool-rifle, substrate is much larger at this point (i.e., predominantly cobbles and boulders). Not much sediment accumulation or storage in this reach, even in the slower-moving pool sections. Not much floodplain development, though the channel has become much wider and storing relatively less sand-sized sediment compared to upstream of Phoenix Lake (i.e., SCR-1).

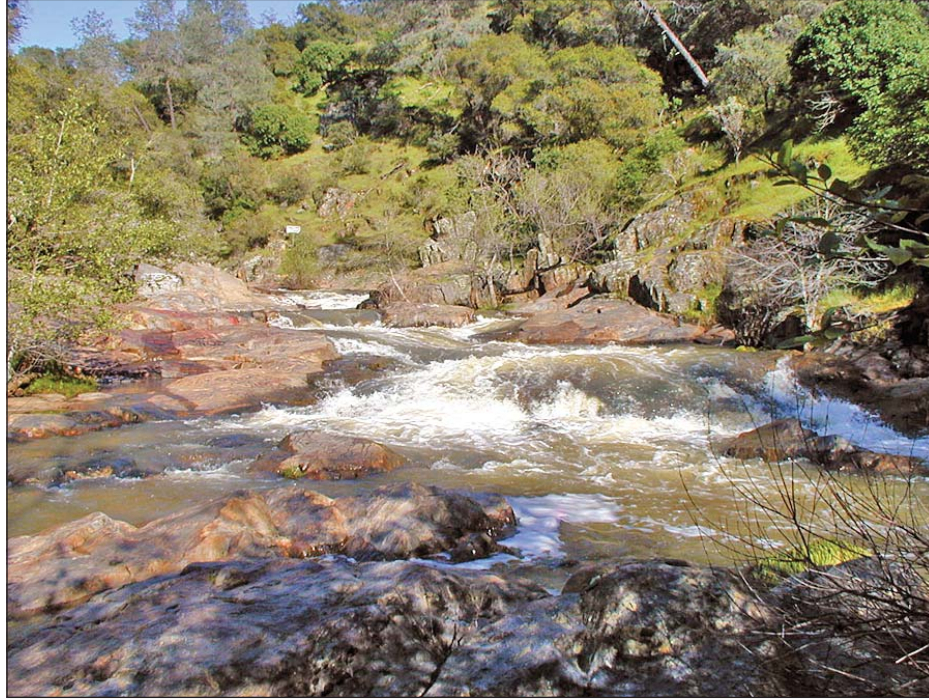
SCR-12. Looking upstream. Sullivan Creek has incised deeply into the canyon at this point, exposing the rock of the Calaveras Complex, and is highly confined. This is essentially a bedrock reach in terms of morphology.

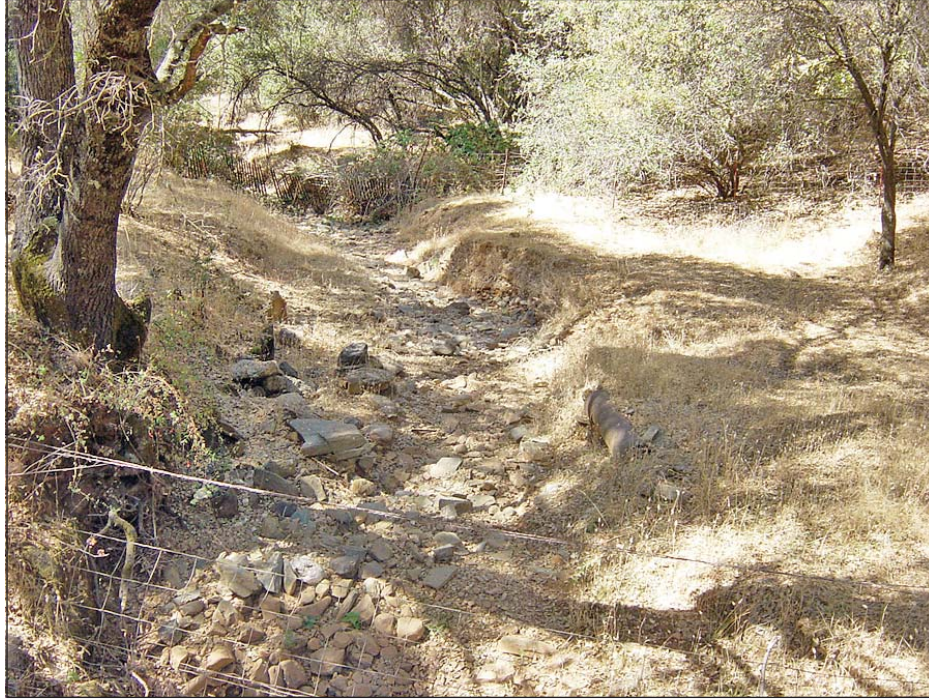
SCR-15. Low-order tributary to Sullivan Creek in the lower watershed. Compare to the steeper low-order tributaries observed in the northern half of the upper watershed and note the difference in morphology and condition. Distinct floodplain (active or relic) and terrace features are evident. Channel has incised slightly into the valley and is likely a source of fine sediments and sand, but the cobbles and small boulders are rarely moved.

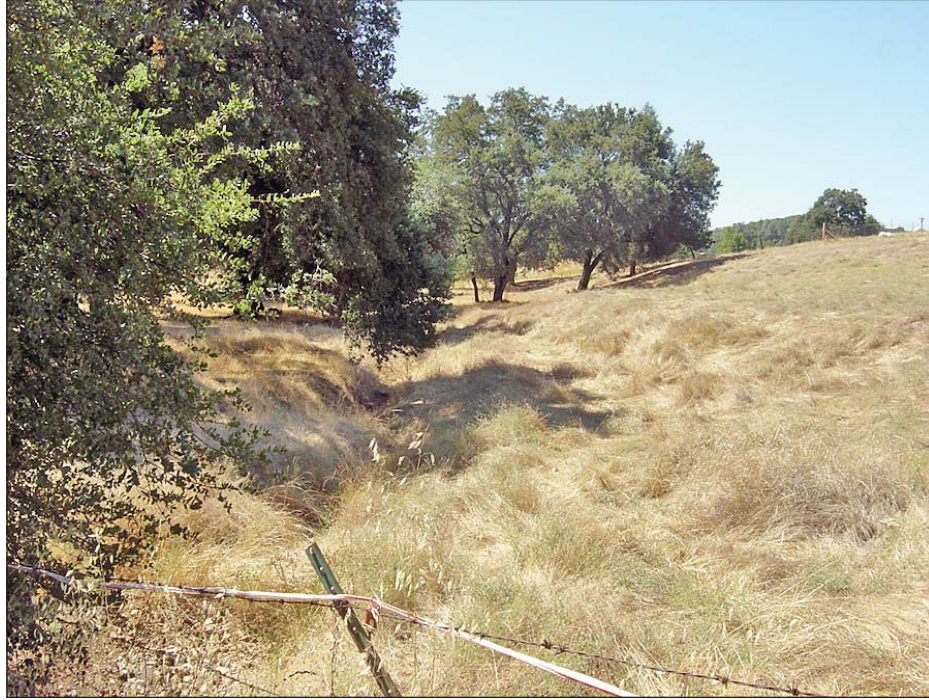
SCR-16. Another example of a low-order tributary to Sullivan Creek in the lower watershed (just south of SCR-15).
