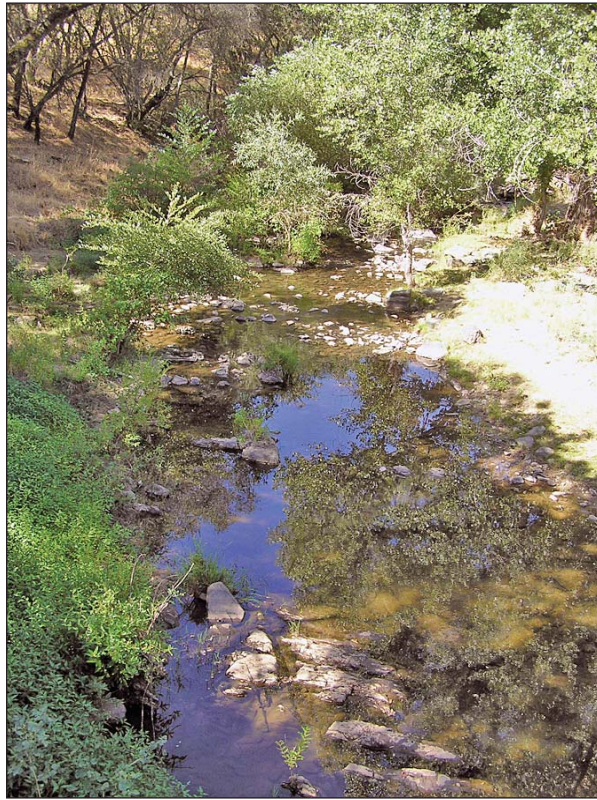
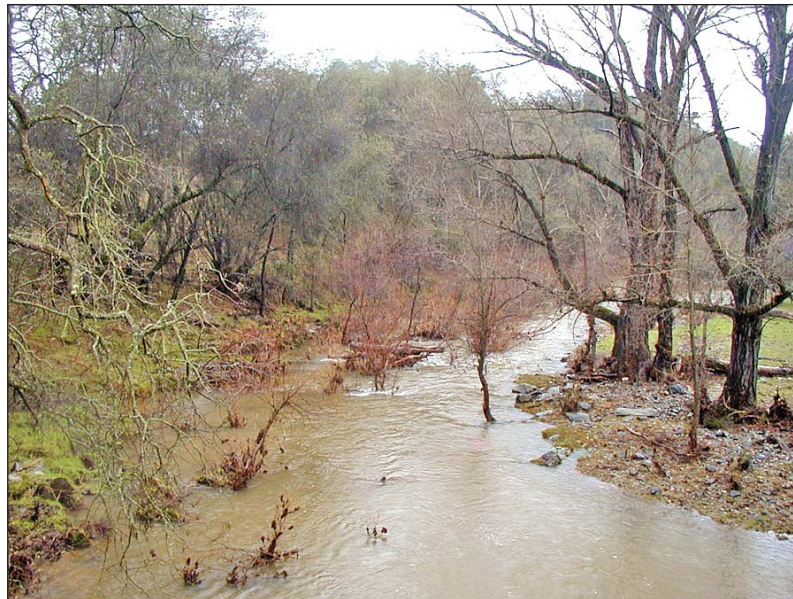
SCR-13. Lower Sullivan Creek, looking upstream from same vantage point on Algerine Road bridge during late summer (top photo) and early spring (bottom photo). Moderate to low confinement at this point, floodplain development is more apparent. Plane-bed/pool-riffle morphology.

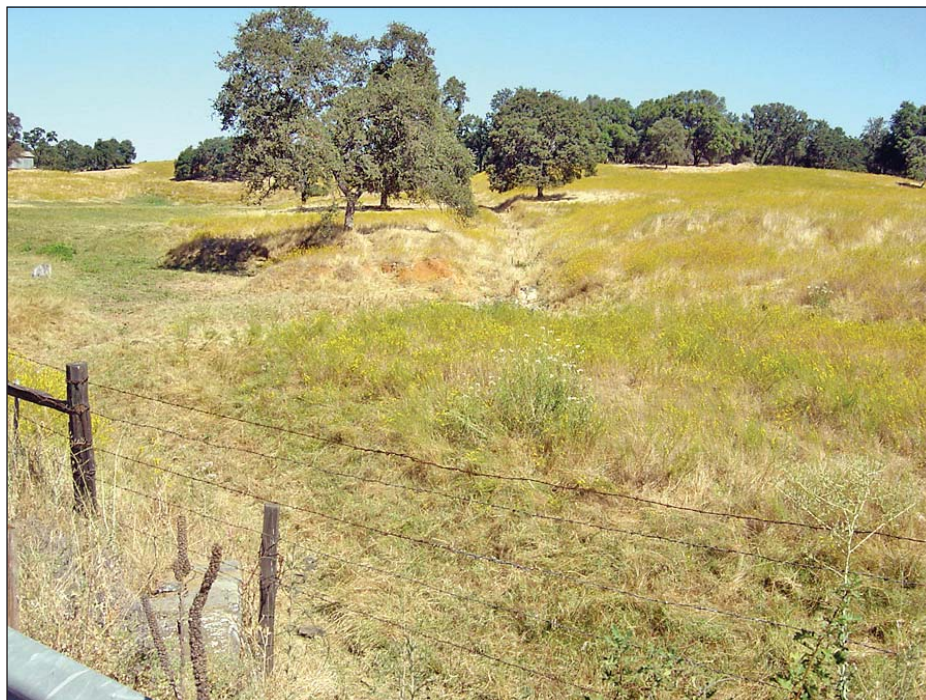
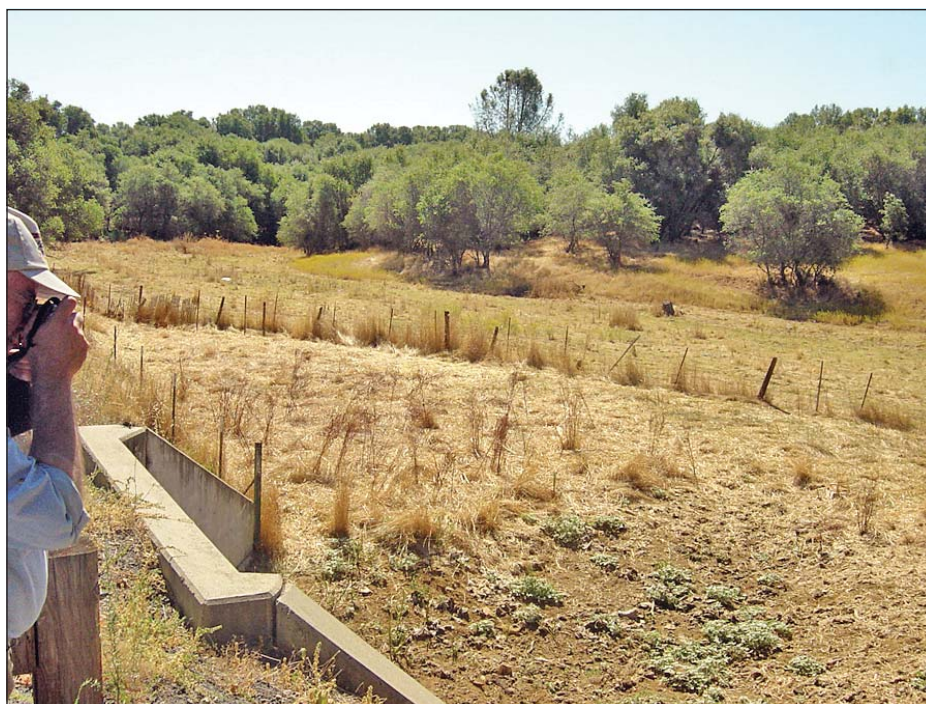
SCR-14. Tributary to Sullivan Creek, looking upstream (top) and downstream (bottom) from road. Example of an aggraded valley, channel features are very non-distinct (if present at all in some areas); such areas have likely been experiencing net storage of fluvial sediments and colluvial material. The transition between the valley fill and the hillside is readily visible just below the trees on the right-hand side of the bottom photo.

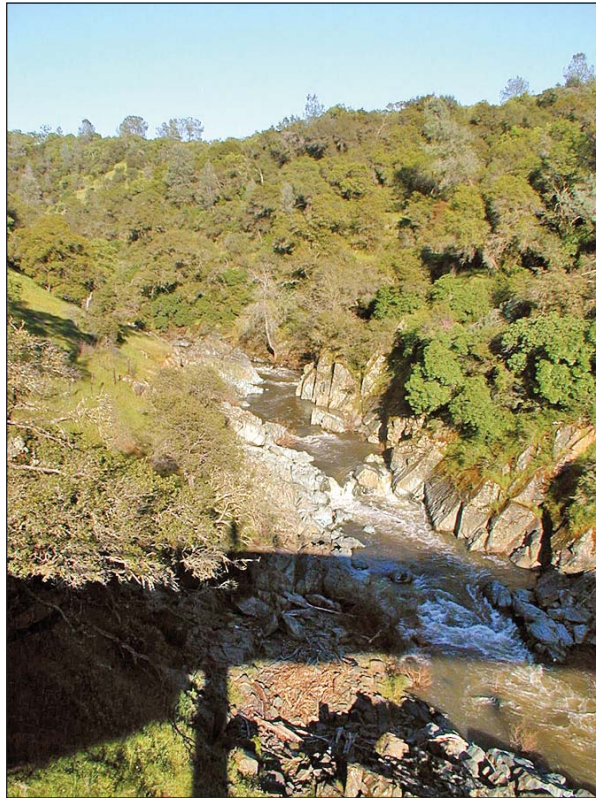
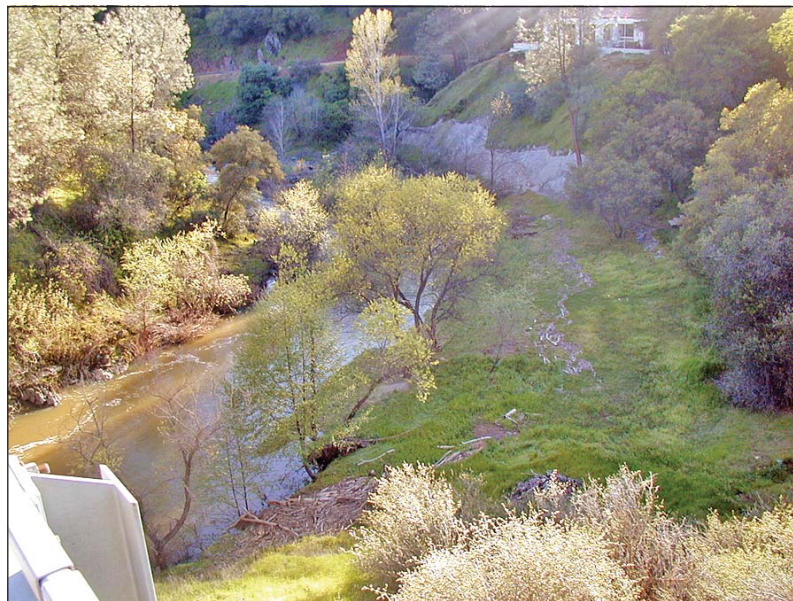
SCR-19. Lower Sullivan near its mouth, looking upstream (top) from the Jacksonville Road bridge. The channel has again incised down to the bedrock and is highly controlled in this upstream reach. Downstream of the bridge (bottom) the gradient flattens and floodplain development is more obvious (note: the line of driftwood on the right is about the midpoint of the floodplain, between the top of bank and the terrace).

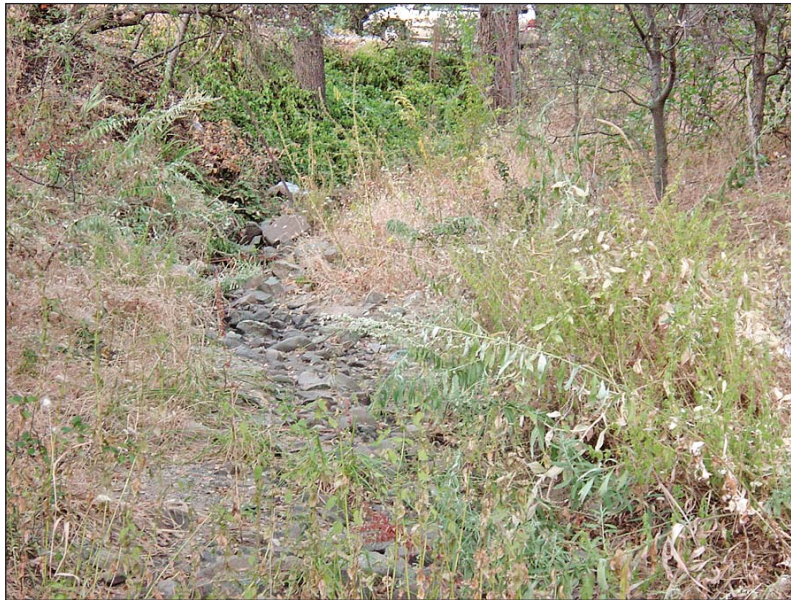
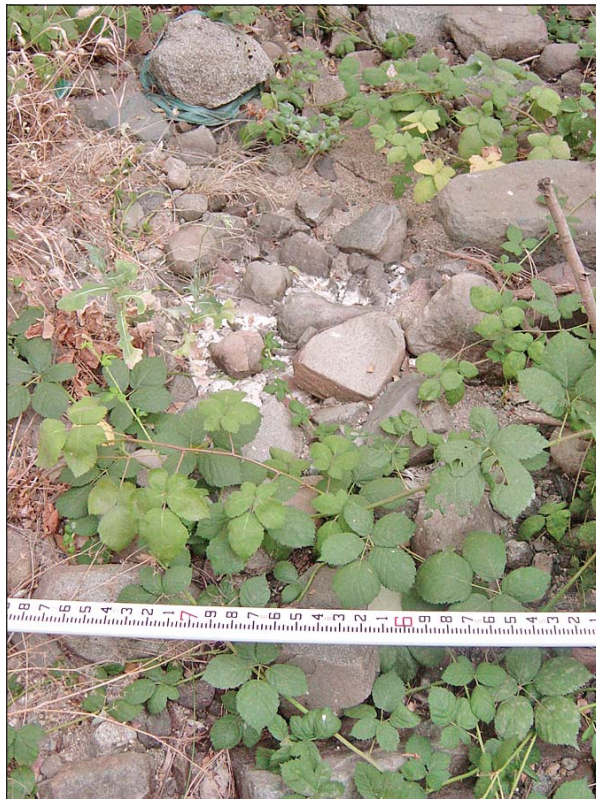
CCR-4. Small tributary to Curtis Creek, looking upstream (top). Morphology is similar to SCR-5, in that this is a headwater-type cascade or partially colluvial channel. However, there is much less storage of fine sediments compared to SCR-5 and, in general, compared to all of the small tributaries draining the northern half of the upper Sullivan Creek watershed (though concentrated flow from the upstream culvert has likely contributed to flushing out stored sediment).

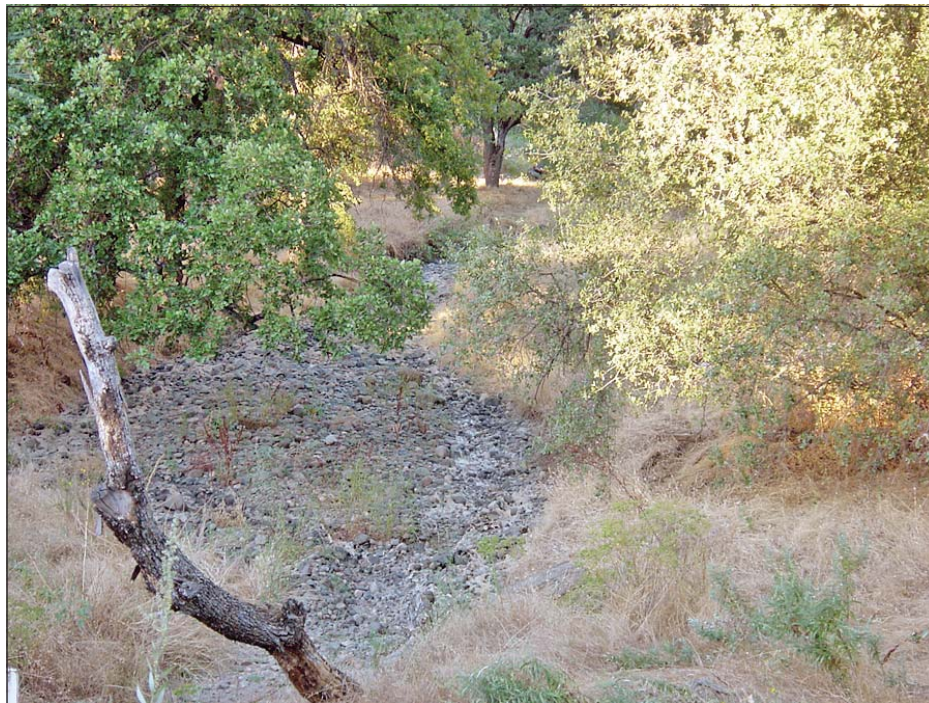
CCR-3. Tributary to Curtis Creek. Plane bed morphology, stable bed consists of highly embedded cobbles and small boulders. Channel is shallow and wide and heavily armored.

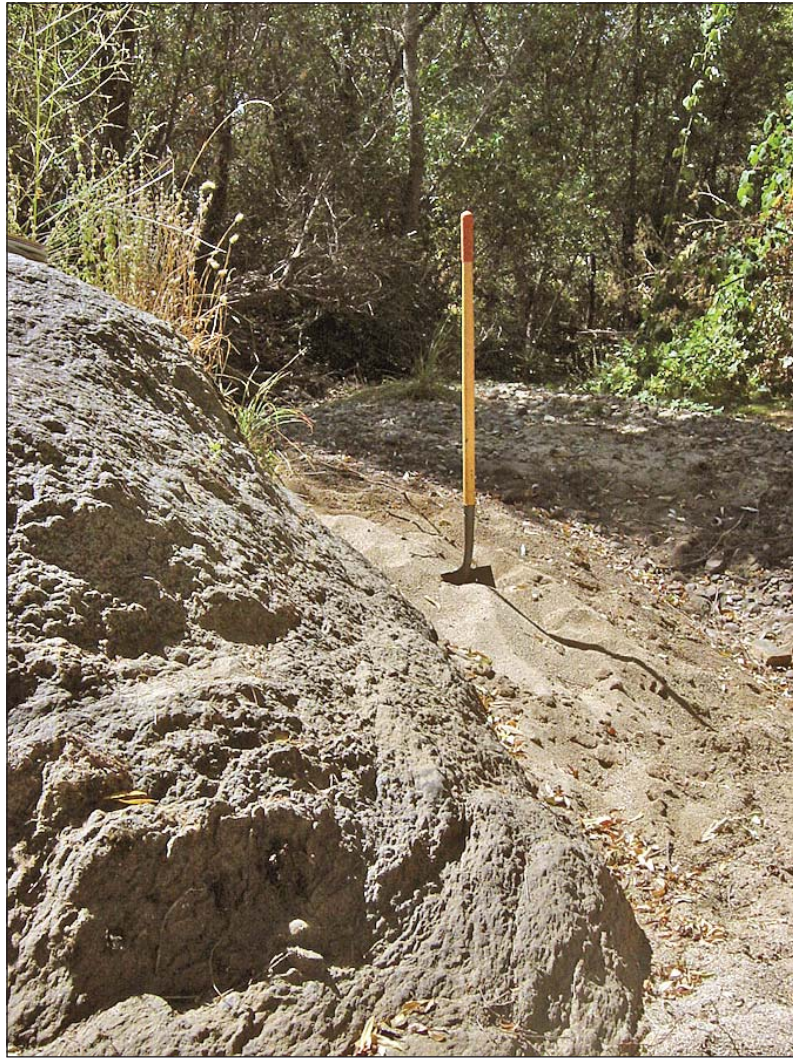
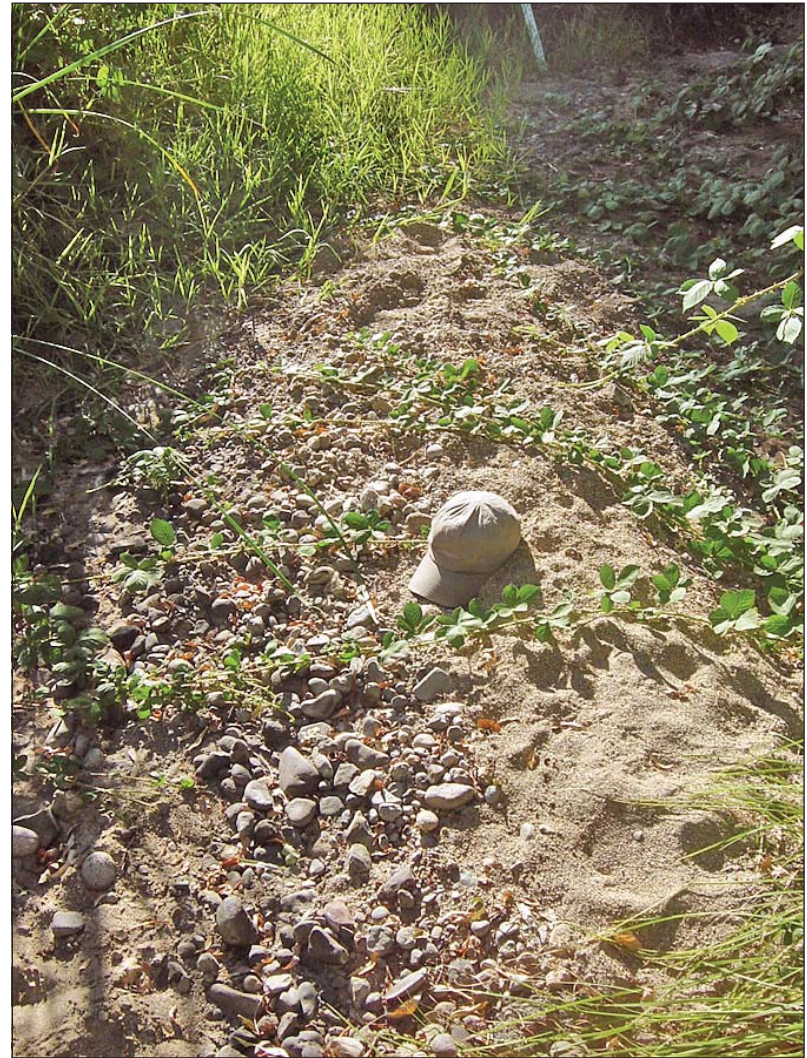
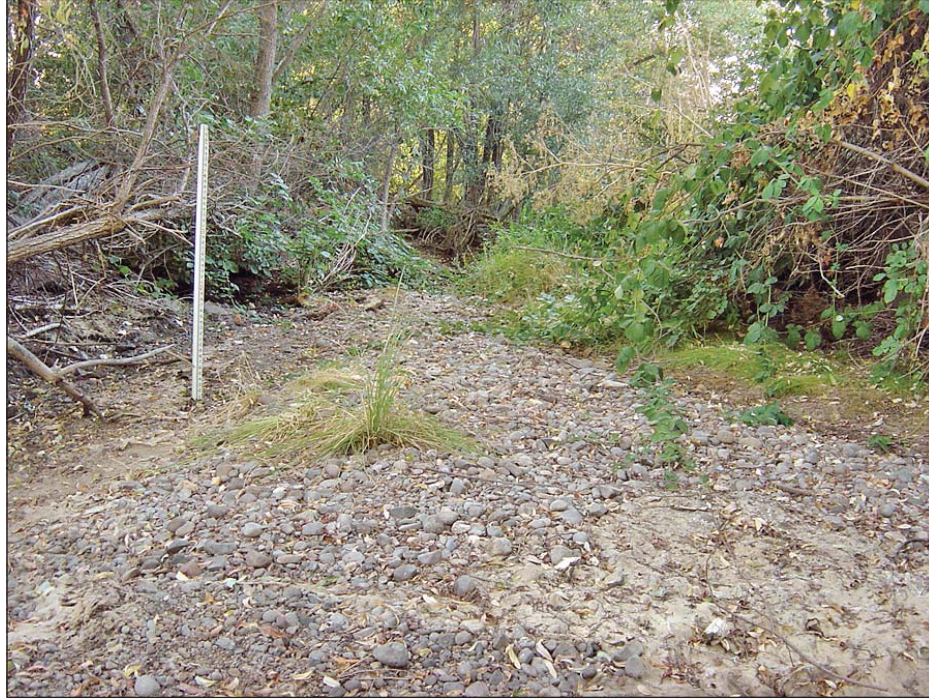
CCR-2. Curtis Creek at Standard Park. Large deposits of sand, gravel, and cobbles. No flow in channel, severely transport-limited with regard to overall substrate. Channel morphology is pool-riffle, but appearance is almost braided in some areas, underscoring the transport-limited characteristic. Indicative of highly variable flow-regime, periodic large flows appear to be resulting in recent channel aggradation. A pebble-count was conducted at the section in the bottom photograph.

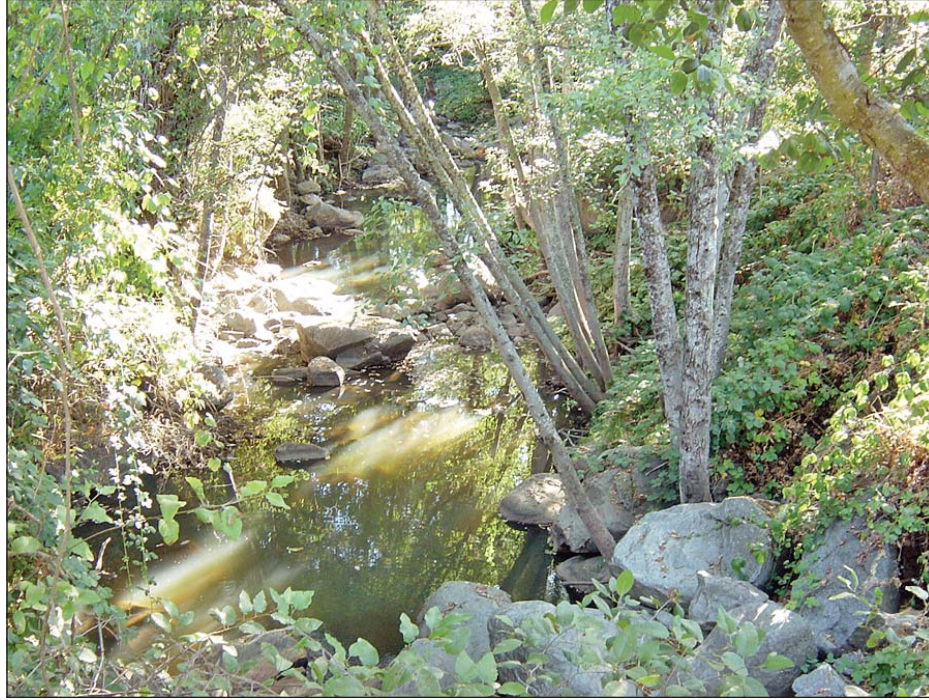
CCR-1. Curtis Creek at the mobile home park. Morphology, which is generally step-pool and pool-riffle, is similar to that of Sullivan Creek at a similar elevation and point in the watershed (i.e., at SCR-11), yet more storage of silts and sand compared to Sullivan Creek. Lack of even gradation of bed material and presence of large, remnant boulders likely prevents formation of plane-bed morphology.

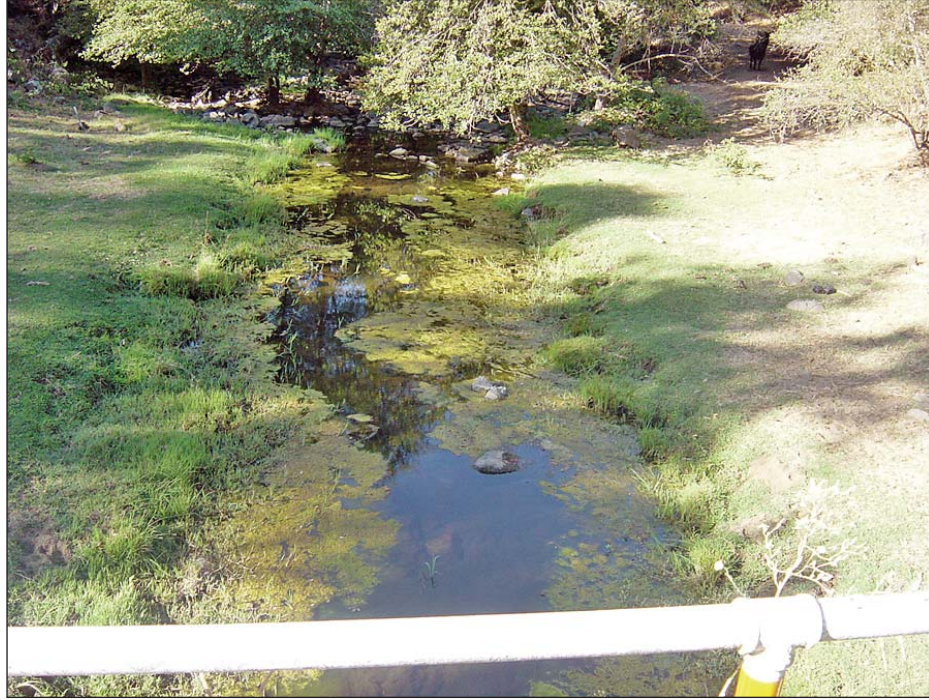
CCR-6. Looking downstream from Lime Kiln Road bridge. Curtis Creek cascades down from the reach just upstream of bridge and widens in this area downstream, which is lower gradient and exhibits more depositional features such as the short stretch of floodplain.

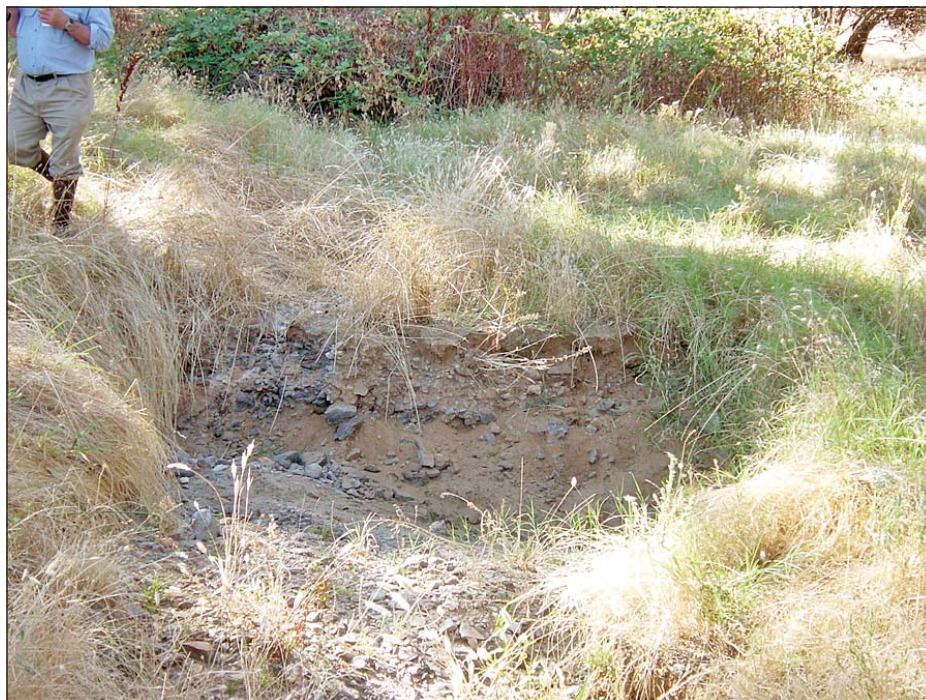
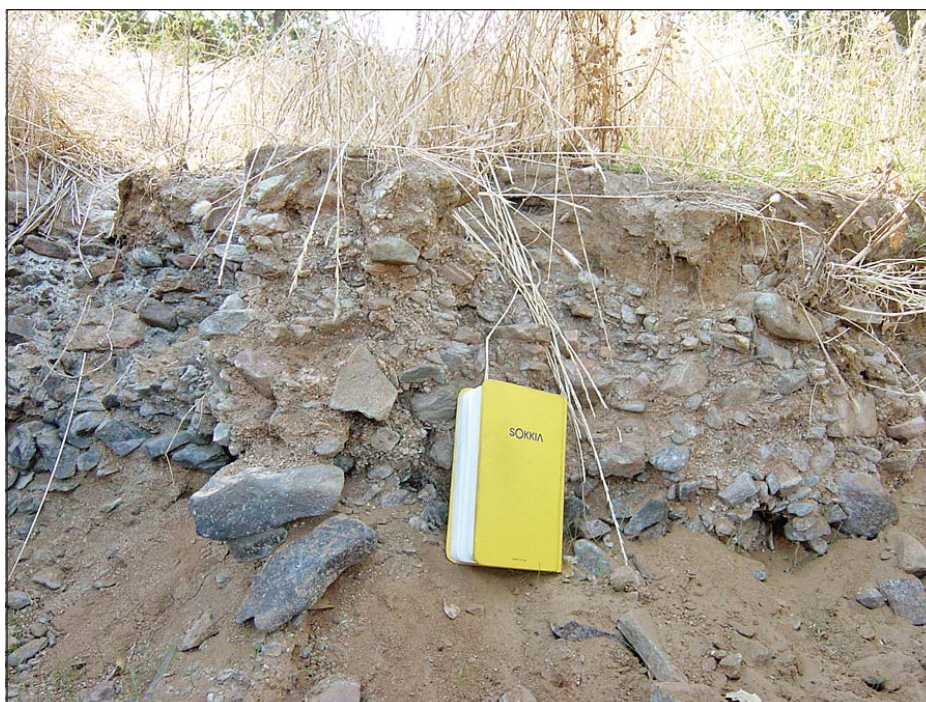
CCR-7. Small tributary to Curtis Creek. Large nick-point and scour-pool has formed a channel within what was simply just a colluvial swale (looking upstream). Runoff is likely being concentrated by a ditch which parallels Lime Kiln road nearby. The nick-point exposes a profile comprised of large, angular cobbles and gravels embedded within a sandy matrix (possibly deposited by a debris flow or landslide). The material is not being moved very far.

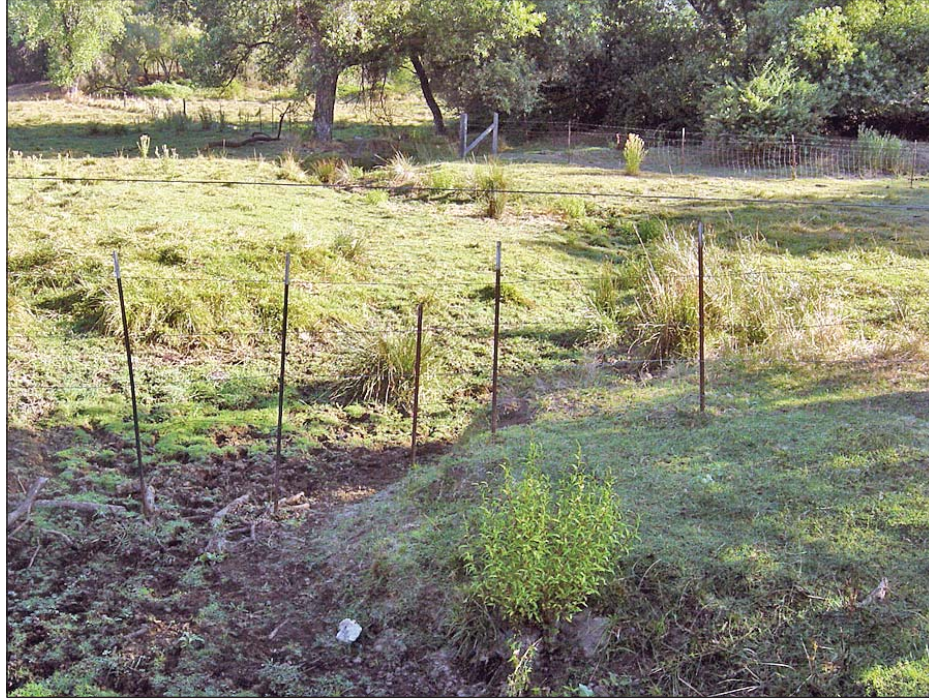
CCR-5. Tributary to Curtis Creek, looking upstream from Lime Kiln Road. In general, we begin to observe a marked transition in channel/valley type downstream of Lime Kiln Road, primarily along the mainstems of both Curtis Creek and Sullivan Creek. Much evidence for channels that are transport-limited and have experienced aggradation (but may, or may not, be beginning to incise). Geology map shows a Qal (quaternary alluvium) deposit immediately upstream of this site; the deposit is also described as containing colluvium, landslide debris, and mine tailings, locally.

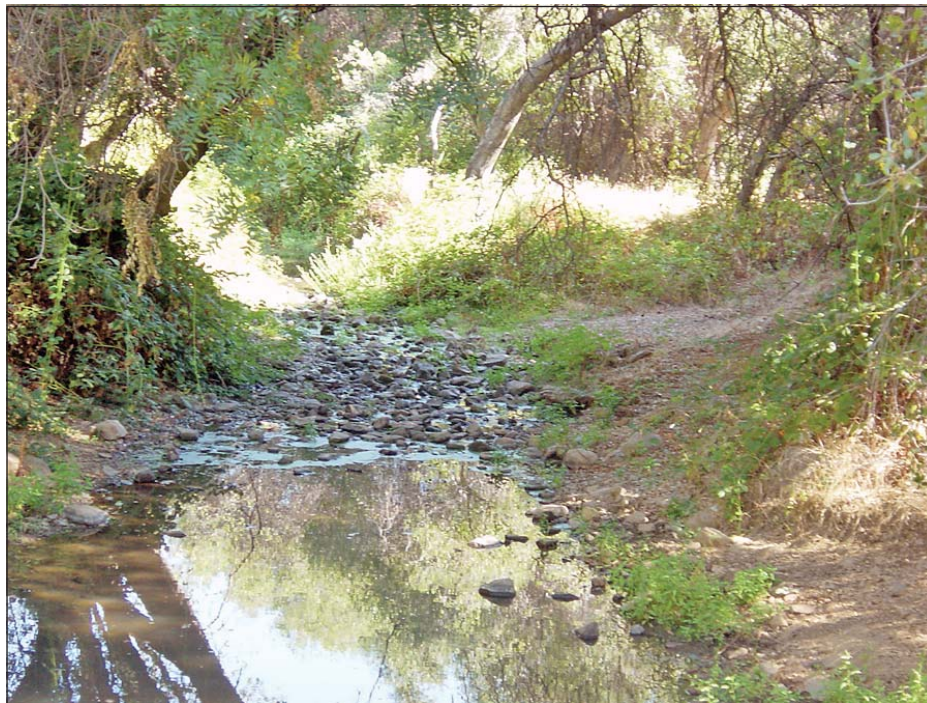
CCR-9. Larger tributary to Curtis Creek, looking downstream. Plane-bed and pool morphology.

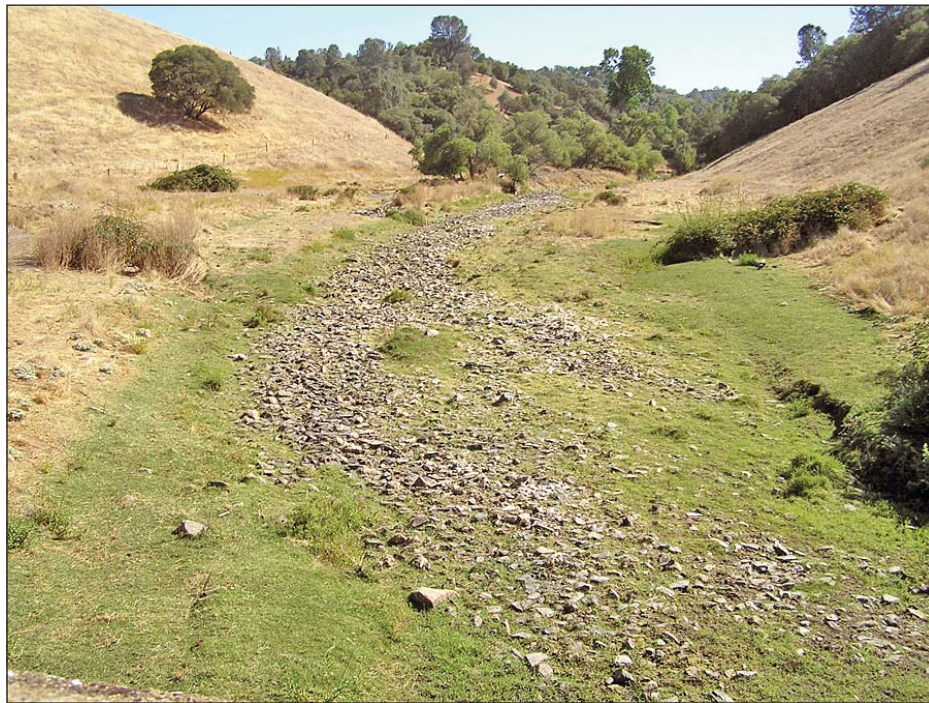
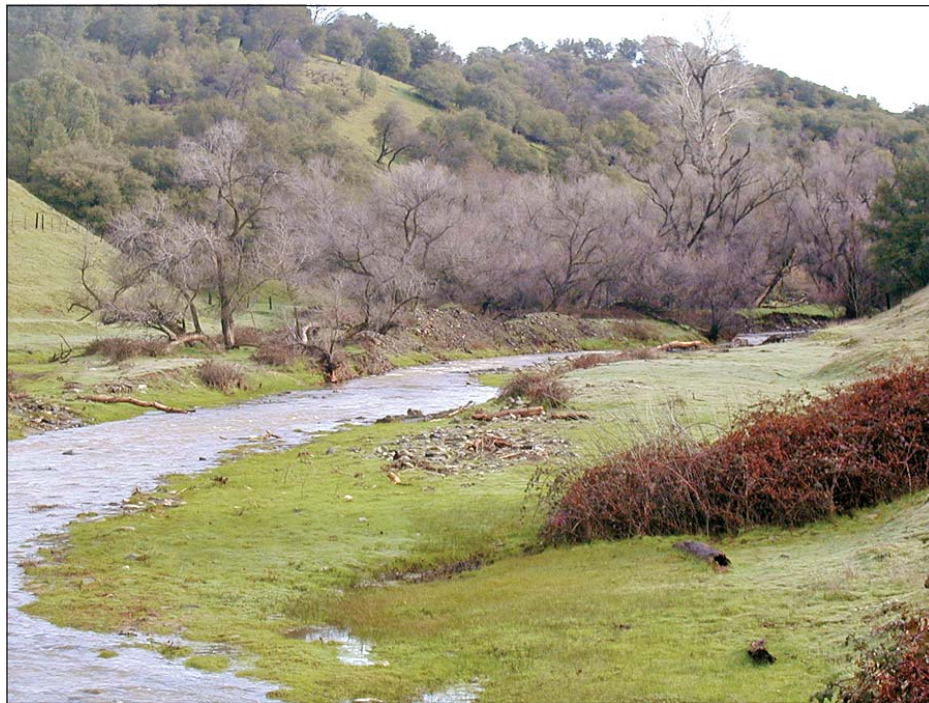
CCR-10. Mainstem of lower Curtis Creek, looking upstream from Algerine Road bridge during late summer (top) and early spring (bottom). Note fan formation emanating from canyon and aggrading out onto valley and channel; highly armored cobbles mark the primary flowpath. Combination of valley widening and back-water effect from bridge likely increased the tendency for large cobble deposition in this area. Floodplain and terrace development becomes more obvious in this lower reach.

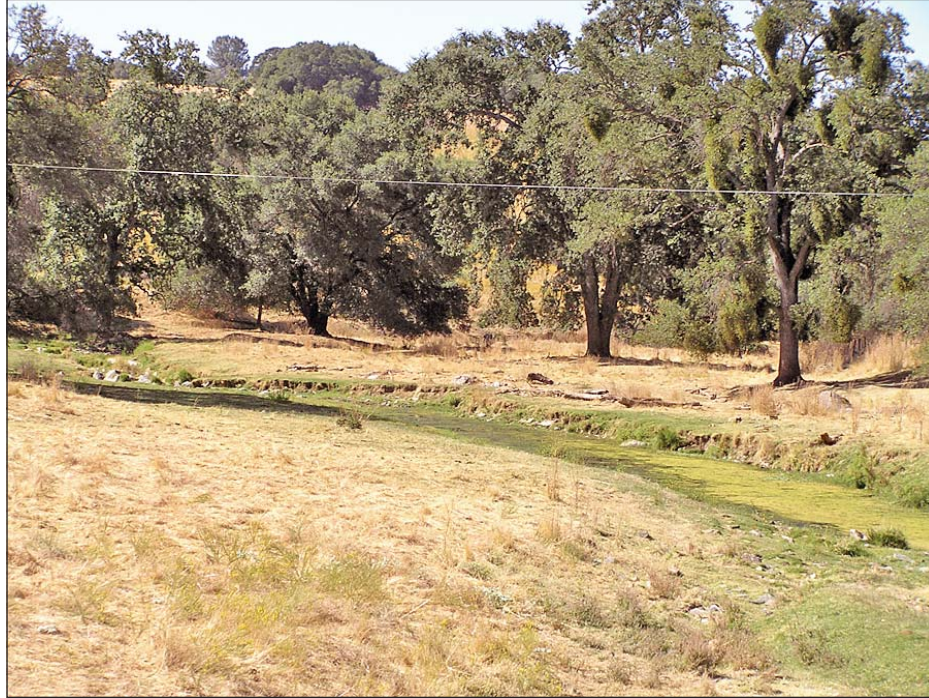
CCR-10. Mainstem of lower Curtis Creek, looking downstream from Algerine Road bridge during late summer. Downstream, the channel has incised some two to three feet into the valley and may be in the process of separating itself from the full extent of the current floodplain.
