# *San Diego River Baseline Sediment Investigation*

## *Final Report*

City of San Diego  
1970 B Street, MS27A  
San Diego, California 92102

**October 2005**

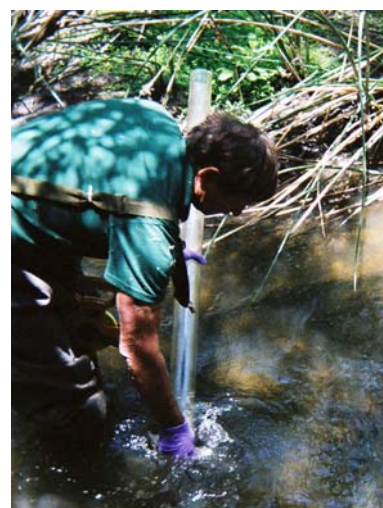
Sediment samples were collected with a piston core equipped with a 3" LEXAN® barrel. Sediments were collected manually from either a small boat or, from shallower channels, by wading. When collected from a boat, a stainless steel slide hammer was used to push the barrel into the sediment. The sampling vessel used was a rigid inflatable boat equipped with floor boards. When the field technician waded into the channel, the barrel was physically pushed into the sediment by hand. Figure 2-2 illustrates the latter sediment sampling method.

**Figure 2-2. Collecting sediment samples by wading into the channel and manually pushing the core into the sediment.**

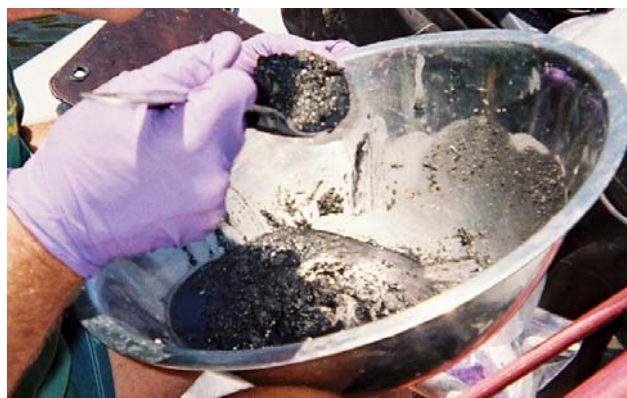
Three sediment samples were collected at each sample location, one from the center of the channel and one from each river bank. The target core penetration depth (15 cm) was successfully achieved for all samples. The top 5 cm of sediment from each of the three stations (river right, river center and river left) were combined and thoroughly homogenized to a uniform consistency in the field using a stainless steel mixing bowl and mixing spoon (Figure 2-3). This composite was then delivered to the analytical laboratory for analysis.

**Figure 2-3. Composite being mixed in the field.**
