**REPORT on the
GEOLOGIC and GEOMORPHIC
CHARACTERISTICS of the
MATTOLE RIVER WATERSHED,
CALIFORNIA**

Clifton W. Davenport, CEG, CHG;
Jennifer Thornburg CEG, CHG; Marc P. Delattre CEG;
Wayne D. Haydon CEG; and John M. Curless CEG

Prepared in cooperation with the
CALIFORNIA RESOURCES AGENCY'S
NORTH COAST WATERSHED ASSESSMENT PROGRAM

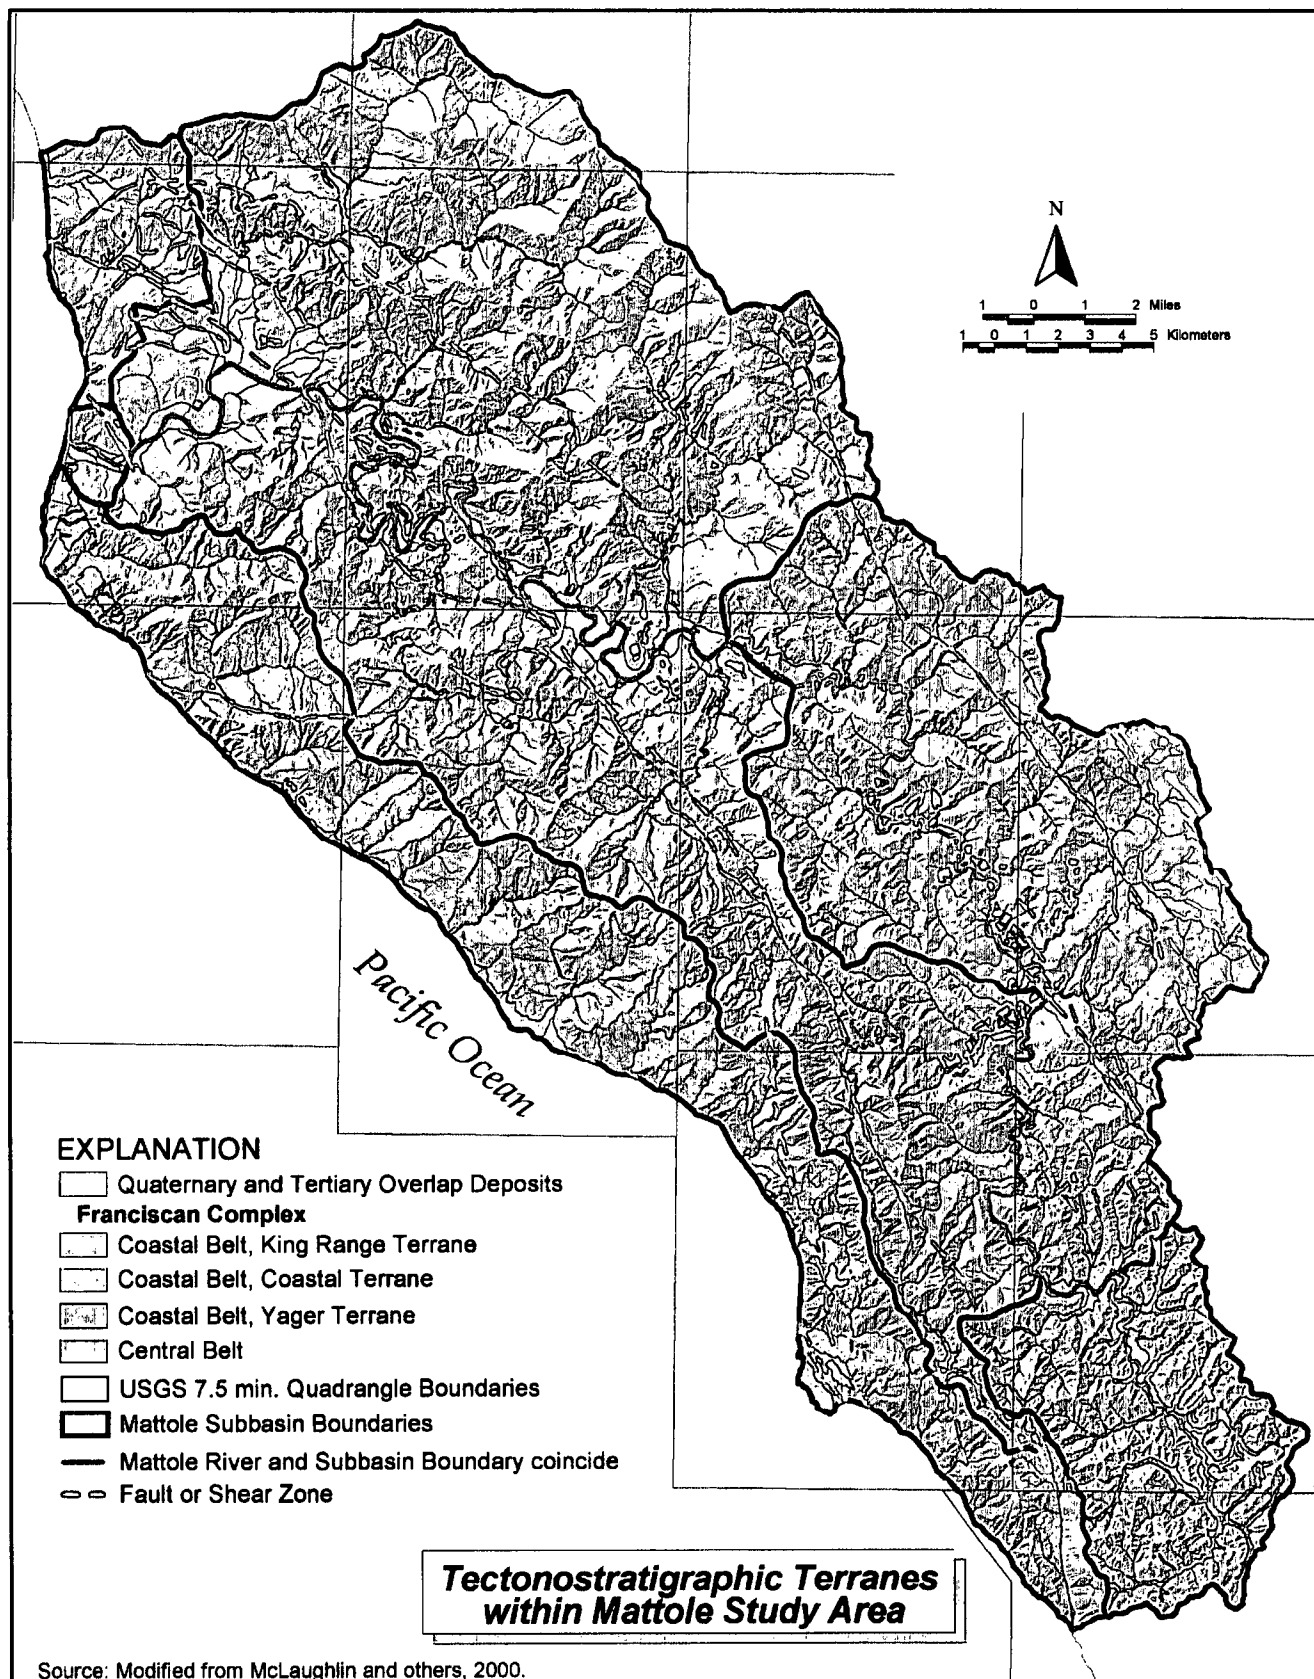
Figure 4. Tectonostratigraphic terranes within the Mattole study area.

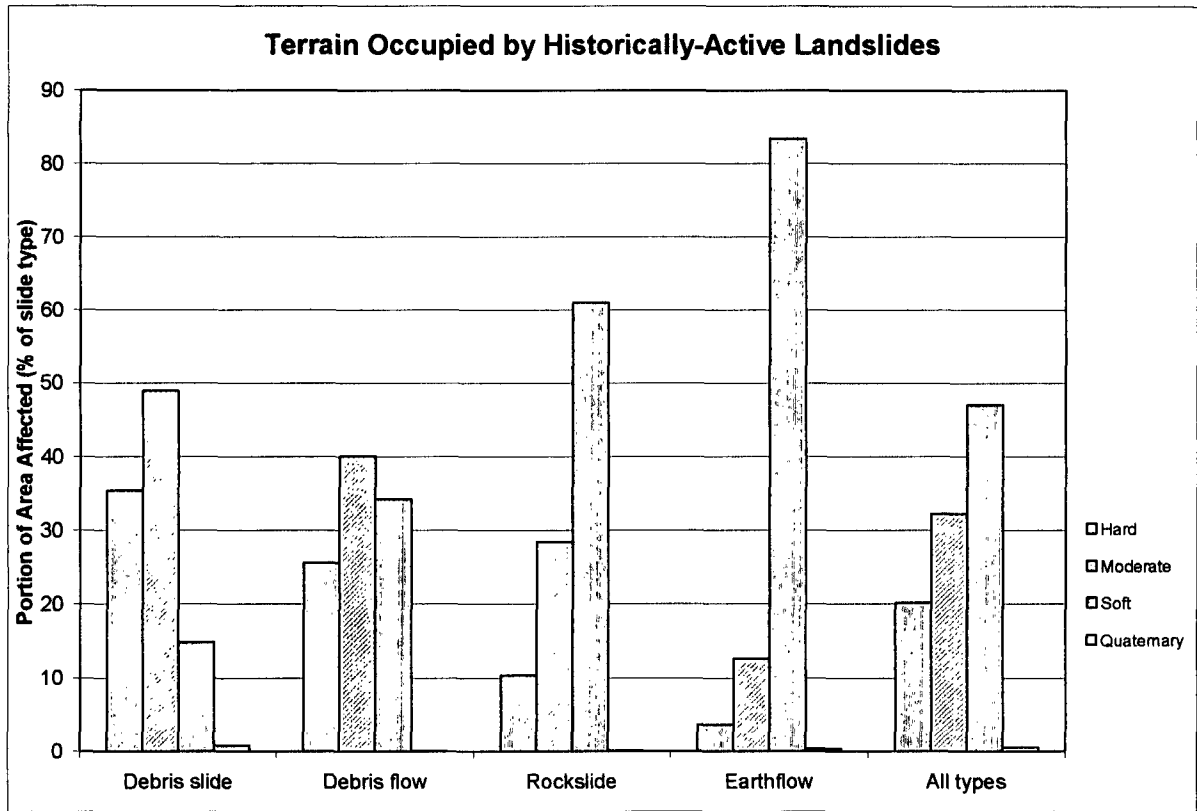
Figure 11. Percentage of area occupied by various historically-active landslide types within each geomorphic terrain.

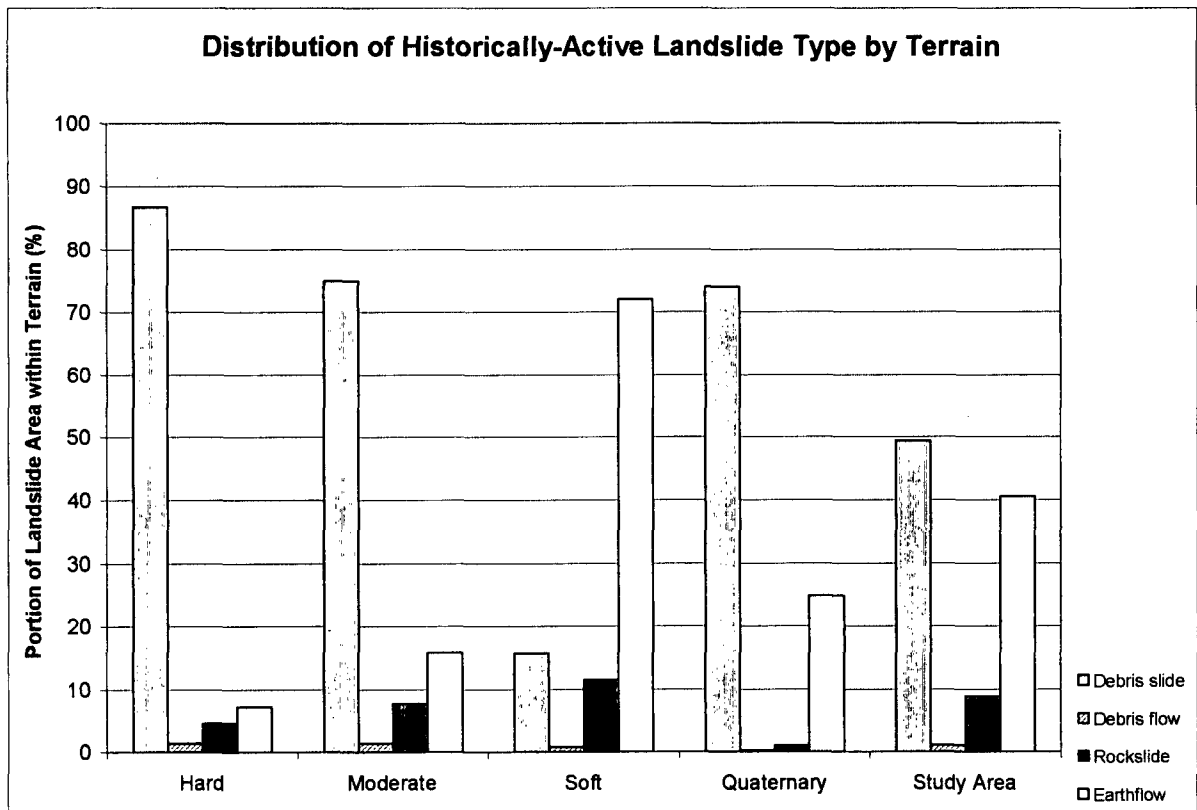
Figure 12. Distribution of landslide types within each of the geomorphic terrains.

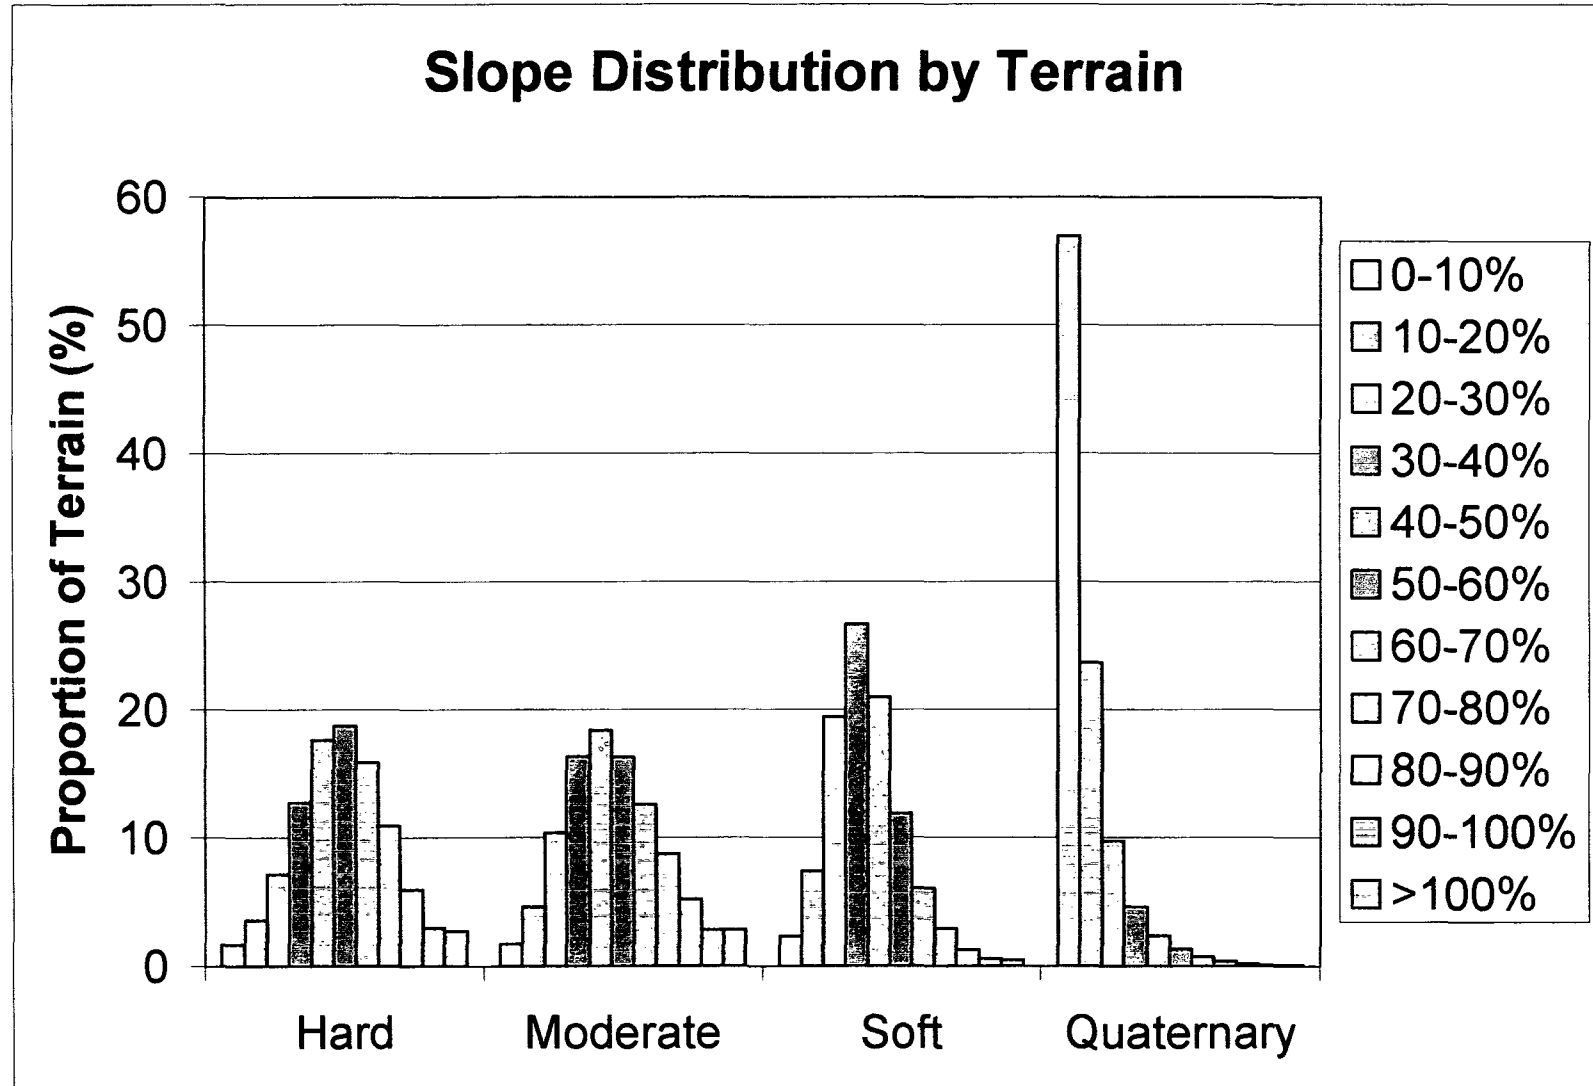
Figure 15. Histogram of slope distribution by terrain.

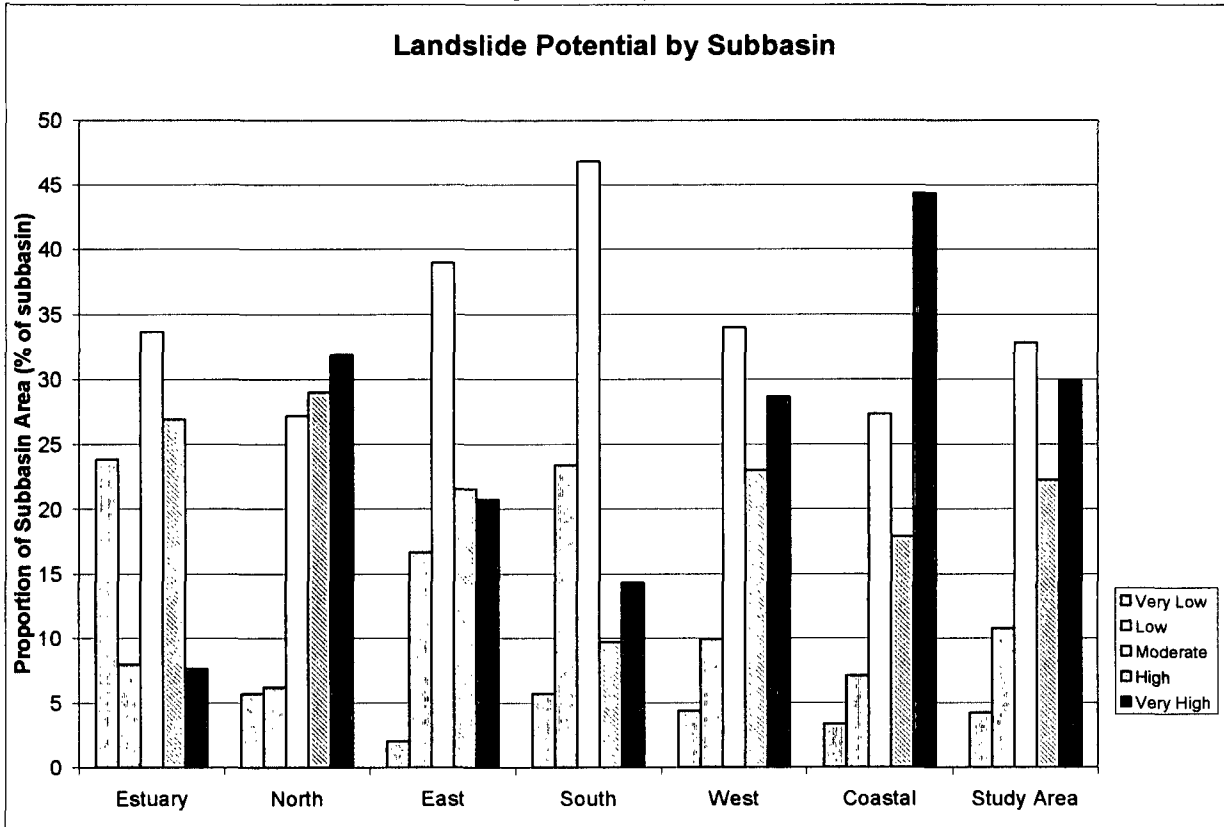
Figure 17. Proportions of each subbasin area that were assigned to the various landslide-potential categories.

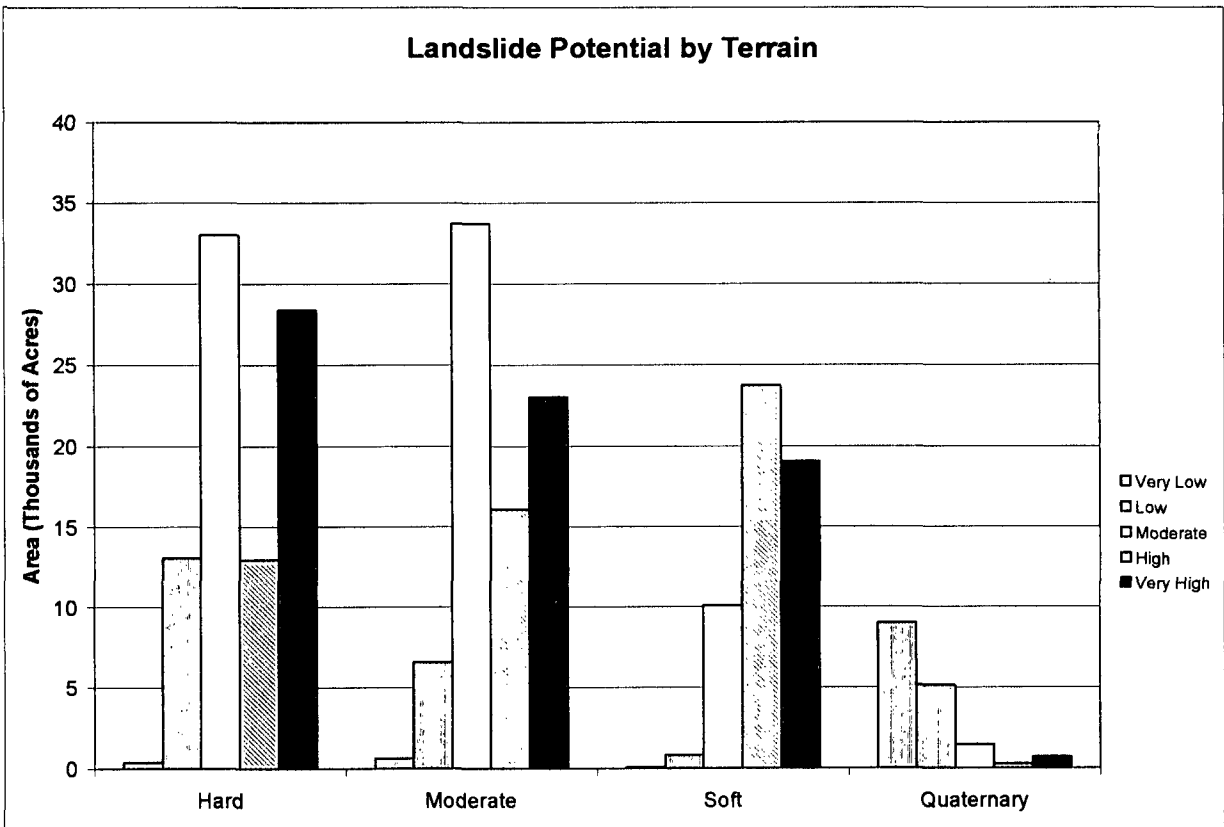
Figure 18. Area within each terrain type that was assigned to the various landslide-potential categories.

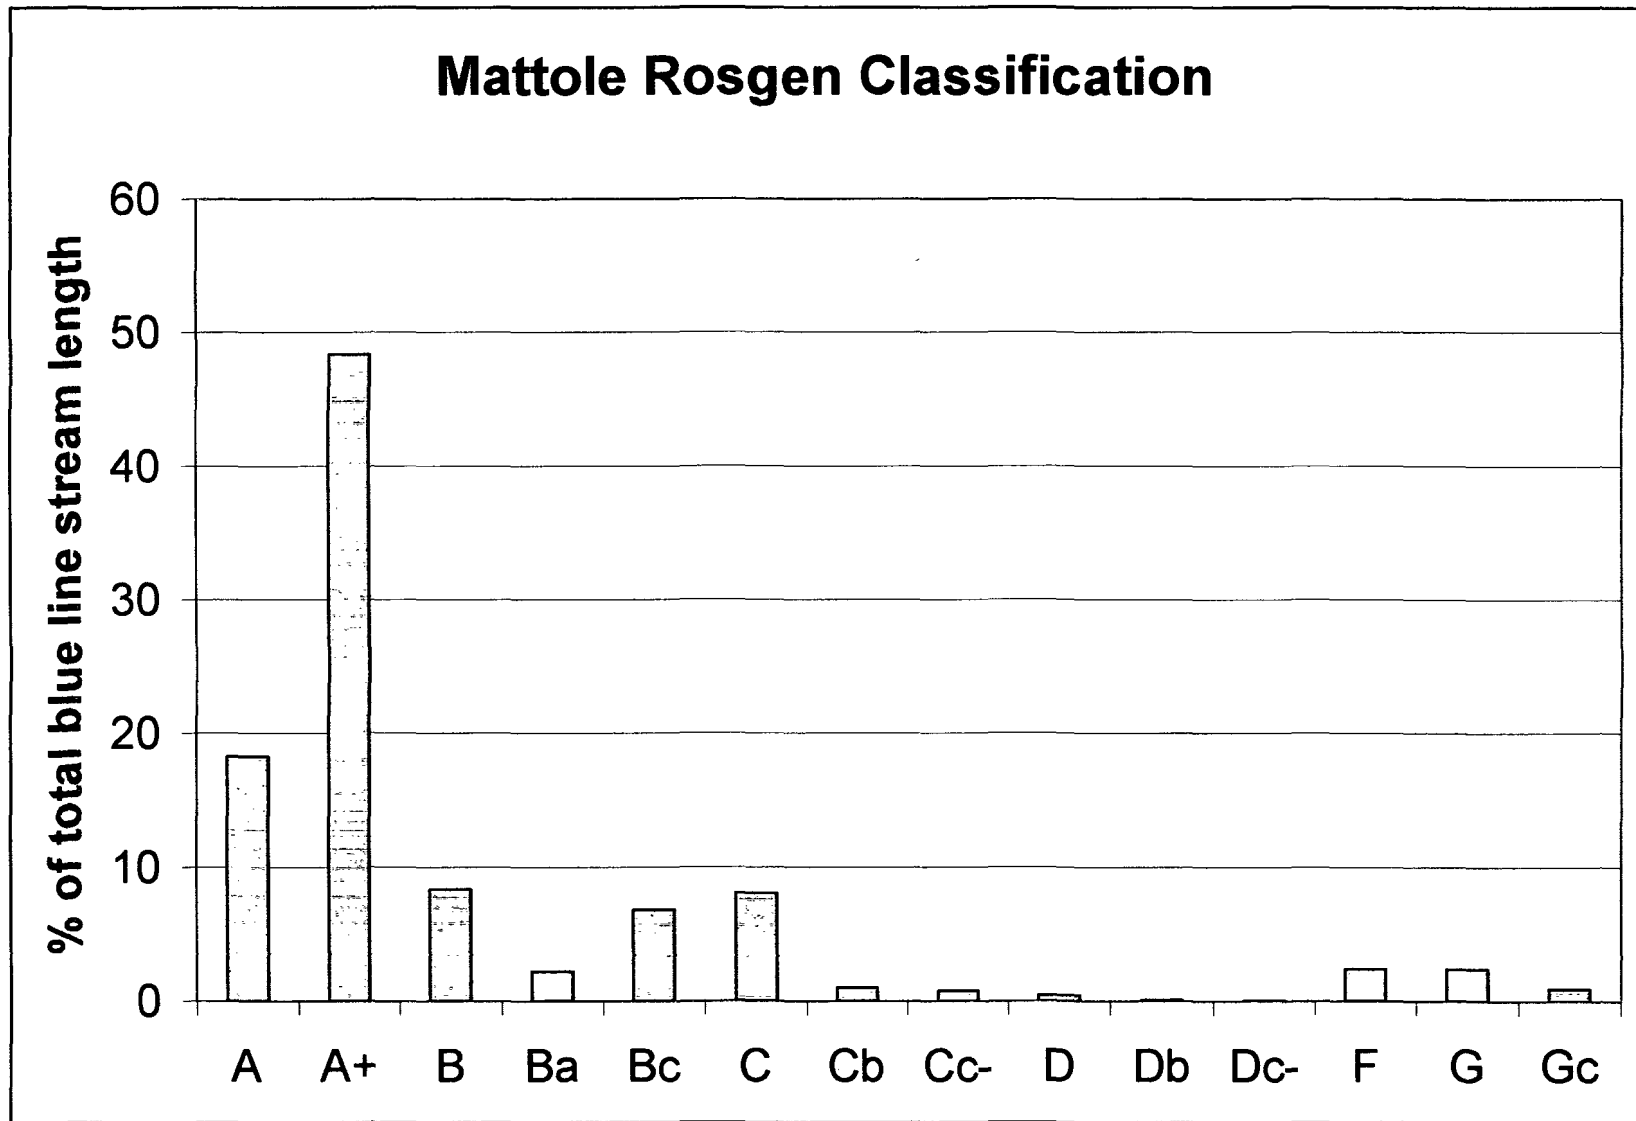
Figure 20. Histogram of Rosgen stream types as a percentage of all blue-line streams within the Mattole study area.

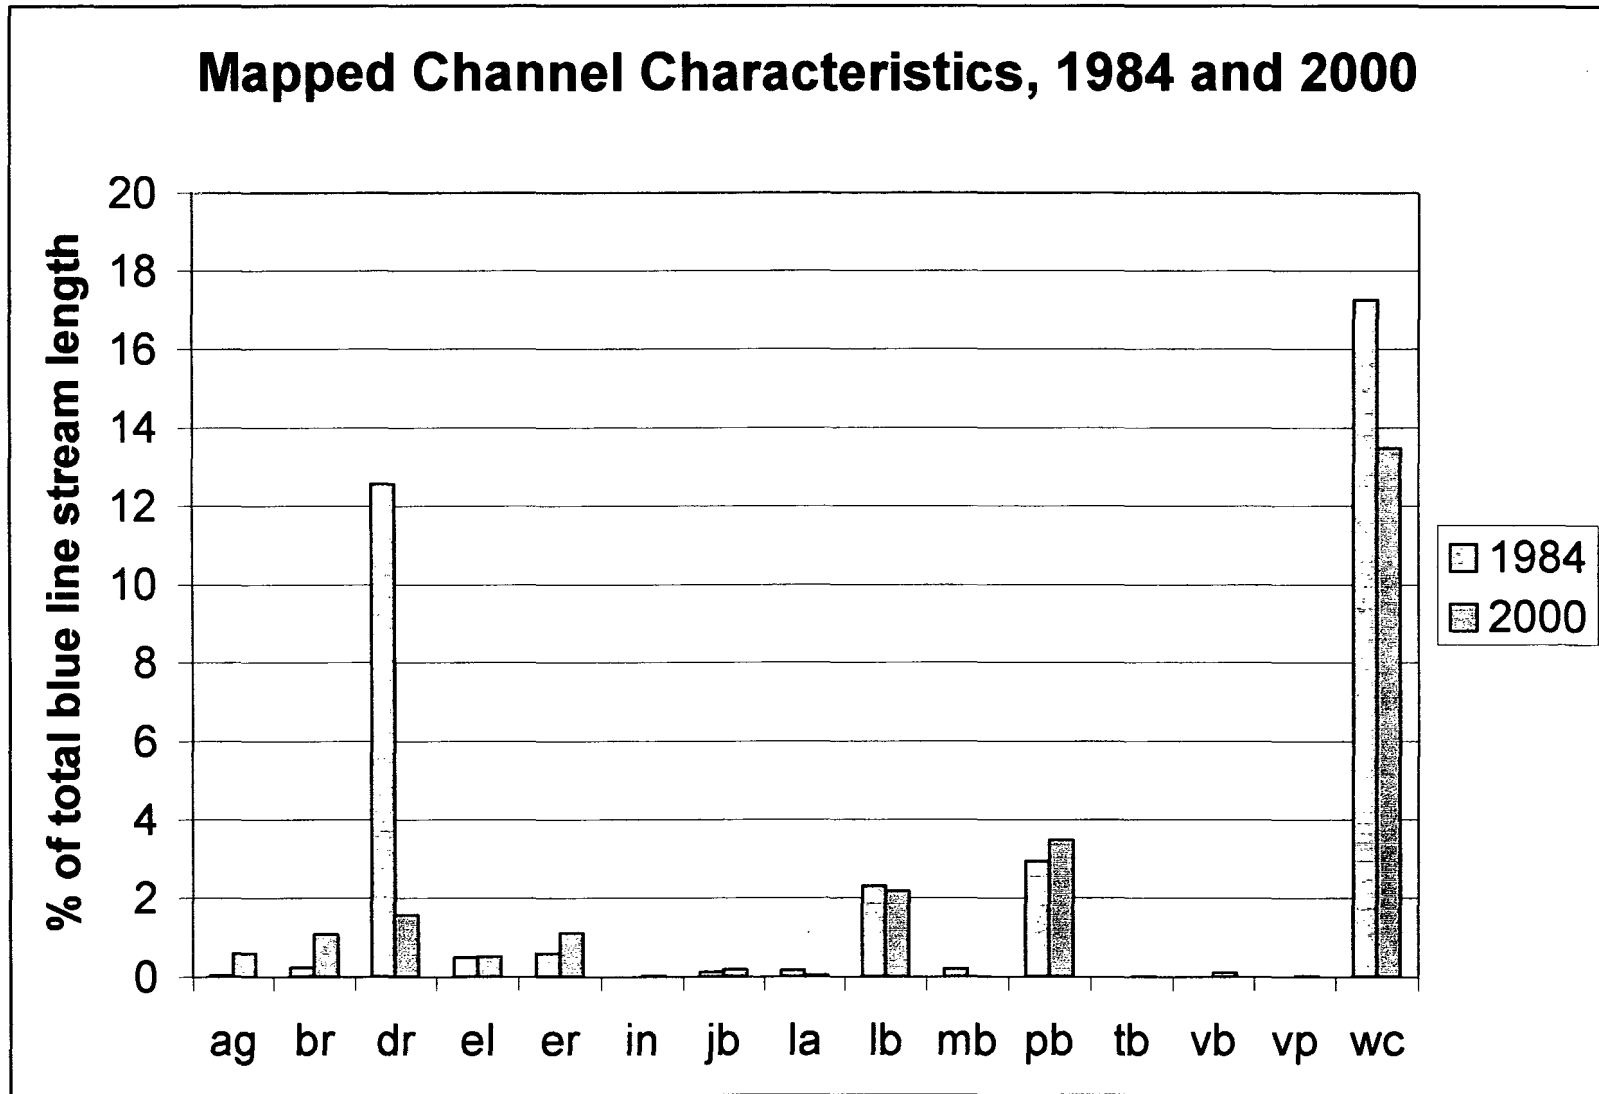
Figure 24. Percentage of all blue-line streams affected by individual primary channel characteristics mapped from 1984 and 2000 photographs (see Table 3 for explanation of channel characteristic terms).

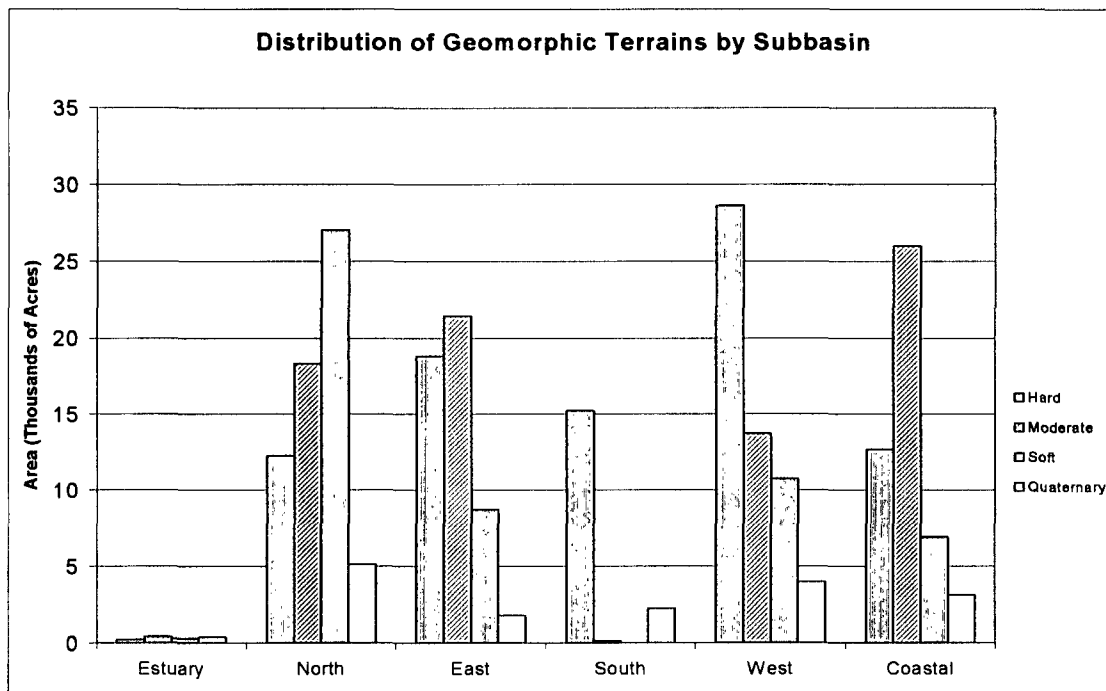
Figure 27. Area within each subbasin occupied by each of the various geomorphic terrains.

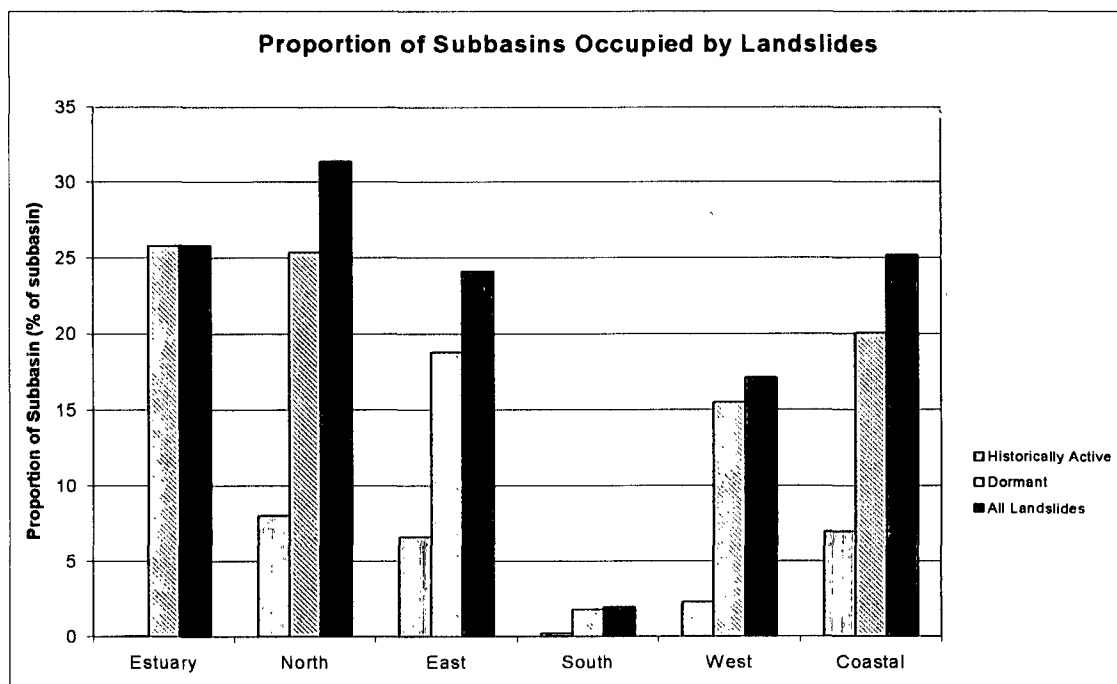
Figure 28. Percentage of each subbasin occupied by historically-active and/or dormant landslides. Those too small to delineate at map scale were assumed to have an average area of 100 square meters (approximately 1,076 square feet), and were combined with larger mappable landslides. Histogram reflects data from 1981, 1984, and 2000 photographs. Portions of dormant landslides overlain by historically-active landslides were not included in the collective totals.

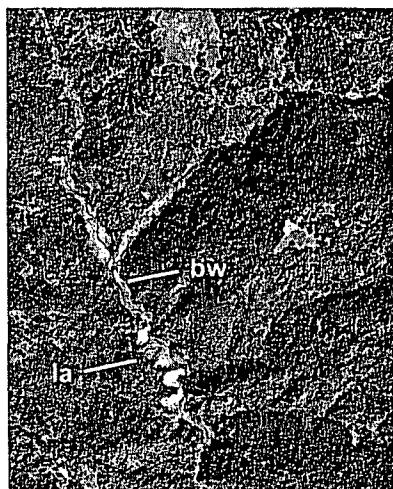
Backwater reach (bw) – characteristic is mapped when sediment deposits built up at the mouth of a tributary channel as it joins with a larger river or due to channel constriction or blockage, such as a delivering landslide. Deposition is generally caused by a slowing and blocking of storm flows as they try to merge with the main channel or flow through a constriction. Changes in channel gradient are often associated with areas of backwater. Since this characteristic is observable on an aerial photo it is much larger than backwater areas mapped in channel habitat surveys. Channel deposits in sections of backwater often cause low flows to go partially or completely into the subsurface.

Flow backwaters (bw) as channel is constricted by toe of active landslide (la) causing sediments to deposit upstream of constriction.

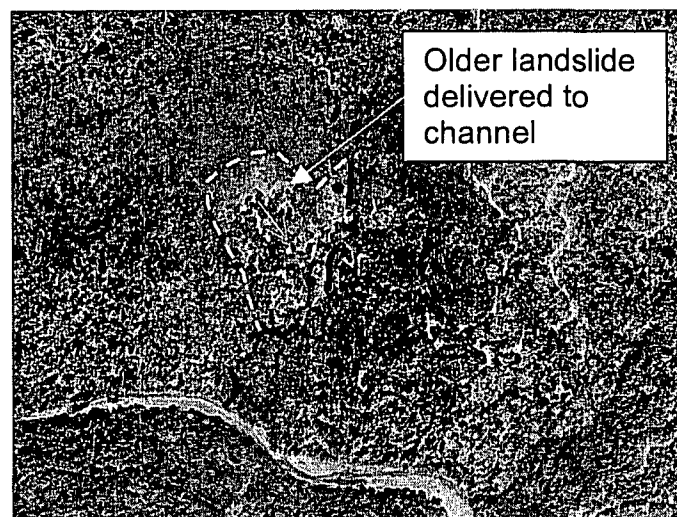
Displaced riparian (dr) – characteristic is mapped when sediment, typically from a landslide, disrupts or displaces riparian vegetation along the channel. Typically this attribute is noted with other channel characteristics, such as active landslide deposit, blocked channel or wide channel.
