I am enclosing a power point presentation for the December 6, 2005 303(d) hearing in Sacramento. I would like to have this included in the Klamath sedimentation written record, and would like to give the presentation at the December 6 meeting.

# KLAMATH RIVER SEDIMENT

Most of the rivers of the California North Coast were placed on the first 303-D sediment impaired list in 1996. Amazingly the Klamath River has not been listed as sediment impaired in spite of sediment listing for the following Klamath tributaries: Scott, East Fork Trinity, South Fork Trinity, Lower Main Stem Trinity, Middle Main Stem Trinity and Upper Main Stem Trinity. The initial sedimentation listings were made on the basis of very little scientific data with notable exception of the Van Duzen River which has been studied for sediment since the 1950's. Now listings are supposed to be made on the basis of scientific data. There is very little good sediment data on most of the North Coast rivers including the Klamath. Instead of re-presenting the Klamath data, I have chosen to present historic and present day pictures of the Klamath River. These pictures show the build up of sediment and the effects this sediment

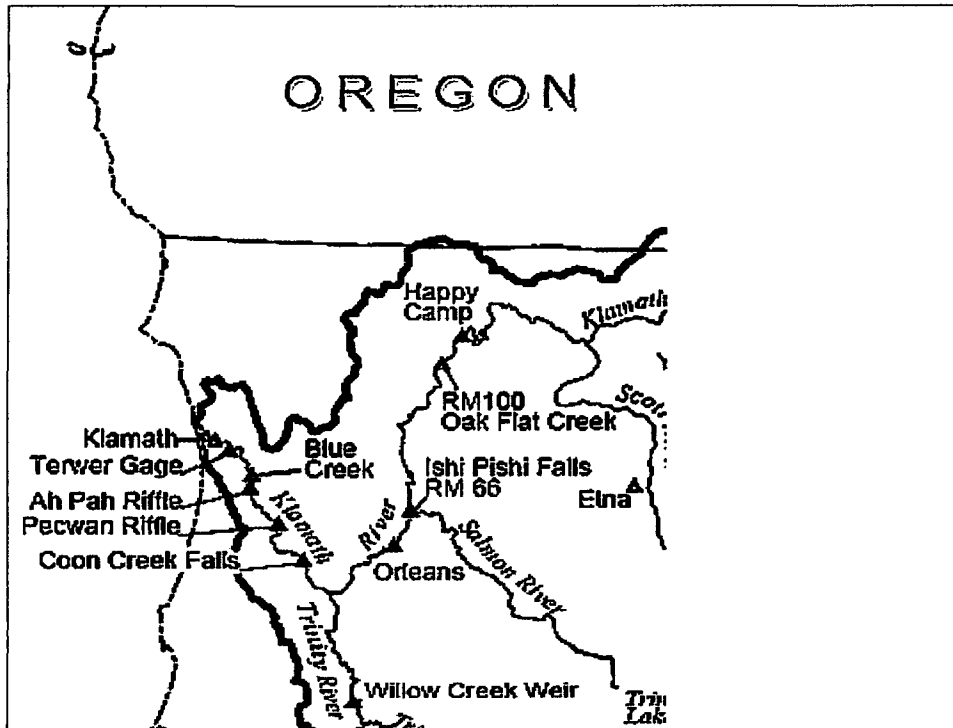
### LOWER KLAMATH RIVER MAP

The following pictures are at the mouth, near the Terwer Gage, near Blue Creek, at Surpur Creek below Pecwan Riffle and immediately below Coon Creek Falls. The Trinity River joins the Klamath River 42 miles upriver from the Pacific Ocean at Weitchpec. Simpon and other private land owners now own 98% of the reservation.

The Yurok Reservation is a one mile corridor on each side of the river from the mouth to just above the Trinity mouth.

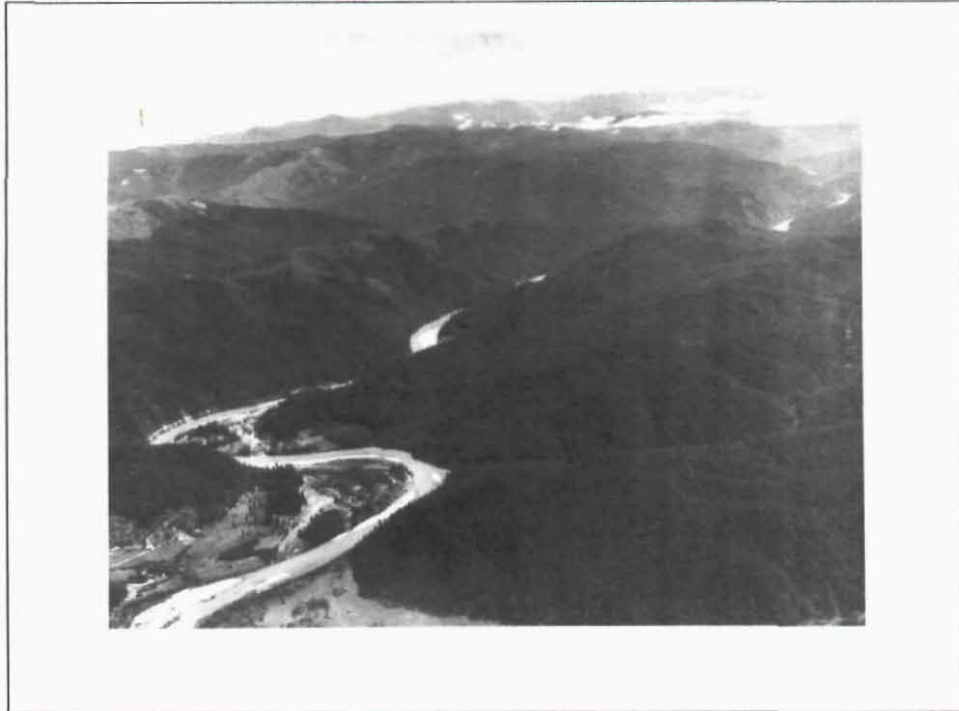
#### LOWER KLAMATH 1948

This 1948 aerial photo shows most of the lower river from the mouth to Surpur Creek prior to logging. The Yurok reservation extends from the mouth to the Trinity for one mile on either side of the river. The lower housing area at Klamath Glen was destroyed by the 1955 and 1964 floods. The V-shaped river topography and steep canyon walls are well seen. A few years after this picture was taken, the Yuroks patented most of their reservation lands and logged or sold them to Simpson Timber Company which then logged them. Simpson is now logging this area again. The second growth trees are 50 to 60 years old.

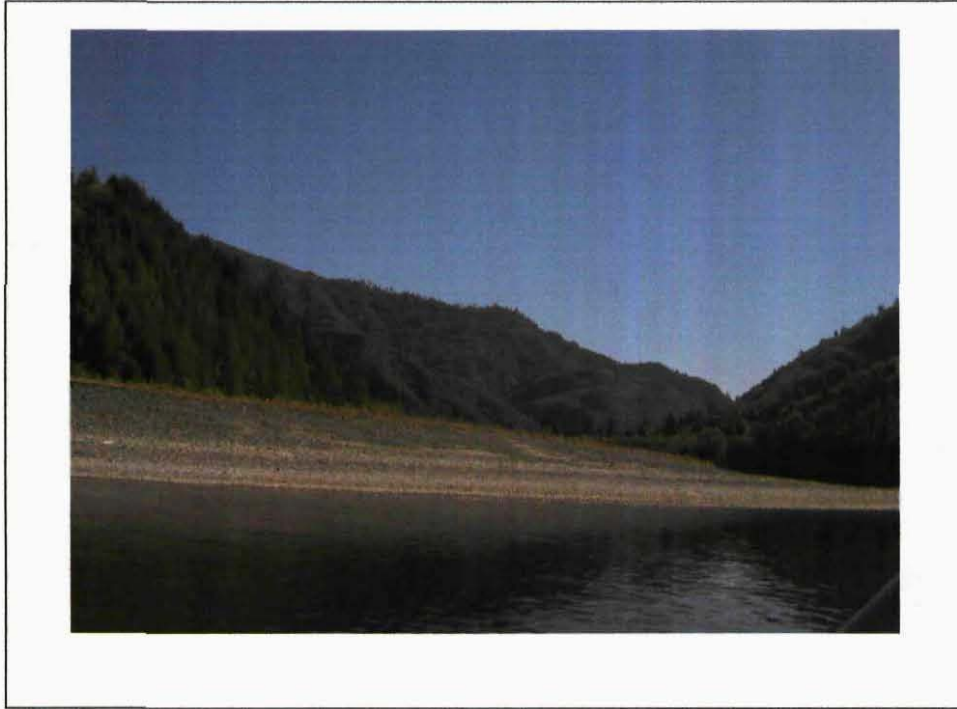
**STARWEIN FLAT 2004**

**This 40 foot high bank of sediment was not here 80 years ago according to my old and departed Yurok friends and neighbors.**

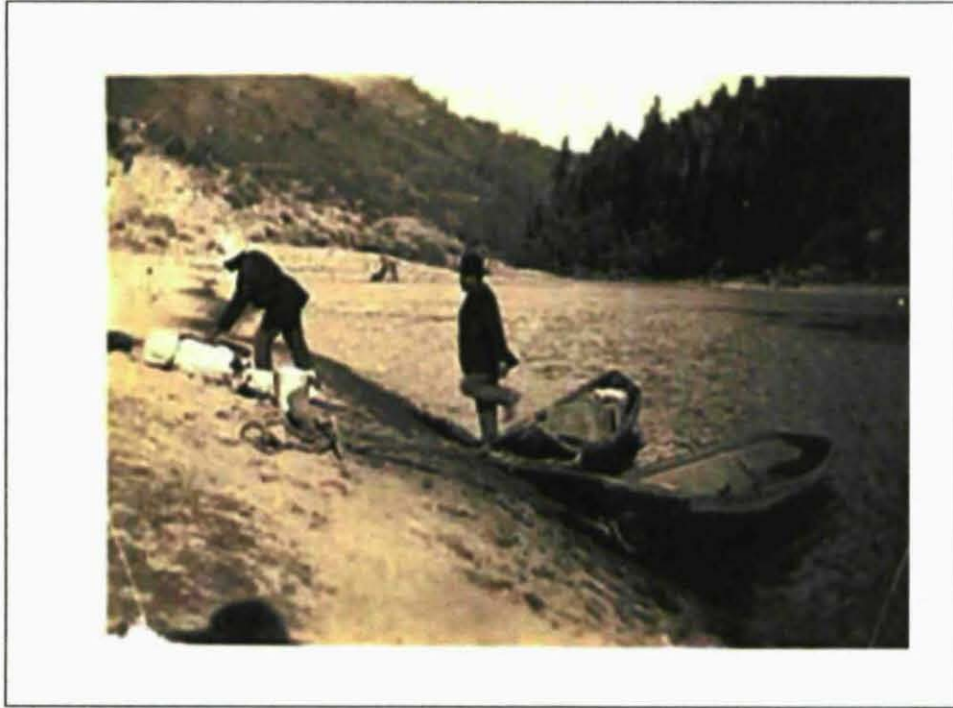
BEAR CREEK 1901

A picture taken by Koelber in 1901 shows Yuroks getting out of dugout canoes. Note the narrow V-shaped river bed.

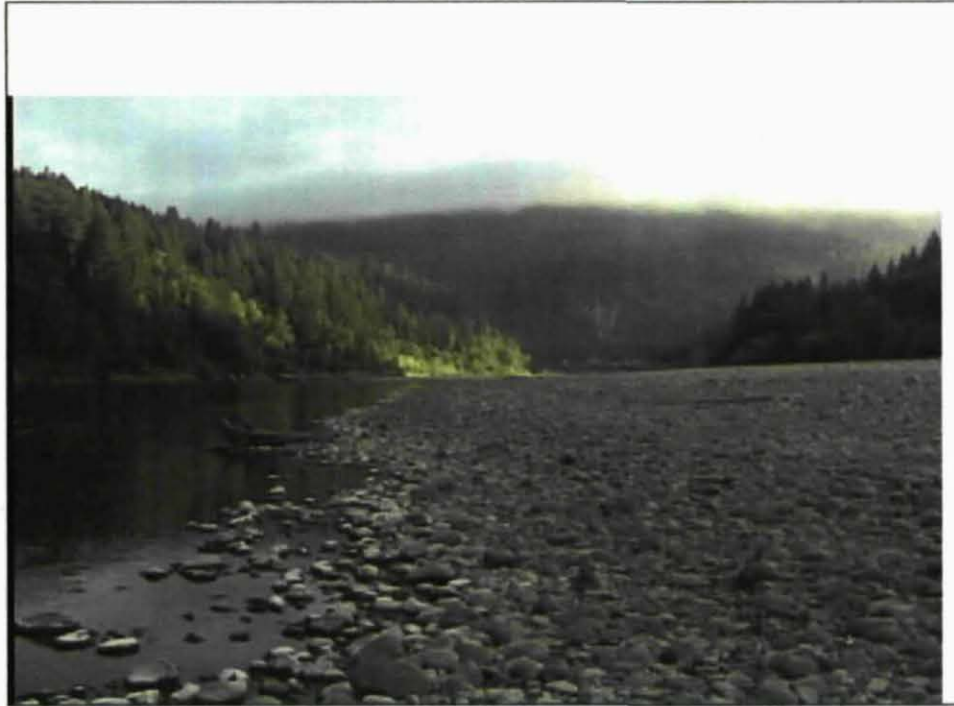
BEAR CREEK 2001

Almost the entire riverbed is filled with gravel and rock sediment.

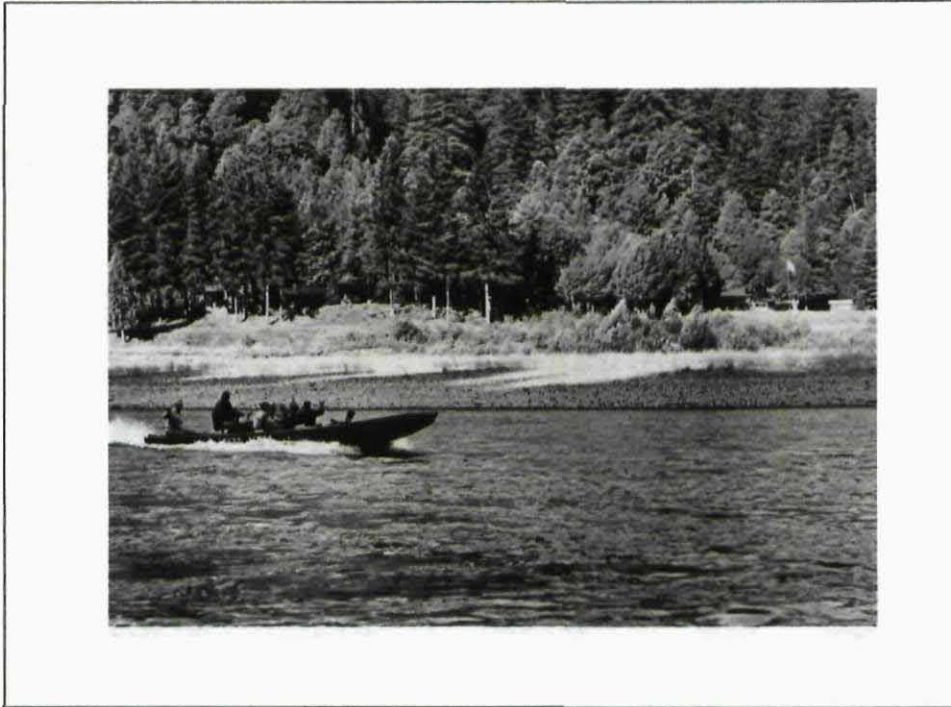
**BLUE CREEK LODGE 1950**

The Blue Creek Lodge and the land in front of the lodge was completely washed away by the 1955 and 1964 floods. This is the original Blue Creek Lodge boat. Note the boat's position in the river. In the next picture taken 50 years later the boat would be high and dry on a large sandbar.

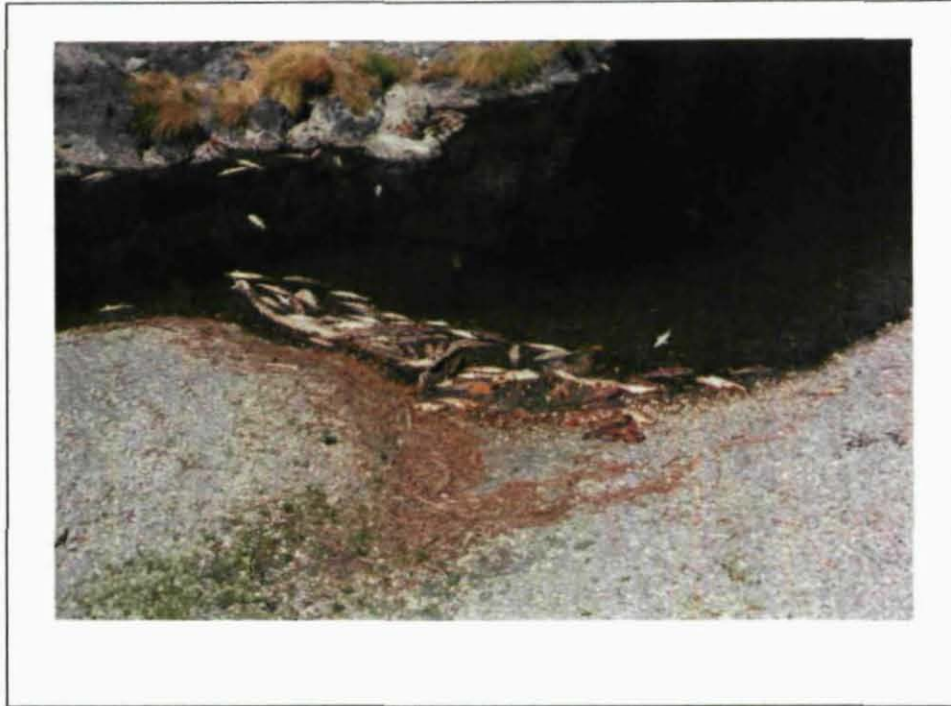
### **KLAMATH FISH KILL 2002**

**In 2002 68,000 fish were trapped and died in the lower 16 miles of the Klamath River due to a combination of too little water in the river and too much sediment. The sediment made the river wide and shallow.**

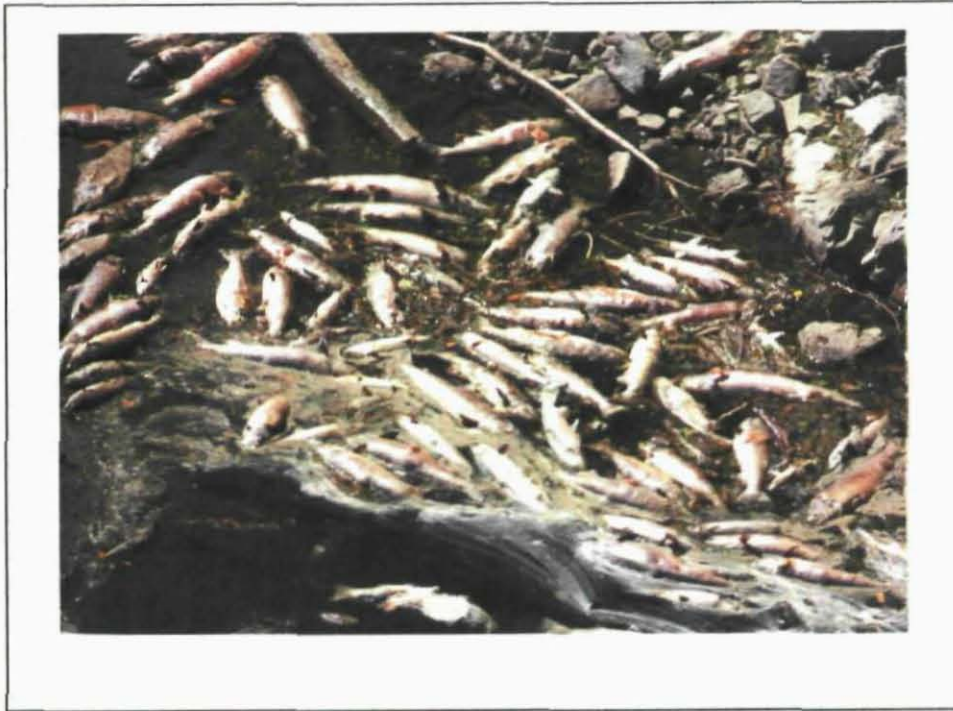
#### KLAMATH FISH KILL 2002

Thousands of dead and decomposing Salmon, Steelhead and Sturgeon lining both sides of the lower 16 miles of the Klamath River was a life-altering experience for many. The Yuroks were so deeply moved that they stopped fishing for the rest of the year.

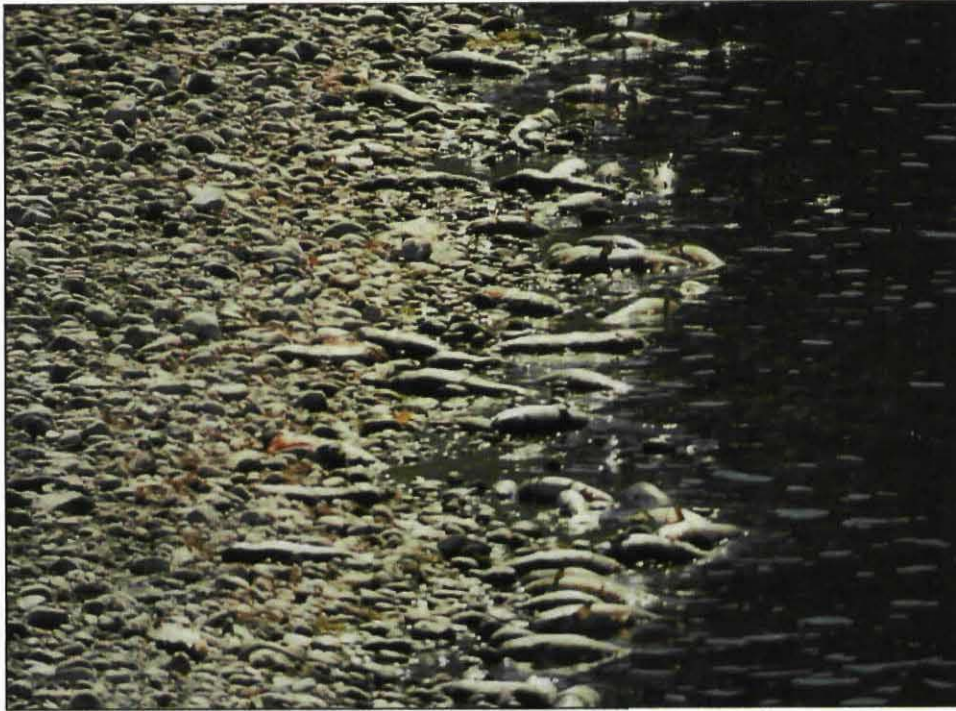
**DEAD FISH 2002  
RIVER MILE 0 TO MILE 16**

**Dead Salmon, Steelhead and Sturgeon lined both sides of the river from the mouth upriver for 16 miles.**

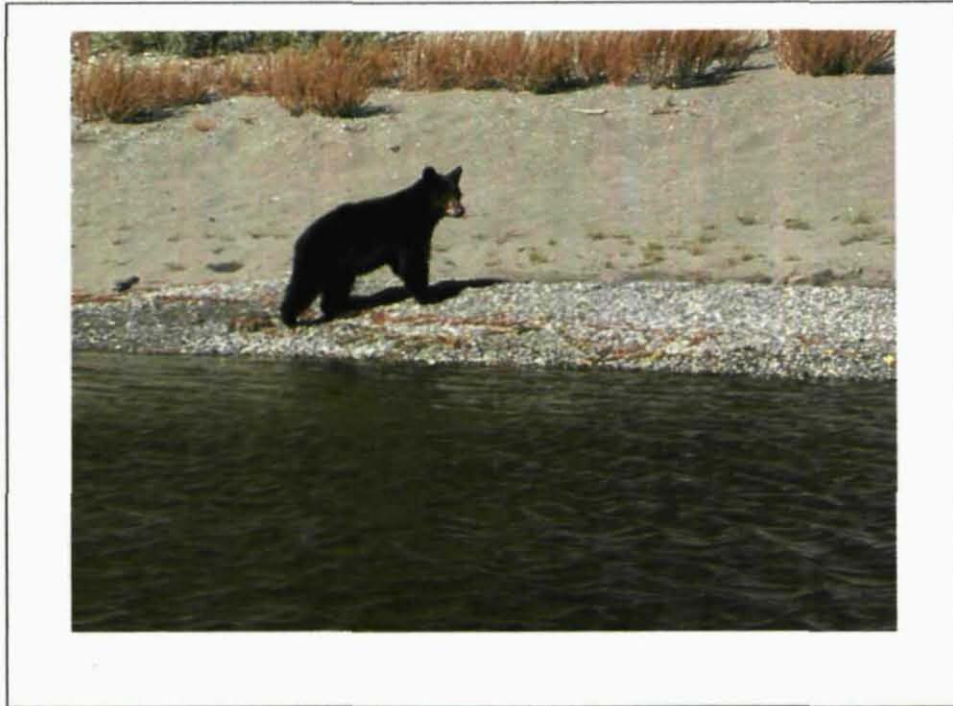
**BLACK BEAR ABOVE BLUE CREEK 2004**

**Note the volume and diversity of size of the sediment.**

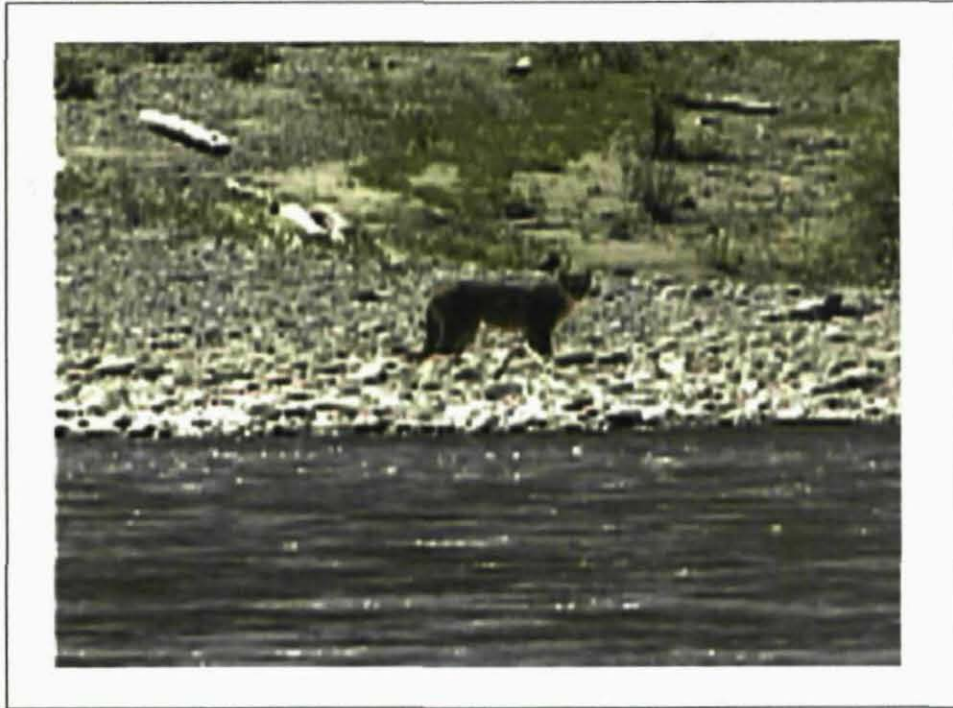
MOUNTAIN LION ABOVE SURPUR CREEK 2001  
RIVER MILE 30

Note volume and size of sediment.

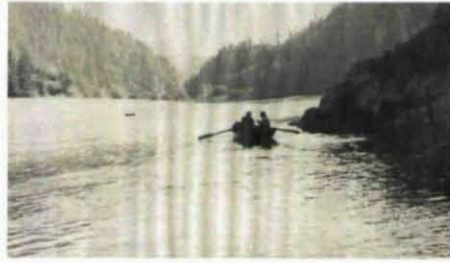
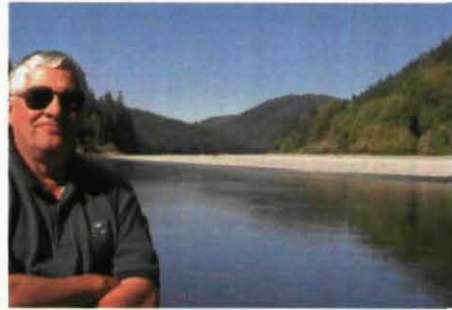
YUROK BOAT ABOVE AH PAH 1920  
DENVER NELSON ABOVE AH PAH 2004  
RIVER MILE 18

These photos taken 80 years apart show the same area of river above Ah Pah Creek. Note the huge build up of sediment from the rock outward on the right side of the river. The river bed has been transformed from V-shaped to wide and shallow.

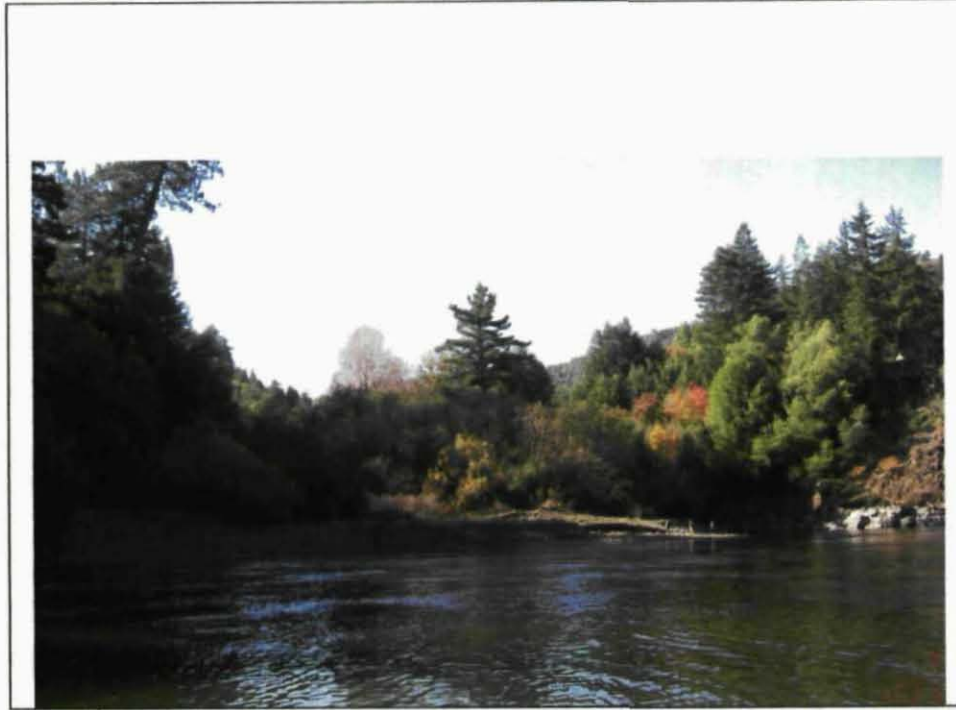
**SURPUR CREEK 2004**

**A closer view than the preceding slide. The huge plug of sediment extends from one edge of the creek mouth to the other.**

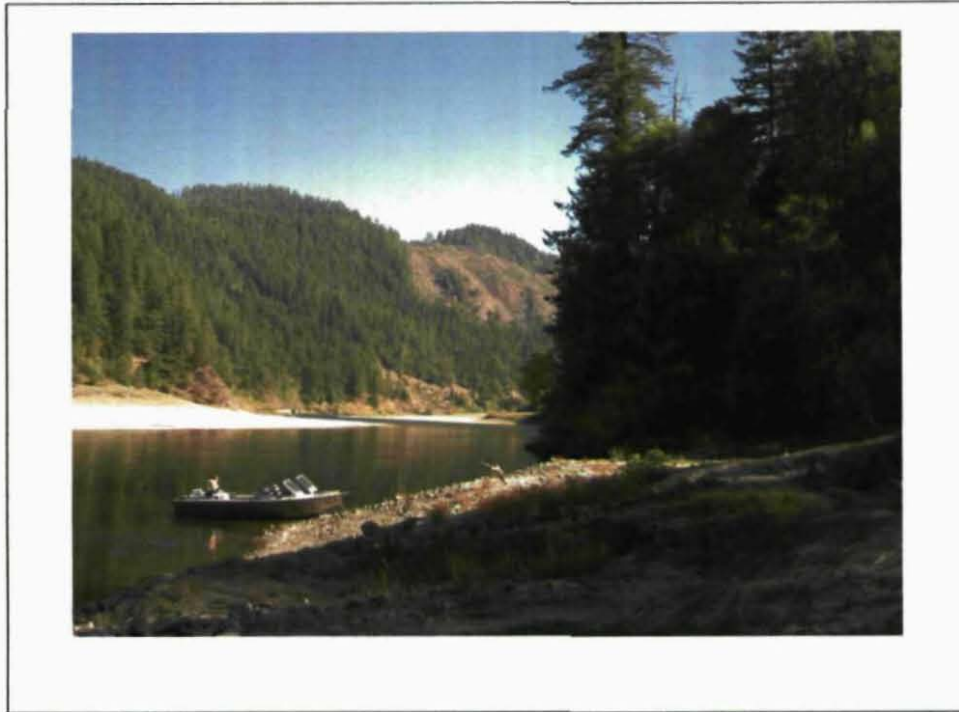
#### SURPUR CREEK AUGUST, 2004

I own the mouth of Surpur Creek and have a small fishing shack in the trees on the right. Surpur Creek runs year round but in the summer and fall goes underground about 500 feet up from the river due to the large sediment plug. If the winter is wet enough, the creek washes the sediment plug into the Klamath allowing Salmon and Steelhead to come up the creek to spawn. My river boat is 22 feet long. There is a sediment plug 30 feet high by 500 feet long by 1000 feet wide blocking the mouth of Surpur Creek in the summer. Note the recent clear cut logging on very steep slopes in the background. I believe this manner of logging and yarding contributes to the excess sediment in the Klamath River

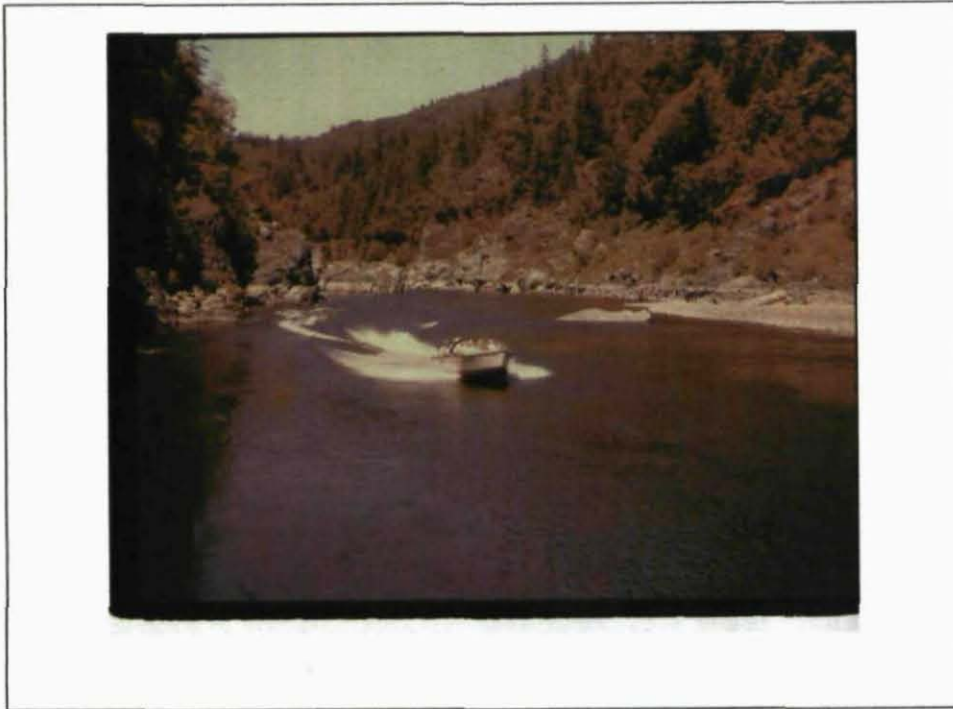
THE KLAMATH QUEEN BELOW COON CREEK 1964

The Queen carried passengers in the 50's, 60's and 70's. Note the beach and the large rock on the right of the picture.

Jill and Daniel on the same beach below Coon Creek in 2004. Note the much larger size of the beach. The rock seen in the preceding picture is completely covered by sediment.
