3N16 and Crab Creek, focusing on road delivery to crossing (Spring 2008, Erin Lutrick)

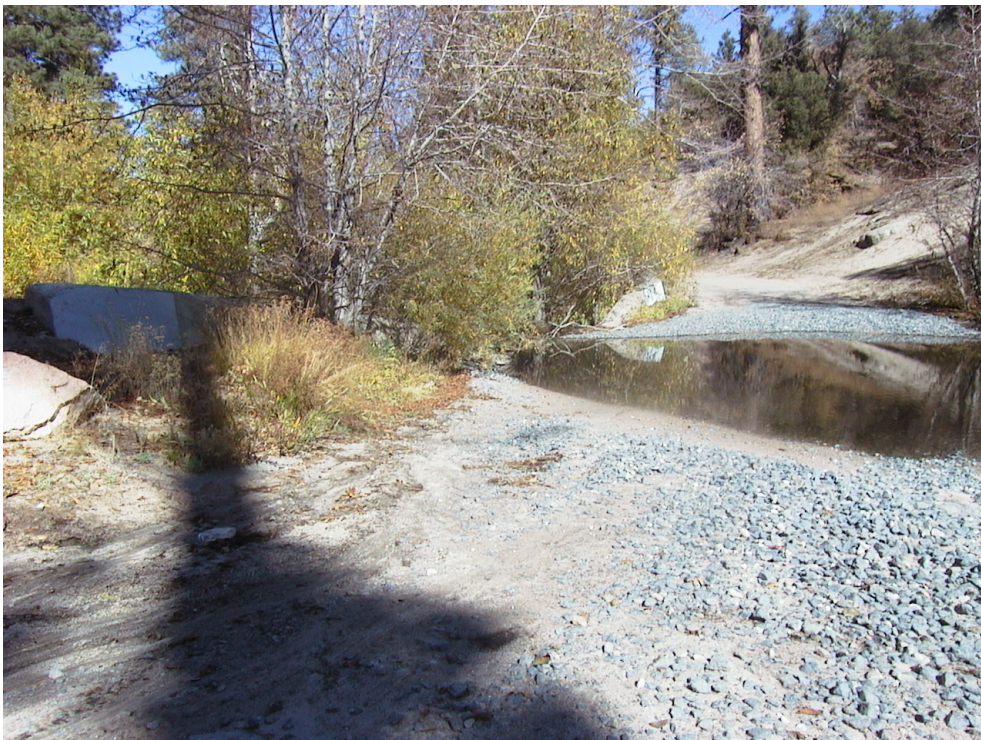
Same location as above, but shows more of south creek bank. Shows rill entering the creek from the road bed. (Fall 2008, Robert Taylor)

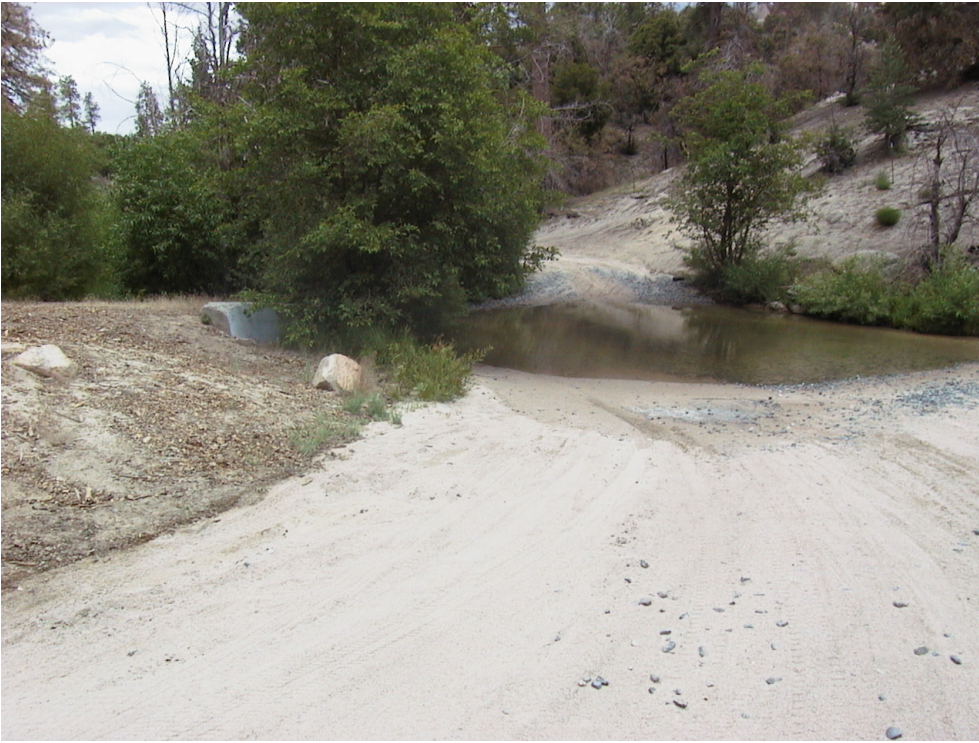
Less gravel seen - some likely buried. Road work removed rill entering the creek from the road. (June 2009, Robert Taylor)

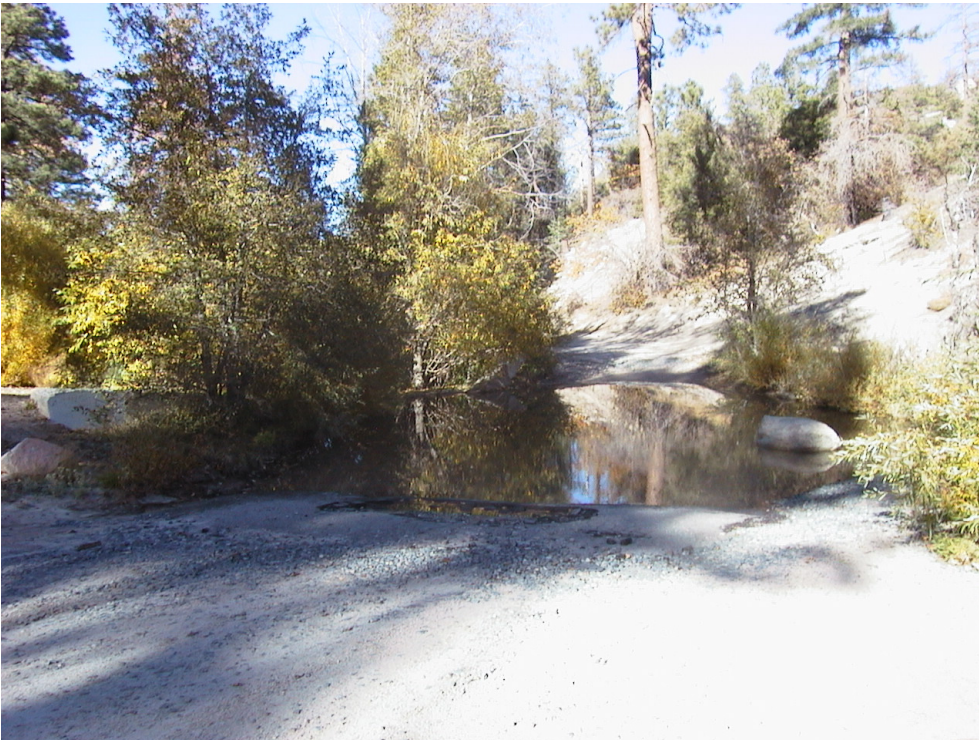
More gravel seen; road has had maintenance work (October 2009, Mikaila Rimbenieks)
