# ***Coastal Watershed Planning Assessment Program***

## **Big River Basin Assessment**

**November 2006**

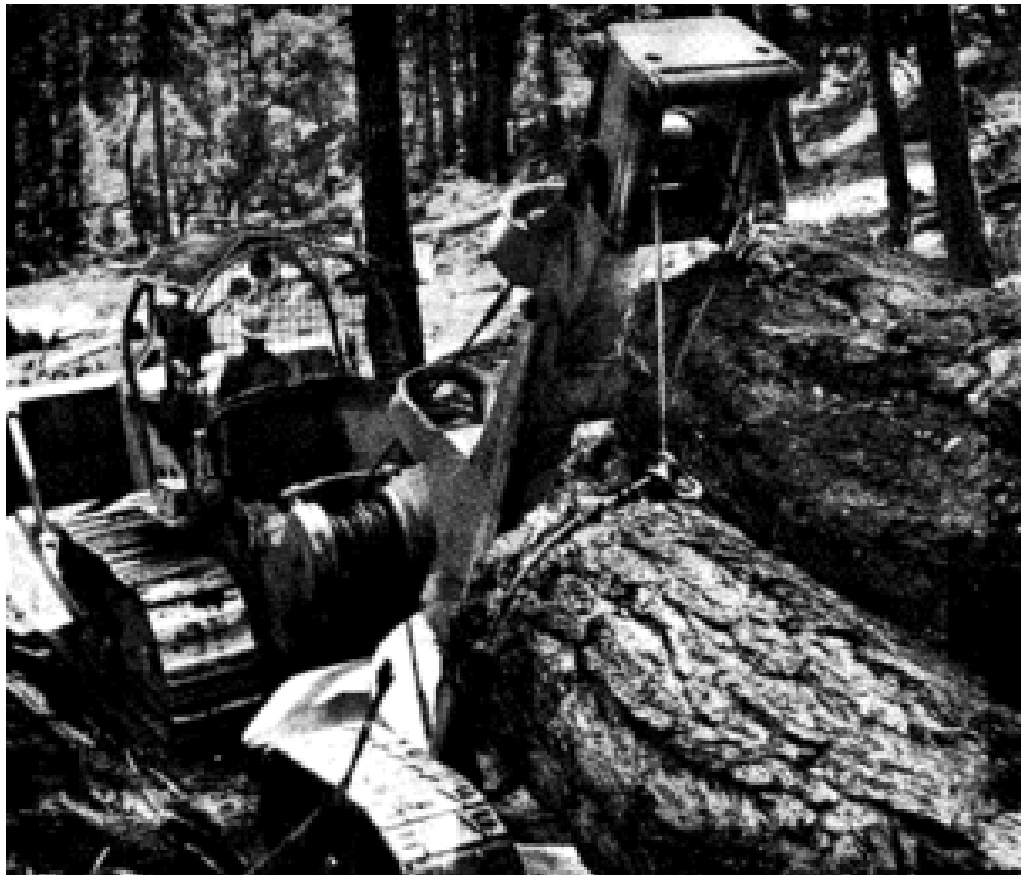
Figure 31. Tractor arch operations.

The logs were then winched up into the arch and the leading end hoisted clear of the ground. Due to the size of the tractor-arch combination there was a significant reduction in the maneuverability of the machine, resulting in an increase in the size of skid trails and landings. Each skid trail also needed a “turn around” for the tractor before it could connect to a turn of logs. These large, significant skid trails resulted in large cut banks, significant fills at low points and the increase in soil displacement. This combination of equipment, the manner of its use, and the disturbance almost certainly resulted in significant erosion and delivery of sediment to streams. Development of the integral arch eliminated the tractor arch operations, as the arch was now a part of the tractor and eliminated the need for a second piece of equipment.

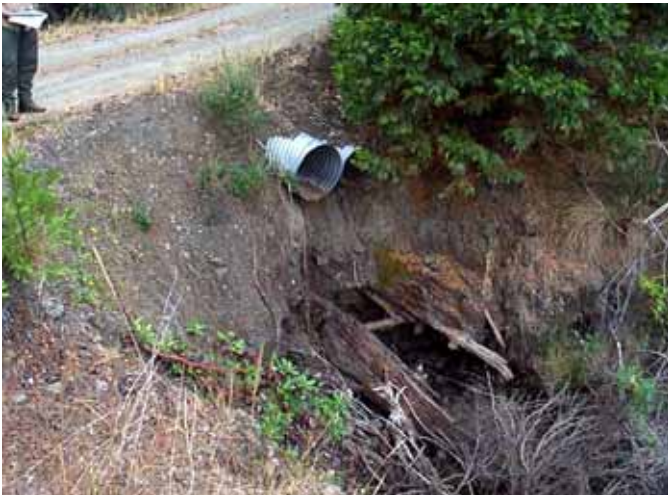
*Figure 36. Watercourse crossing at high risk of failing.*

Some of the techniques being used currently for abandonment of roads include the removal of watercourse crossings and re-contouring of the road prism (Figure 36, Figure 37 and Figure 39). Additionally, the number of roadside turnouts and large landings used for large old growth logging are being reclaimed (Figure 38).

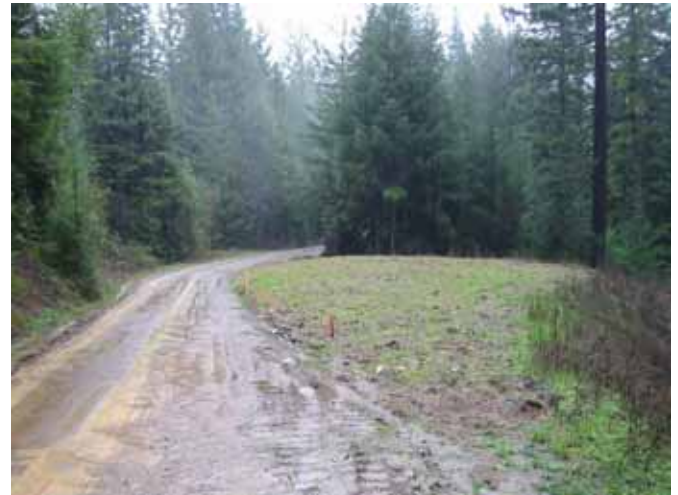
*Figure 38. Reclaimed landing on mainline road.*
