OFFICE MEMO

TO: Ed Morris Jason Harbaugh	DATE: 27 September 2009
	SUBJECT: Webb Tract visit - Sept 9, 2009
FROM: Kim Rosmaier

This is the last visit to Webb Tract for the 2009 Water Transfer pilot program. A separate report which provides examples of the attributes used in this project has been prepared. The surface renewal equipment will be removed next week.

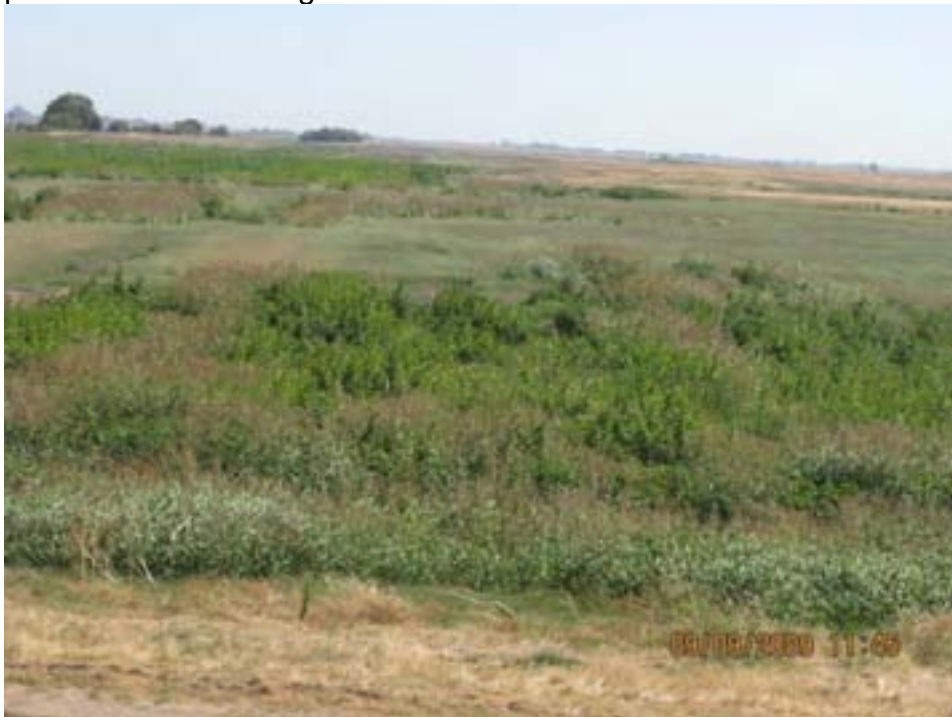
There is considerable amount of Bermuda grass which hinders the discing activities. This poses a problem in the discing activities.

Field 99 looking east from levee.

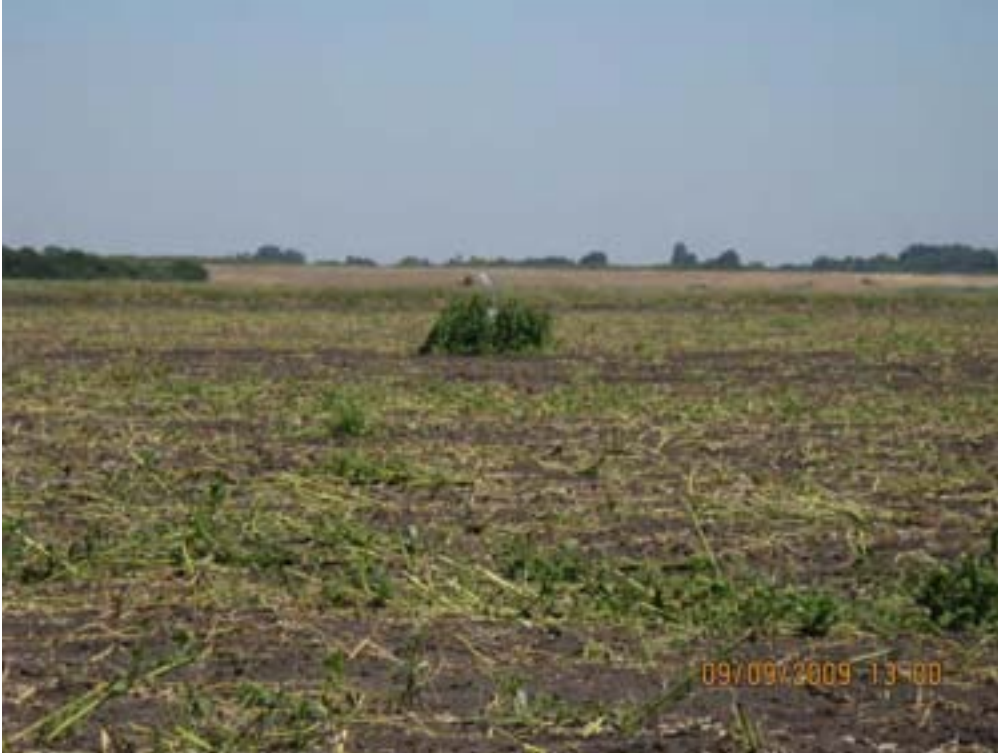
The location of the permanent SR, field 23, was disced last week. To avoid damage to the SR equipment, the vegetation around the station was not disced. To decrease the influence on the SR data, staff attempted to lessen the height of the vegetation.

Approaching the SR1 in Field 23.

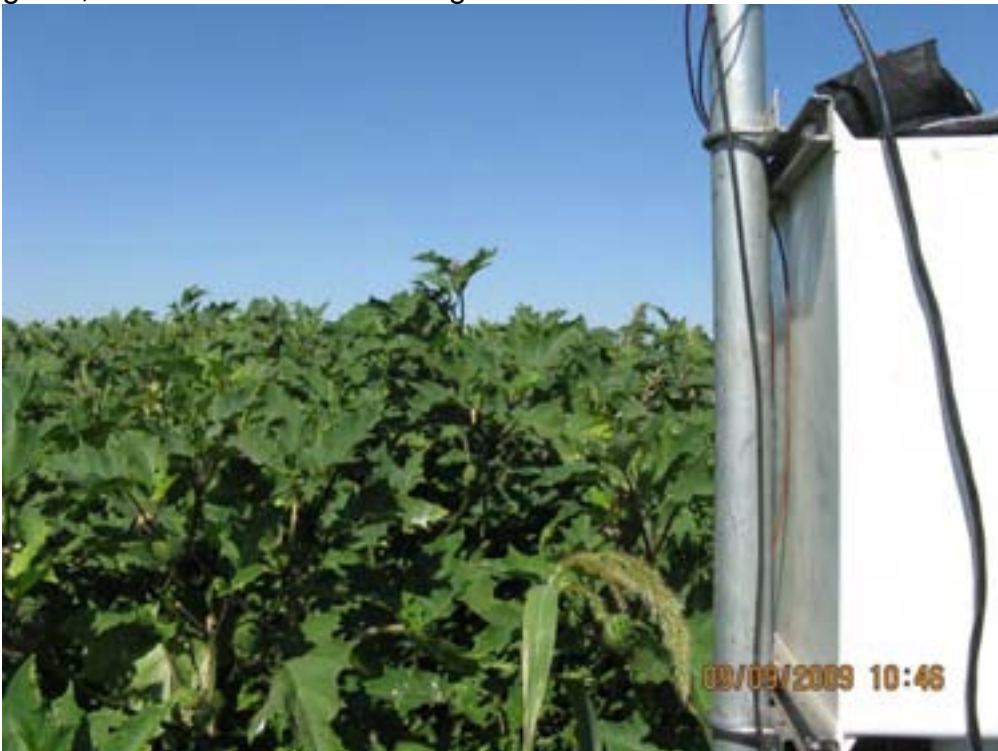
The rover SR is in field 79 and is surrounded by pigweed, jimsonweed, Bermuda grass, Johnson grass, and other unidentified vegetation.

This is the SR2 in field 79, looking west. The photo was taken at a height of approximately 5 feet.

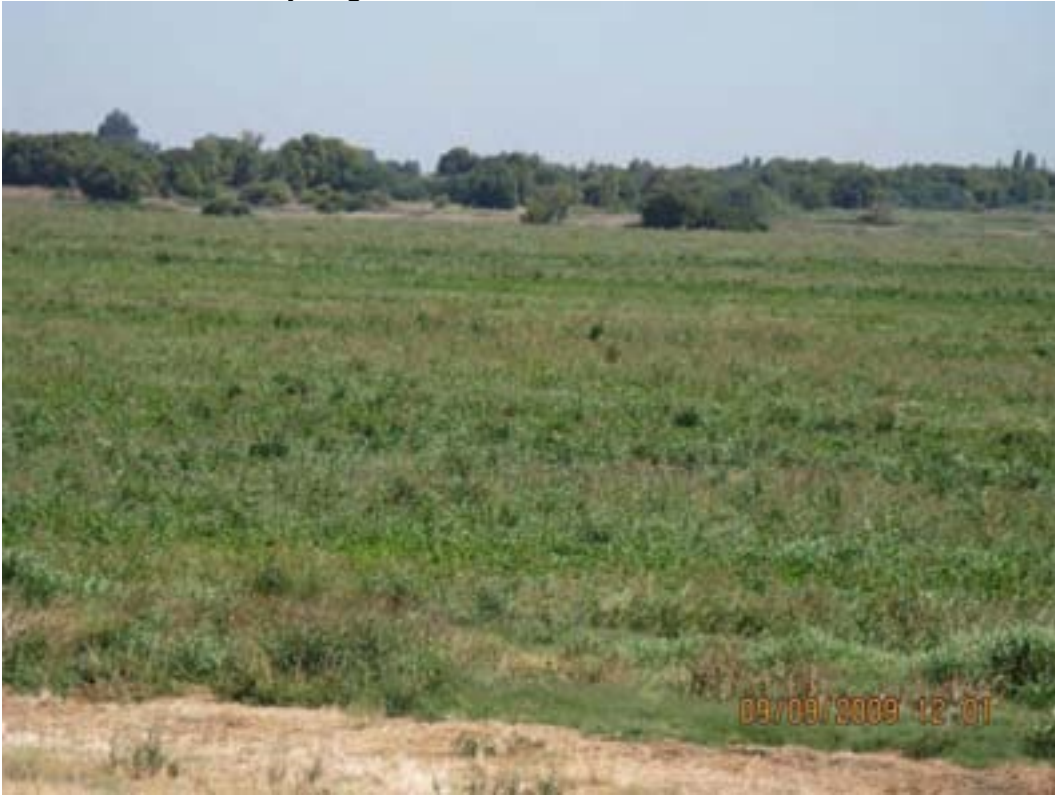
Growth of vegetation is not hindered by lack of irrigation. Fields 16-20 were disced on August 5 have become heavily vegetated within one month

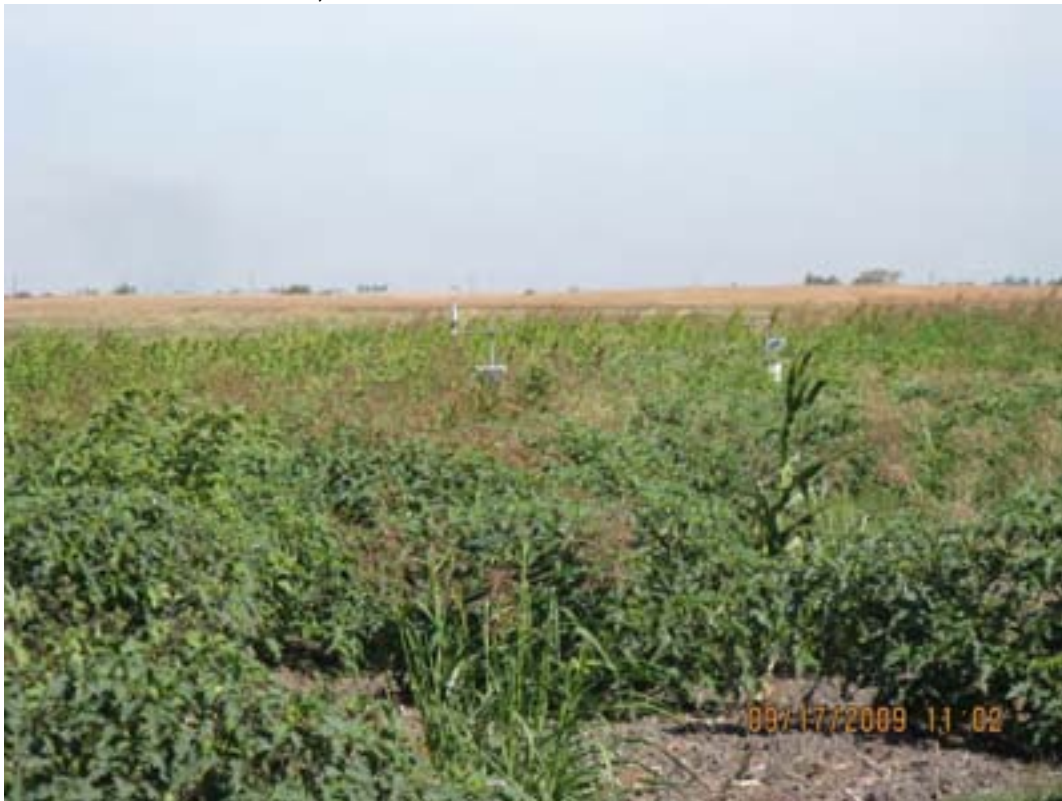
The rover SR remains in the north portion of field 79 and is surrounded by vegetation, heaviest to the west of the station, with less to the east.

This is the location of SR2, looking from the south.

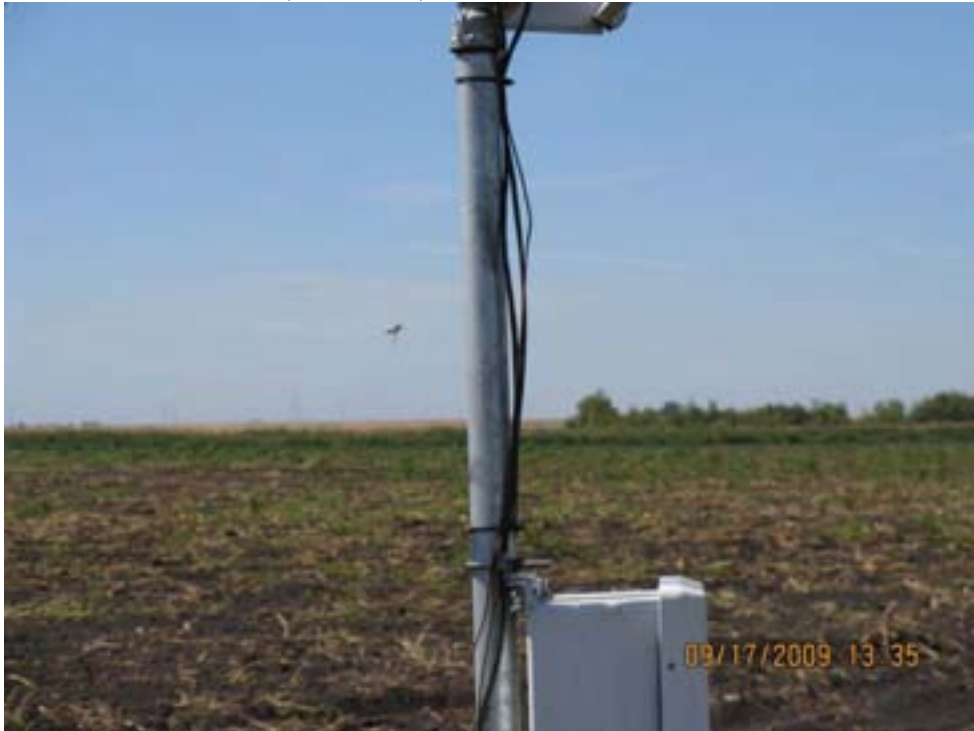
The location of SR1, Field 23, was disced last week.

SR1 in field 23, looking west.

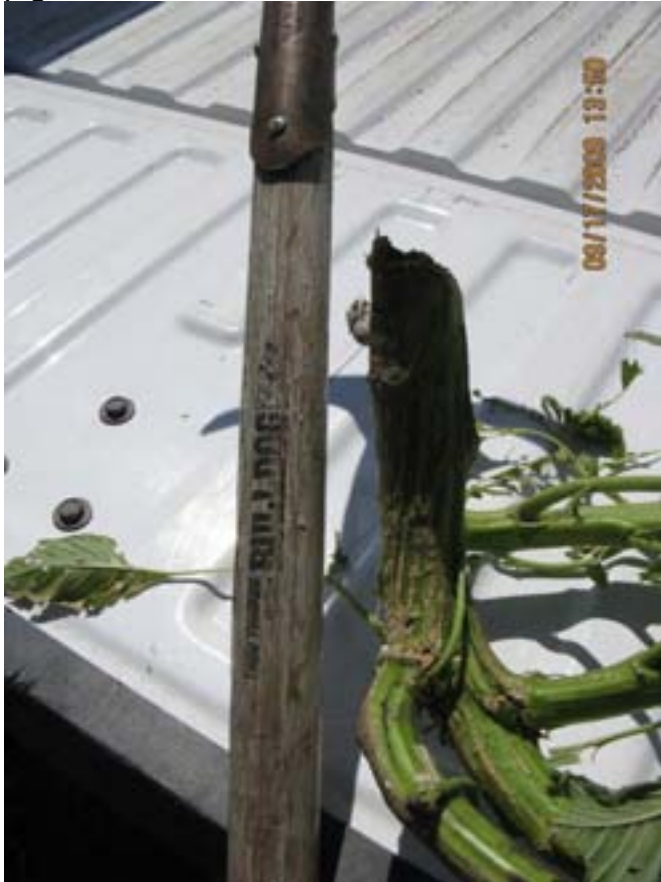
DWR staff cut down the pigweed surrounding the station. The picture below is of a stalk of cut pigweed. As can be seen, the diameter of the stalk is equivalent to that of the shovel.

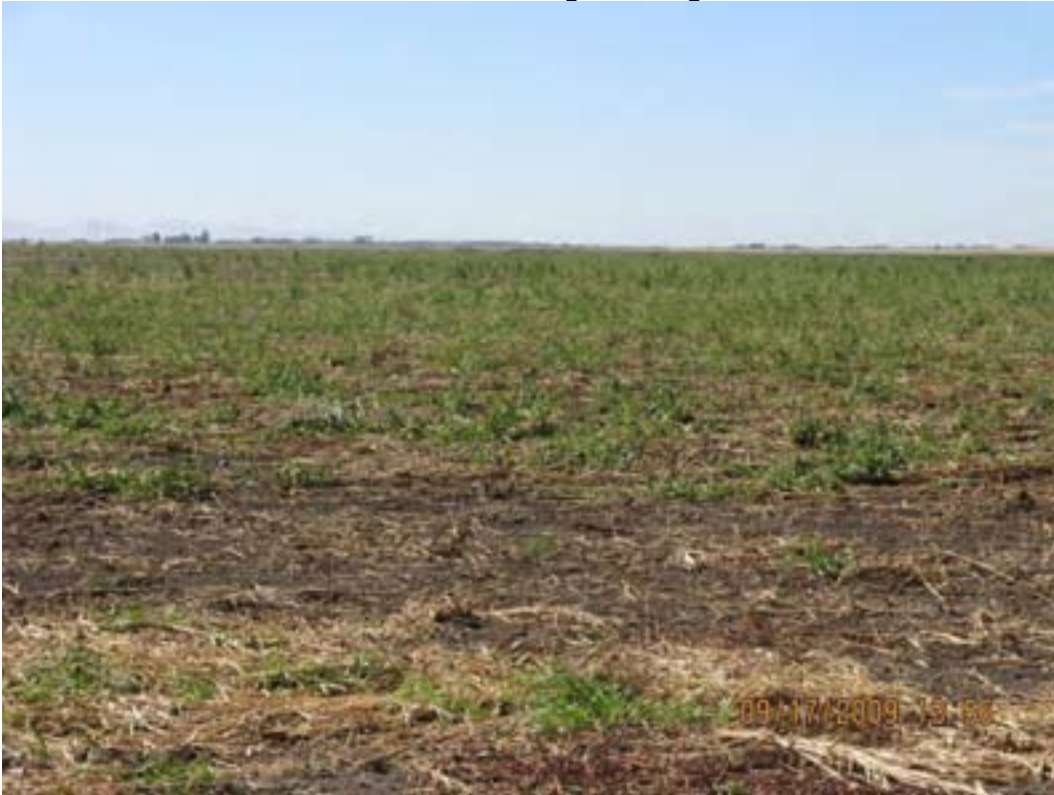
Field 21 was disced on August 26 and was attributed as NV+D (native vegetation being disced) and is now attributed at FF+I1 due to the vegetation growth.

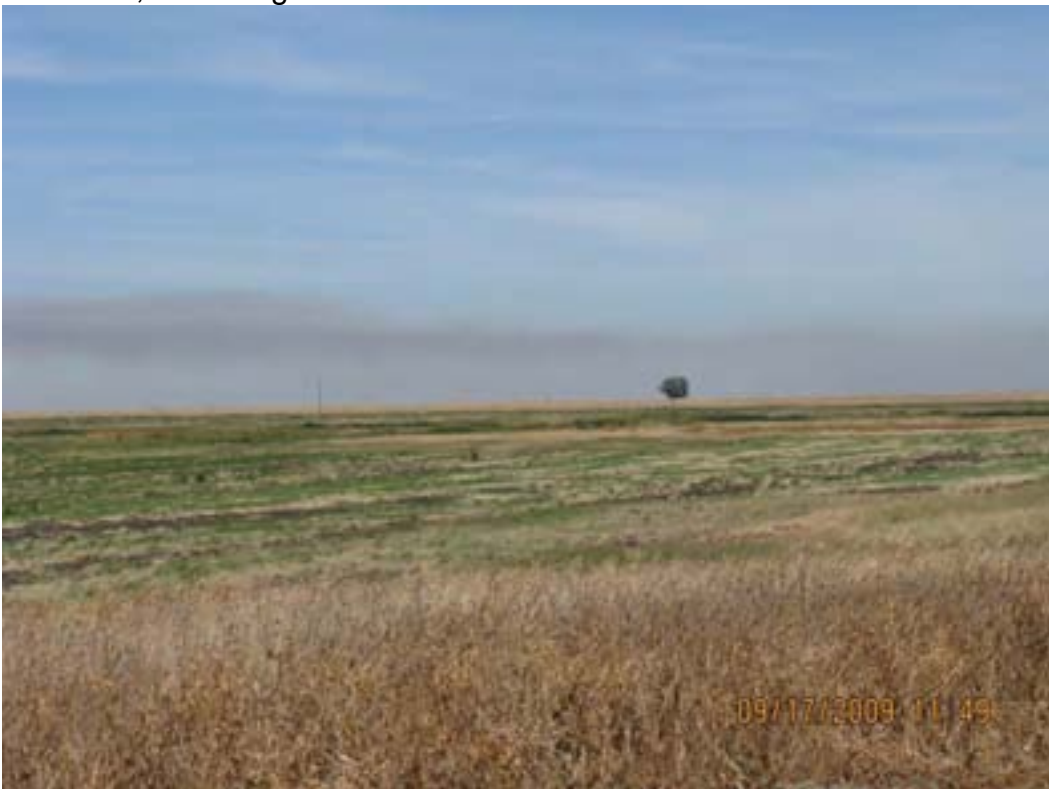
Due to extensive amount of Bermuda grass, some newly disced fields are not evaluated as fallow. Field 98 was disced on September 9th and was attributed as FF+I1, providing recognition that the field was partially fallow but also indicating sufficient vegetation (Bermuda grass) existed in some areas to be considered idle. Due to the increase in Bermuda grass, the field was attributed as I1 this week, indicating minimal bare soil.

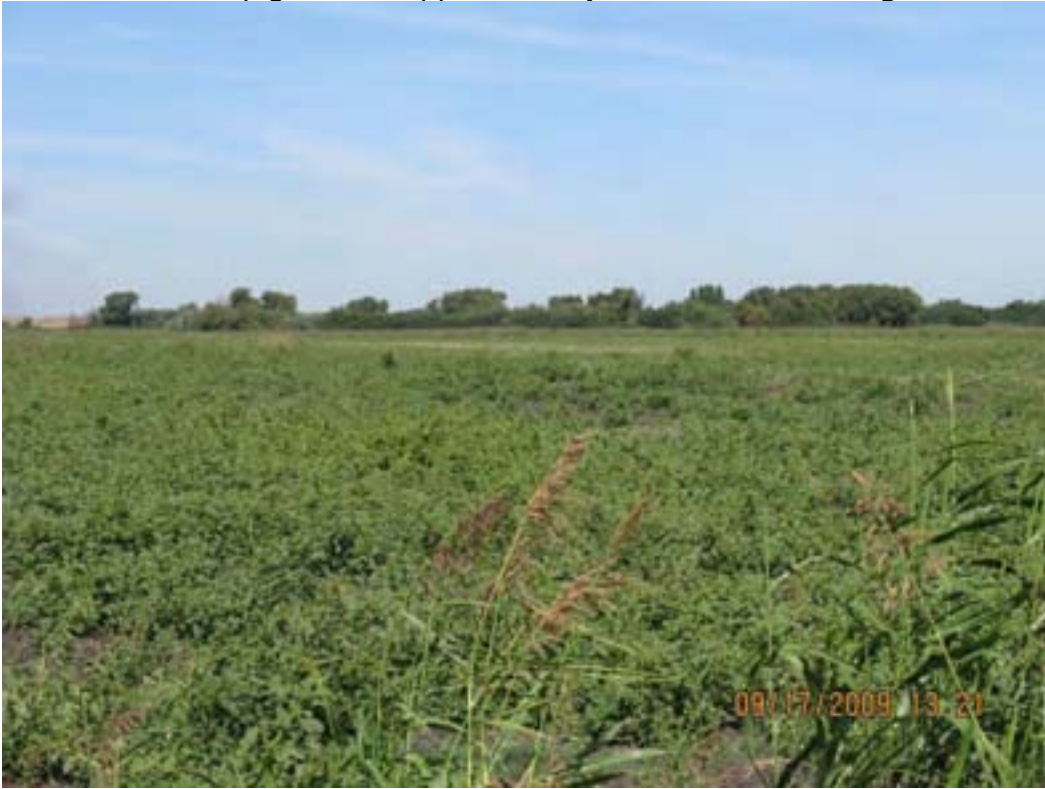
Field 18 was disced on August 5th and attributed as fallow. Due to the growth of pigweed, the field is now idle. The pigweed is approximately 12-18 inches in height.

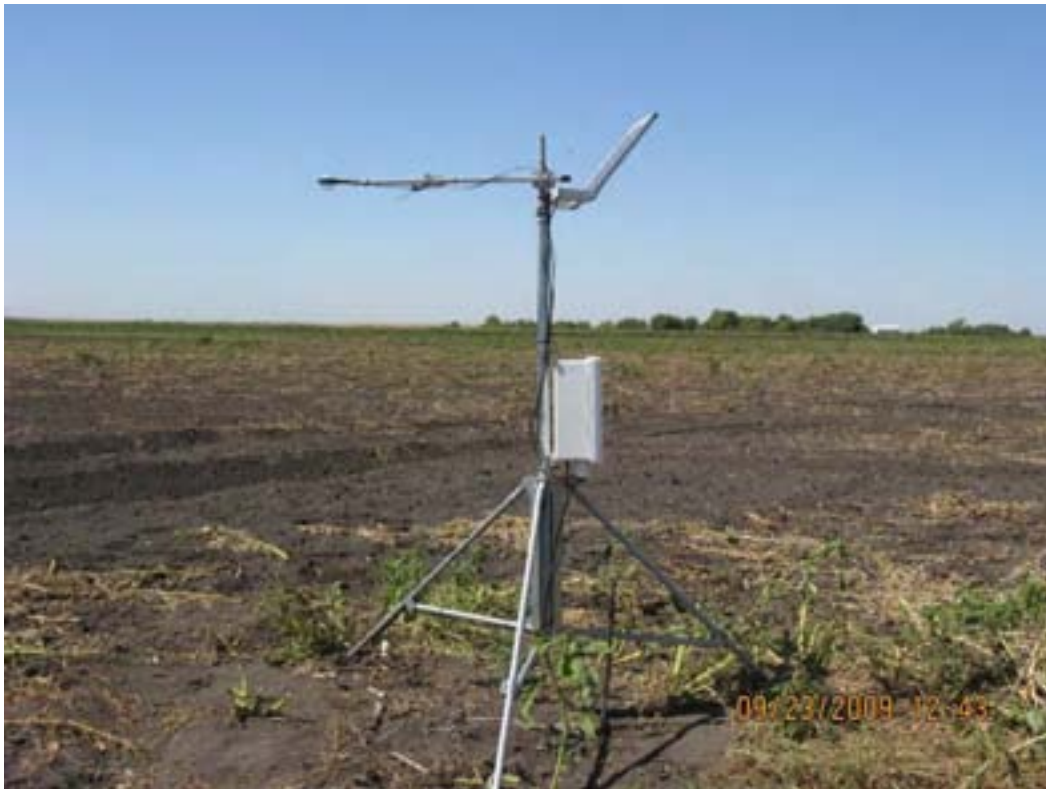
The location of SR1 remains fallow.

SR1 Looking West

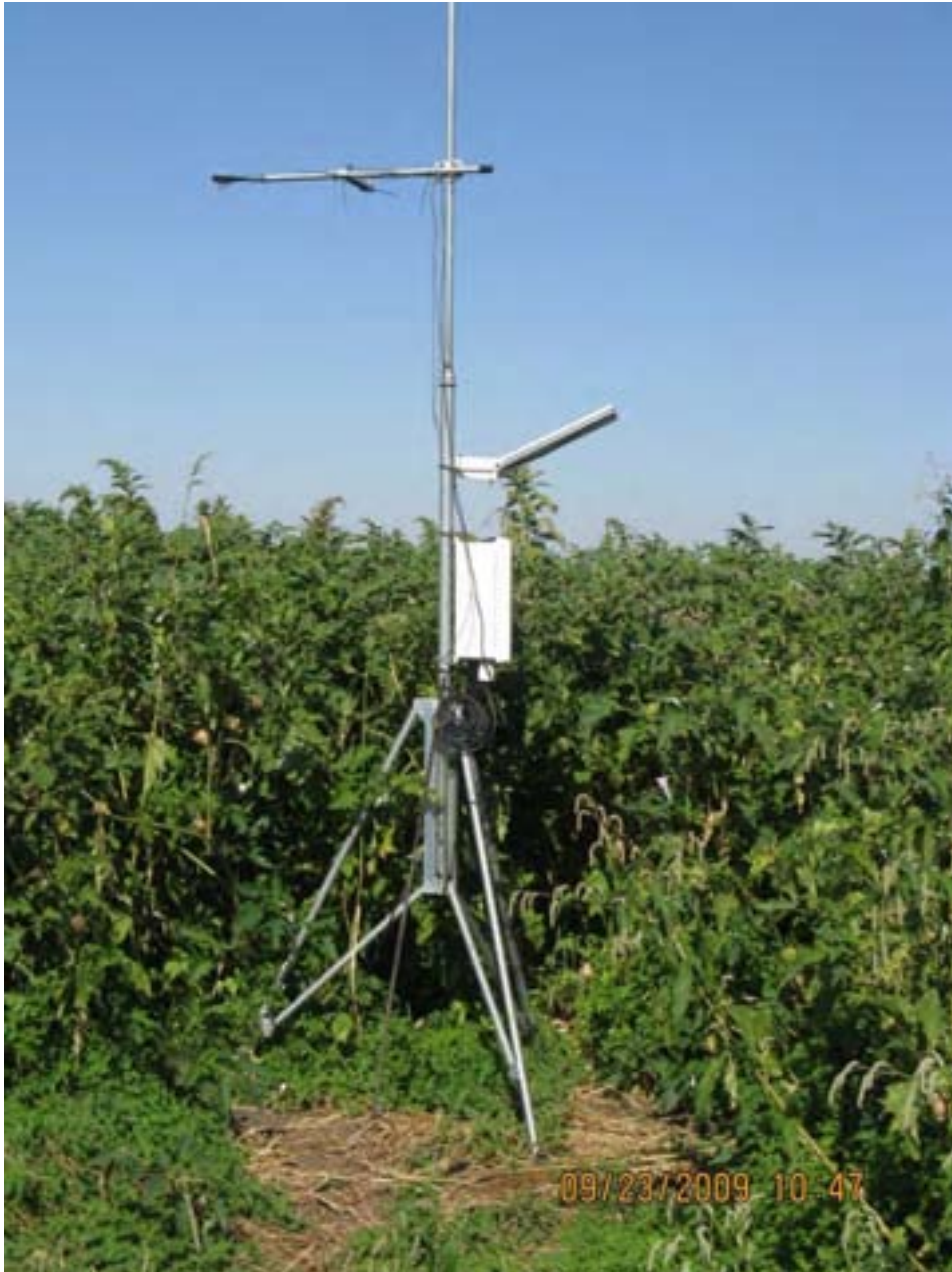
The rover SR has not been moved due to the high volume of vegetation. More data from this field will assist in determining an NDVI index. The vegetation has remained at the same height but some infill has occurred.

SR2 looking west

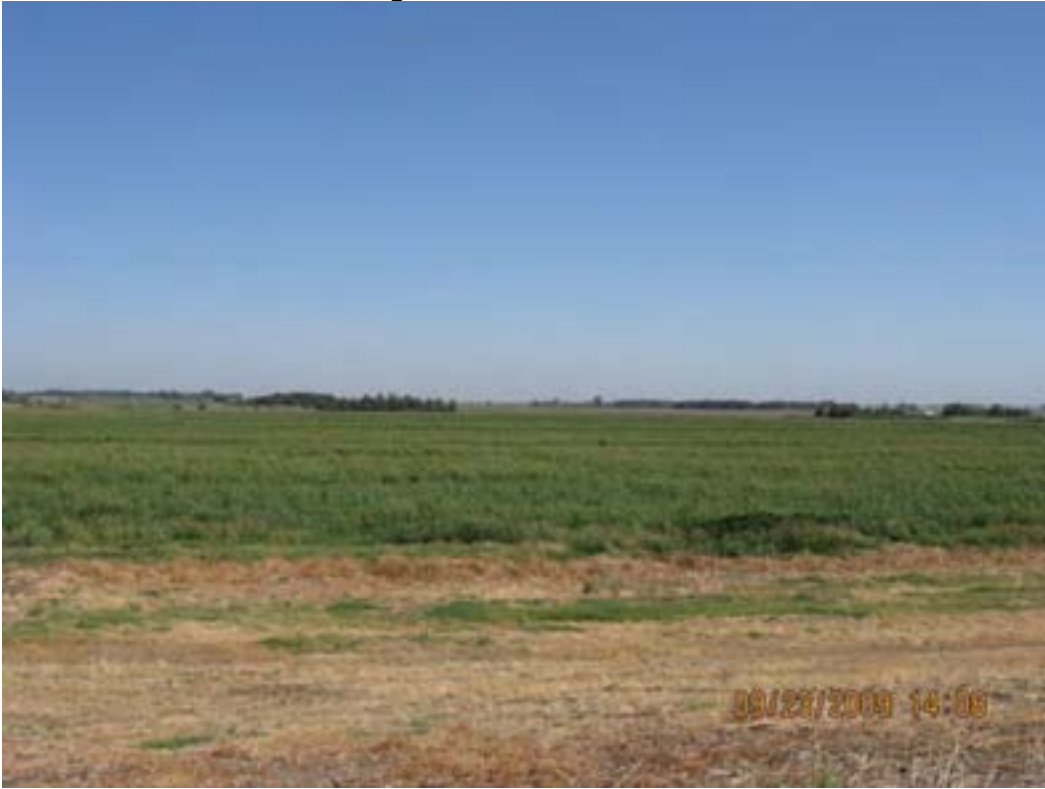
Fields 16 and 17, disced on August 5th and evaluated as fallow, have been revegetated and are now evaluated as native vegetation.

Field 16 looking east.

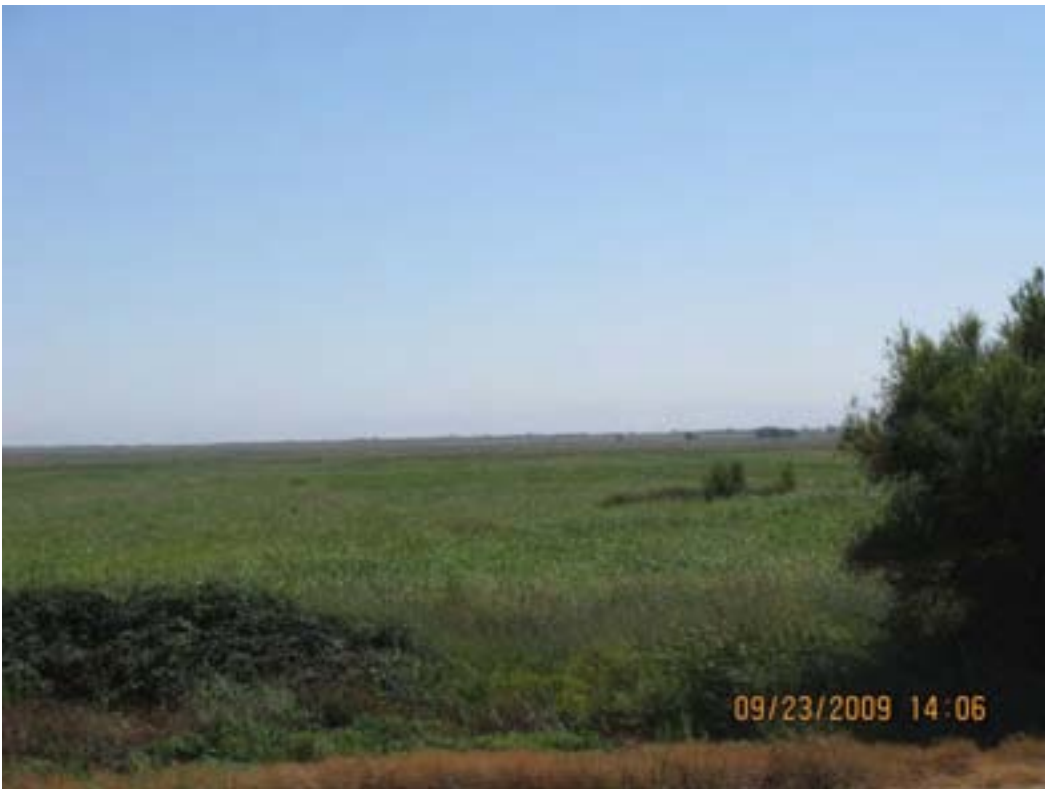
Field 17 looking south.

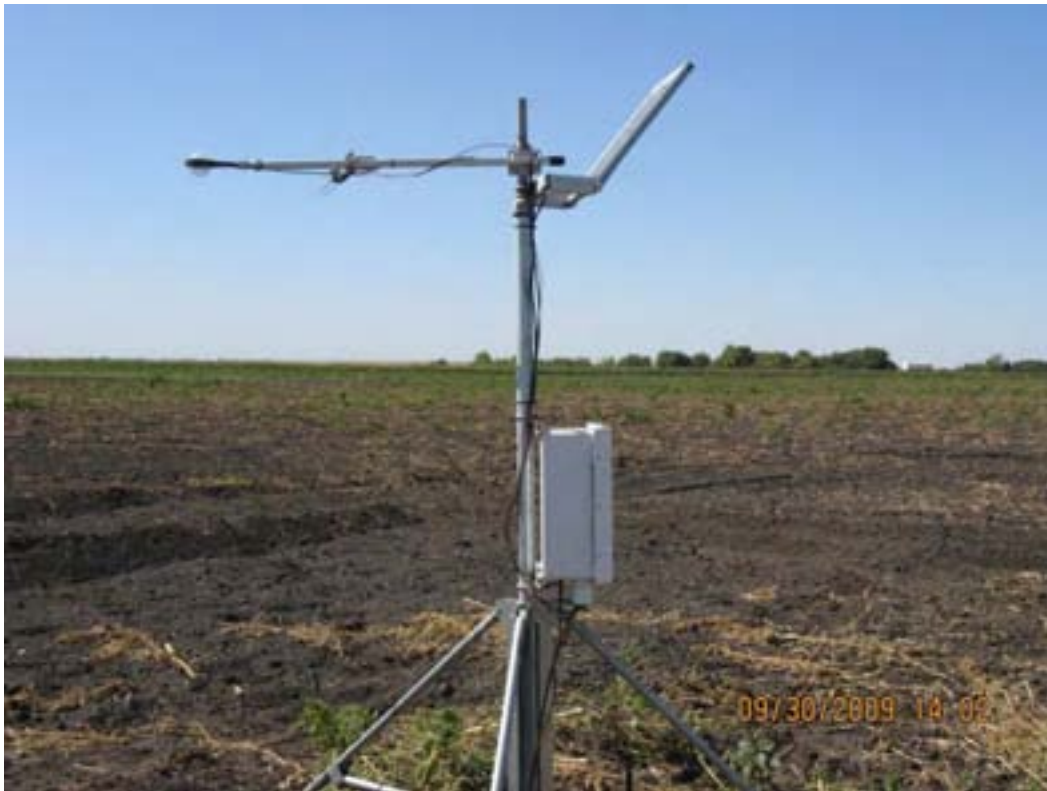
The location of SR1 remains fallow.

SR1 looking west

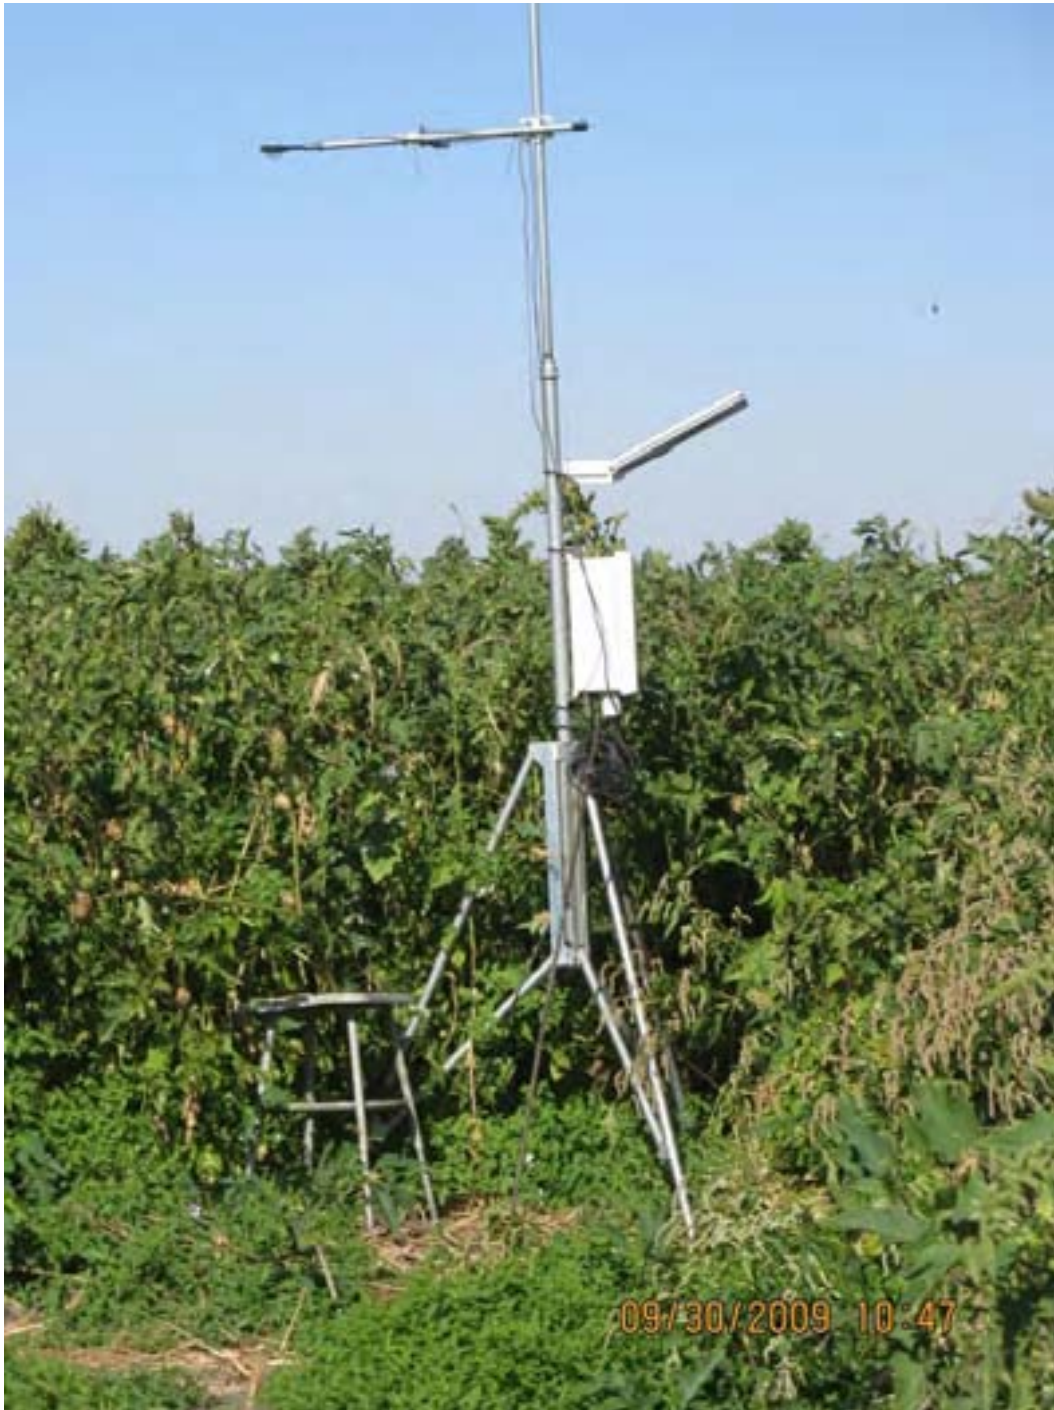
The rover SR has not been moved due to the high volume of vegetation. More data from this field will assist in determining an NDVI index. The vegetation has remained at the same height but some infill has occurred.

SR2 looking west

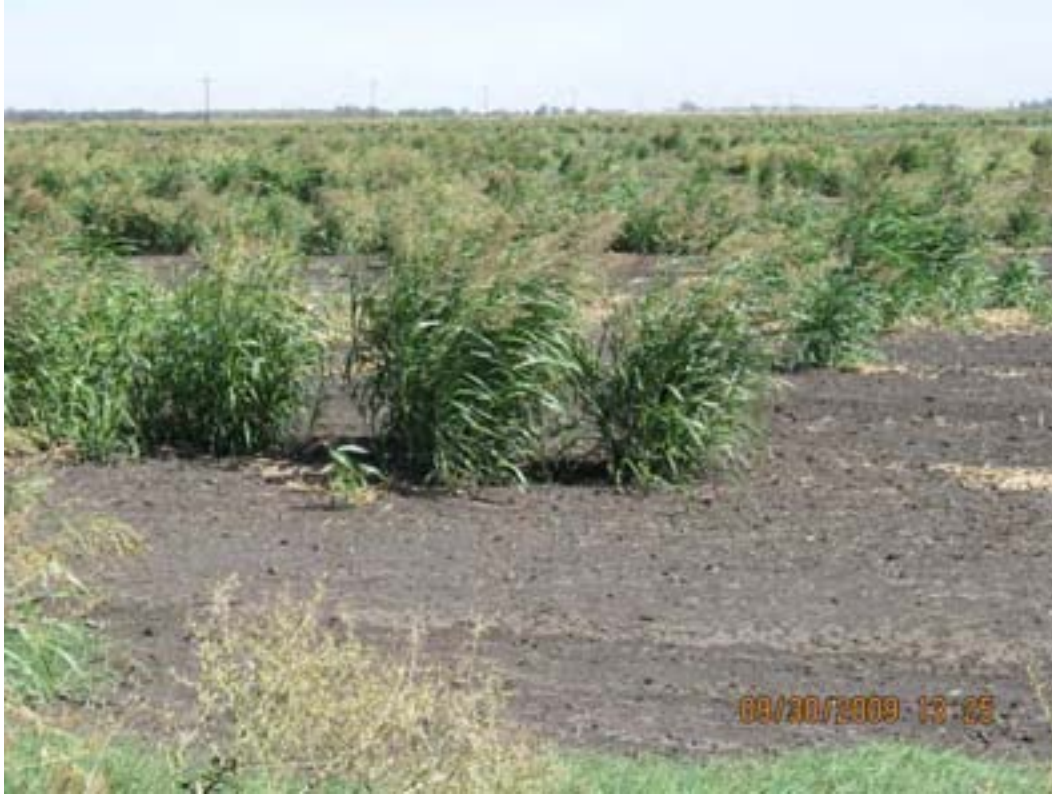
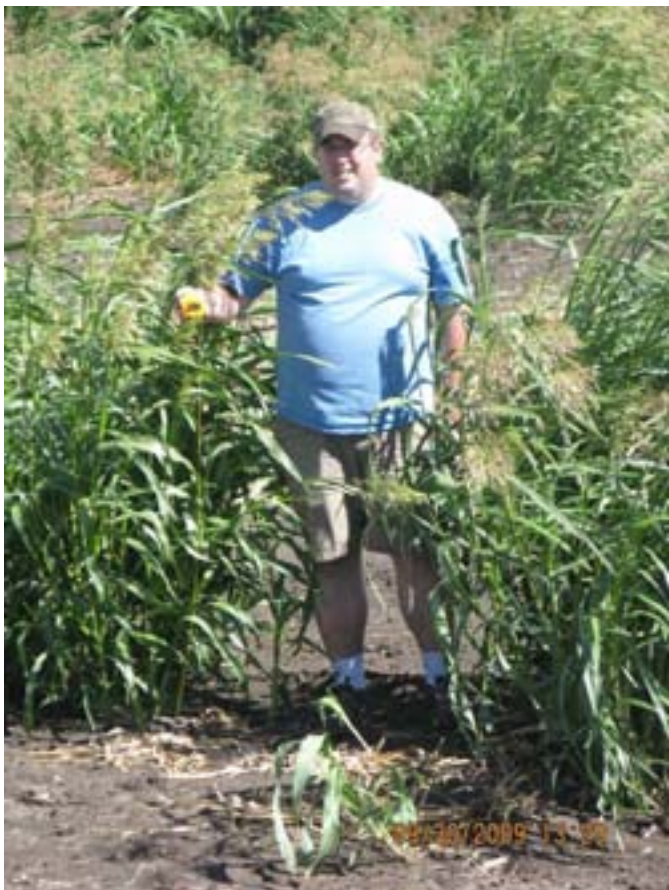
Field 43 was disced between Aug 20 and Aug 26. The 8/26 survey identifies the field as FF+nC, i.e fallow but not clear of vegetation. The two photos below show the status of field 43, the infill of Johnson grass, attaining a height of two to four feet (photo shows four feet).

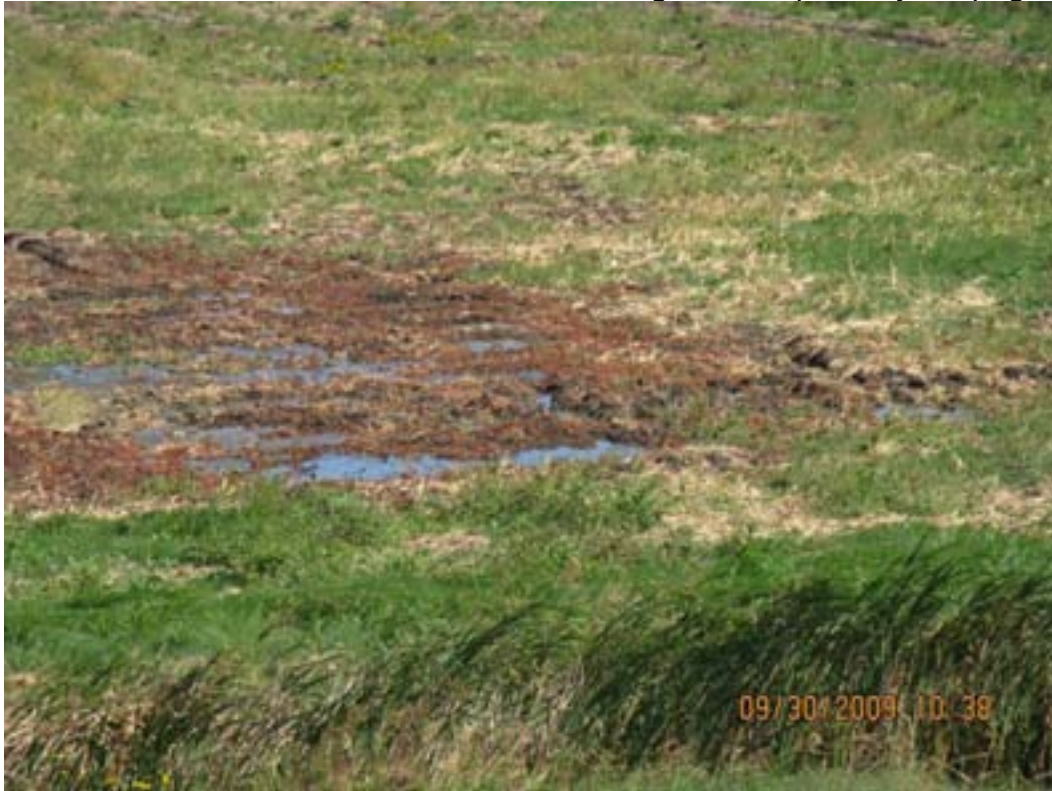
There was standing water in field 101. Since no precipitation was recorded by the Twitchell Island CIMIS station #140, the source of this standing water is possibly seepage in a low lying area.
