Figure 5C.4-27. Bench Habitat Analysis Sites

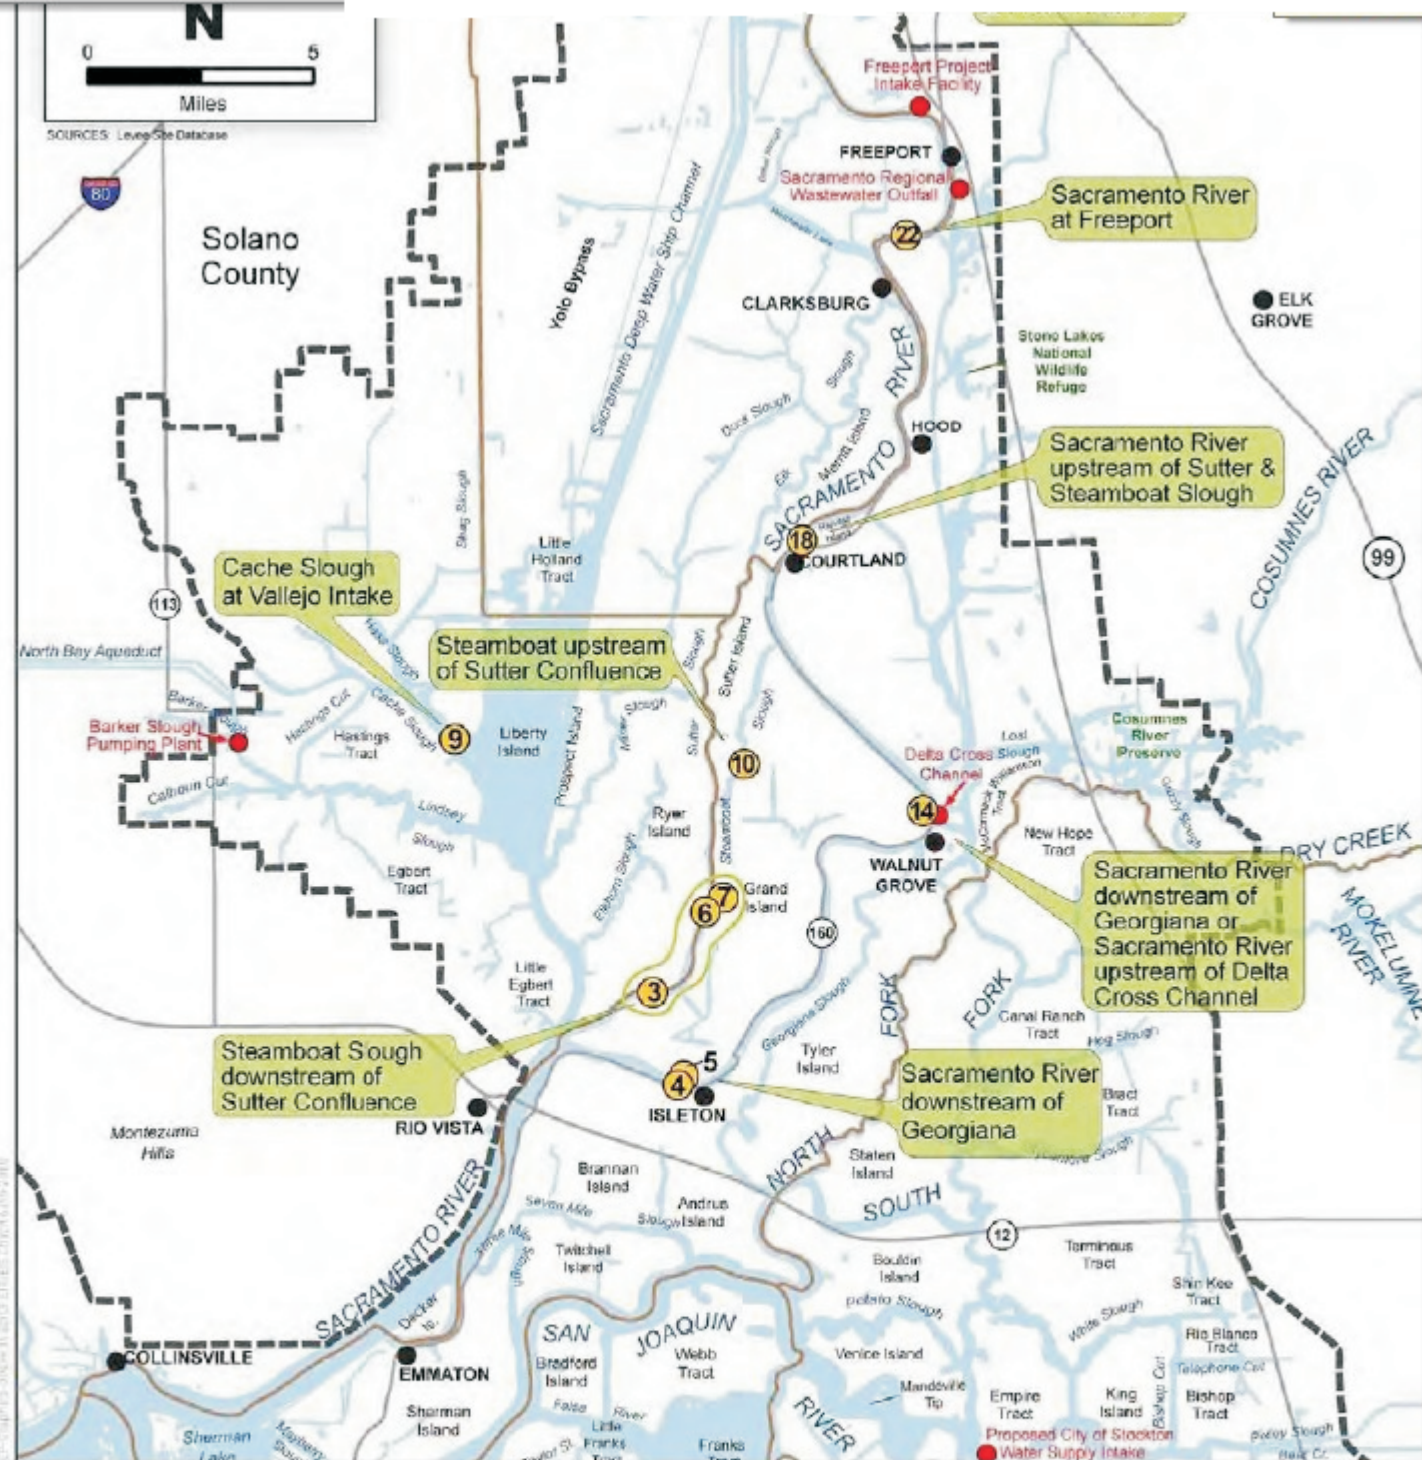
10-sediment insertion and bench test resulted in raising bed of waterway  
 6,7 Large trees down placed in waterway near banks to capture sediment & reduce waterway navigation and use in this area  
 3 bench built up and planted with tules but was infested with egeria densa which is not suitable for salmonids. Also causes flood control issues as bench reduces water outflow in high flow times.
