Appendix 24A
Draft Phase 1 Initial Site Assessment

Draft Phase 1 Initial Site Assessment

24A.0 Executive Summary

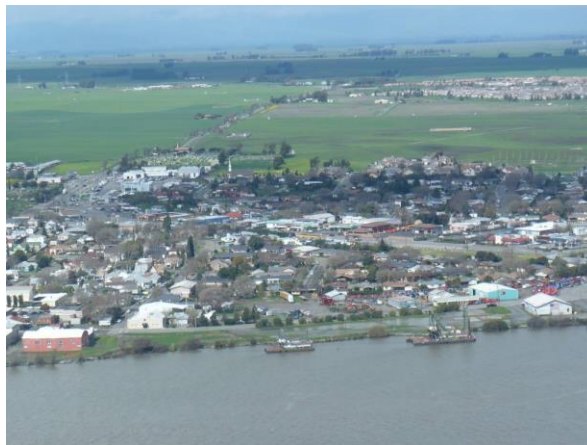
Figure 24A.4-1. City of Rio Vista

Urban areas have many facilities with the potential for hazardous materials releases.

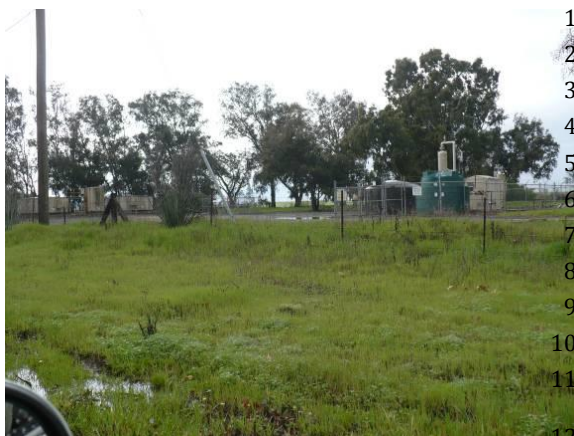
Figure 24A.4-2. Oil and Gas Production

Active oil and gas extraction fields are present in some parts of the study area. Petroleum wells and field processing facilities, whether oil or gas, can release contaminants to the surface or subsurface. Generally, the actual well bores are not large sources of releases. The wells themselves are designed to move the product from the geologic strata to the surface with no loss of product. Releases are more common in transport pipelines and processing facilities, which are nearer the surface, and therefore more exposed to disturbance by weather or man. In addition to the wells and pipelines which tend to carry raw petroleum products, many other chemicals may be used in the extraction, treatment, or processing of the raw materials in field locations. For example, Figure 24A.4-2 shows a well with attendant holding tanks that contain some form of secondary recovery chemical, which is used to treat the well or the product for maximum production. A wide range of chemicals are used in oilfield applications for this purpose.

In addition to production facilities, an active well field has a historical issue with exploration facilities. For example, during the drilling process, every well has a “mud pit” which serves as an overflow impoundment for excess drilling fluids. These drilling fluids often contain petroleum compounds in both raw (crude) form and refined form (drilling enhancement additives). Relict mud pits, although usually lined, may be a historic source area for hydrocarbon contamination.

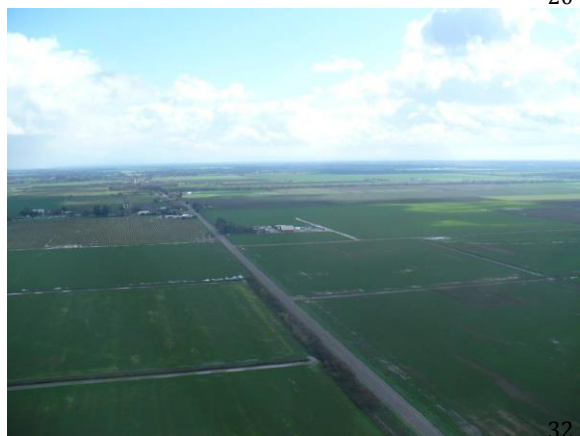
Figure 24A.4-3. Agricultural Fields

availability makes it a major contributor to the nation’s food supply and a wide variety of crops are grown year-round. Agricultural chemicals, including pesticides, herbicides, fertilizers, and crop-specific additives have been used in the Delta for decades. Each crop has specific chemical use associated with it, and a more robust discussion of the history of agricultural chemical usage in the study area may be found in the technical report that will be prepared. Although most agricultural chemicals are designed to break down in soil, some chemicals have a longer residence time in soil, and may break down into residual products that can accumulate to form toxic residue. Still other agricultural chemicals, banned from use today, may be found in trace amounts in

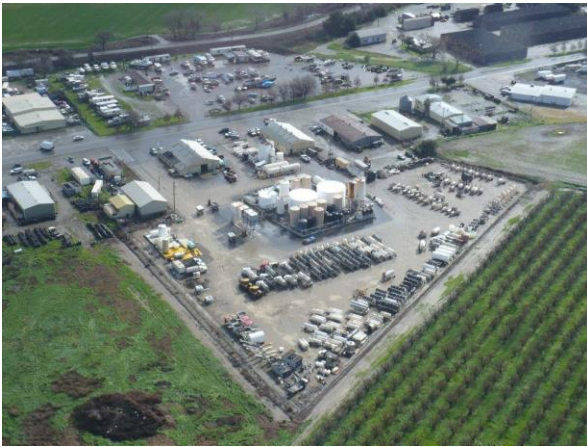
Figure 24A.4-4. Crop Production Services Walnut Grove

Pesticide/herbicide/fertilizer batch plants and supply companies including facilities that sell, store, concentrate, dilute, or distribute agricultural chemicals are present throughout the study area. These facilities may be large-volume supply businesses that have large tanks with thousands of gallons of these chemicals, which are sold to farmers or distributors for local use.

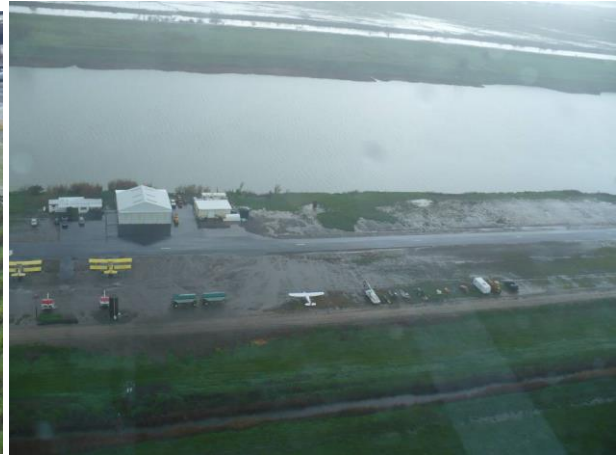
Figure 24A.4-5. Aerial Pesticide Application

These facilities may also be farm-level batch plants, which take the raw material from a supply yard or tanker and temporarily store the material prior to loading into distribution equipment. The main difference between a supply business and a batch plant is the volume and duration of storage. Another important distinction is that supply businesses often have extensive spill-containment equipment and specially trained staff, while a batching operation is less sophisticated regarding spill containment, and the farmer may or may not have specific training for handling these chemicals. Another category of batch plant is the aerial applicator (commonly known as a crop-dusting operation). These businesses function like a local batch plant, but the chemical is loaded onto an airplane rather than a tractor.

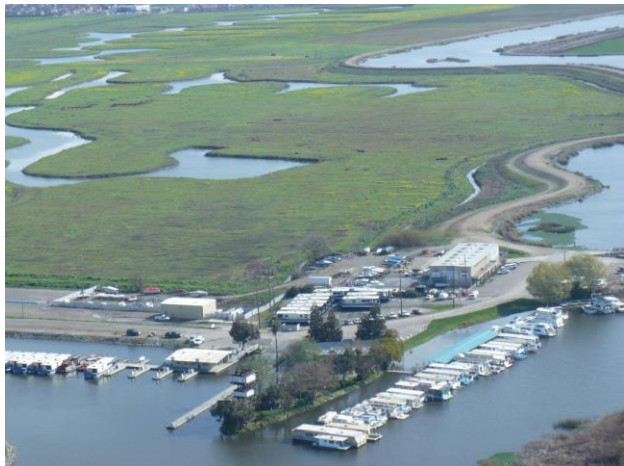
Figure 24A.4-7. Paradise Point Marina

Throughout the Delta, on all alignments, are located large marina operations that include houseboats and pleasure craft. These marinas typically have large fuel storage and overwater fueling operations, along with boat repair facilities of many types.

In addition, the marina facilities include commercial stores, boat storage facilities, and camping facilities. Typical chemicals, in addition to boat fuels, would include lubricants, cleaners, anti-fouling paints, sand blast grits, and fiberglass components.

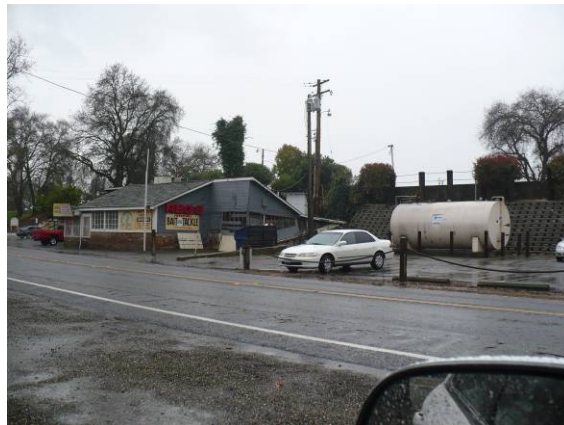
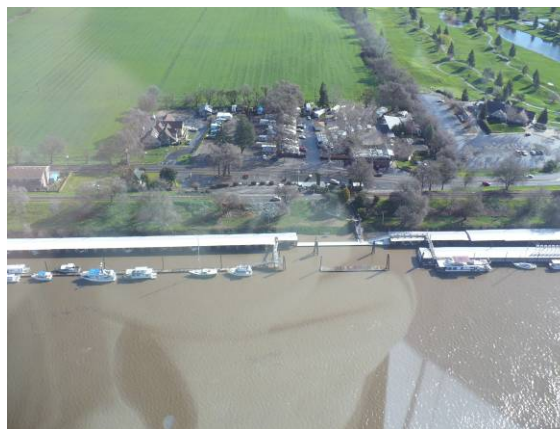
HDR SITE NUMBER: E-1

Current fueling achieved by AST, see photograph.

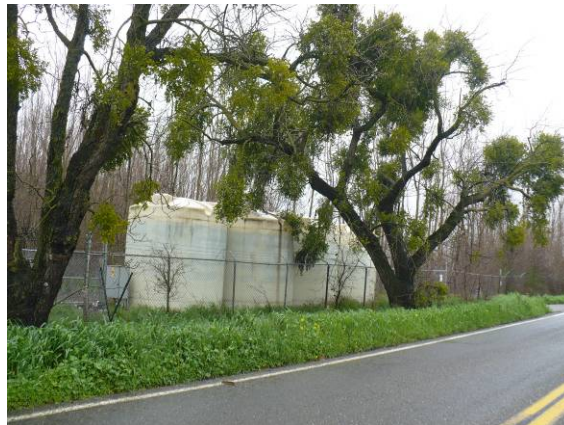
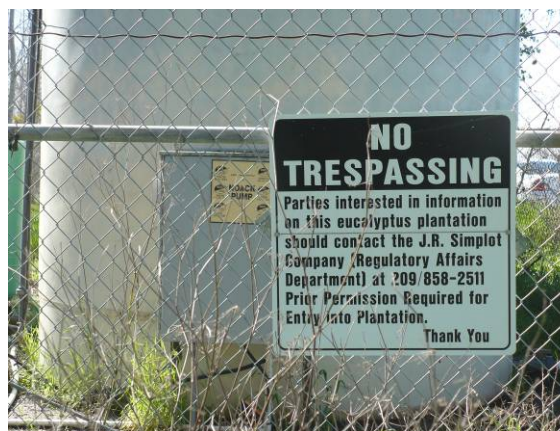
HDR SITE NUMBER: E-3

Remediation systems onsite, including phytoremediation and monitoring.

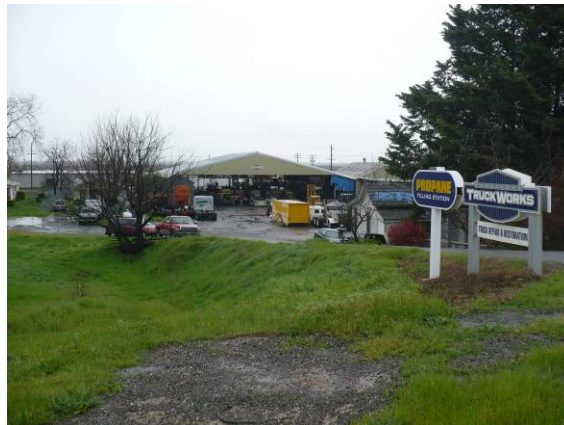
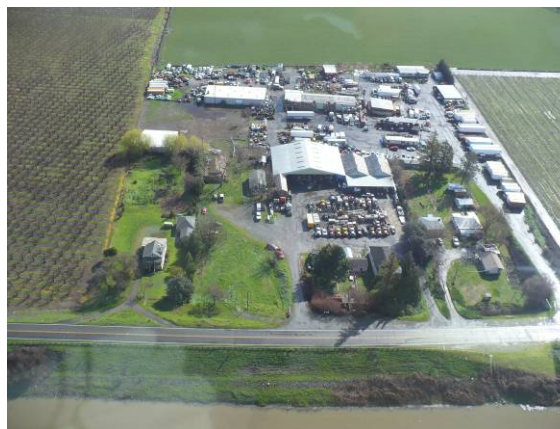
HDR SITE NUMBER: E-6

Widespread surface staining present onsite.
Historical aerial photographs indicate presence of facility since at least the 1960s.

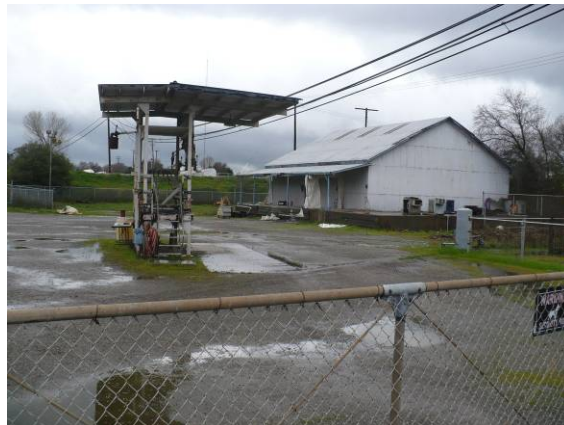
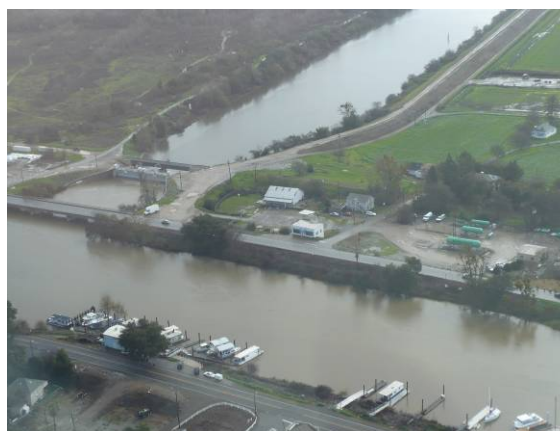
HDR SITE NUMBER: E-9

Multiple monitoring wells onsite

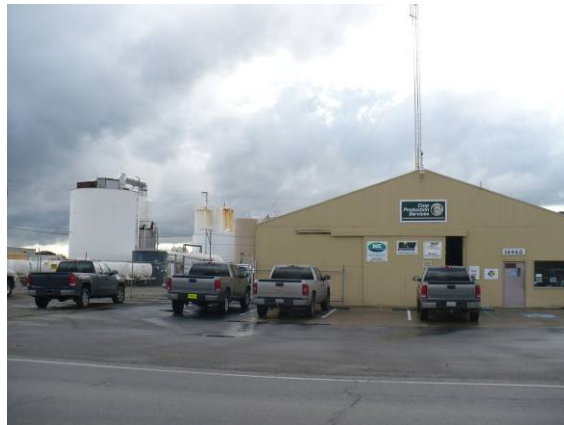
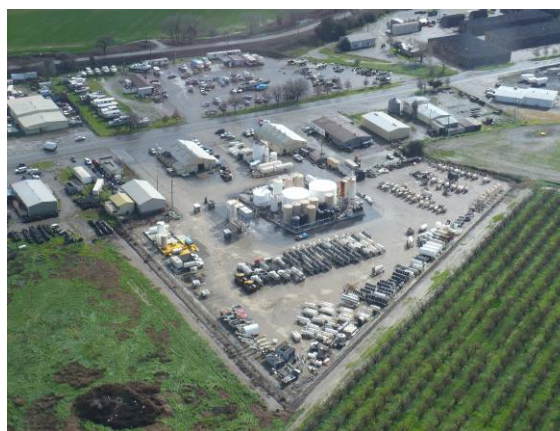
Historical aerial photographs show site presence since at least the 1950s.

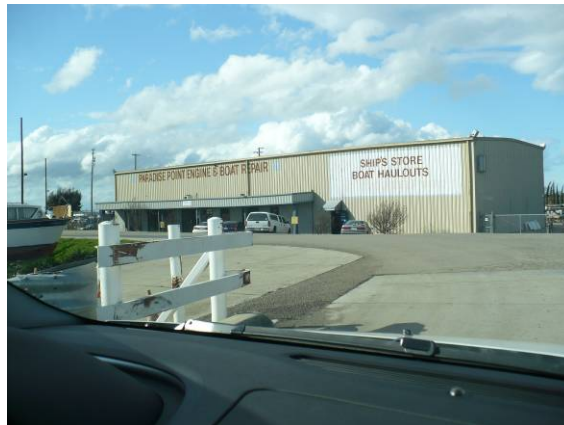
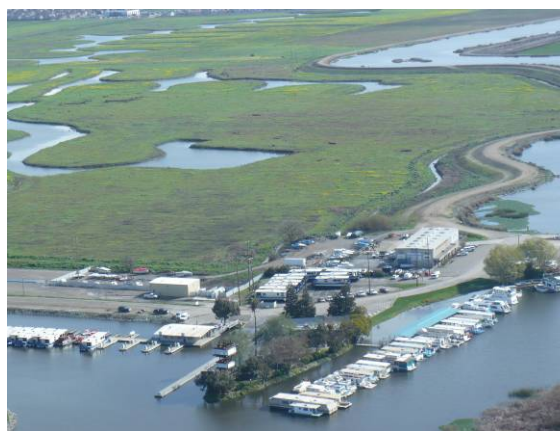
Listing related to sandblasting operations and
heavy metals release.

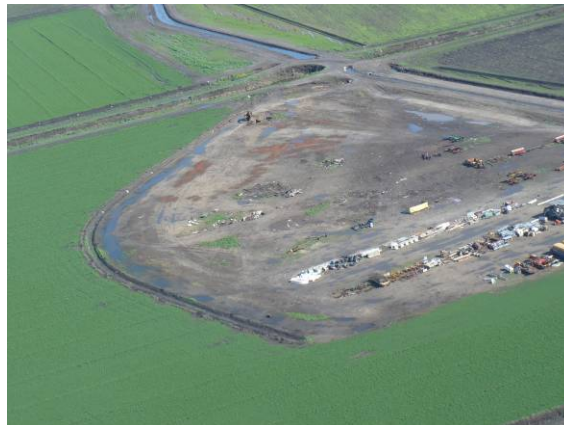
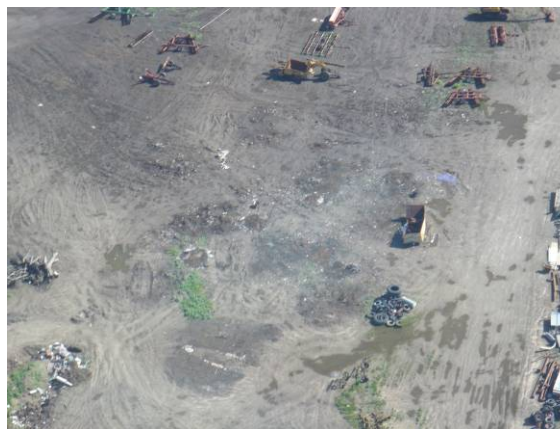
HDR SITE NUMBER: E-20

Large disturbed area with agricultural storage, general refuse and surface staining. Stressed vegetation present

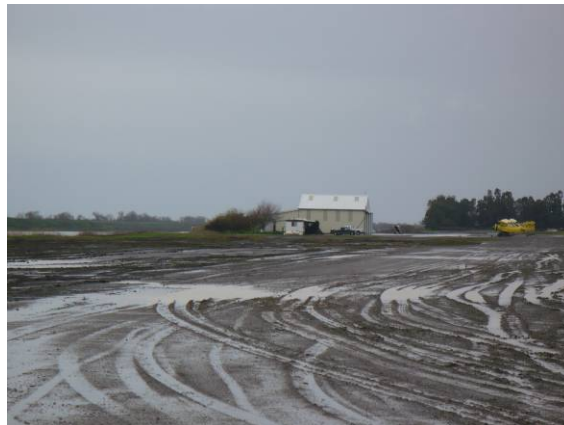
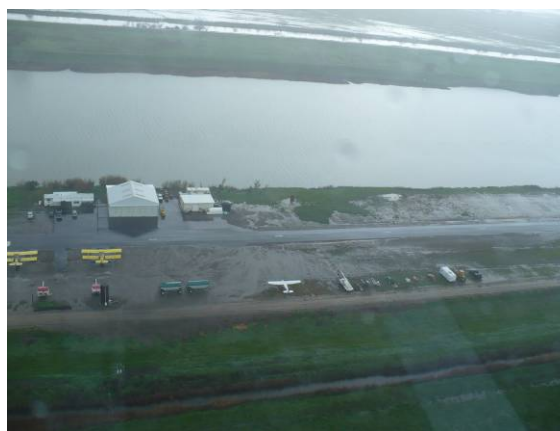
ASTs present on the north side of the shed, some drums present (contents or condition unknown). Drums located on apparently unpaved surface.

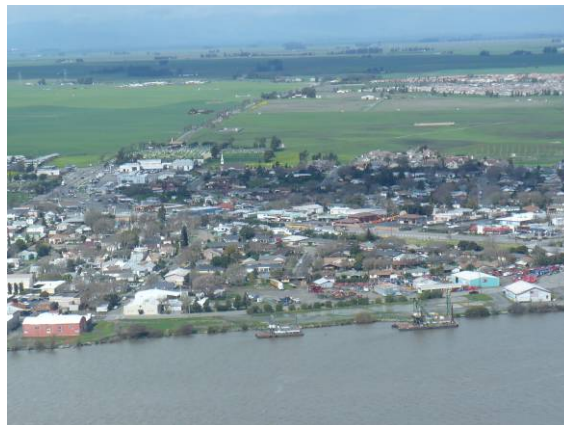
VIEW TOWARD THE: WEST (White building at river's edge, lower right corner.)

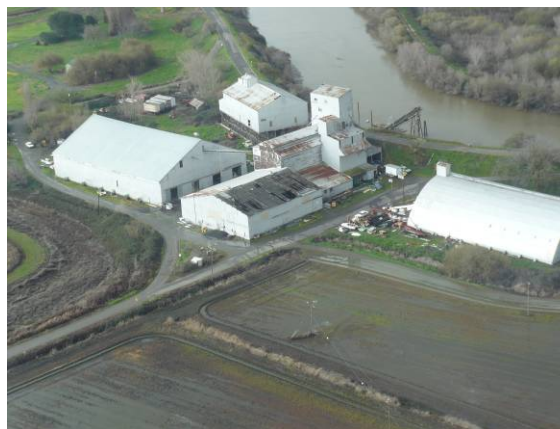
Large agricultural mill with outbuildings, considerable debris. Historic aerial photographs show that the facility has been present since 1972. Most of the debris has accumulated since the 1999 aerial photograph.
