SUPERIOR COURT OF CALIFORNIA
COUNTY OF HUMBOLDT

Case No. CV2001113

**FIRST AMENDED COMPLAINT FOR
INJUNCTIVE RELIEF AND CIVIL
PENALTIES**

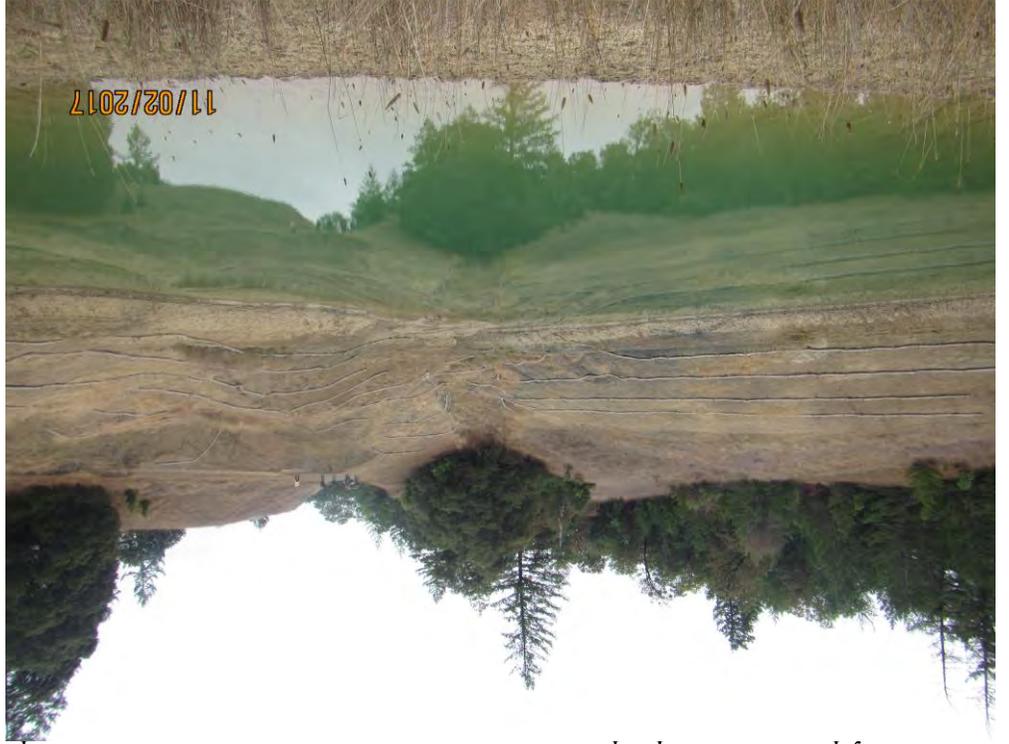
Figure 4. Substantial alteration of the bed, bank, and channel to an unnamed tributary to Bear Creek and the South Fork Eel River by placement of rip rap where the Class III channel meets the on-stream pond.

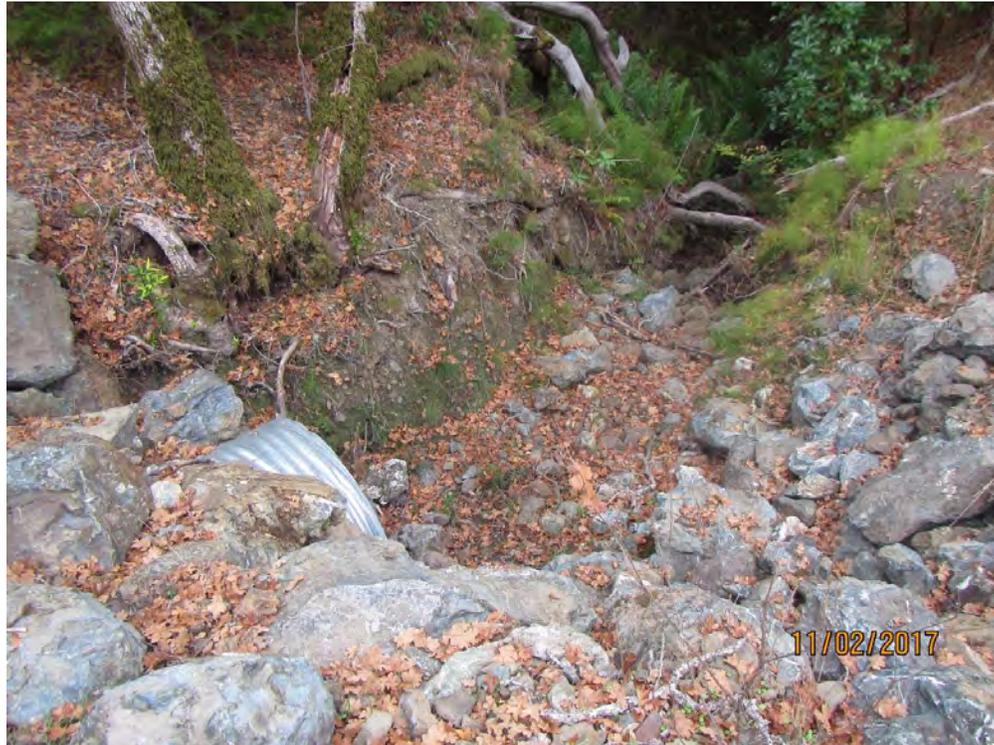
Figure 7. Substantial obstruction of the natural flow and alteration of the bed, bank, and channel of an unnamed tributary to Bear Creek and the South Fork Eel River by the placement of a culvert and fill within the channel.

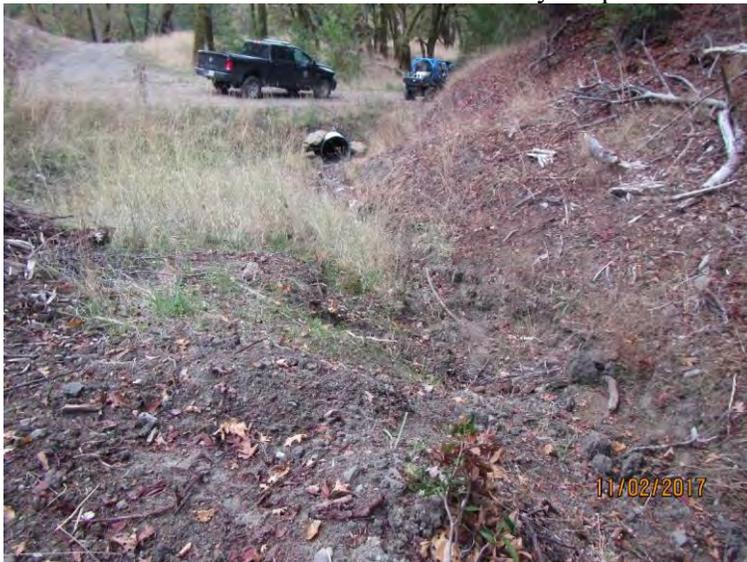
Figure 10. Substantial alteration of the bed, bank, and channel of an unnamed tributary to Bear Creek and the South Fork Eel River by removal of vegetation and burning causing sediment delivery.

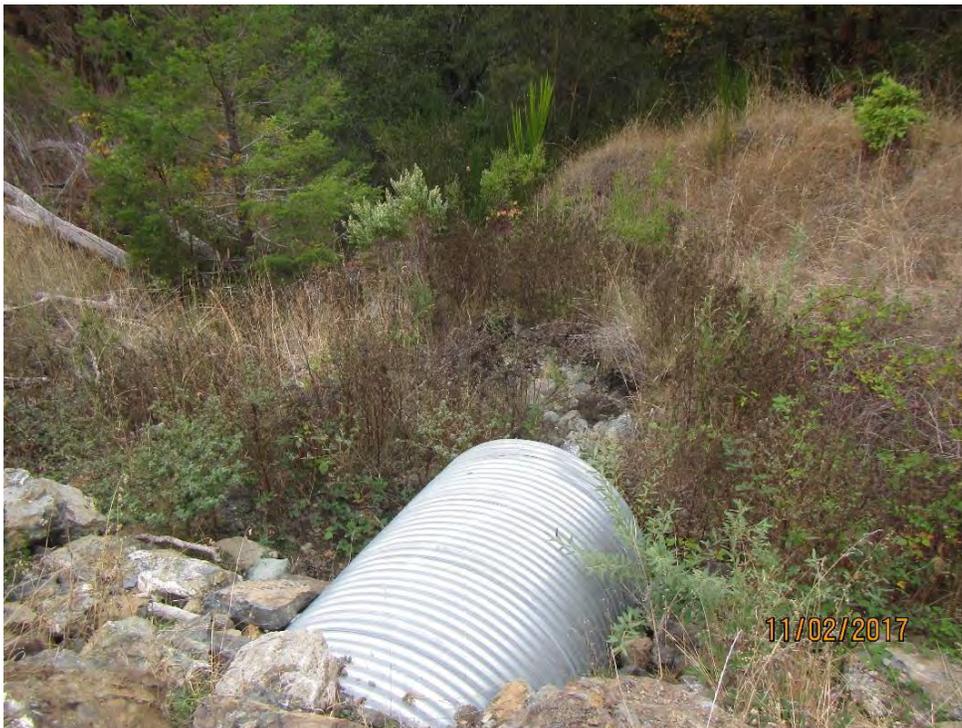
Figure 14. Substantial obstruction of the natural flow and alteration of the bed, bank, and channel of an unnamed tributary to Bear Creek and the South Fork Eel River by the placement of a culvert and fill within the channel.

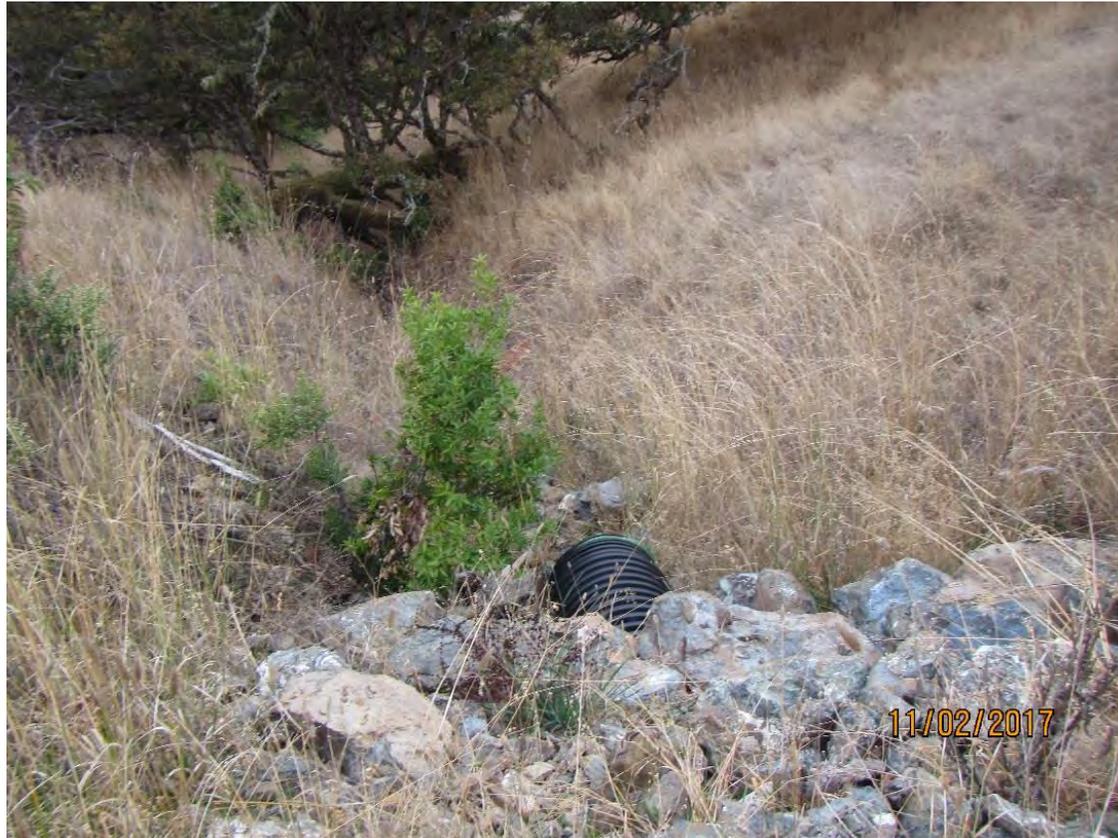
Figure 15. Substantial obstruction of the natural flow and alteration of the bed, bank, and channel of an unnamed tributary to Bear Creek and the South Fork Eel River by the placement of a culvert and fill within the channel.

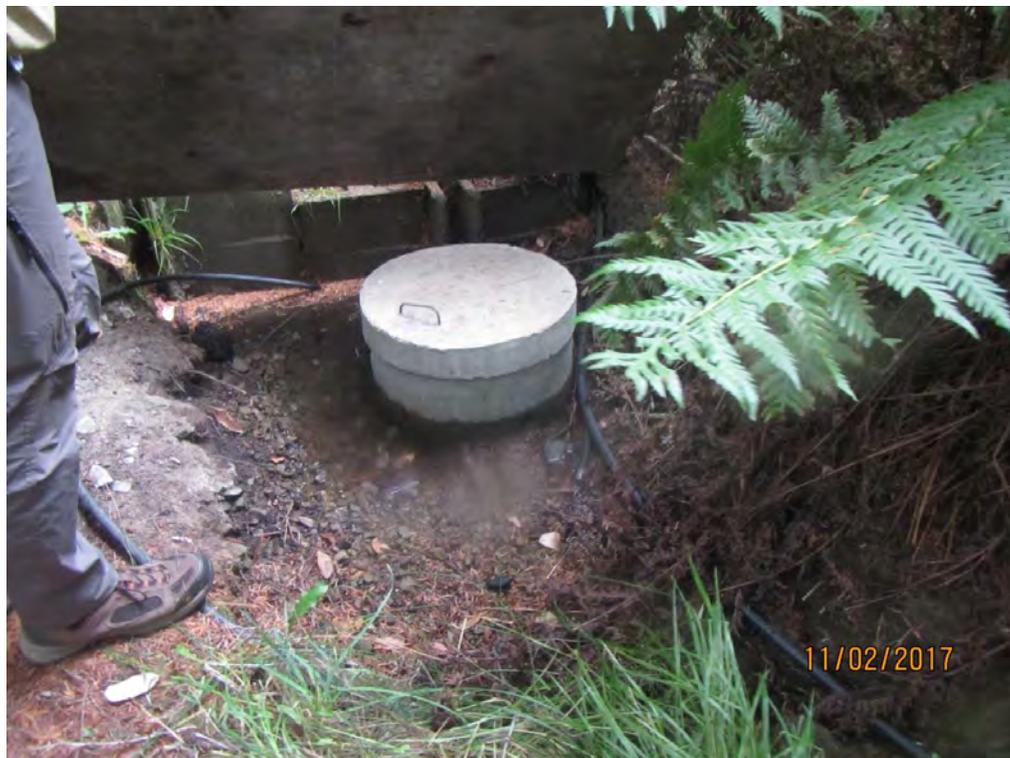
Figure 17. Substantial obstruction of the natural flow and alteration of the bed, bank, and channel of an unnamed tributary to Bear Creek and the South Fork Eel River for water diversion by impounding the channel with concrete and diverting water from a cistern located in the center of the channel.

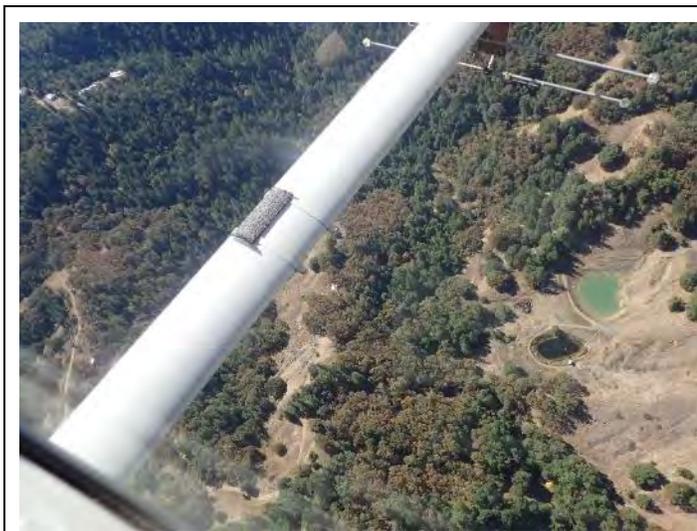
Photo 1: Image taken on October 25, 2017, by Warden Kyle Shaw provided by California Department of Fish and Wildlife (CDFW) showing large upper pond with landslide and smaller lower pond.

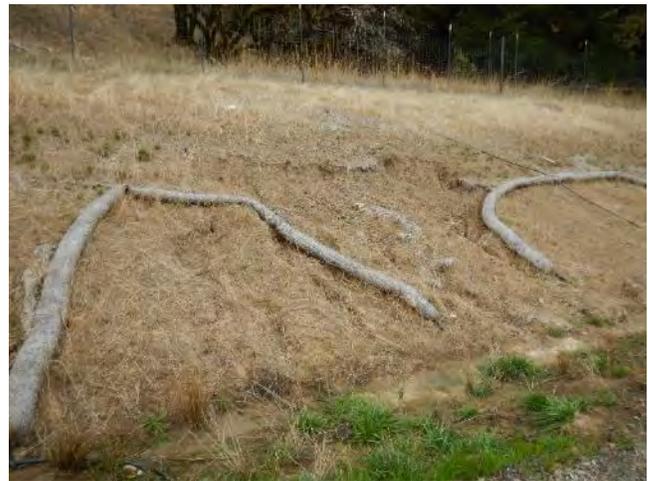
Photo 22: Image of drainage trench at outdoor cultivation area CA1. Image also shows fiber rolls disturbed by soil slumps caused by vegetation removal and erosion of the graded hillside. The fiber rolls were not functioning.

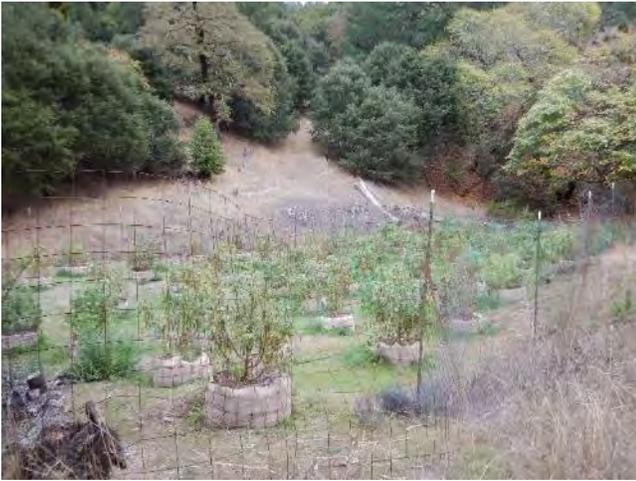
Photo 23: Image of outdoor cultivation area CA2 (approximately 7,800 square feet) located 28 feet from Class III watercourse at stream crossing C1.

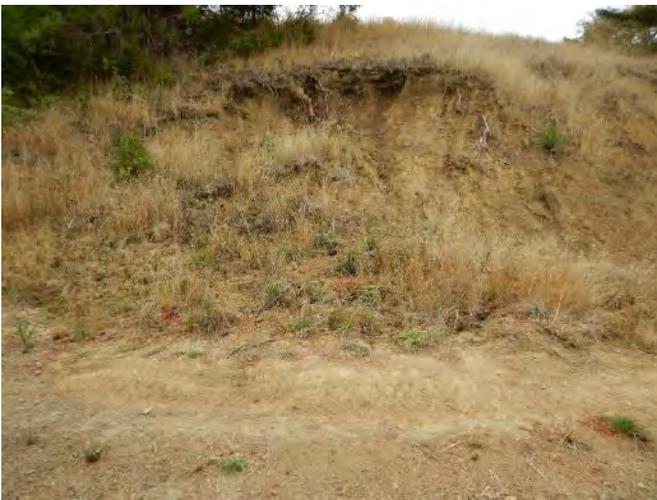
Photo 37: Image of landslide slope failure (SLIDE2) upgradient of the road, located between stream crossing C2 and POND1 caused by road development, grading and surface runoff.

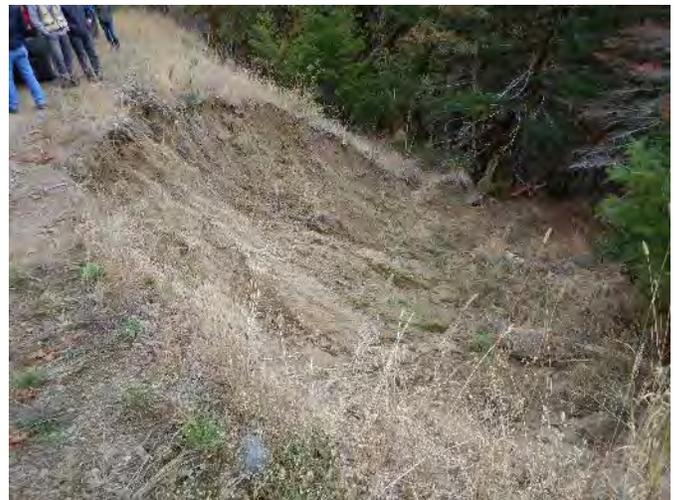
Photo 38: Image of landslide (SLIDE2) downgradient of the road located between stream crossing C2 and POND1 caused by road development, grading and surface runoff.

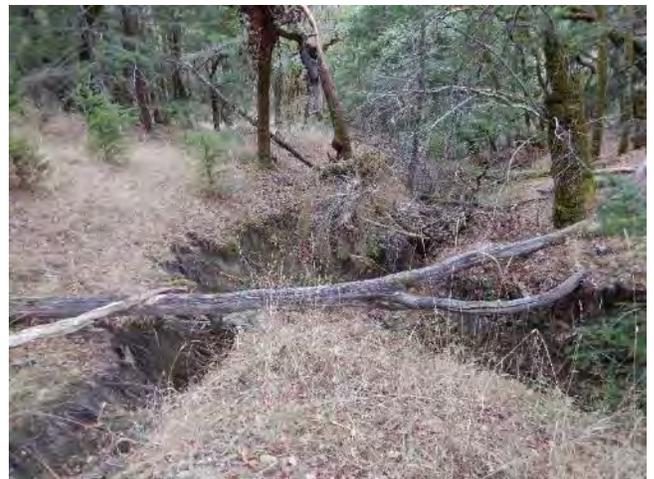
Photo 42: Image downslope of SLIDE2 showing stream channel degradation influenced by the SLIDE2 discharge to the Class III stream channel and hydrologic connectivity of the road network.

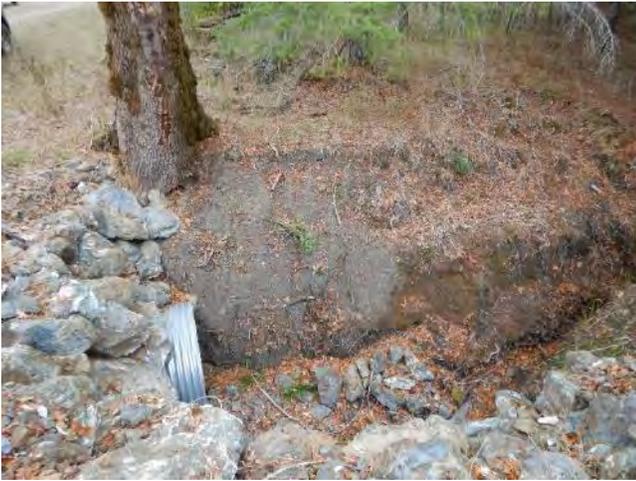
Photo 43: Image of upstream side of stream crossing C3 showing erosion of streambanks and armoring of streambed.

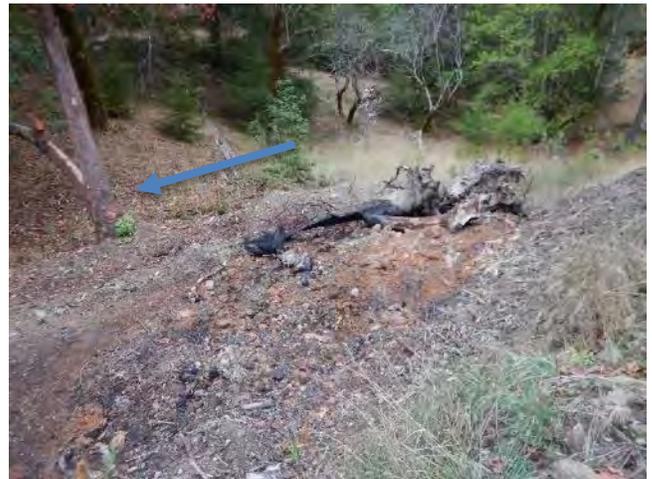
Photo 54: Image showing burn pile (BURN) located adjacent to stream channel upstream of stream crossing C5 (blue arrow is placed above stream channel and shows flow direction).

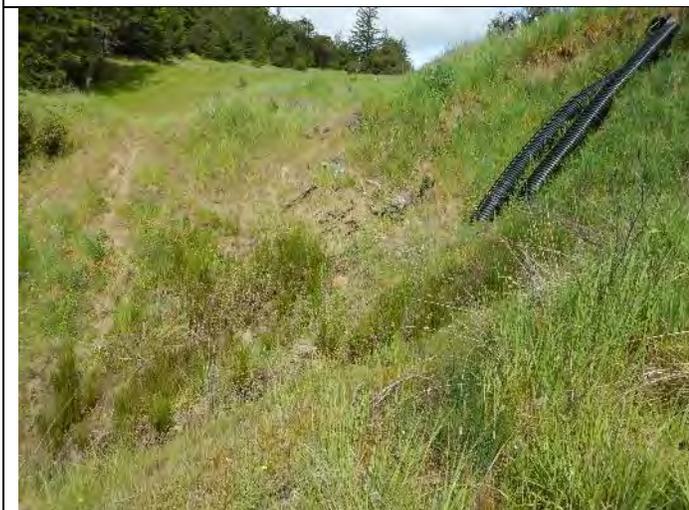
Photo 12: Image of surface cracking within top of POND2 berm

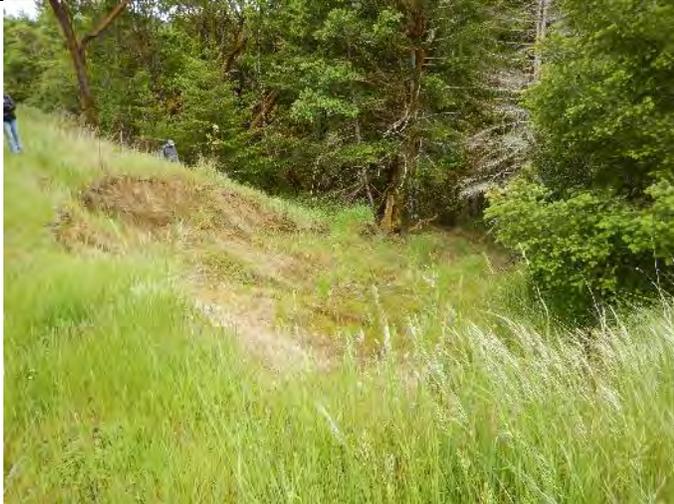
Photo 15: Image of lateral surface cracking below POND2. Orange line is below the lateral crack.

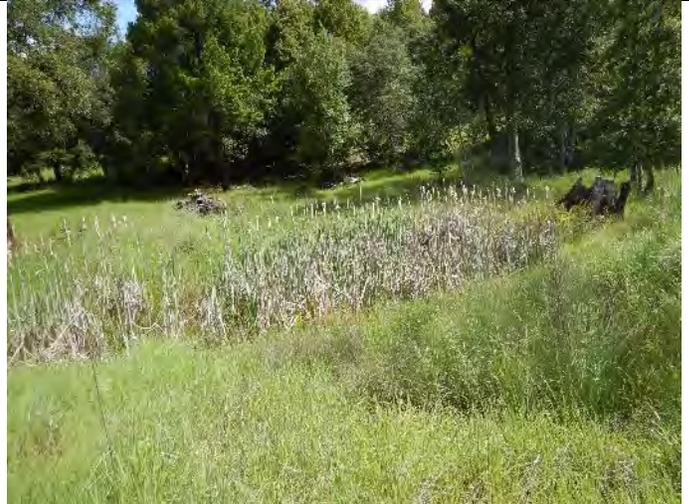
Photo 16: Image of lateral surface cracking below POND2. Orange line is below the lateral crack.
