Re: Marble Mountain Ranch Proposed Time Schedule and March 17, 2017, Notice of Violation No. 2

Stanshaw Creek Diversion Ditch Sediment Source Assessment

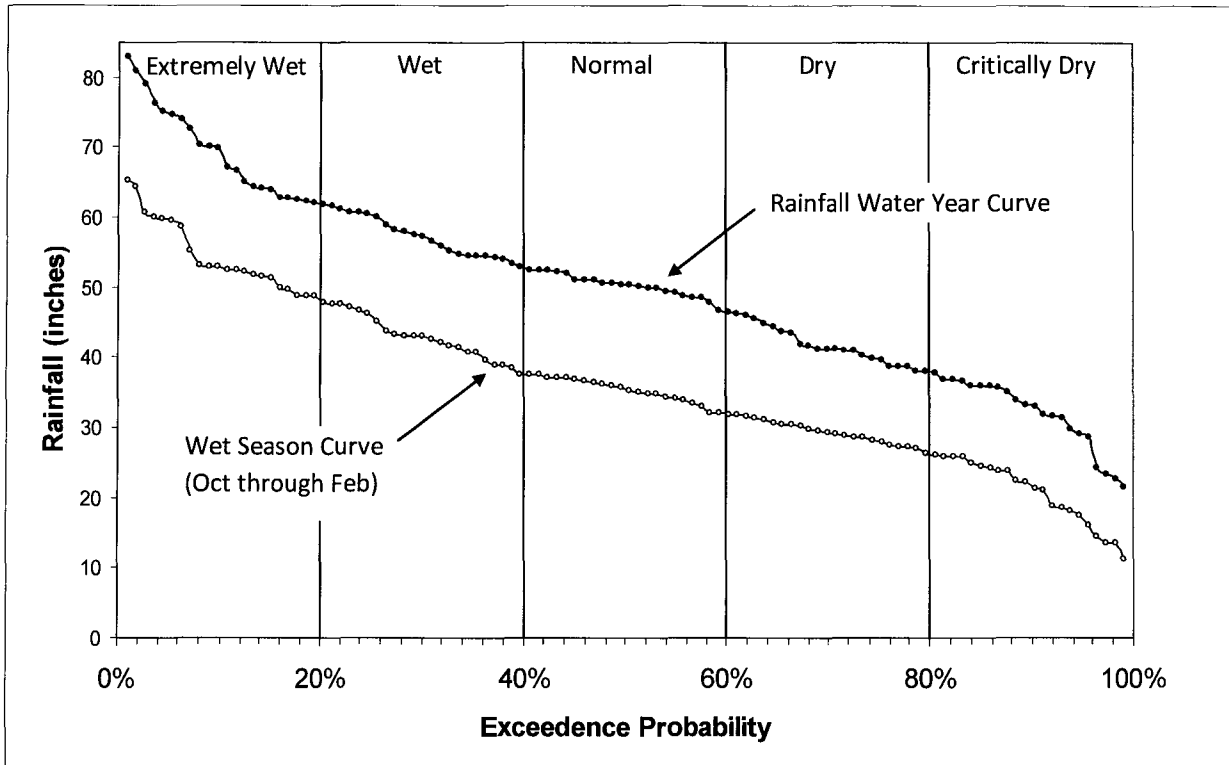
Figure 1. Rainfall exceedence probability and water year type for Orleans, California (NOAA Gage ID: 046508).

Rainfall records for the gage at Orleans California indicate the 2017 water year wet season rank as the 9th wettest for the 112-year period of record (Table 2). Rainfall statistics for this gage also show the WY2017 wet season had a rainfall total of 53.26 inches, a 12.6-year recurrence interval (RI), and characterized as an “Extremely Wet” water year type (Table 2 and Figure 1). In comparison, the Orleans rainfall data show the WY2016 and WY2006 wet seasons rank as the 30th and 6th wettest for the past 112 years of record (Table 2).

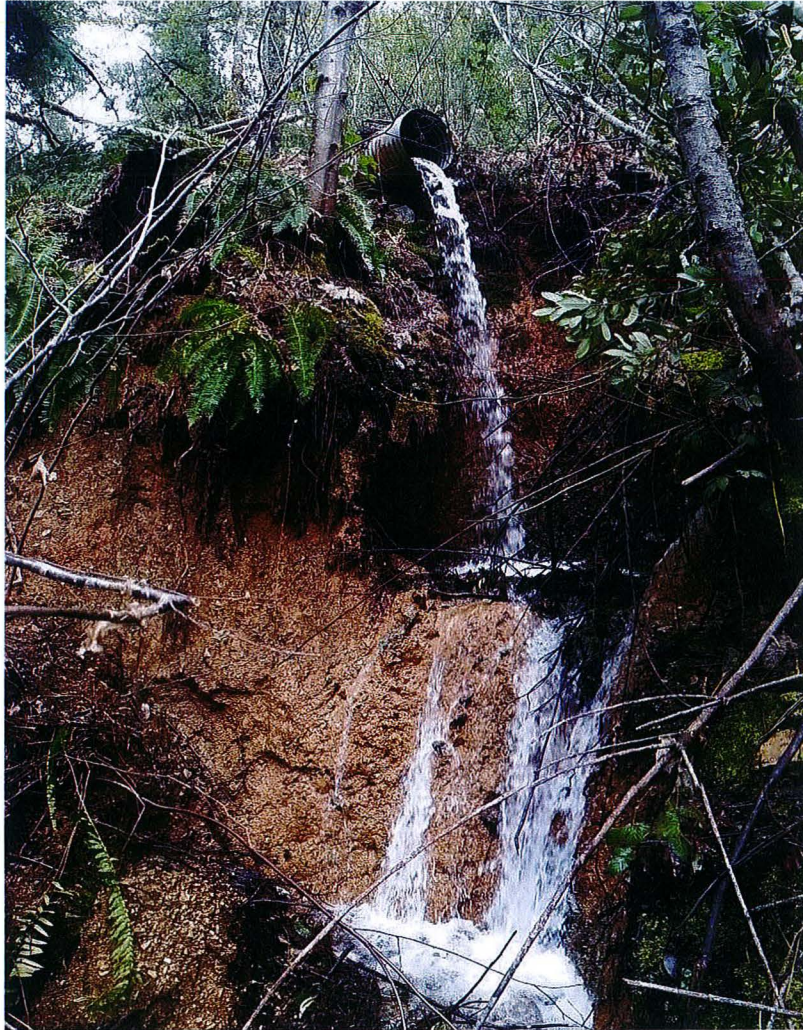
Figure 3. Upstream view of the shotgun culvert located at an unnamed tributary to Stanshaw Creek, Station 474.

Sediment production and delivery volumes were estimated for the shotgun culvert located at Station 474. During WY2017 study period, erosion related to the outfall from the shotgun culvert was estimated to produce and deliver 1 yds³ and 0.7 yds³ of sediment, respectively. The long-term sediment production and delivery volumes were estimated to be 6.3 yds³ (Table 3). According to Douglas Cole, the culvert was installed in 1996. By assuming the plunge pool volume represents erosion over a 21-year period an erosion rate of ~0.3 yds³/yr and incision rate of ~ 4"/yr was estimated. Field inspection of the feature indicates the plunge pool has become quasi-stable in the consolidated paleo-landslide deposits that underlie the site. The difference in the short- and long-term of sediment delivery rates, 0.7 yds³ versus

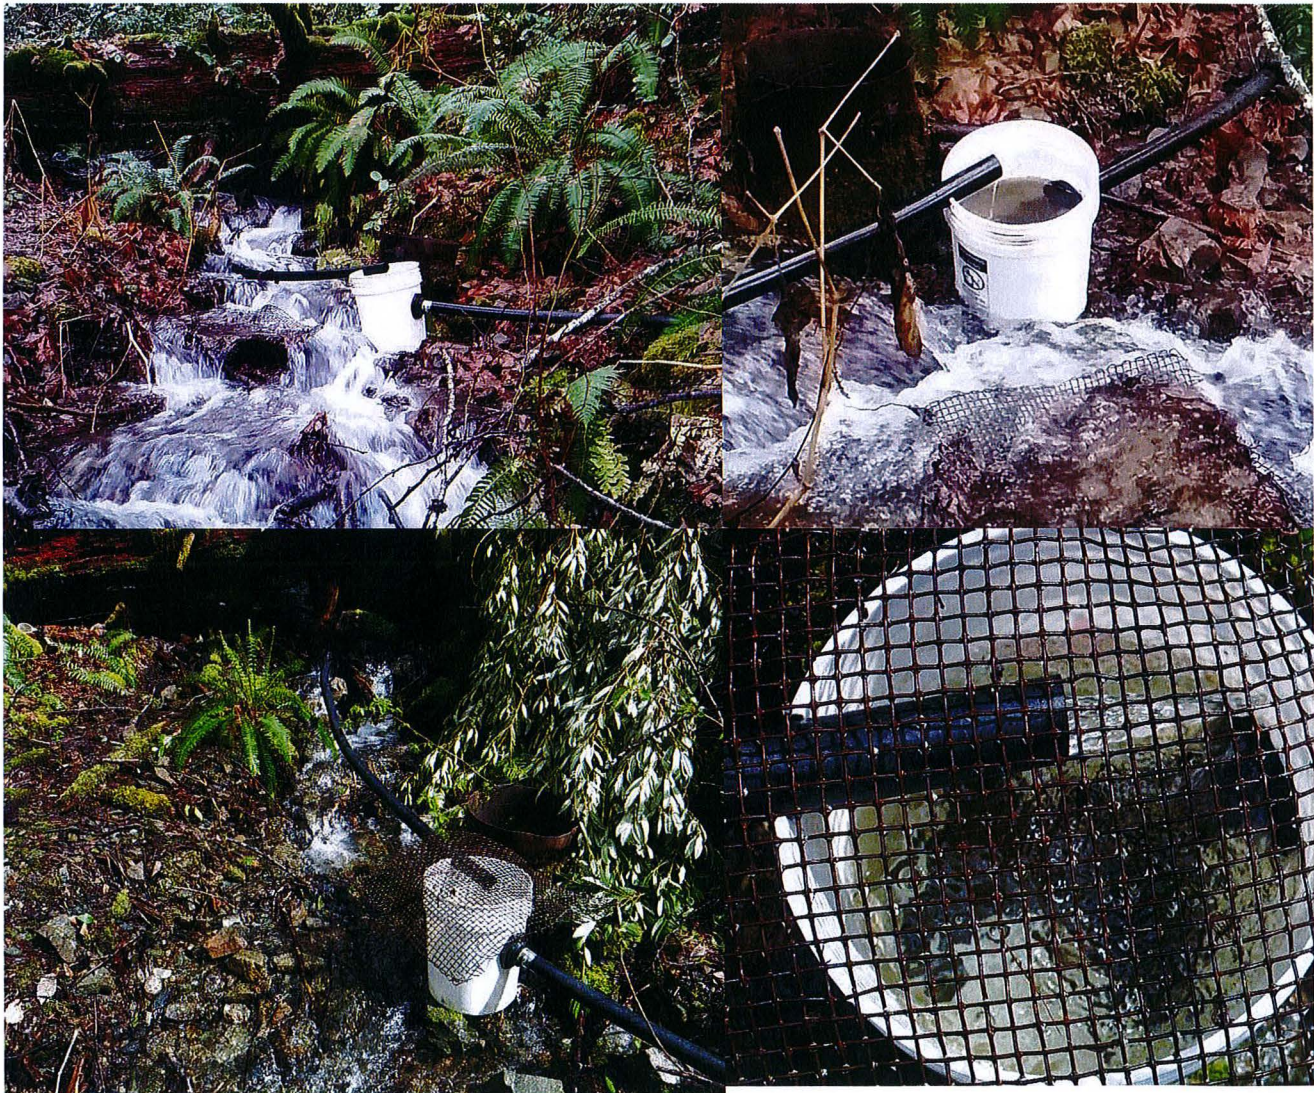
Figure 4. Photographs of downstream receiving waters of the Stanshaw Creek Ditch (Stations 1000 to 2880) and the domestic water supply intake system. Note the five-gallon bucket used as a sediment trap. Survey dates: Upper photographs - December 16, 2016, lower photographs - March 22, 2017.

Field assessments including storm water quality monitoring conducted on the topographic bench located downslope of Stations 1000 to 2850 found no clear evidence that ditch related sedimentation or turbidity has affected or has the potential to affect the waters of California, barring natural and catastrophic events. Instead, FGS observed clear water consistently draining from the topographic bench during storm water runoff periods, a high degree of surface roughness from vegetation and irregular topography capable of trapping and storing fine sediments proximal to sediment producing features, and soils with a significant fraction of coarse angular particles that appear to resist surface erosion. Additionally, a sediment trap (in the form of a five-gallon bucket) connected to a domestic water intake system contained negligible amounts of fine sediment and organic materials during two field surveys (Figure 2 and 4).

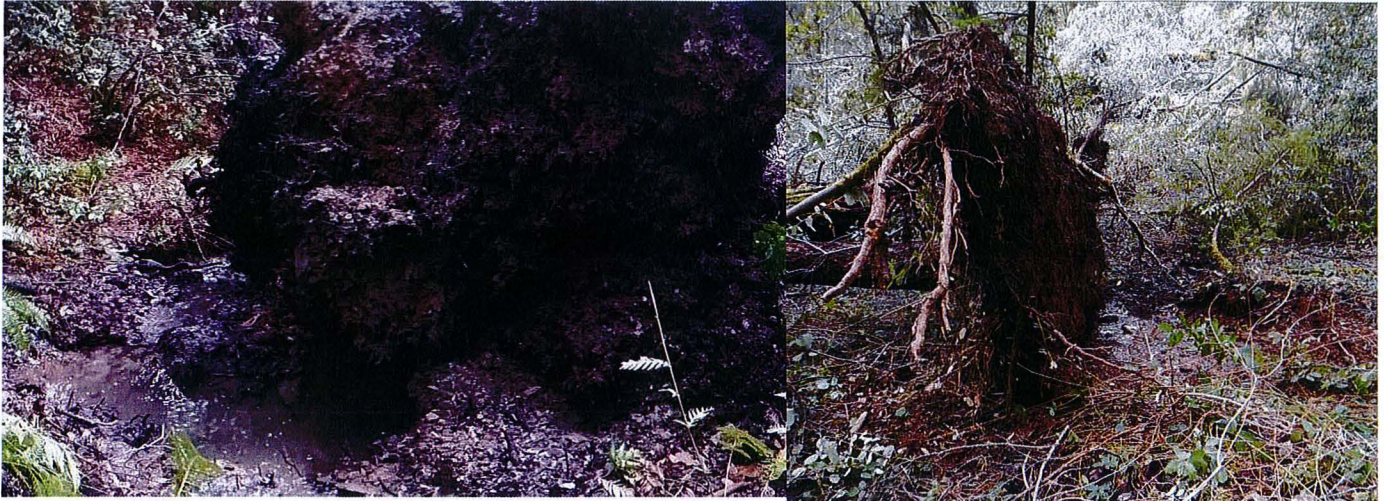
Figure 5. Photographic examples of uprooted trees and overland flow in the study area. These natural sediment sources are located on the topographic bench upstream of the domestic water supply that is shown in Figures 2 and 4. Survey dates: Left photograph (5a) - December 16, 2016, Right photograph (5b) - February 24, 2017.

Several toppled trees were identified and mapped during fieldwork conducted on December 16, 2017. Some of these toppled trees were located within 1200 feet of the domestic water intake and overland flow was observed to connect these sediment sources to the ephemeral channel and domestic water supply intake (Figures 4 and 5a). However, field observations conducted during overland flow conditions indicate sediment transport and/or turbidity originating from these sources would likely occur only during the most extreme, short duration, high intensity rainfall events.

During the field assessment on February 24, 2017, FGS observed the initial aftermath of a significant snow-down event that occurred in relation to a winter storm that delivered several feet of wet snow to the Mid-Klamath region on January 2nd and 3rd, 2017. This snow-down event resulted in toppling a significant number of trees across the study area, including trees in close proximity to the domestic water system intake. Overland flow was observed to connect to the ephemeral watercourse upstream of the domestic water system, yet no sediment transport nor turbid waters were noted (Figure 5b).

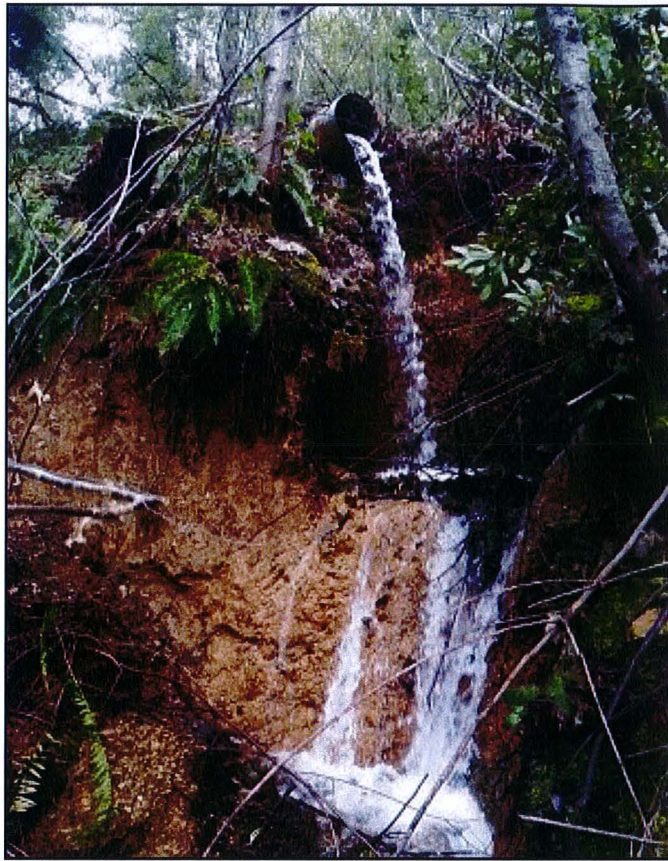
The Irving Creek headcut is located at Station 5755 near the terminus of the Stanshaw Creek ditch. This feature most likely formed as the result of draining Stanshaw Creek ditch flow over a natural slope and into Irving Creek. Feiler (2015) identified this feature as an area of concern.

Photo #1. Existing Irving Creek Outfall. Taken by Fiori Geosciences.

The Sediment Source Assessment recommends simple, low cost actions to address erosion at outfall. To implement this suggested approach, a new culvert designed to direct flows away from the edge of slope will be installed. In addition, several large rootwads from downed trees on the property will be installed at the base of the outfall to serve as flow velocity dissipation devices and reduce erosional activity. The culvert will be designed such that flows are directed onto the rootwads for maximum energy dissipation, in order to reduce scouring and sediment production.

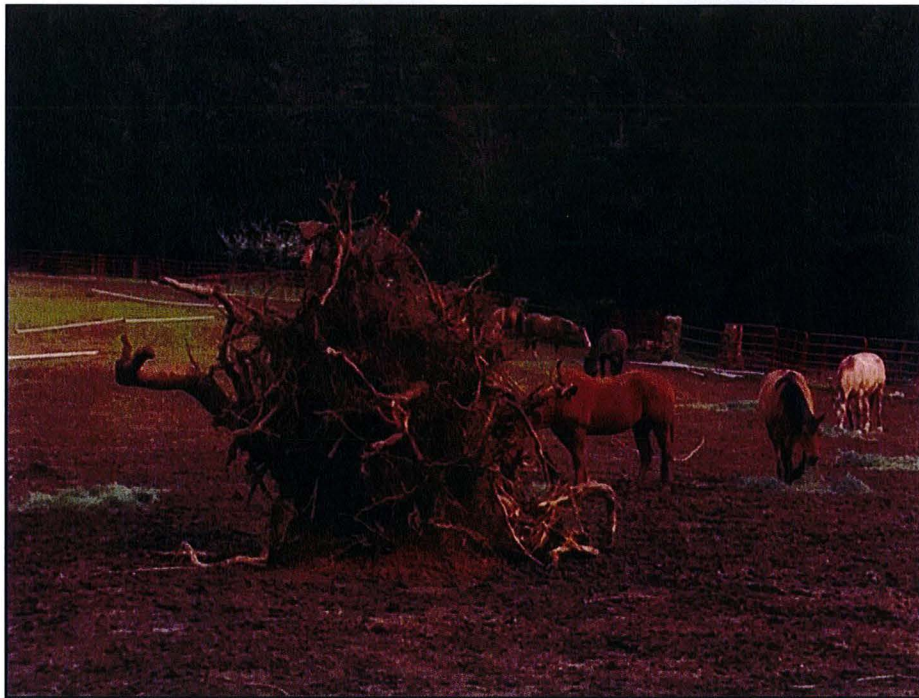
Photo #2. Example Rootwad. Photograph taken 28 March 2017.
