**North Coast Regional Water Quality Control Board**

**Subject:** **Notice of Violation No. 3 of Order No. R1-2016-0031** and Response to Your April 10, 2017, letter Regarding Proposed Time Schedule and March 17, 2017, Notice of Violation No. 2

**File:** Douglas and Heidi Cole, Marble Mountain Ranch, 92520 Highway 96, Somes Bar, Siskiyou County APN 026-290-200, Klamath River Watershed WDID No. 1A15024NSI

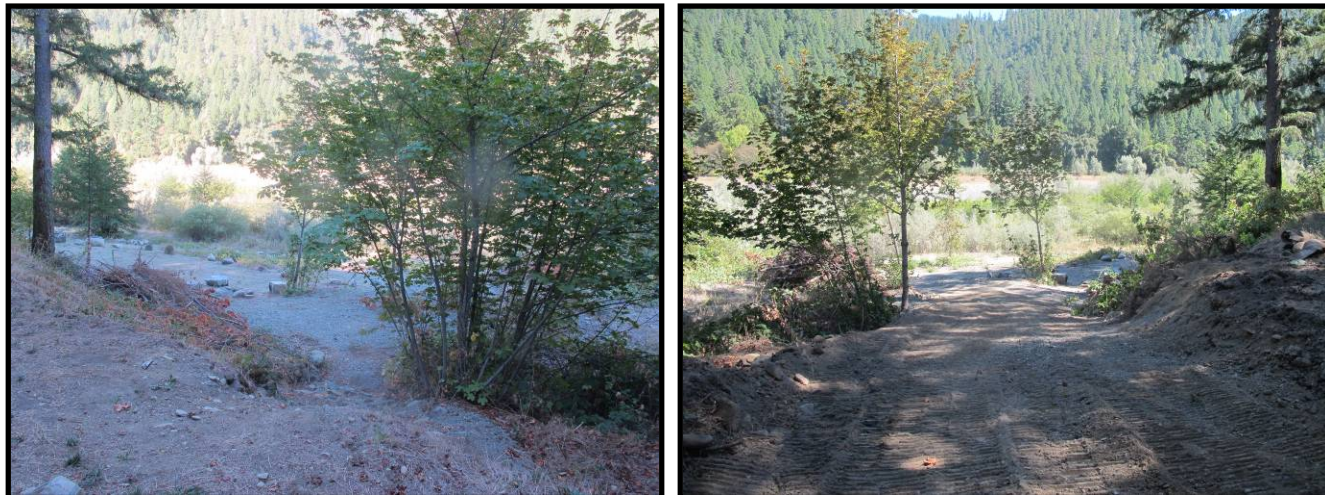
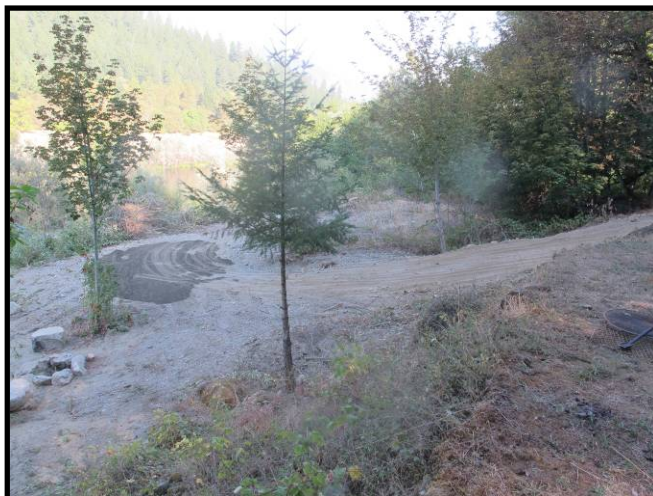
**A 200 foot access road was constructed between an existing roadway and the project site, across the Klamath River floodplain. This access road was seeded and mulched after project construction was completed. Images above left and right show the access road from the top, before and after construction. Below, the perspective show's a more complete view of the access road from the top and across the river floodplain.**

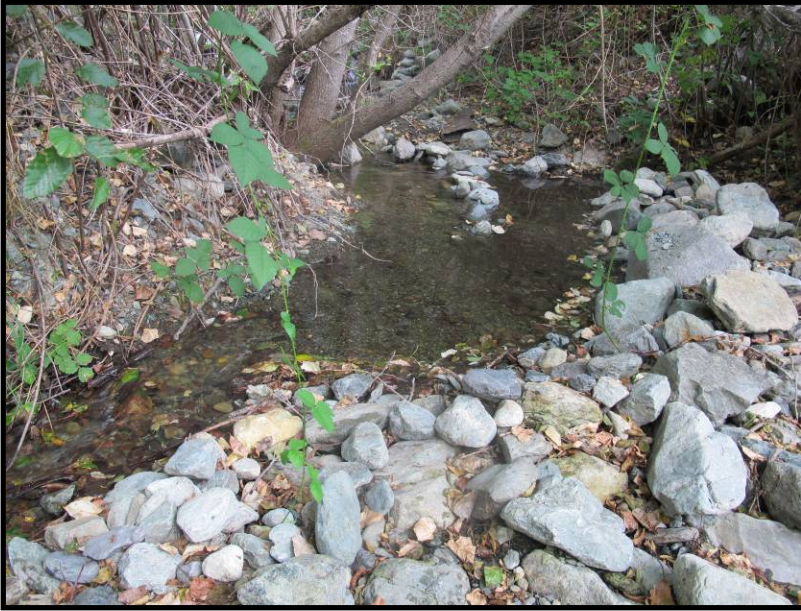
Prior to construction activities, it was necessary to divert a small amount of Stanshaw Creek's flow around the project area. The point of diversion was located at the top of Stanshaw Creek's active delta (above left and right), and 120' of 16" flexible tile was used to reroute approximately .24 cfs of water around the site and into the existing pool habitat, assuring a cold water connection to this habitat (below). The "head gate" was constructed using a plywood splash board, sand bags, and 1/8' screening both on the end of the tile and across the stream bed, approximately 6' above the diversion.

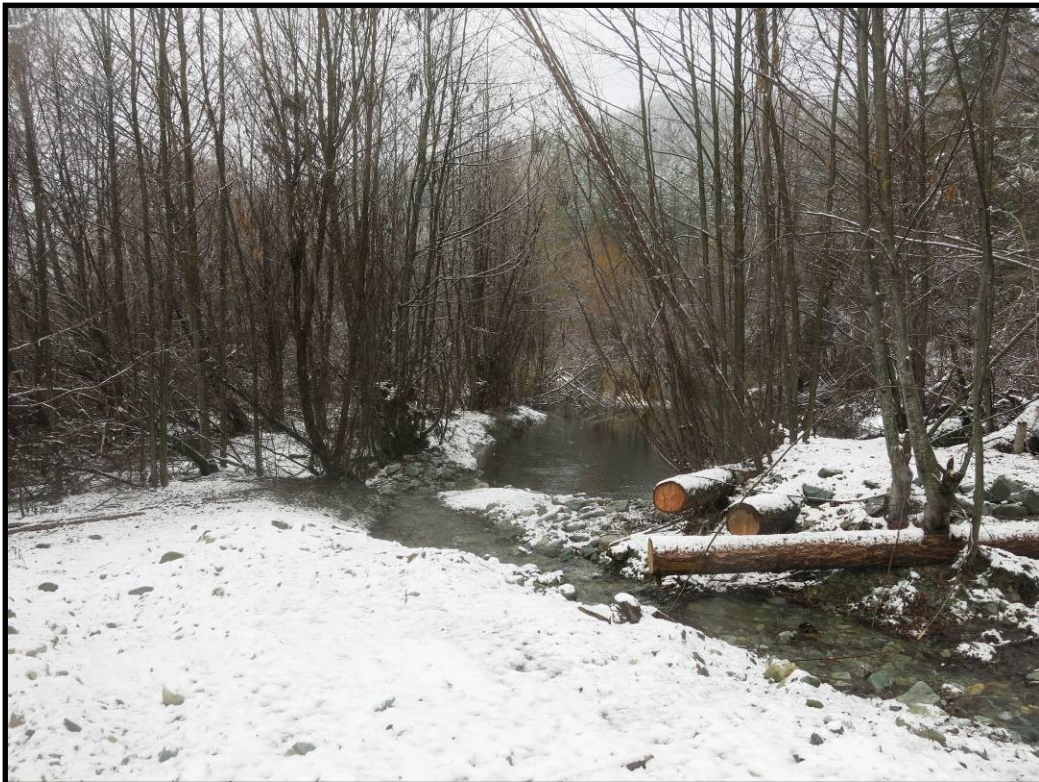
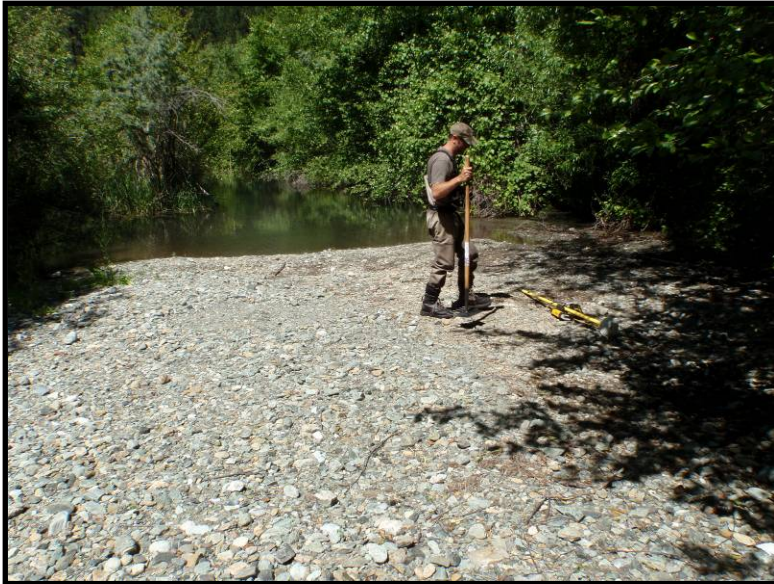
**Approximately 560 cubic yards of gravel, rock and sand was removed from the site, more than doubling the volume of off-channel habitat. Photos taken before and after (above and below) illustrate the quality and quantity of habitat restored through this project.**

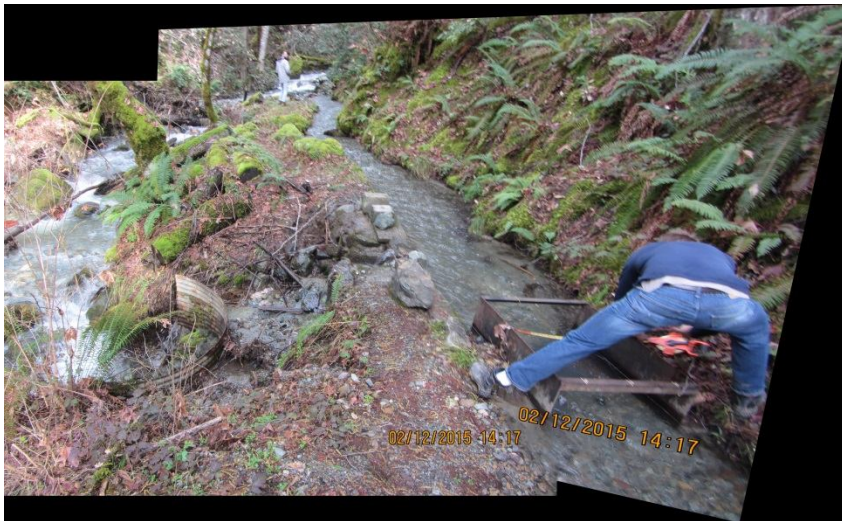
Image 4- shows Point 2, a failure along the outboard berm, approximately 70 feet downstream of Point 1, allowing some of the water in the ditch to flow down to Stanshaw Creek, potentially resulting in erosion and sediment transport. This location appears to have failed repeatedly in the past. The instream flume in the Ditch just downstream of this failure is used to measure flows entering the diversion. (Photo 8454 and 8455)

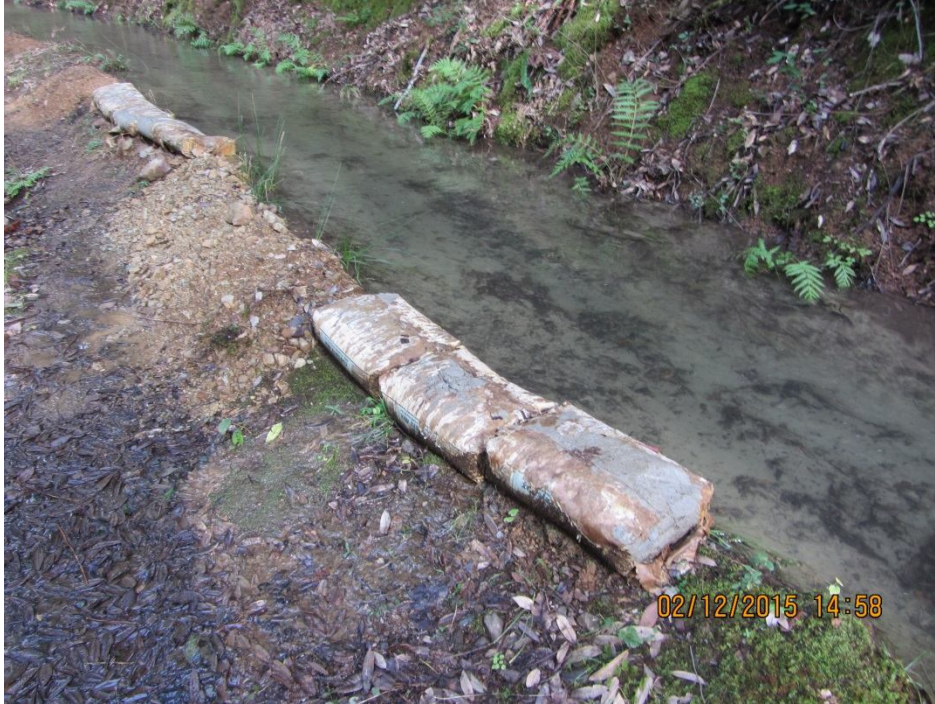
Image 19- Point 12, closer view of berm repair made with ready crete concrete sacks and soils. Note the saturated soils along the outboard berm where water is seeping. (Photo 8510)

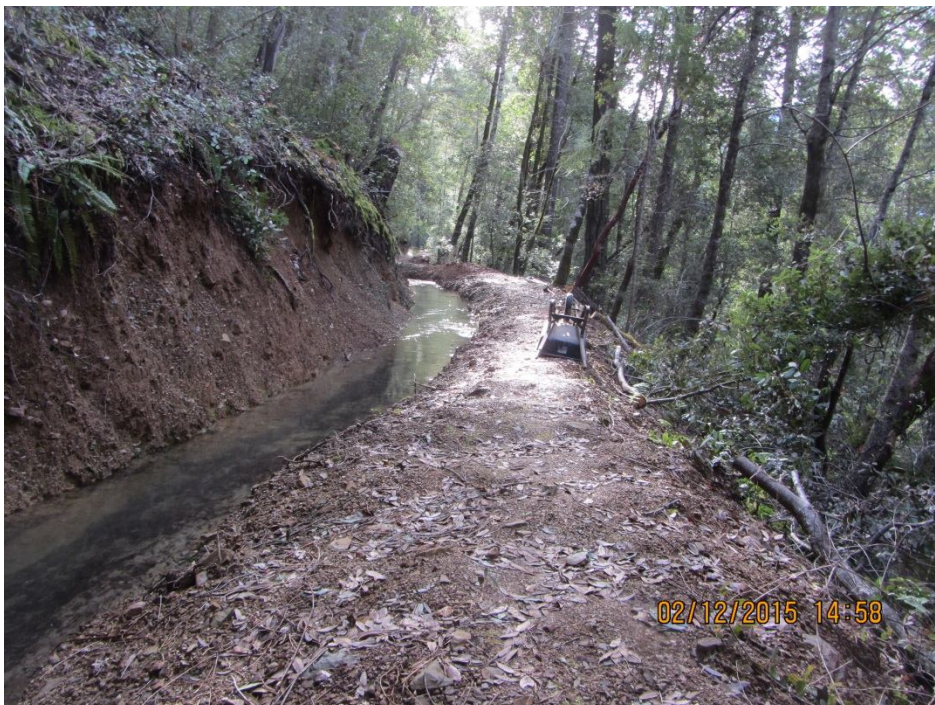
Image 20- Point 13 shows a large continuous cut bank slump that extends for approximately 220 feet. Based on my observations, it appears the cut bank slumped along this stretch over this past winter, delivering approximately 10 yds<sup>3</sup> of sediment into the ditch, blocking the channel, and causing water to overtop the berm

and erode the lower slopes. Cut banks are often chronic sources of erosion, delivering additional sediment to streams and ditches each year.

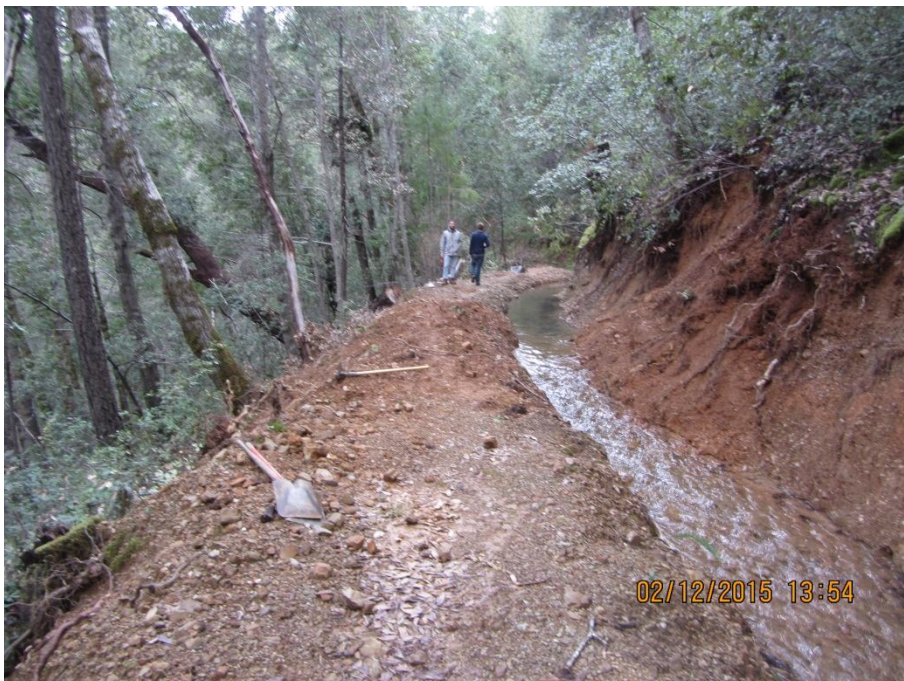
Image 24- Point 17 shows a segment of channel with an active cut bank slump and evidence of recent repairs to the outboard berm.

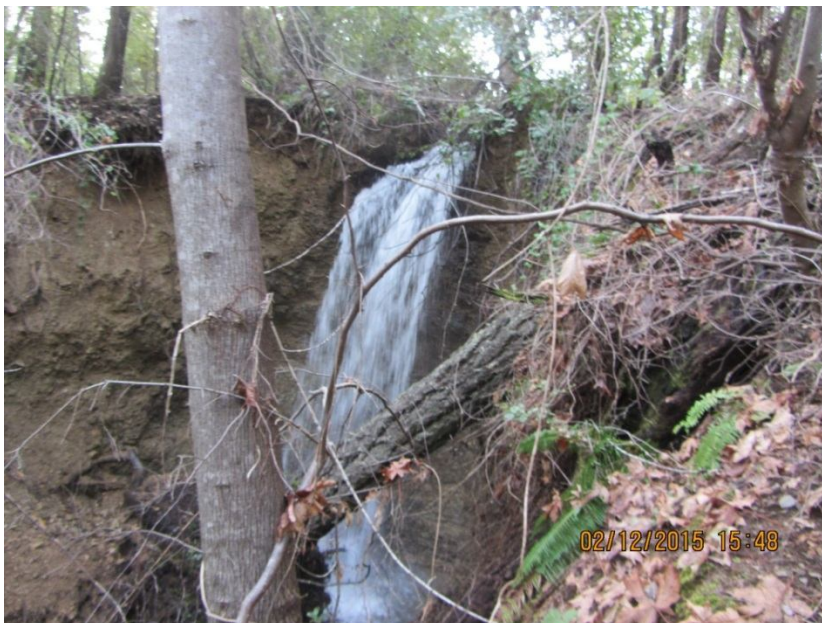
Image 26- Point 20 is the headcut upslope from Irving Creek. This is where tailwater from the Stanshaw Diversion is discharged to an unnamed stream, tributary to Irving Creek. This area is actively eroding. Several trees appear to have fallen recently through erosion of their root masses. I estimate that the headcut erosion has delivered between 1500-2200 yds<sup>3</sup> of sediment to the Irving Creek watershed. (Photo 8529)
