# ENVIRONMENTAL FIELD REPORT

Prepared by Robert E. Miller  
SWRCB, Division of Water Rights (DWR)  
Environmental Assessment Section (EAS)

**Application No.:** 29449

**PROJECT DESCRIPTION:** Applicant seeks a right to directly divert 3 cubic feet per second (cfs) from Stanshaw Creek, tributary to Klamath River, thence Pacific Ocean, in Siskiyou County. Water is conveyed through 5,200 feet of earthen ditch and 455 feet of 16-inch diameter steel pipe (penstock). The penstock uses 200 feet of fall to turn a Pelton wheel turbine. The hydroelectric generator produces a maximum of 33.9 kilowatts of electricity at 80% turbine efficiency. After use (see note), the water is conveyed via ditch into Irving Creek, thence Klamath River. (Note: Some water is taken from the ditch before and after the hydroplant for use by the Cole's for domestic use and pasture irrigation, respectively. Irrigation and domestic use is not applied for by this application and may be covered by pre-1914 rights and a Small Domestic Use Permit. Neil Tocher takes water from the ditch before it enters Irving Creek for domestic use, pasture irrigation, power generation, and to maintain a recreational reservoir. Mr. Toc

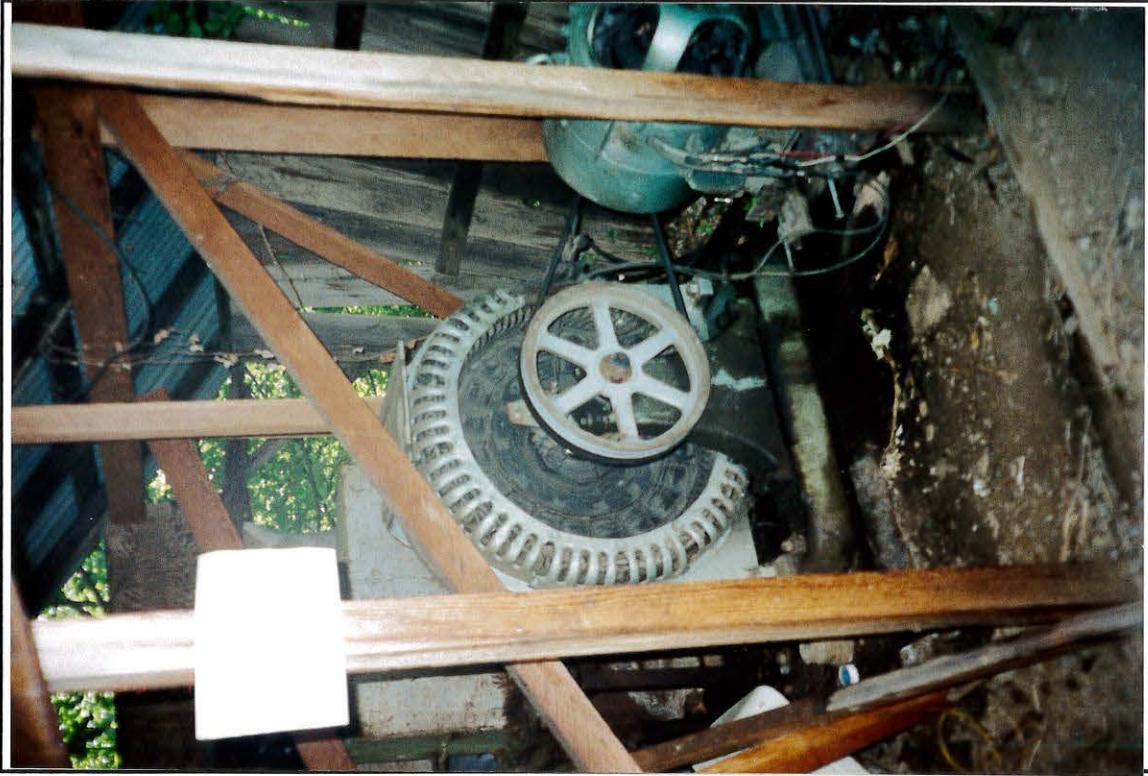
**Land use.** The Place of Use (POU) is a hydroelectric generator (pelton wheel) producing 33.9 kilowatts of electricity (**photos 1, 3, 4**). This power is used on the premises of Marble Mountain Ranch, supplying power to 11 cabins, 2 rental homes, a lodge, the Cole residence, and recreational vehicle hookups. A diesel powered Caterpillar Electric Generator (75 kW) supplies backup and supplemental power, but its high operational cost (\$2,500-\$3,000/month) make it inhibitive to operate on a full-time capacity (**photo 2**).

**Photo 1.** WWII era pelton wheel and hydroelectric generator.

#### **3. Improve the efficiency of the hydroplant.**

This is another method that would require less water to be diverted. We discussed increasing the drop of the penstock, installing a smoother penstock, and installing a newer, more efficient generator.

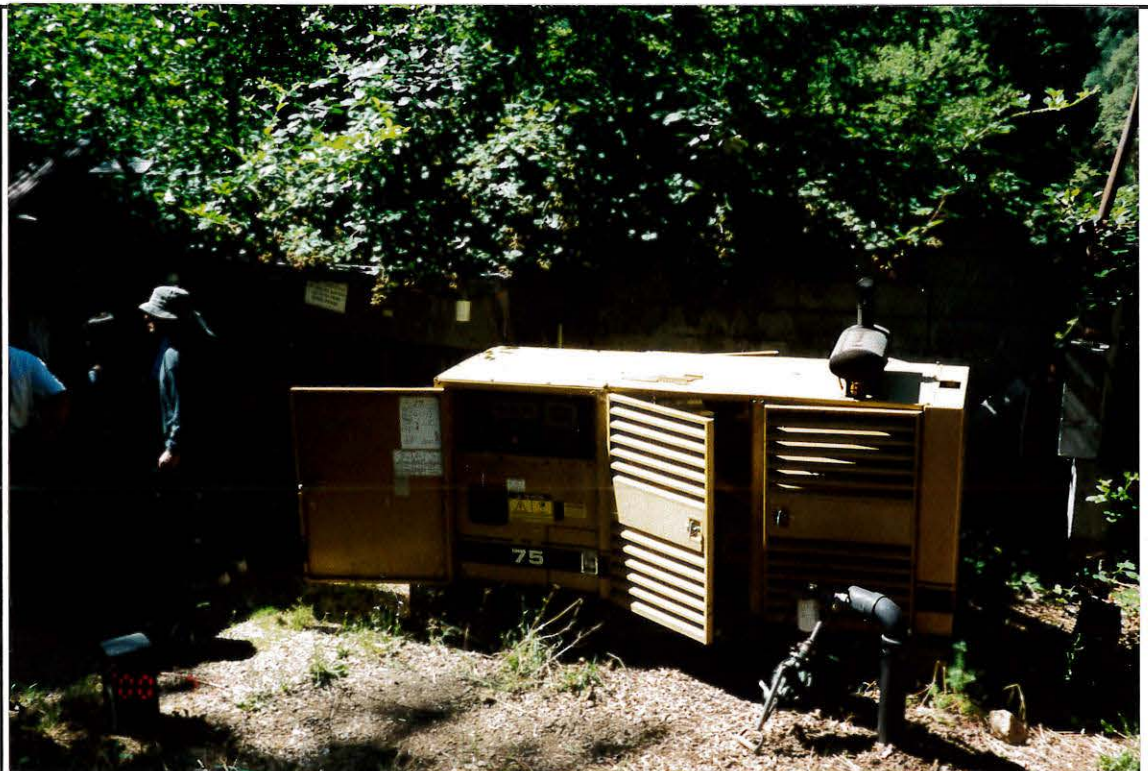
**Photo 2.** Diesel powered Caterpillar generator

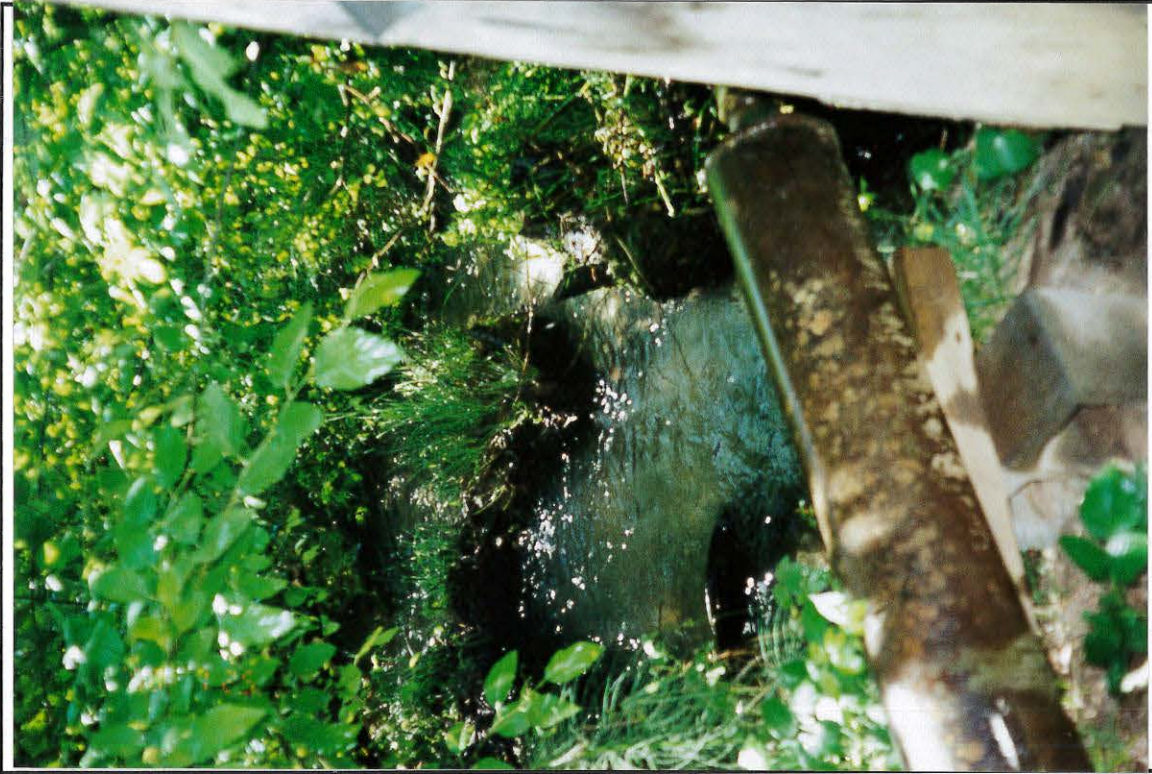
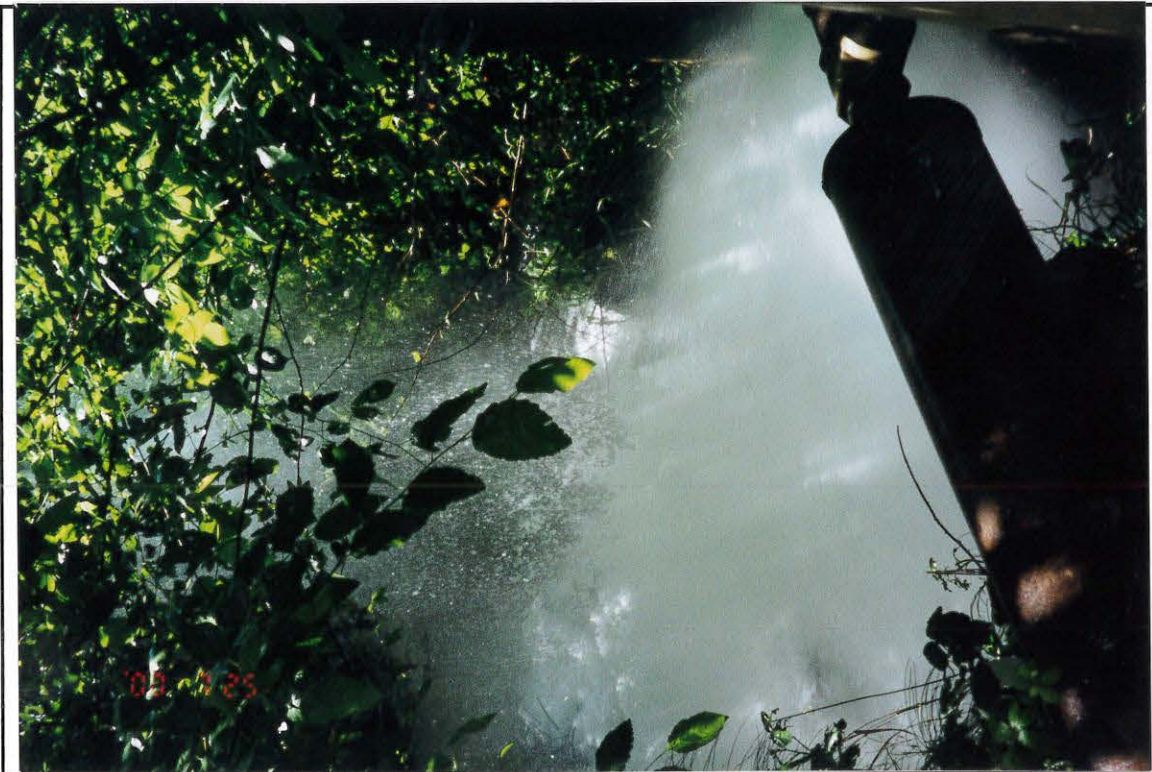
Photos 3 and 4 . Relief valve at hydrogeneration facility. When water is not running through the pelton wheel, water is released through this pipe (left).

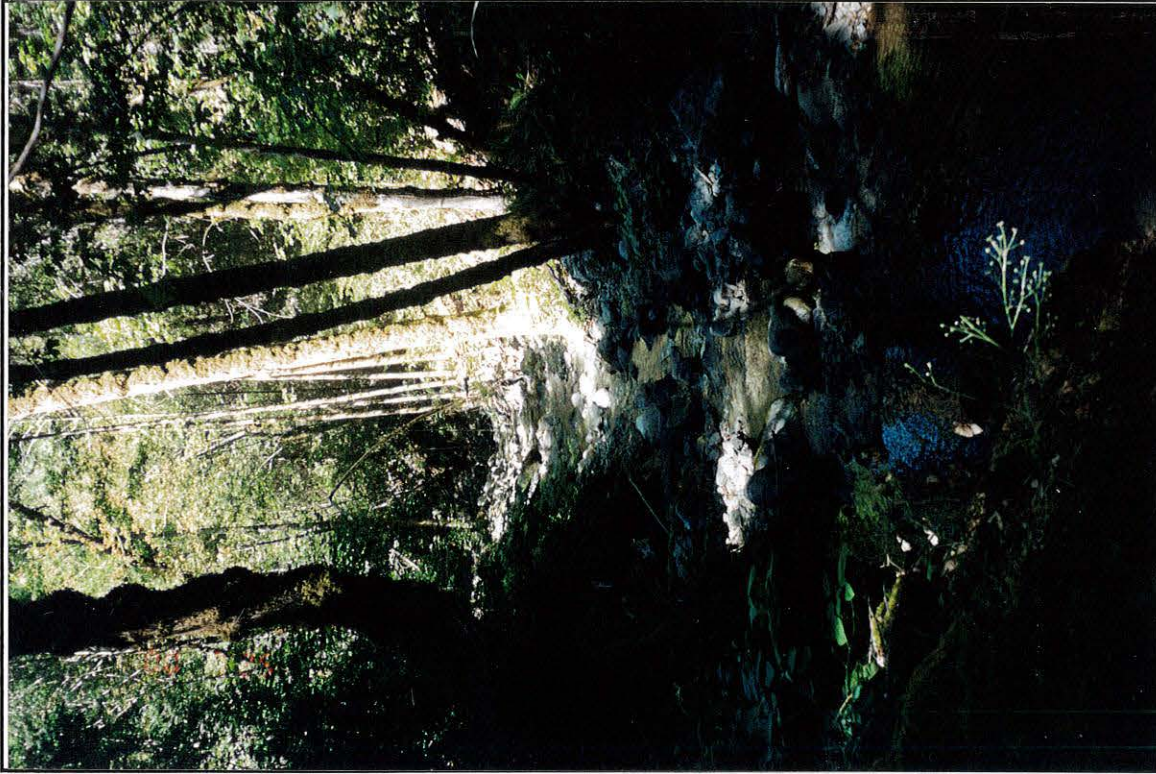
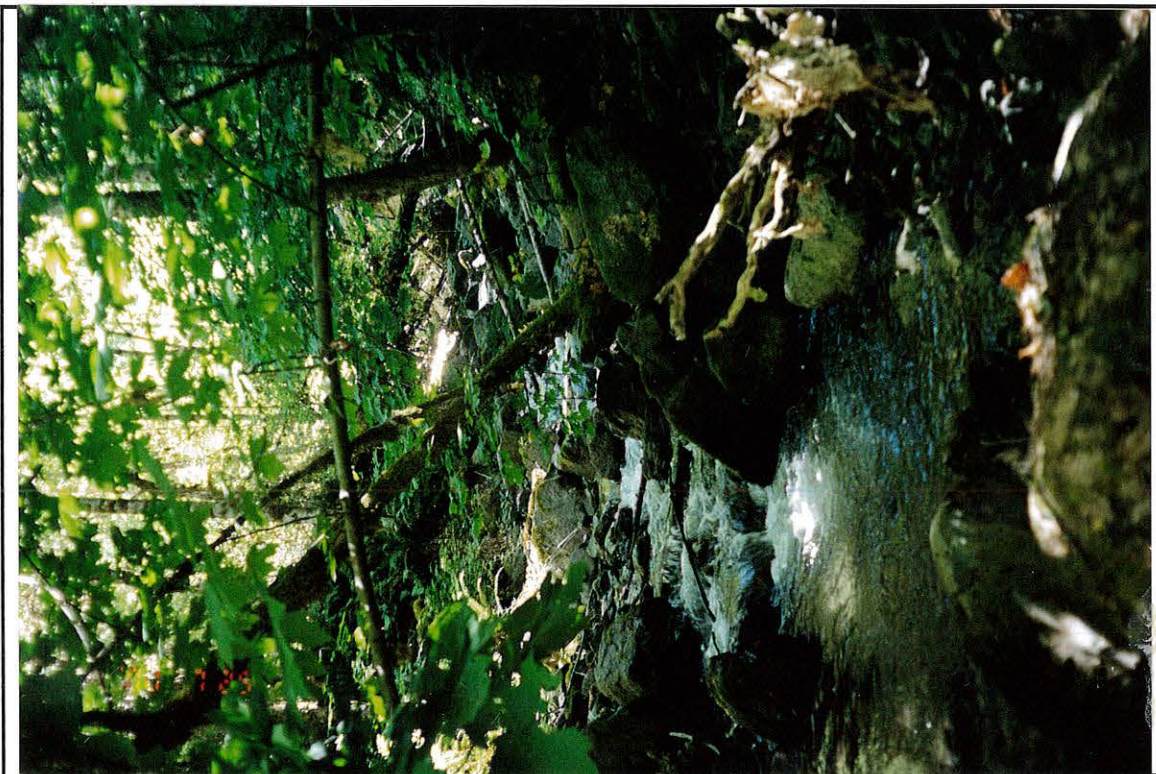
**Vegetation.** The ranch is surrounded by North Coast Coniferous Forest. The riparian area surrounding both Stanshaw and Irving Creeks is lush and in good condition, supplying approximately 90% stream shading and large woody debris (LWD) to the channel (**photo 5, 6**). LWD is ideal for creating pools and offering cover for rearing salmonids.

Photos 5 and 6. Stanshaw Creek just above (left) and below the POD.

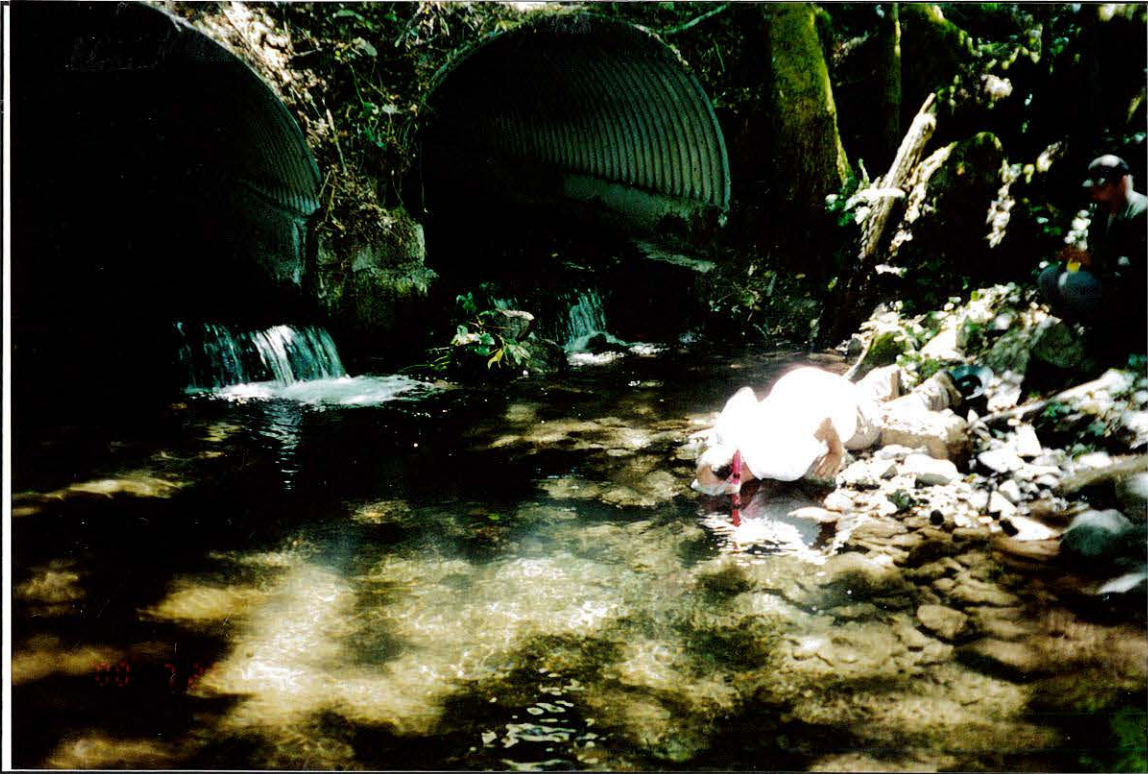
As mentioned earlier, there is a fish passage issue in Stanshaw Creek at the Hwy 96 crossing. The culverts are long (>50 yards) and on a steep slope (~5%) with a smooth concrete substrate that offers no resting areas for salmonids migrating upstream (see photos 7, 8).

**Photo 7.** Todd Soto looking for salmonids through dive mask in pool just below Hwy. 96. Three coho and a few steelhead were visually observed.

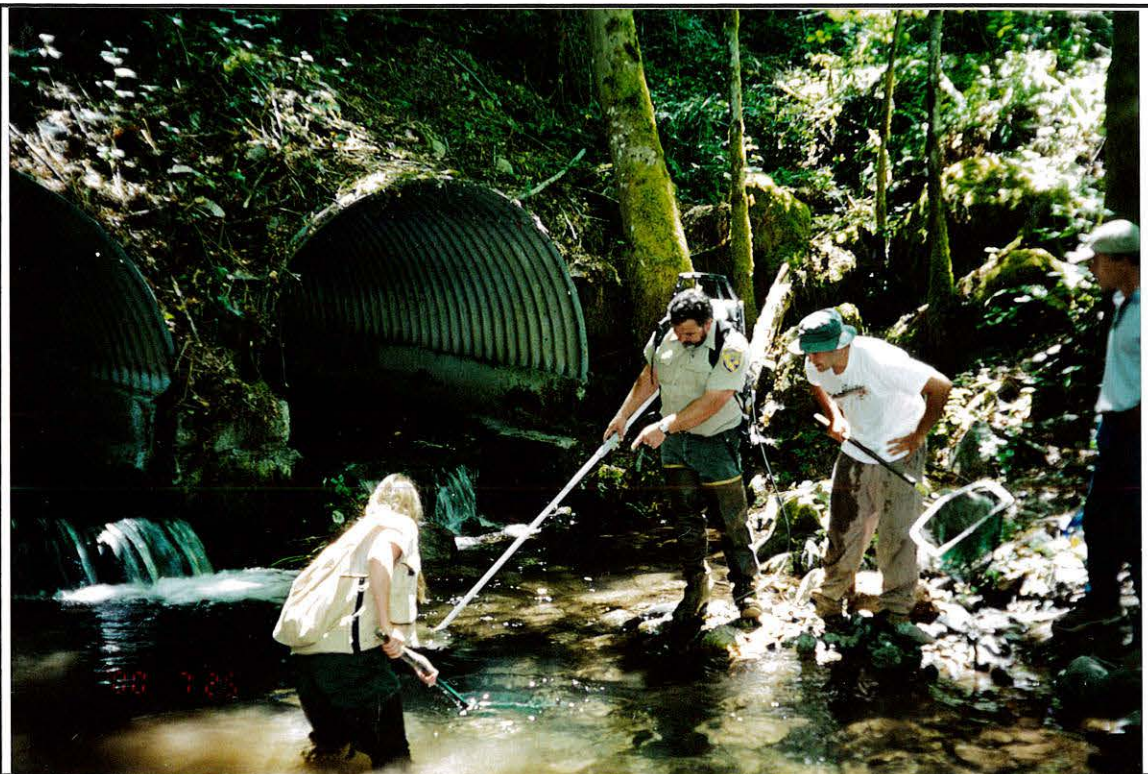
**Photo 8.** Jane Vorpagel (left) and Dennis Maria (pointing) electrofishing in the same pool. Only steelhead were captured via electrofishing in this pool.

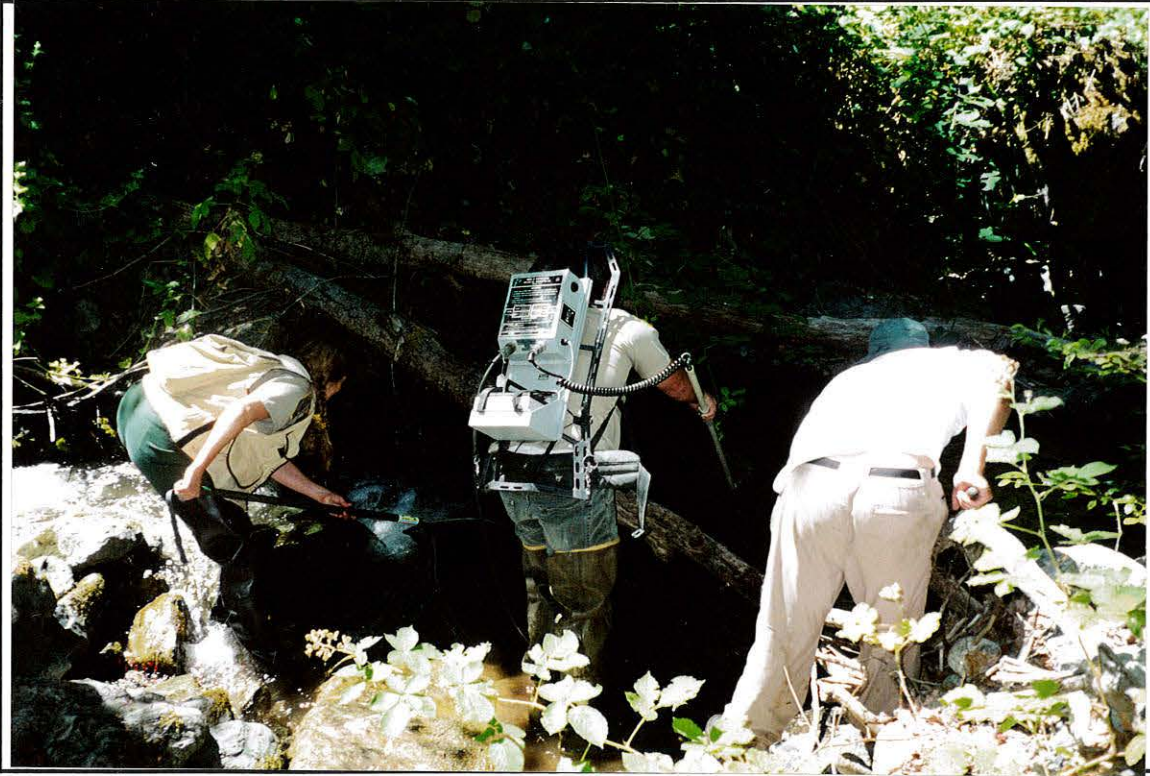
**Photo 9.** DFG electrofishing (Todd Soto assisting) a pool in Stanshaw Creek about 100 yards downstream of Highway 96.

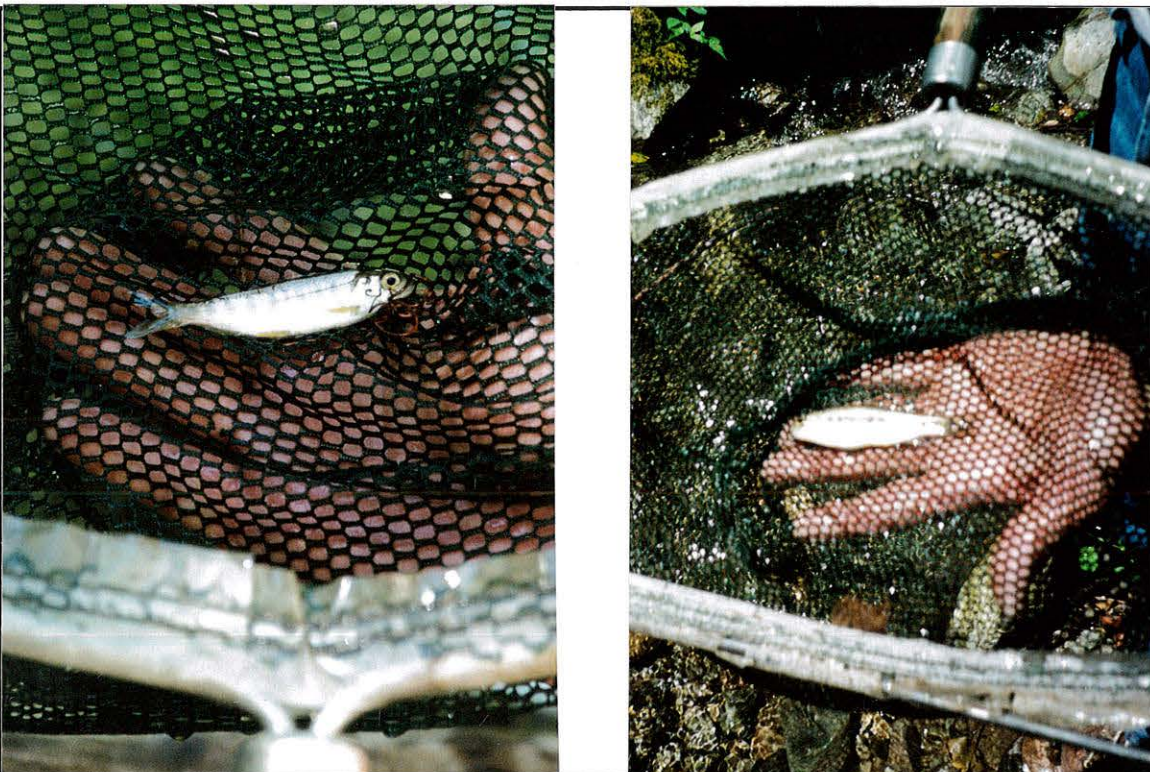
**Photo 10 (left).** An age 0+ coho salmon was electrofished out of the pool mentioned above.

**Photo 11 (right).** A one year-old *O. mykiss* (probably a steelhead) electrofished from a pool about 50 yards downstream of Highway 96.

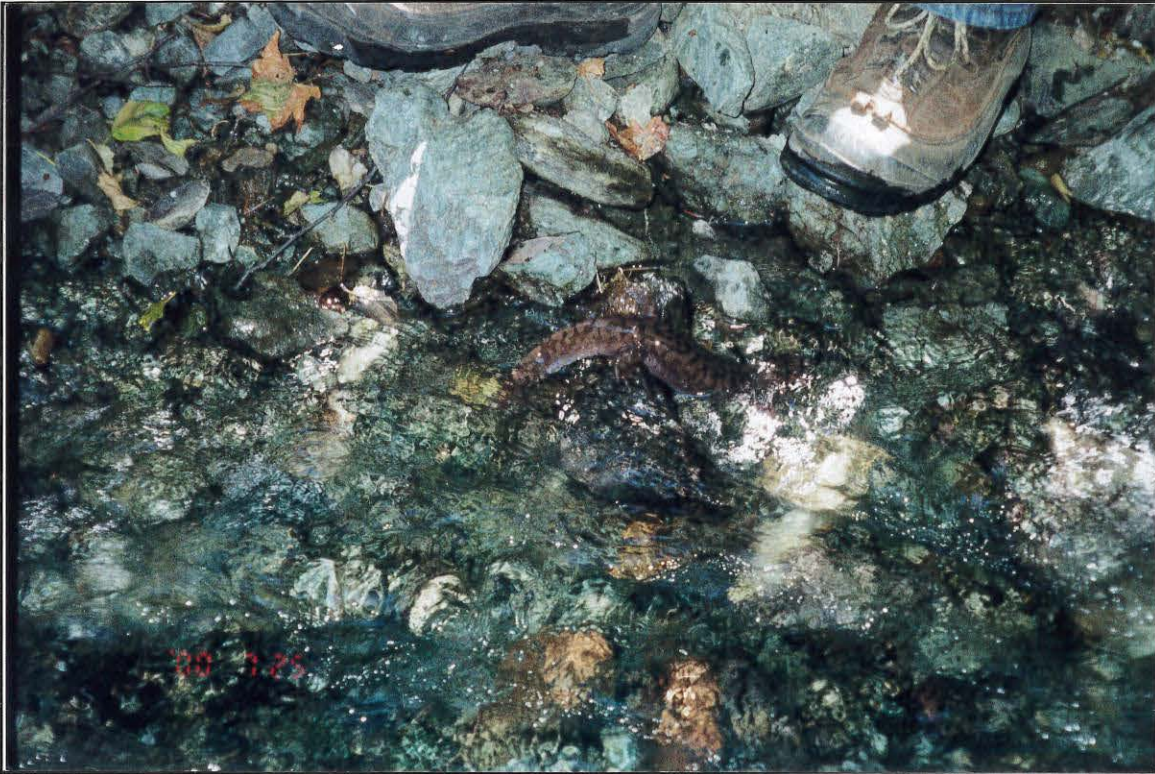
Further upstream, just below the Point of Diversion (POD), Mr. Soto netted an age-0 *O. mykiss* (**photo 13**). It is presumed that this was a resident rainbow trout as steelhead cannot negotiate above the Hwy. 96 culvert. A Pacific giant salamander (*Dicamptodon tenebrosus*) was observed in the diversion channel at the POD (**photo 12**). Another *O. mykiss* (age 1+) was found dead near the diversion ditch about 200 yards before it enters the penstock leading to the generator (**photo 14**). It was probably killed by a predator (it was not stranded, water temp. is not an issue [12.2 °C], and it appeared in good condition).

**Photo 12.** A Pacific giant salamander in the diversion ditch at the POD. It is facing to the right with its head submerged and its back half and tail visible.

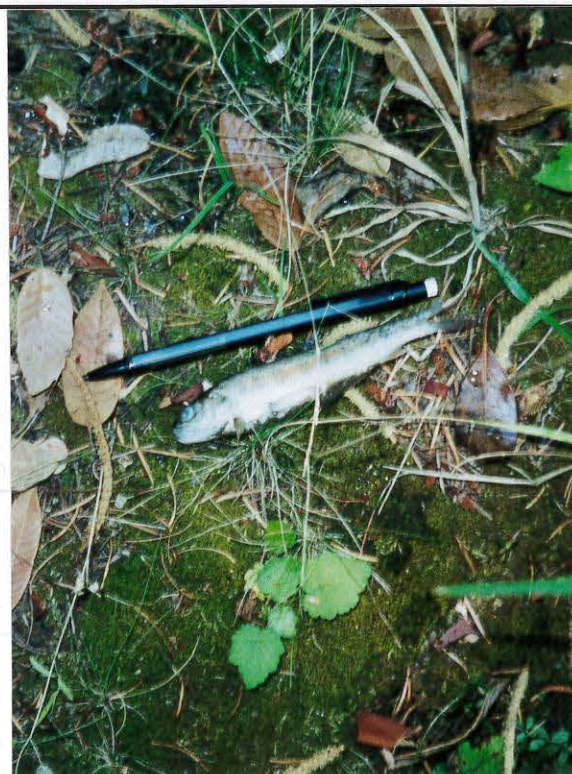
**Photo 13 (left).** An age-0 *O. mykiss* (probably a resident rainbow trout) netted from Stanshaw Creek immediately downstream of the POD.

**Photo 14 (right).** A 5-inch *O. mykiss* (probably a resident rainbow trout) found dead along the diversion ditch.

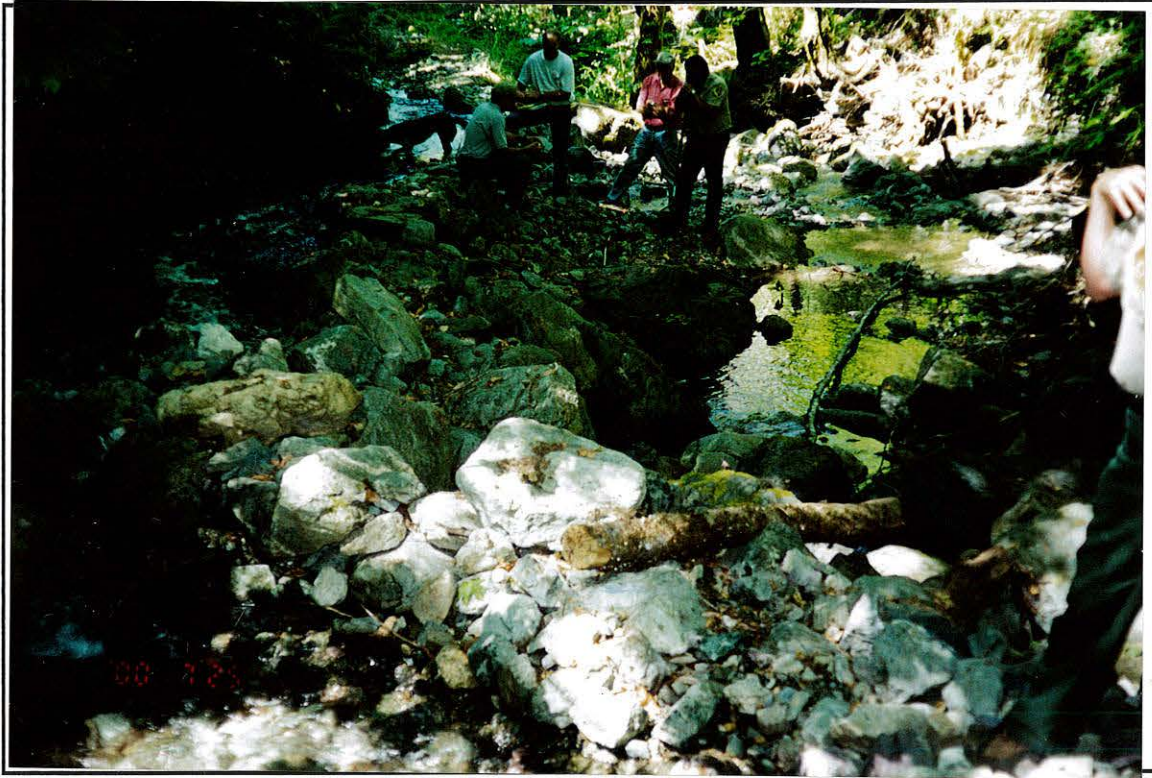
The POD is approximately three-quarters of a mile above highway 96 (photos 15, 16). The diversion structure is maintained annually by replacing rocks in the stream channel. At the time of this trip, the "diversion rocks" were a migration barrier to fish moving both upstream and downstream as the only water entering Stanshaw was seeping under these "diversion rocks". The flow entering the diversion ditch appeared to be at least twice that of the flow remaining in Stanshaw. The applicant does have a 1600 Permit from DFG, but it is stated that the diversion should be constructed so as to allow for the passage of fish. The POD and a large portion of the ditch are on USFS property.

**Photo 15.** The POD looking downstream. The diversion ditch is on the left. Note the “diversion rocks” in foreground.

This may be accomplished by placing a more permanent structure in the stream channel such as a screened pipe/siphon or a small check dam with a slot that allows for bypass and fish passage. This may be difficult since the channel frequently receives high streamflow and debris and the channel is very dynamic.

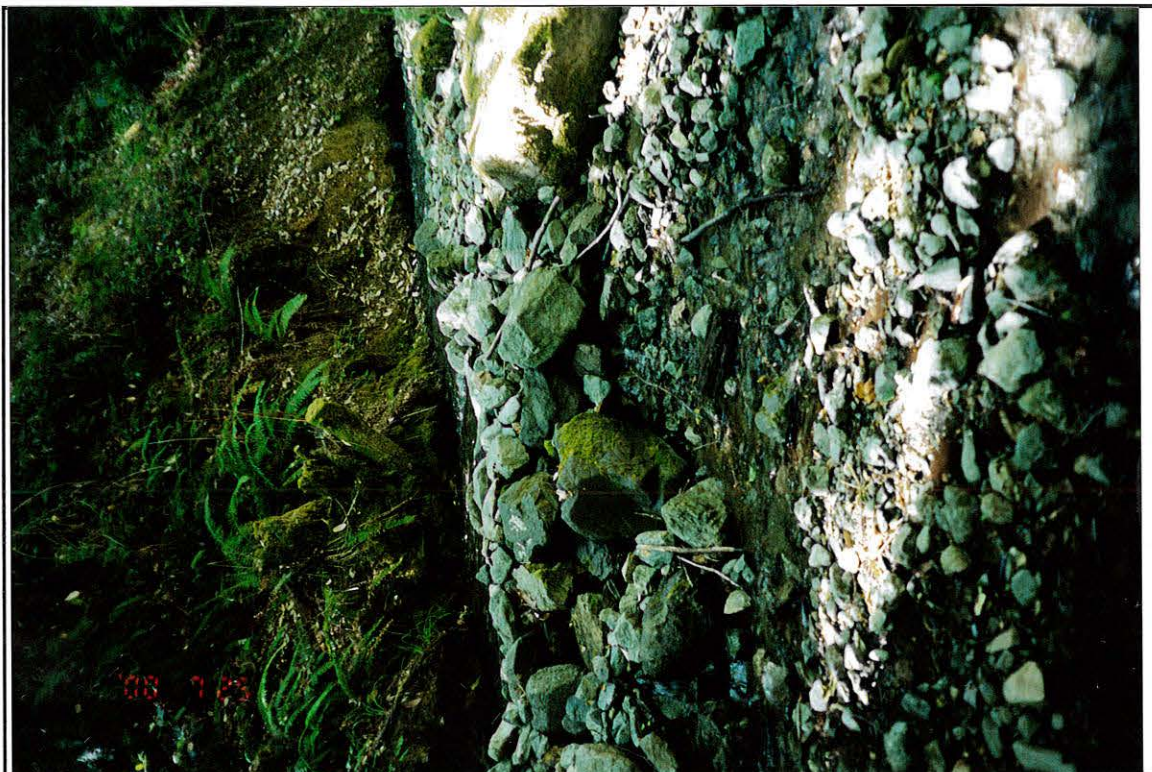
**Photo 16.** The diversion ditch (top) and water seeping through the “diversion rocks”. The ditch and stream are flowing left to right.

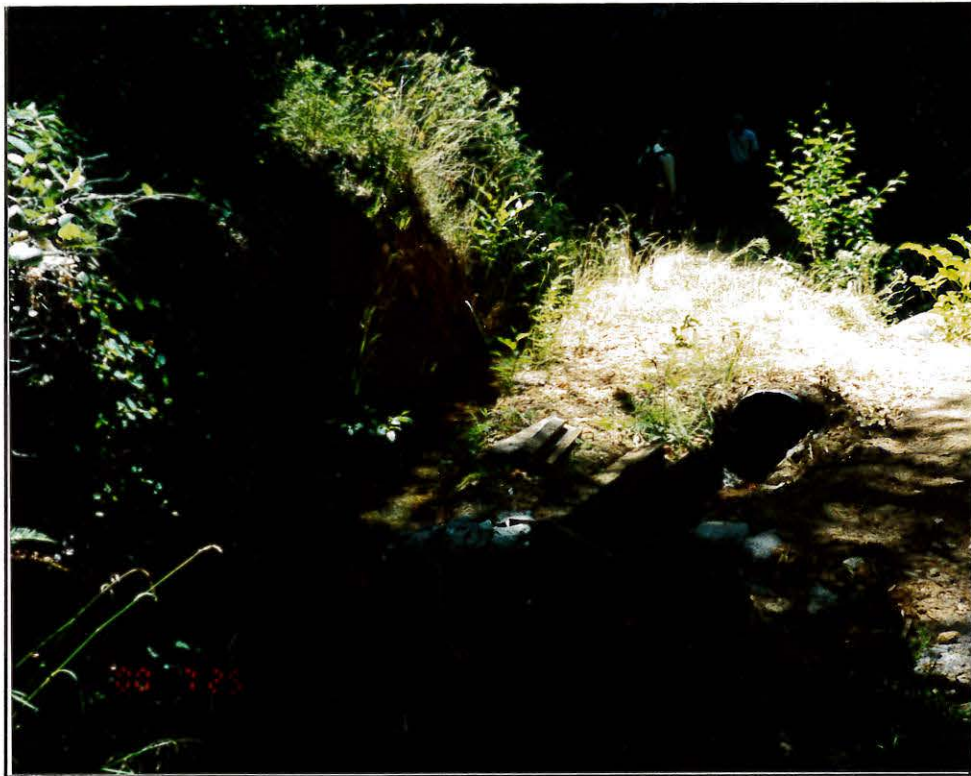
Moving down the diversion ditch, a relief line is situated to convey surplus water out of the ditch during high flows (photos 17, 18, 19). Only a minimal amount of water was passing through this line during this visit. Water passing through the relief line flows back in to Stanshaw Creek.

**Photo 17.** (left) Looking downstream at the relief structure.

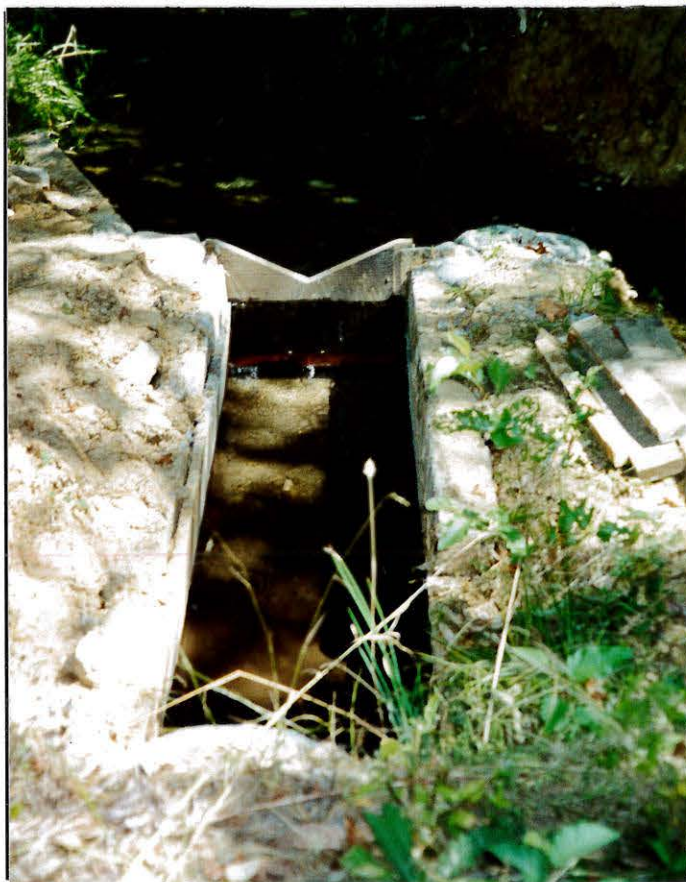
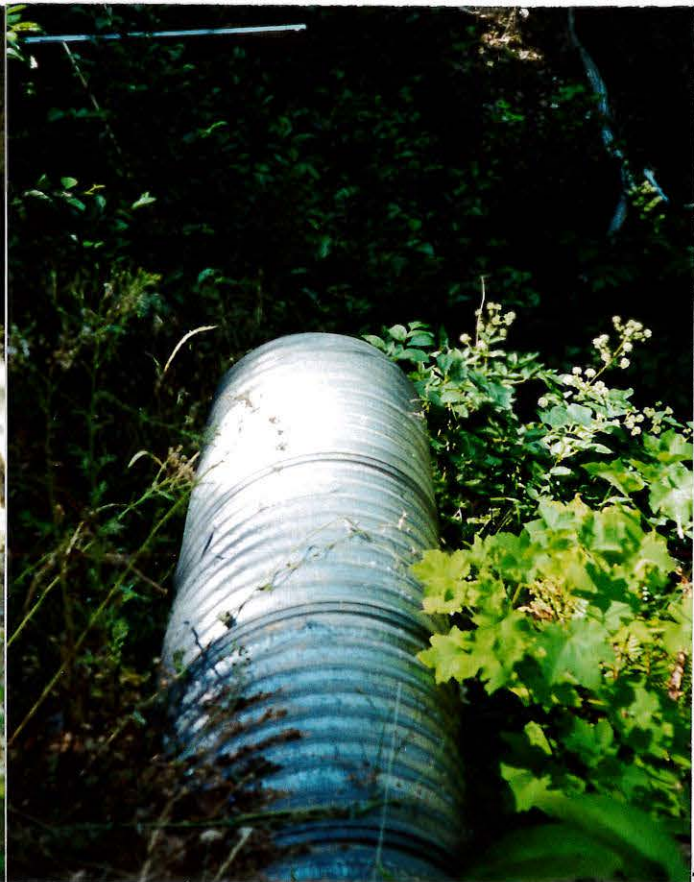
**Photos 18 and 19.** The relief structure looking upstream (bottom left) and downstream at the relief outlet culvert.

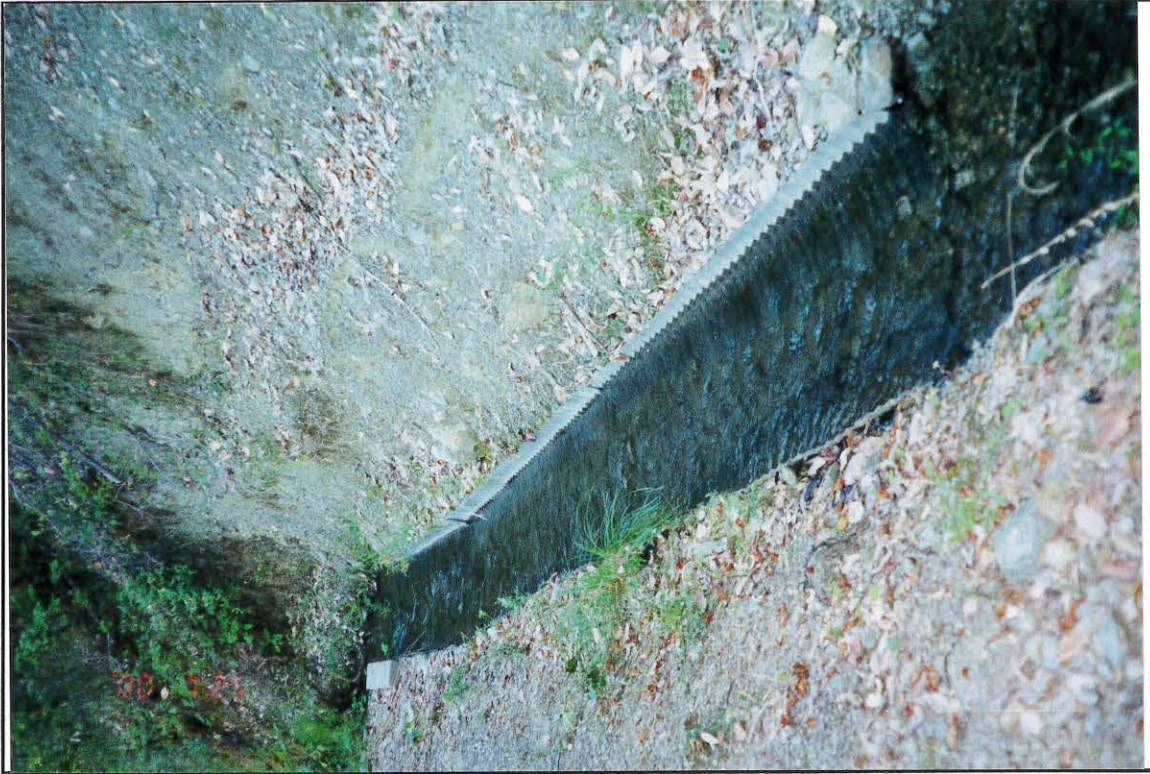
Down-diversion of the relief line, a half-culvert is buried in the ditch (photo 20). The applicant says he needs to keep the half-culvert full (the amount present during our review) to operate his hydropower generator effectively; less than that, and he is short on power, more than that, and most is passed through the relief line described above. This is a good place to measure / monitor flow in the ditch. The flow was estimated just upstream of this half-culvert by timing a float over a known distance and measuring the ditch cross section at this reach (photo 21). Flow was about 1 foot per second and cross sectional area was about 2 feet (flow  $\approx$  2 cfs). The applicant claims, and it was evident, that a lot of water seeps out of the ditch between here and the POD.

Photo 20. Half-culvert in ditch.

If this is accomplished, less water would need to be diverted out of Stanshaw Creek. Lining the ditch or installing a pipeline were possible methods mentioned.

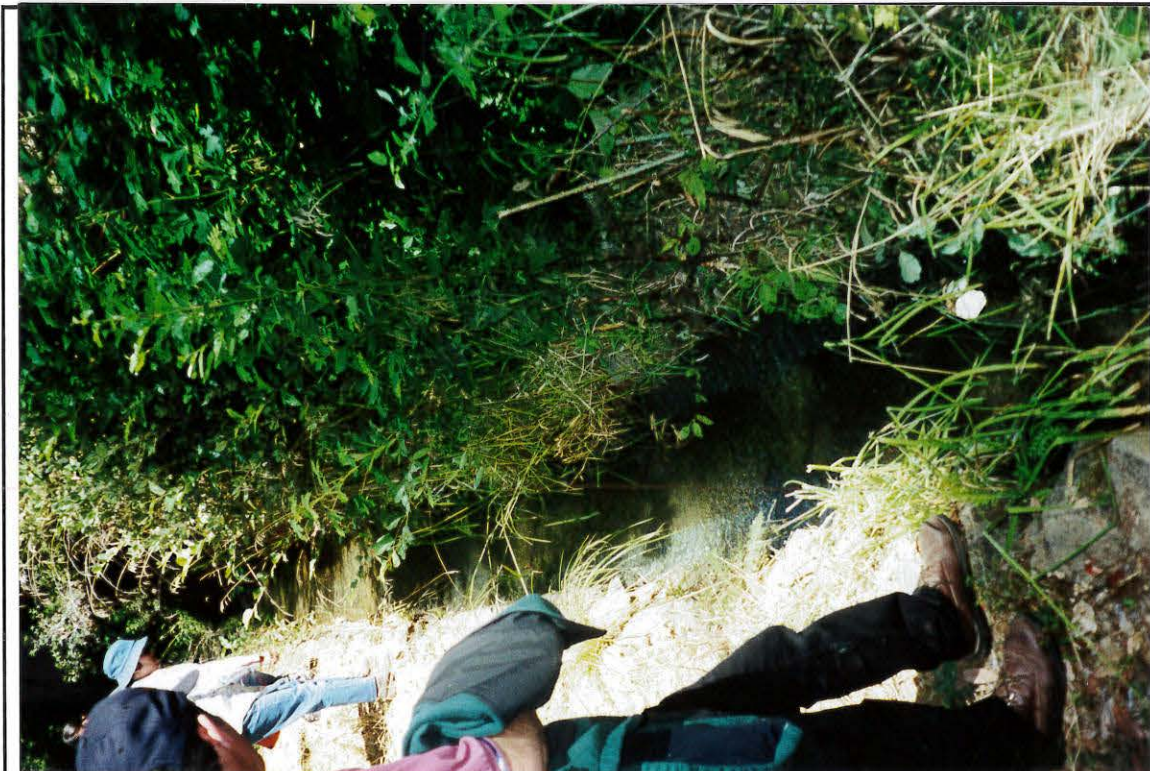
Photo 21. Location where rough stream-flow measurement was taken.

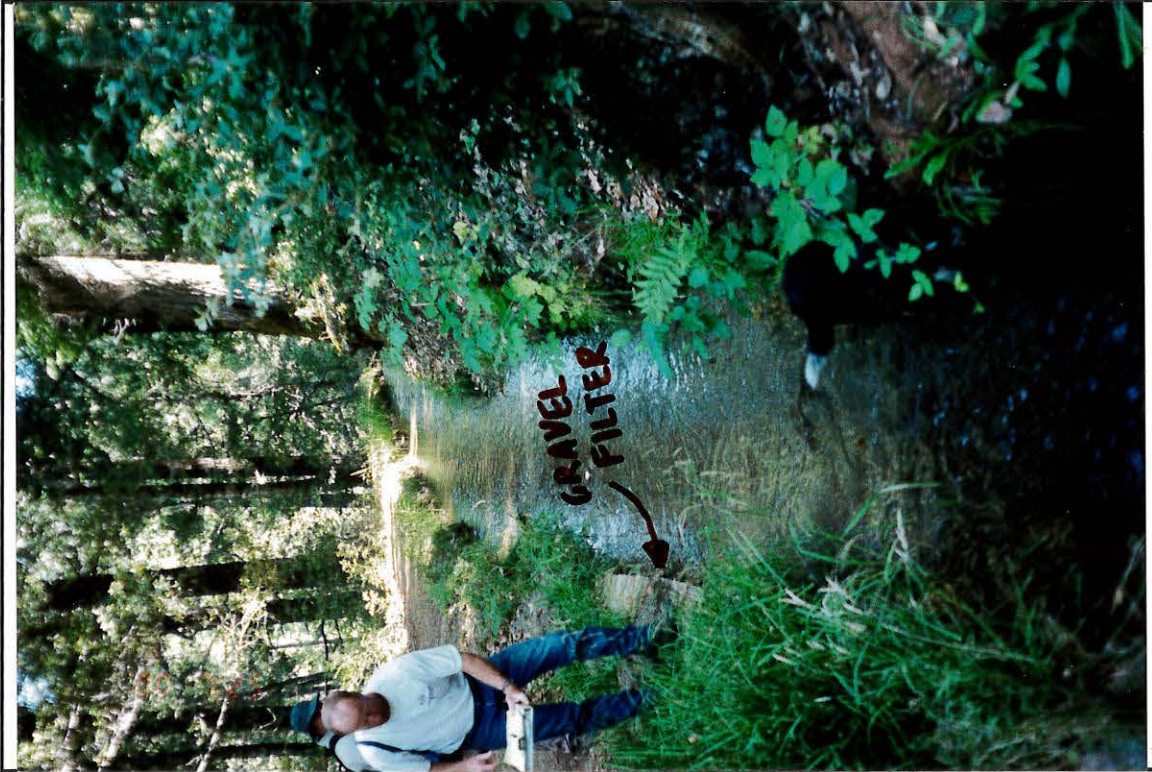
Water is also gravel-filtered out of the ditch (photo 22) into a pipe that leads to water purification tanks to supply domestic uses (photo 23). This water is not applied for in this application (Small Domestic or Pre-14?).

**Photo 22.** Location of gravel filter in ditch which leads to water purification tanks.

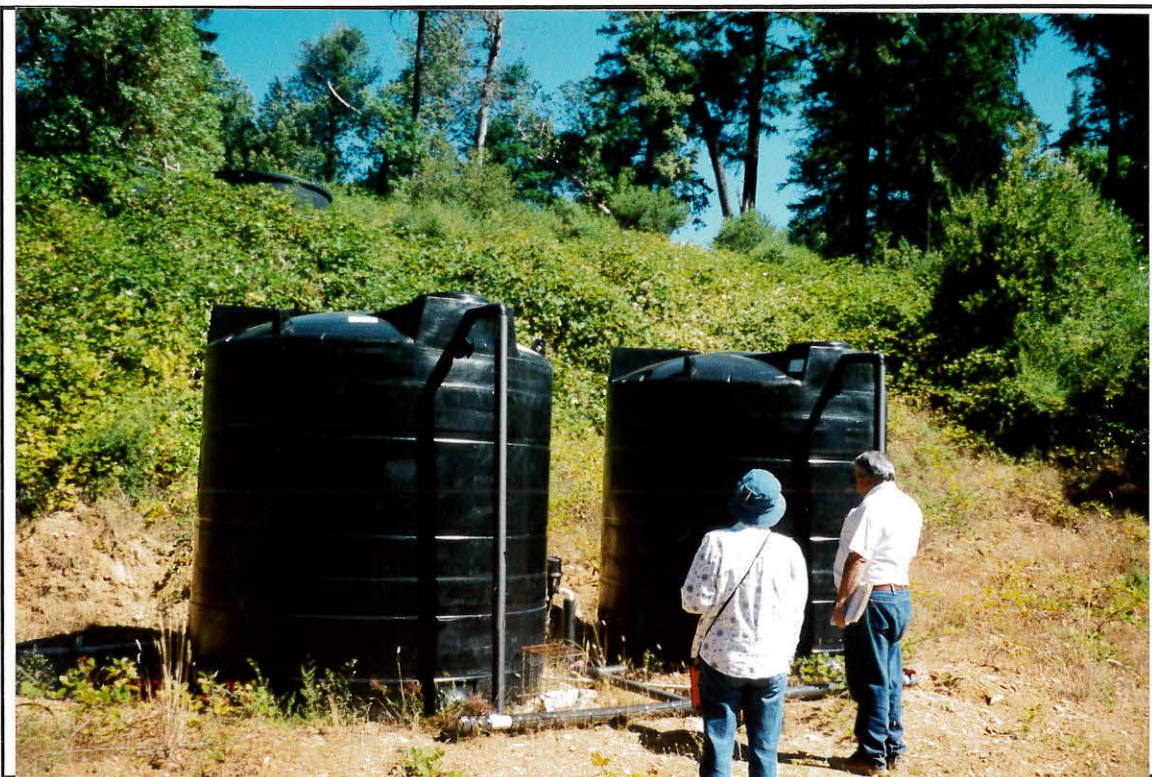
**Photo 23.** Water purification tanks.

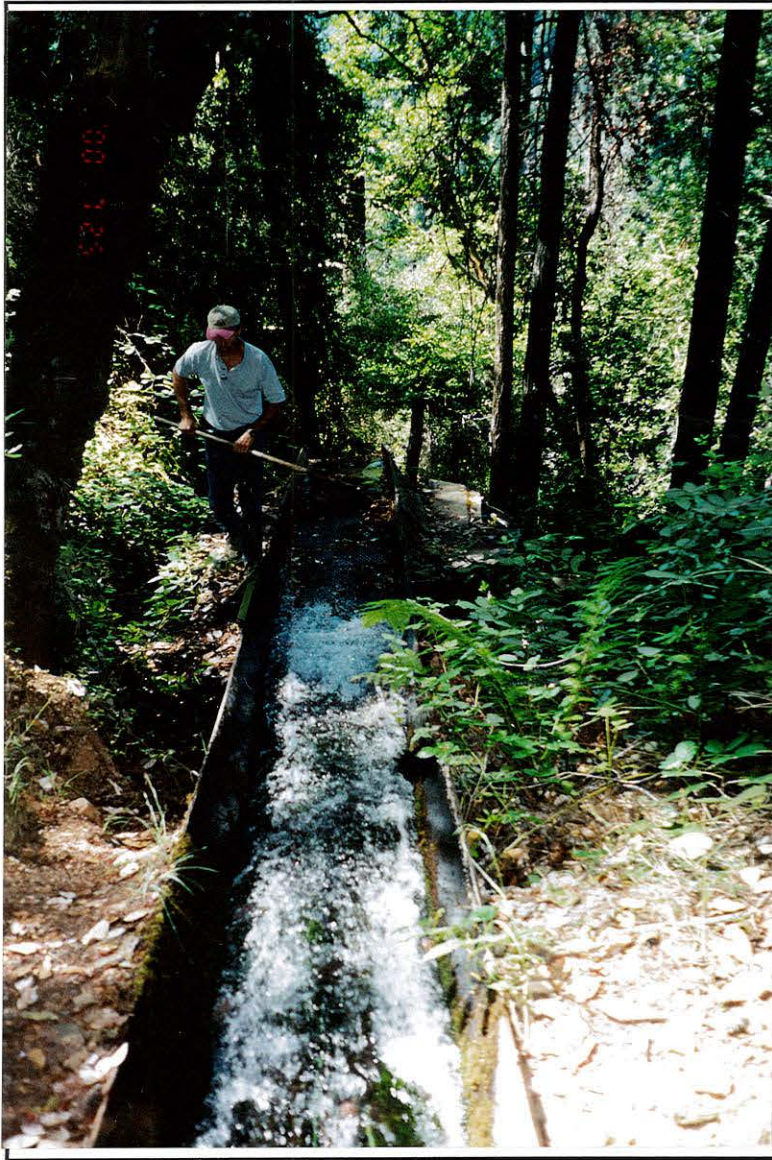
The ditch continues (photo 24) until it enters the trash rack (photo 25), thence the holding tank to produce head, thence down the penstock to the hydroplant (see photos 1,3,4). Water is then redirected into another ditch which flows into Irving Creek. Mr. Tocher takes water out of the ditch before it enters Irving Creek (photo 26, 27).

**Photo 25.** Mr. Cole clearing the trash rack of leaf litter. Clearing is done daily and >5 times per day during the fall. Water then enters a holding tank, thence penstock.

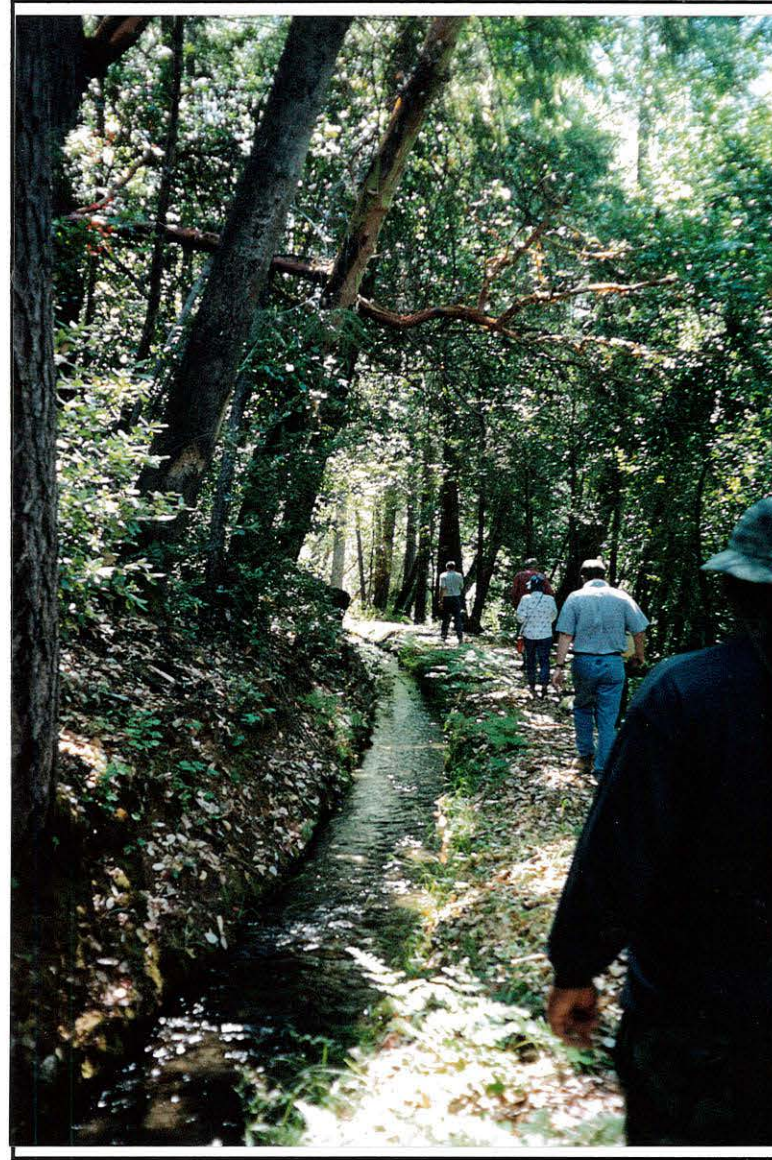
**Photo 24.** Looking downstream at the ditch between the water filtration point and the trash rack / penstock. The dead trout in photo 14 was found near here.

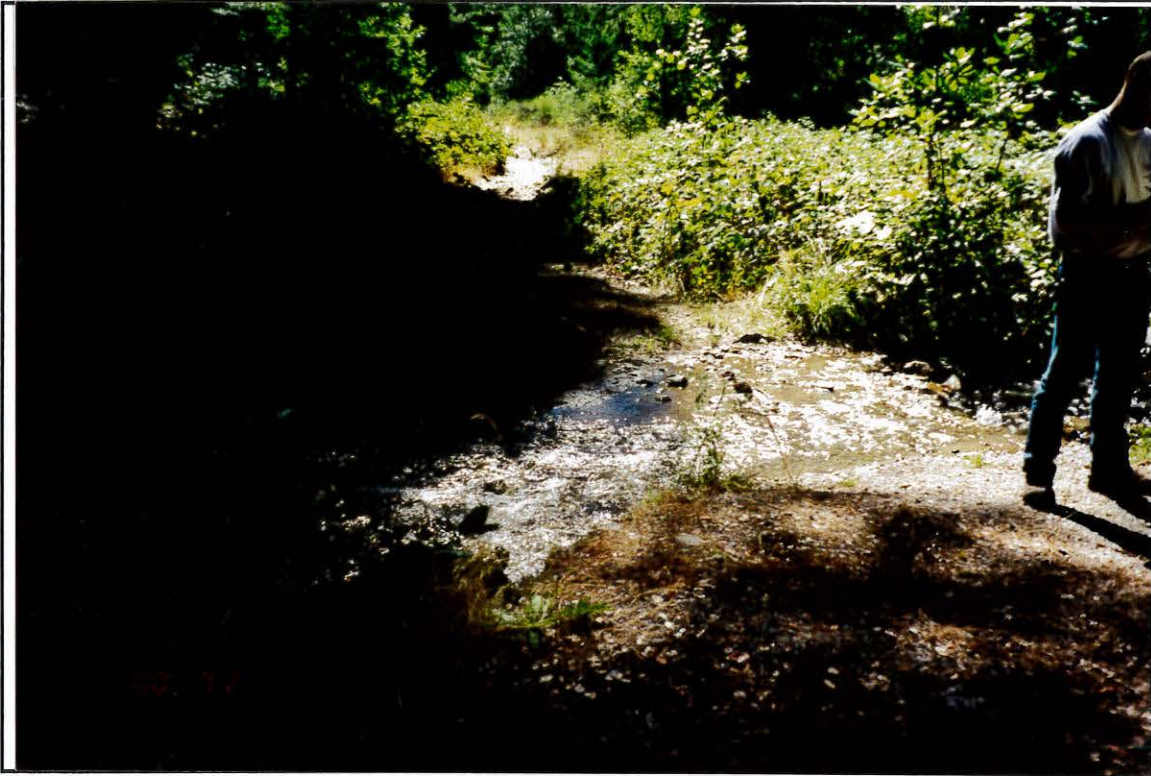
**Photo 26.** The diversion ditch after water has been withdrawn by Mr. Toucher and just before it enters Irving Creek.
