# ENVIRONMENTAL FIELD REPORT

Prepared by Robert E. Miller  
SWRCB, Division of Water Rights (DWR)  
Environmental Assessment Section (EAS)

**Application No.:** 29449

**PROJECT DESCRIPTION:** Applicant seeks a right to directly divert 3 cubic feet per second (cfs) from Stanshaw Creek, tributary to Klamath River, thence Pacific Ocean, in Siskiyou County. Water is conveyed through 5,200 feet of earthen ditch and 455 feet of 16-inch diameter steel pipe (penstock). The penstock uses 200 feet of fall to turn a Pelton wheel turbine. The hydroelectric generator produces a maximum of 33.9 kilowatts of electricity at 80% turbine efficiency. After use (see note), the water is conveyed via ditch into Irving Creek, thence Klamath River. (Note: Some water is taken from the ditch before and after the hydroplant for use by the Cole's for domestic use and pasture irrigation, respectively. Irrigation and domestic use is not applied for by this application and may be covered by pre-1914 rights and a Small Domestic Use Permit. Neil Tocher takes water from the ditch before it enters Irving Creek for domestic use, pasture irrigation, power generation, and to maintain a recreational reservoir. Mr. Toc

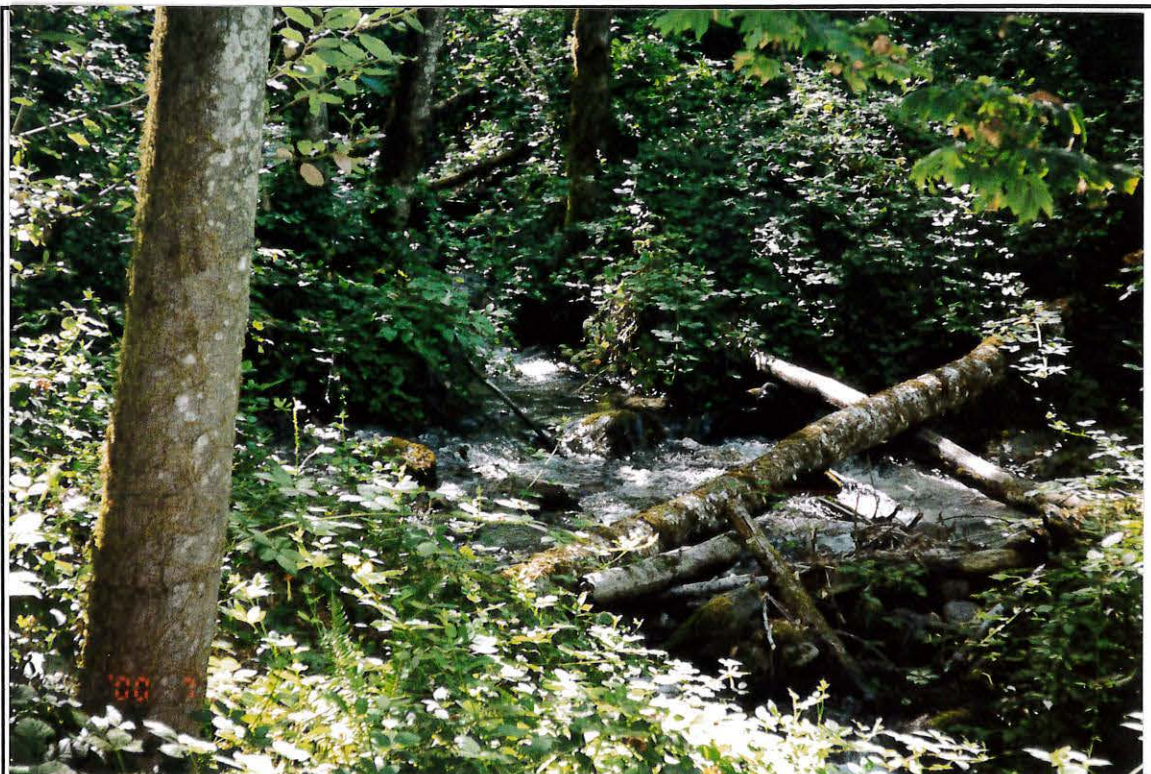
**Photo 27.** Irving Creek, about 200 yards upstream of the ditch discharge.
