RESORT IMPROVEMENT DISTRICT NO. 1
SHELTER COVE – HUMBOLDT COUNTY – CALIFORNIA
9126 Shelter Cove Road, Whitethorn CA 95589-9079
707-986-7447, Fax: 707-986-7435, www.sheltercove-ca.gov

Re: Request for Case-by-Case Exception for Water Right Application 32557 of Resort Improvement District No. 1 to Appropriate Water from Humboldt Creek in Humboldt County

TECHNICAL MEMORANDUM

Biological Stream Classification Survey Results
Humboldt Creek, Shelter Cove, California
Assessor's Parcel Number 109-011-005

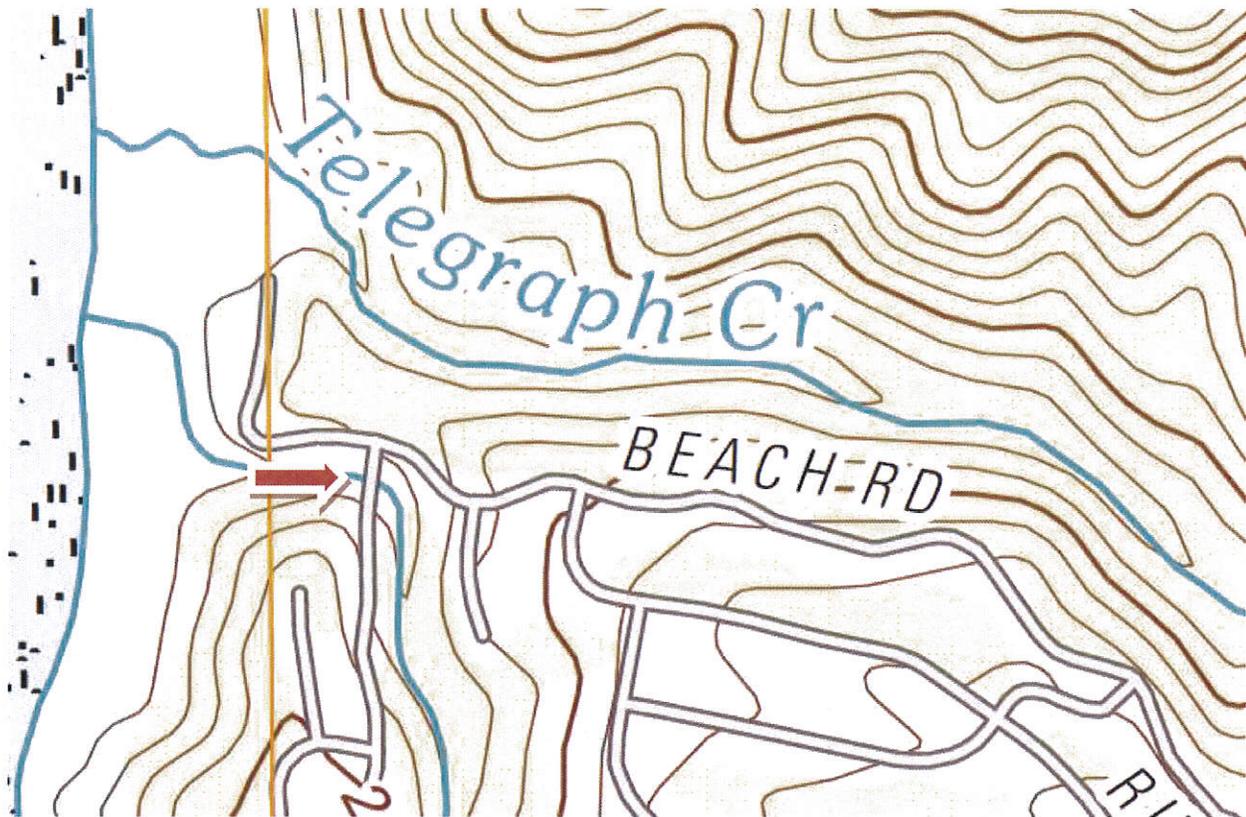
Conceptual dam location would be at tip of red arrow.

CONCEPT: Create a surface reservoir on Humboldt Creek by damming existing culvert area (new dam construction) and create stream by-pass to flow along existing route

- raise road levels of Humboldt Loop and Beach Road (intersection) 30-40 feet
- create interconnection to existing Telegraph Creek downstream intake (6"HDPE) to water plant
- relocate and/or raise existing utility infrastructure (lift station, utility poles)
- clear wooded slopes of Humboldt Creek channel to be filled by reservoir

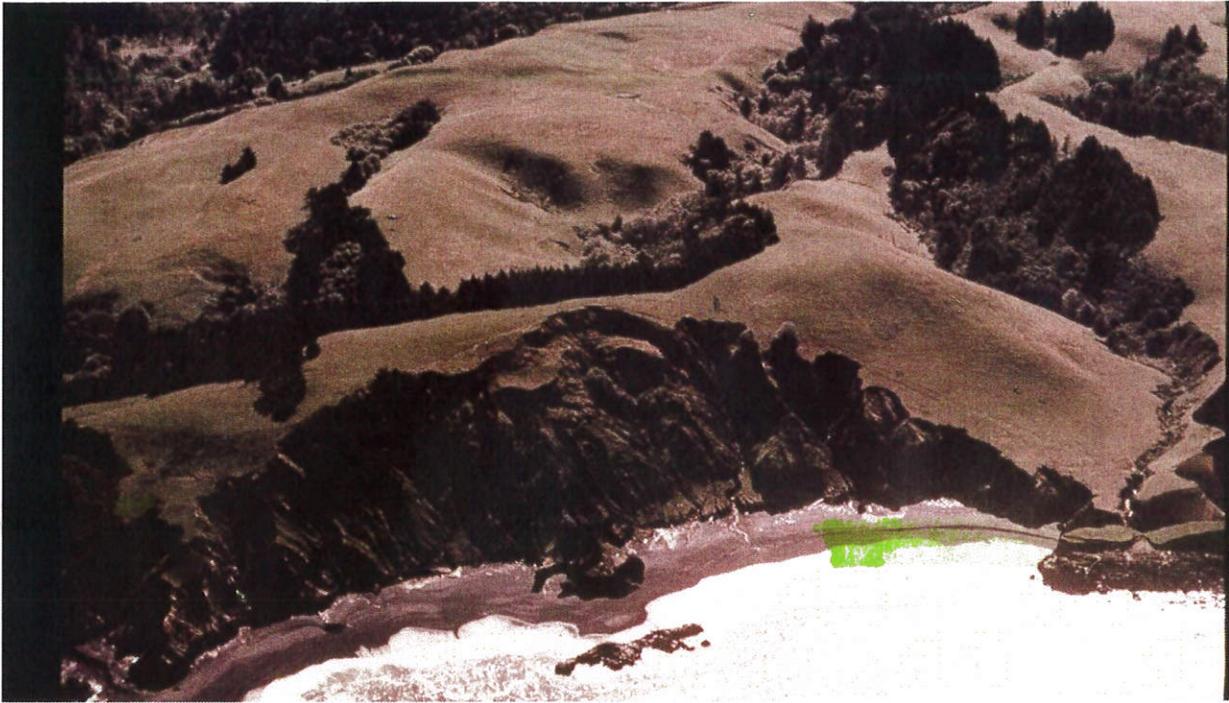
Photo of Humboldt Creek channel ca. 1963-64 prior to development. Ocean outfall is in lower left corner and stream channel is the treed area running from left to upper right of photo. Notice the abundance of coastal chaparral and the absence of trees.

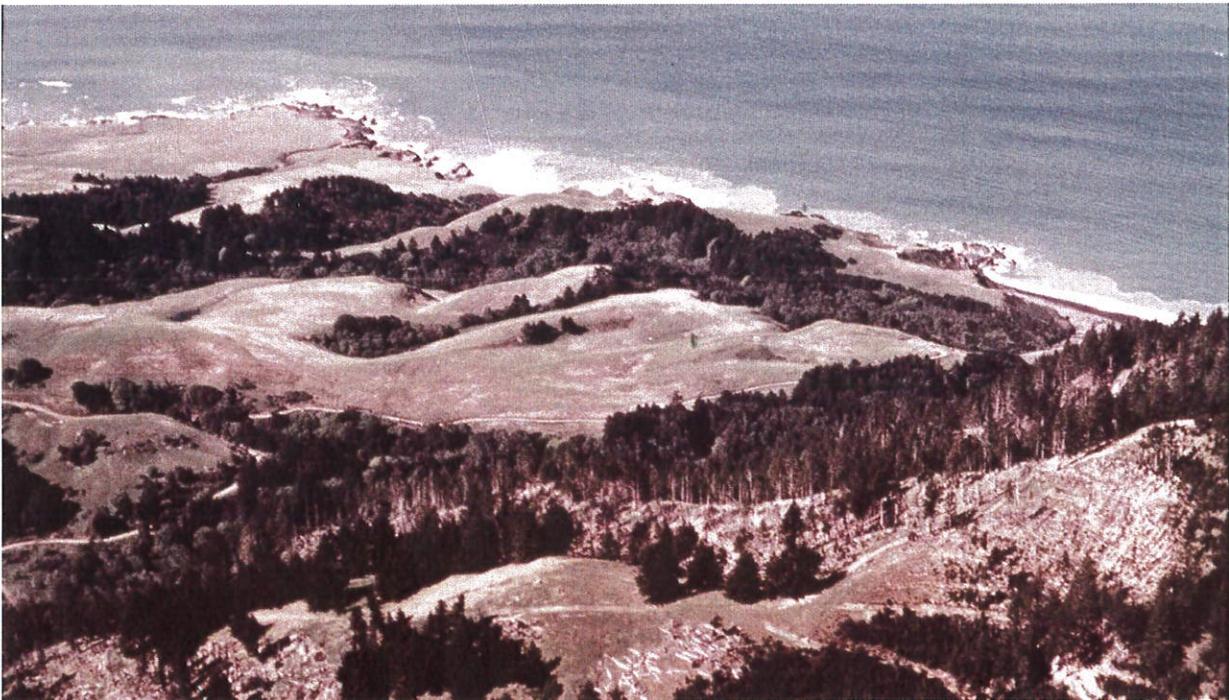
Photo of Humboldt Creek channel ca. 1963-64 prior to development. Ocean outfall is on right side, middle, and creek channel is left to right in top, middle of photo. Notice the abundance of coastal chaparral and the absence of trees.

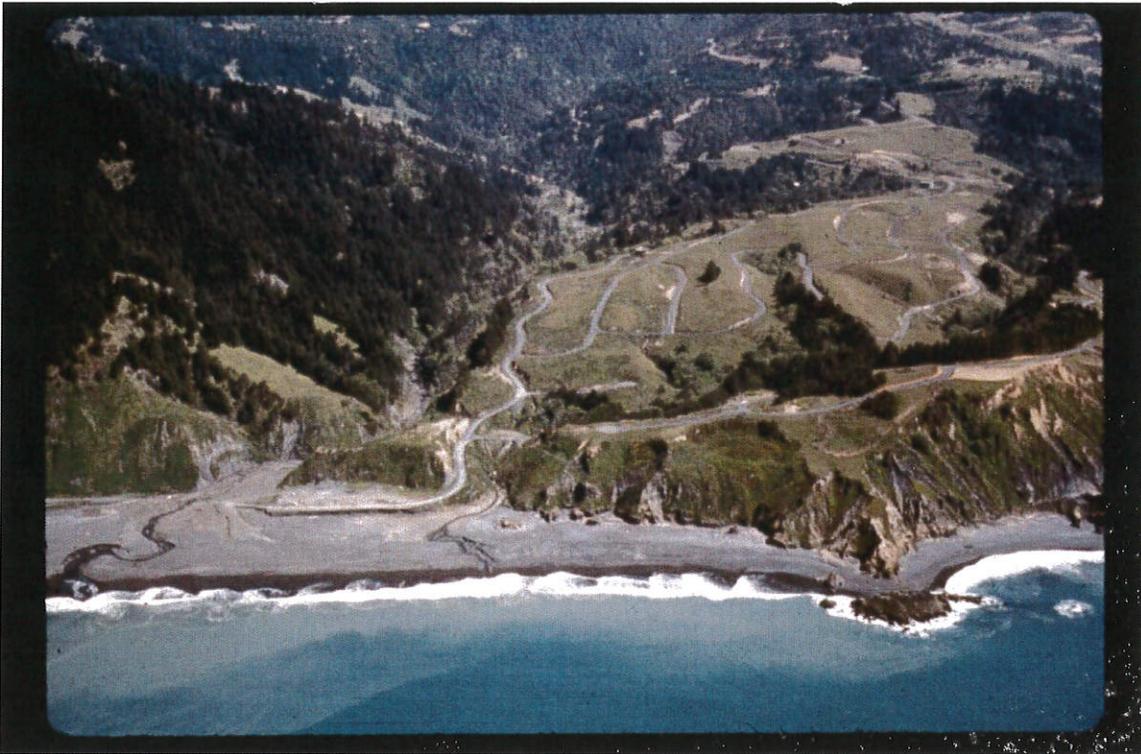
Circa 1972. Telegraph Creek outfall is in the lower left corner, and Humboldt Creek outfall is near center of photo. The road development around the Humboldt Creek channel is plainly visible, and the explosion of tree growth is not yet evident.

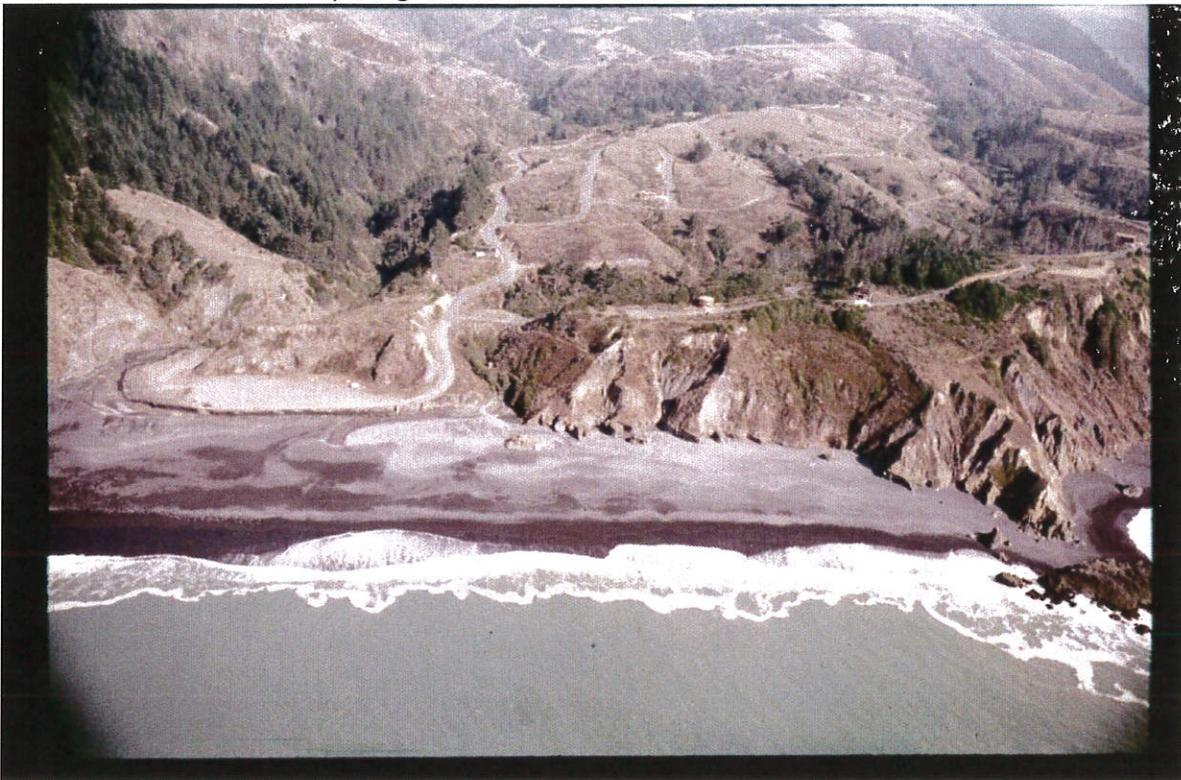
October 1979. In 1972, the Findley Creek Fire swept through the Humboldt Creek channel, and in 1973 aerial re-seeding of the King Range area spread into Shelter Cove. Tree "skeletons" can be seen in the creek channel in this photo.

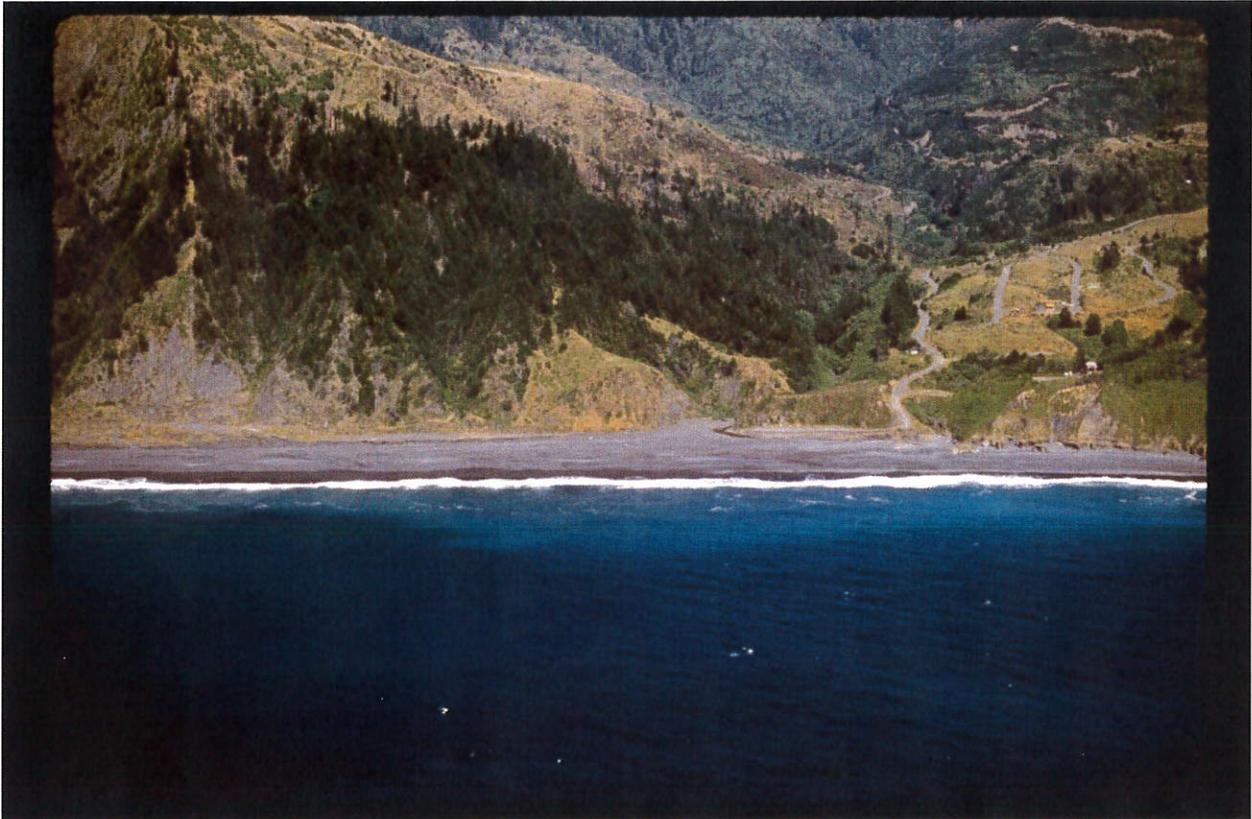
June 1987. Increased tree growth is evident (throughout the Cove as well).

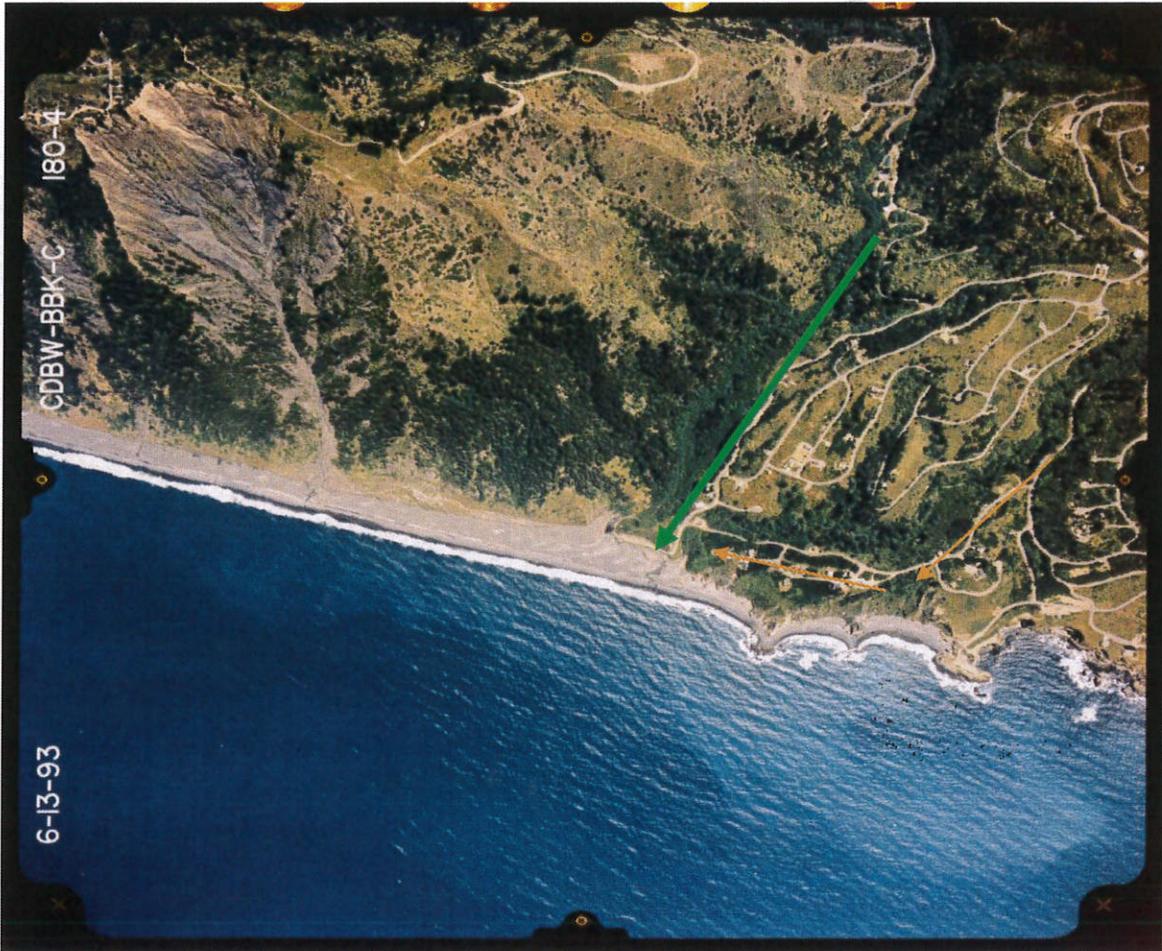
June 1993. Humboldt Creek channel is depicted by orange lines. Telegraph Creek channel (partial) is depicted by the green line. Increasing number of homes and tree growth is accelerating

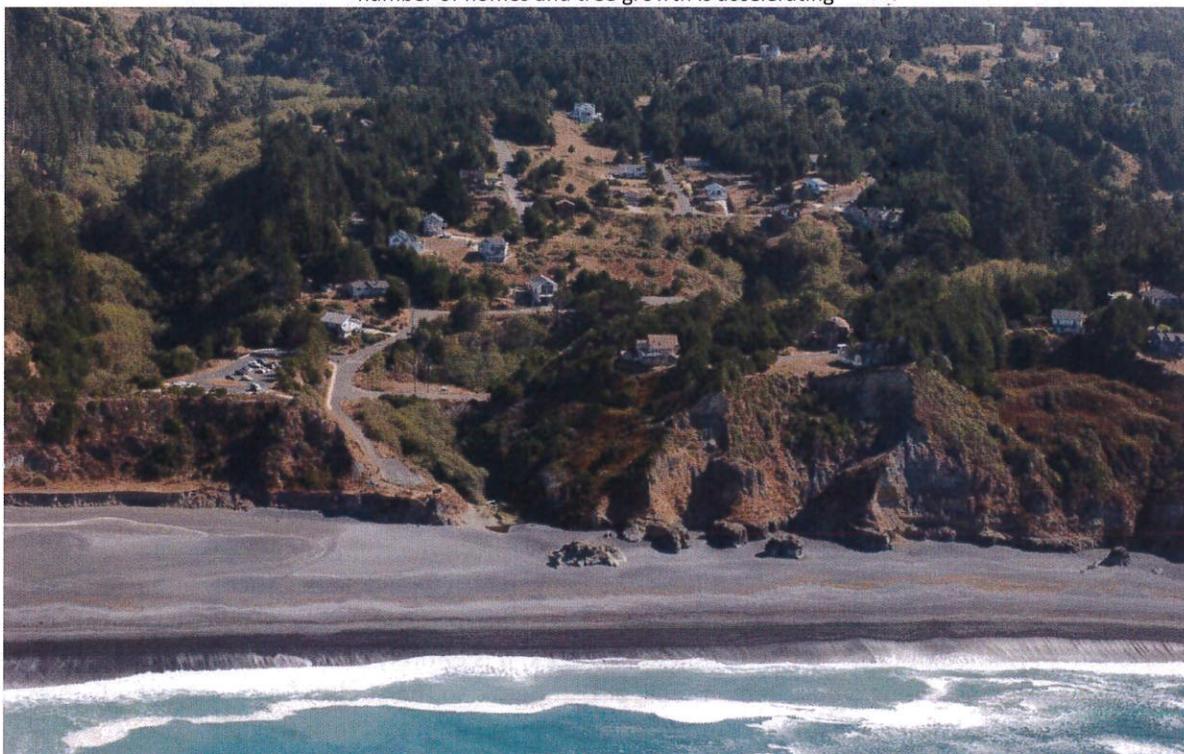
October 2002. The parking lot formerly on Black Sands Beach is gone and the new BLM King Range parking lot is now present on left, center of photo. Greater abundance and growth of trees is more noticeable.

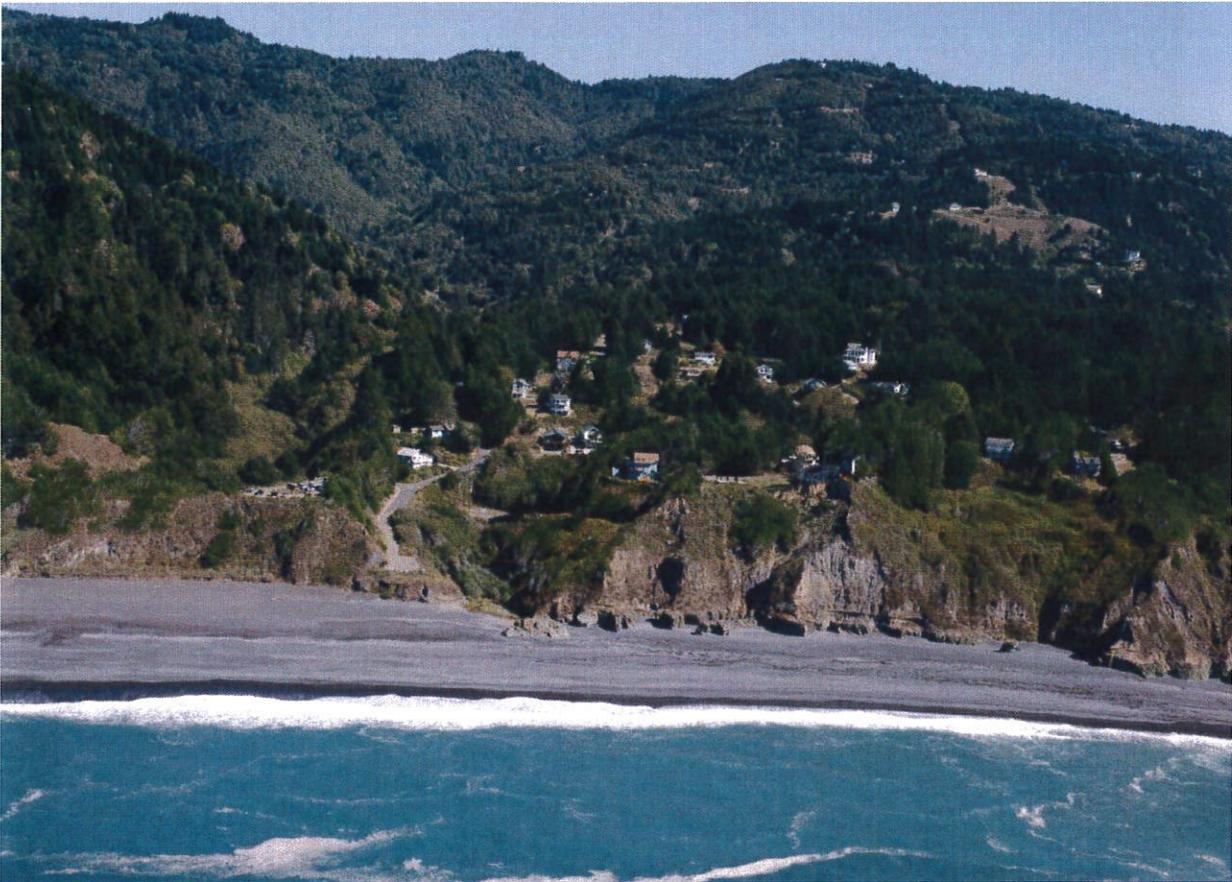
September 2013. Mature Douglas Fir growth now dominates the landscape, drawing ever increasing amounts of water from the creeks and groundwater sources, especially during the dry months.

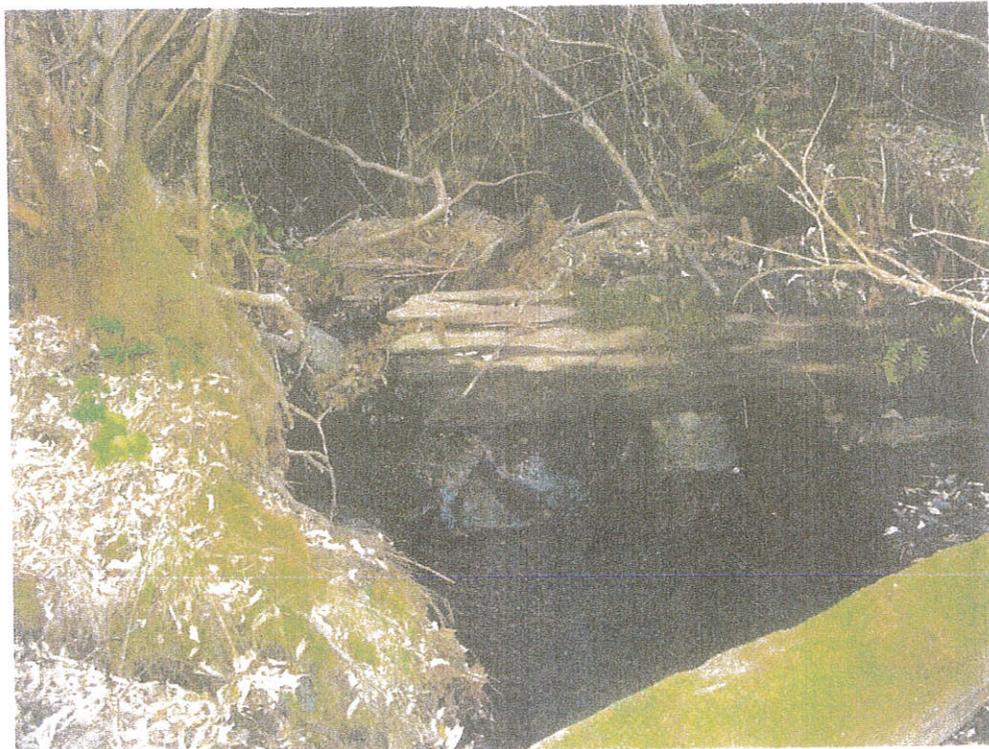
percent below normal (NOAA, 2013). On December 4, 2013, the mouth was observed immediately upslope from the beach; heavy driftwood debris was visible (Please refer to Appendix A, Photo Location 2 and Appendix B, Photo 2). Humboldt Creek below the Humboldt Loop Road crossing is carried below base rock fill by three 24-inch corrugated metal culverts (Please refer to Appendix A, Photo Location 3 and Appendix B, Photo 3). A significant bedrock bench is located approximately 300 meters above the triple culverts (Please refer to Appendix A, Photo Location 4 and Appendix B, Photo 4). The step, although clearly a barrier to most fish at low flows, would be of insignificant height at swollen creek volumes. Relatively-level open-channel creek flow is present throughout most of Humboldt Creek (Please refer to Appendix A, Photo Location 5 and Appendix B, Photo 5). Humboldt Creek below Shelter Cove Road ceases the extent of open-channel flow and upper drainage slopes exceed 12 percent (Please refer to Appendix A, Photo Location 6 and Appendix B, Photo 6).

Photo 2 - Humboldt Creek, immediately above beach, note driftwood

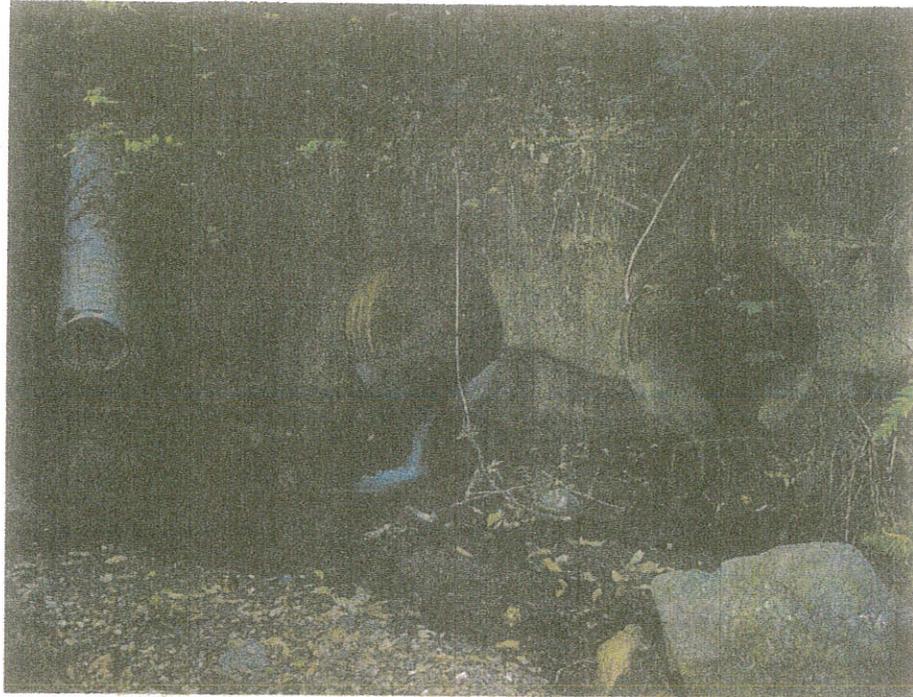
The triple culverts do not appear to be restrictive to fish passage (50 cm in height); however the flow velocity generated by heavy rain events may prevent anadromy (fish passage from ocean to freshwater for breeding purposes). The nearest stream within the range of anadromy is the Class I waterway of Telegraph Creek (300 meters north). Elevation readings were estimated at the Humboldt Creek mouth (5 feet above sea level) and approximately 7,000 feet upstream at Shelter Cove Road (380 feet above sea level); the estimated slope over that distance is approximately 5 percent (USGS, 1969). The maximum slope to support anadromy is approximately 10 to 12 percent (SWRCB, 2010). The response to a request to DFW for fish stream data from Humboldt Creek indicated that no data was known (pers comm., 2013). Based on stream channel grade and conditions observed during the field survey, historic anadromy to Humboldt Creek appears possible. However, there is no known documentation that supports fish presence in the stream. The following description is provided from observations of the length of Humboldt Creek, from ocean outfall to end of open-water channel and permanent flow.

Photo 3 – Humboldt Creek, Humboldt Loop Road culverts

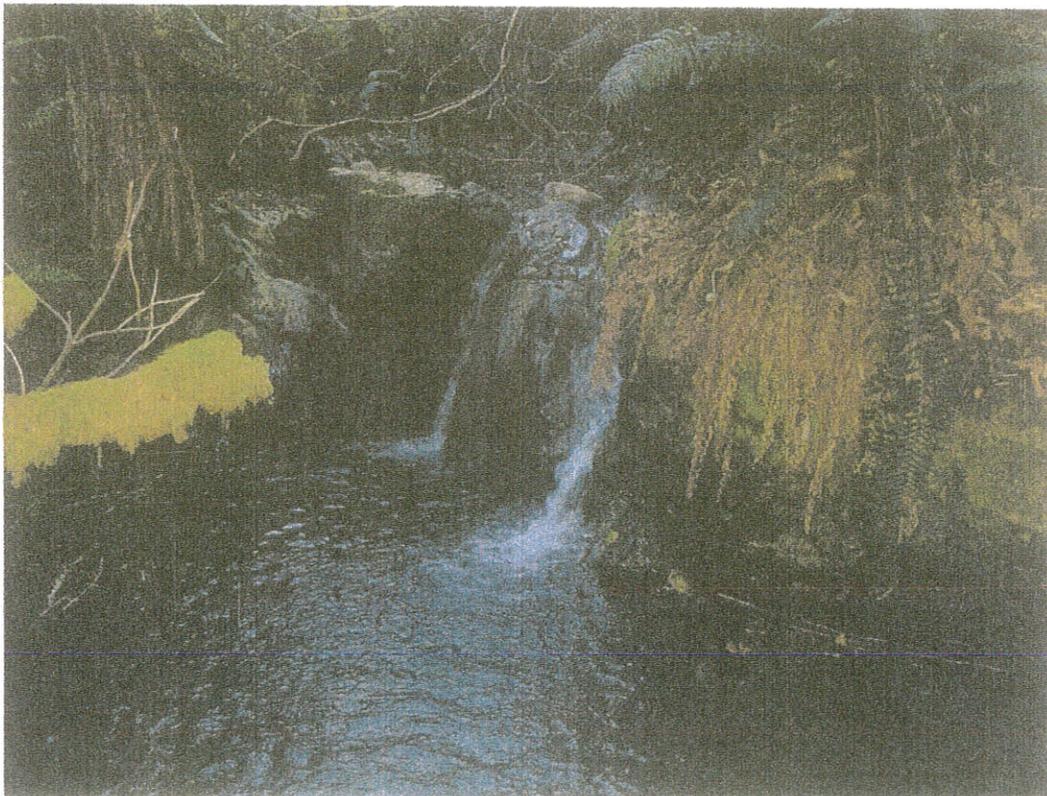
Photo 4 – Humboldt Creek, bedrock bench about 1 meter high, approx. 300 meters above culvert crossing

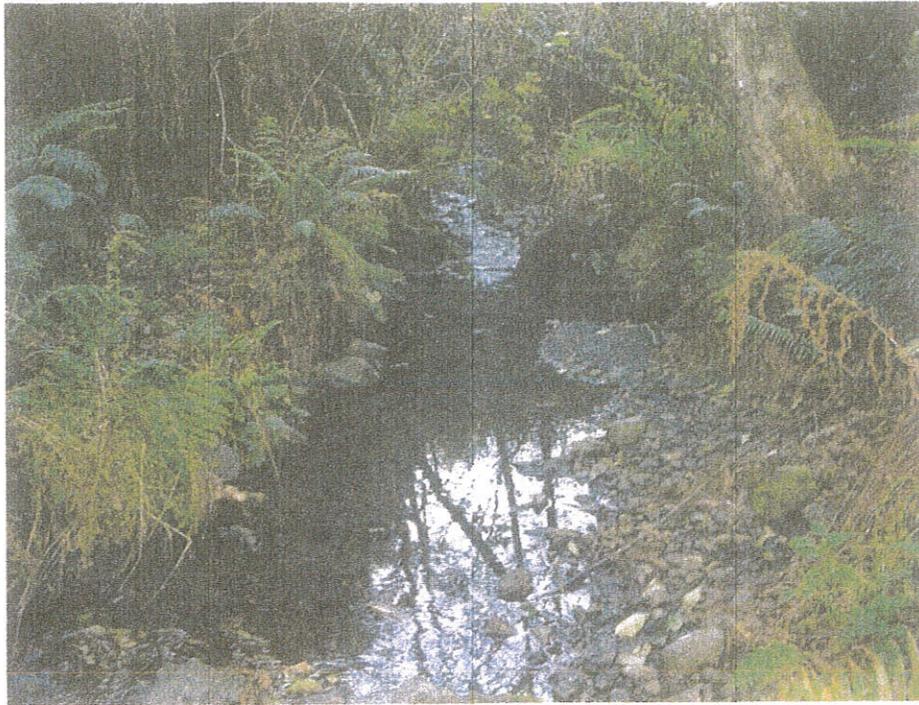
Photo 5 – Humboldt Creek, typical channel above previous bedrock bench at low flow

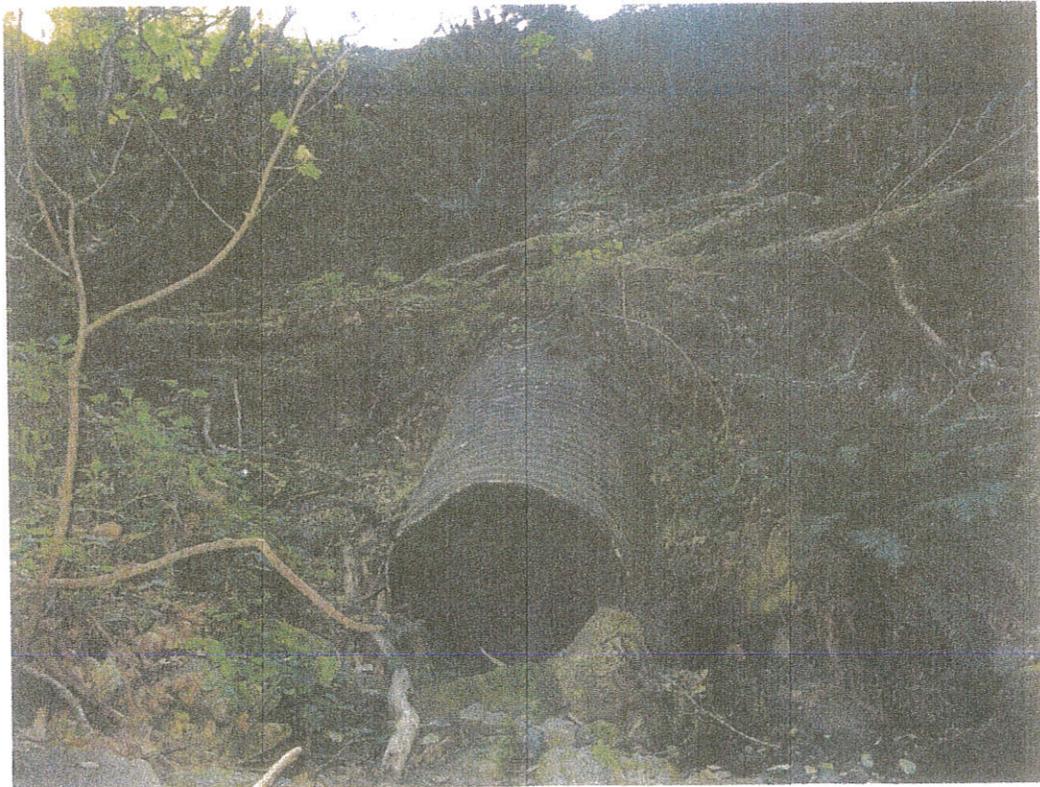
Photo 6 – Humboldt Creek, approximate end of upper reach of open waters,
below Shelter Cove Road

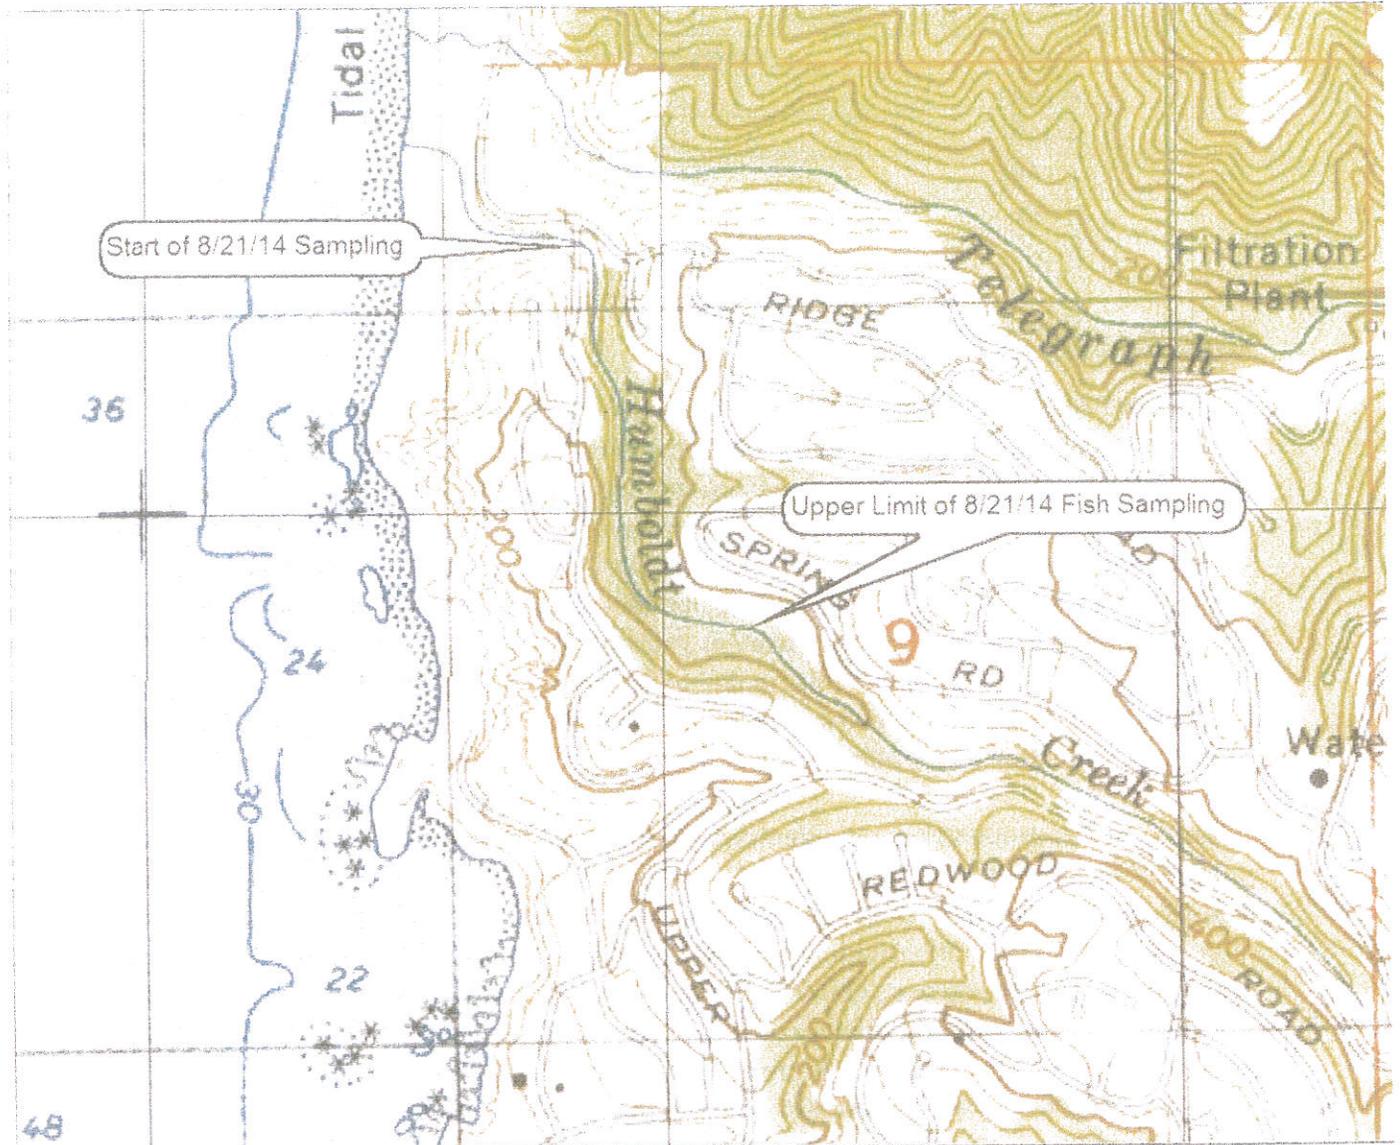
Humboldt Creek is a small coastal watershed with a drainage area of approximately 0.32 square miles (200 acres) located in Shelter Cove, California (Figure 1). Humboldt Creek has approximately 7,200 feet on blue-line channel on the USGS topographic map (Figure 1). The mouth of Humboldt Creek enters the Pacific Ocean just south of Telegraph Creek.

Figure 1. Start and end locations of fish presence-absence sampling conducted by RTA on Humboldt Creek

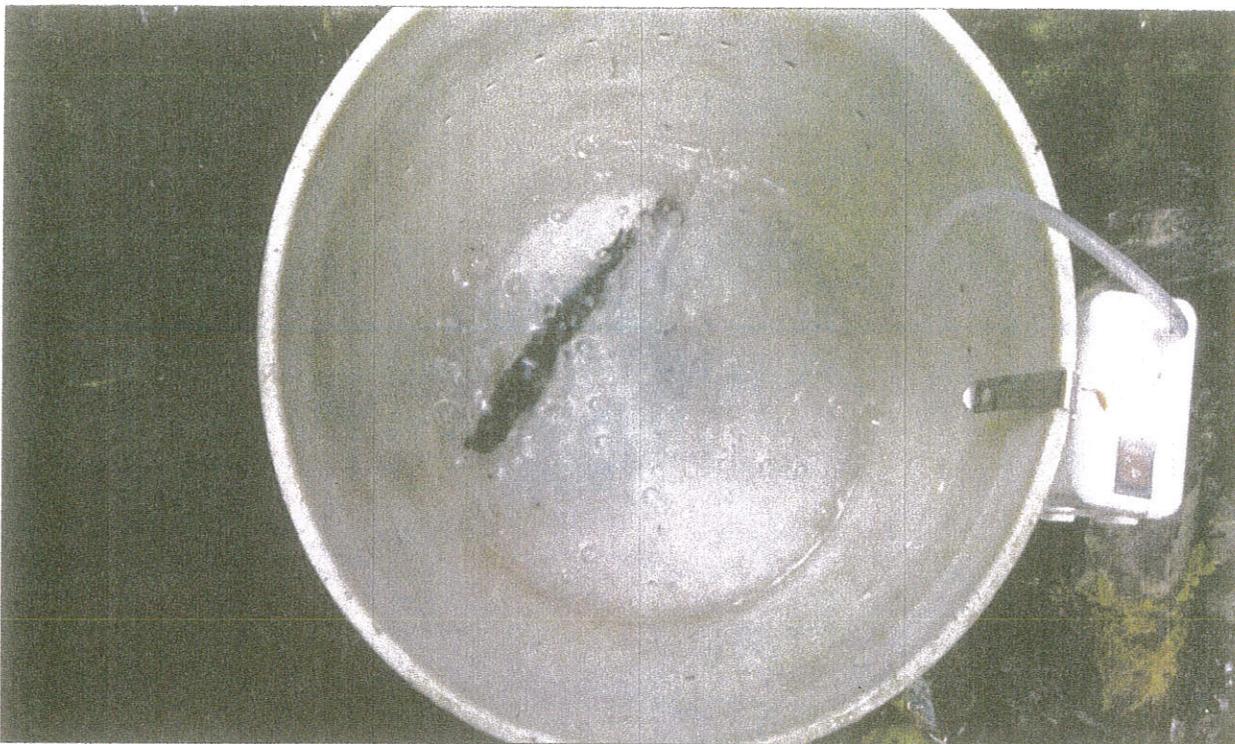
Photographs were taken of some of the fish and BMI's captured within the reach of Humboldt Creek sampled on 8/21/14 (Figures 2-7). All captured fish were in good condition when released, no mortalities occurred.

Figure 2. Coastal rainbow trout from Humboldt Creek in aerated bucket on 8/21/14.

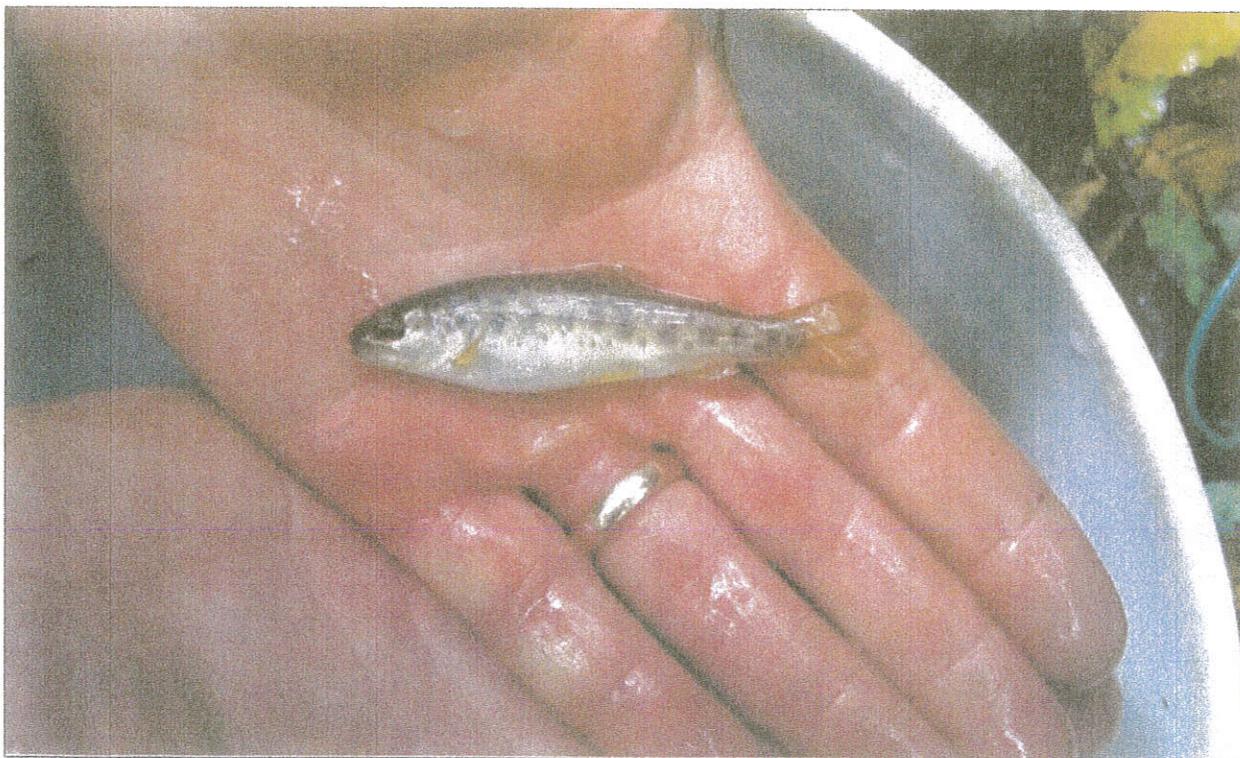
Figure 3. Coastal rainbow trout sampled in Humboldt Creek from pool #3 on 8/21/14.

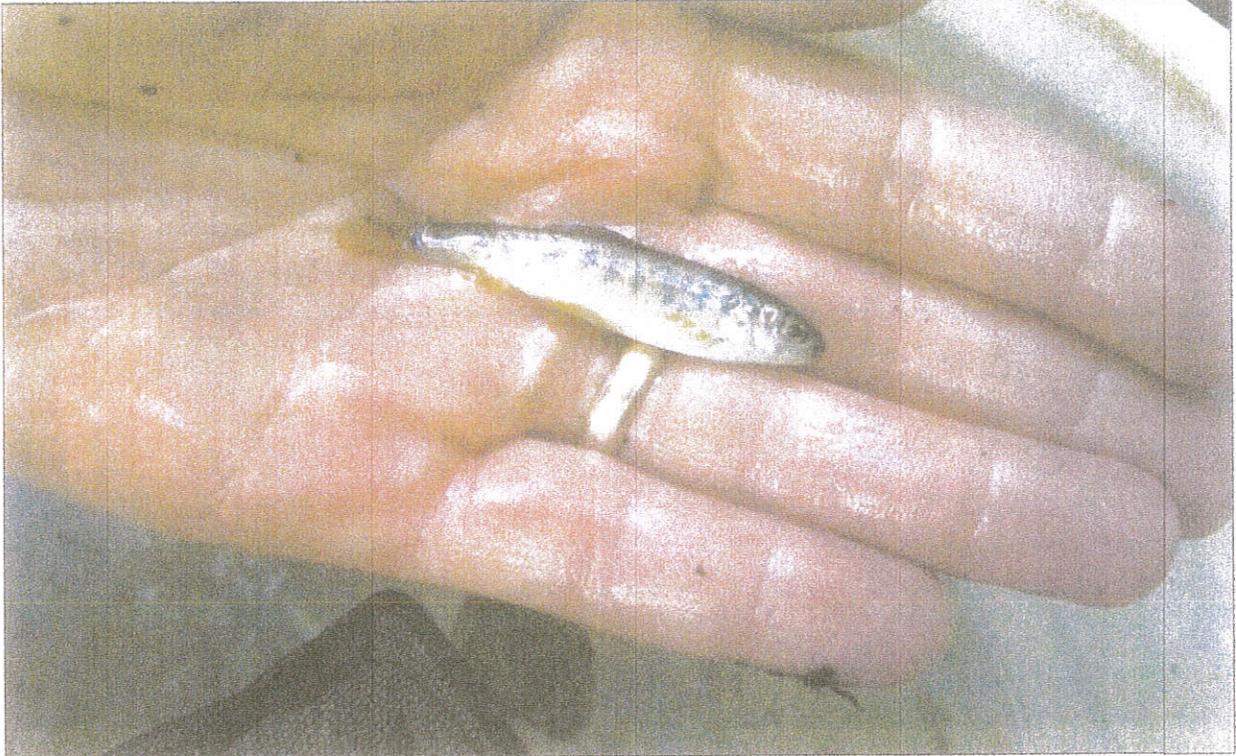
Figure 4. Age-0 coastal rainbow trout sampled in Humboldt Creek from pool #5 on 8/21/14.

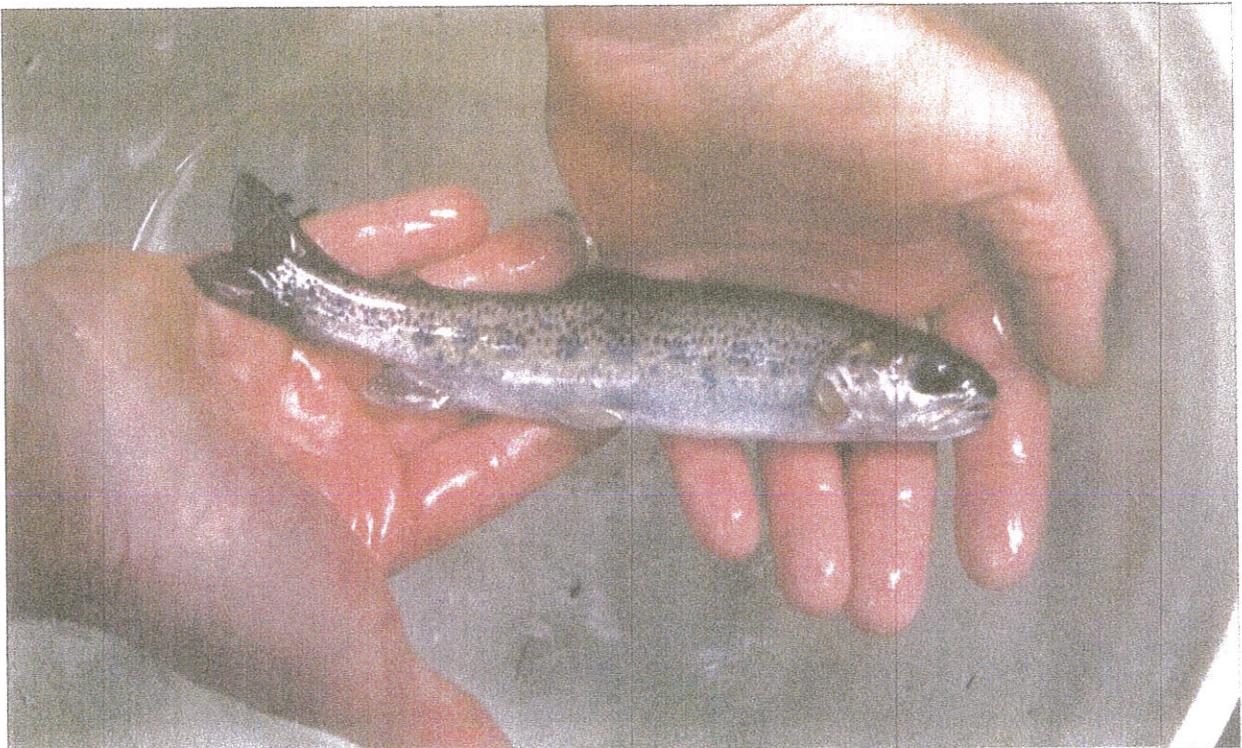
Figure 5. Coastal rainbow trout sampled in Humboldt Creek from pool #11 on 8/21/14.

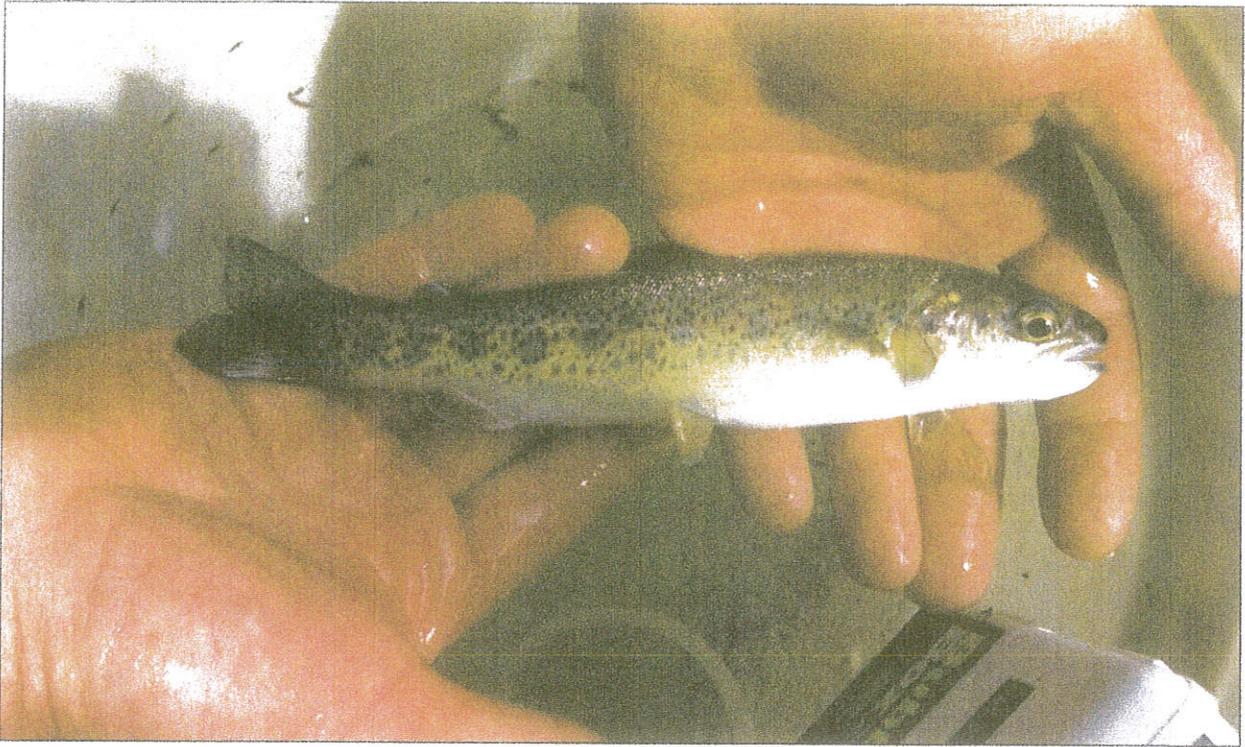
Figure 6. Coastal rainbow trout sampled in Humboldt Creek from pool #16 on 8/21/14.

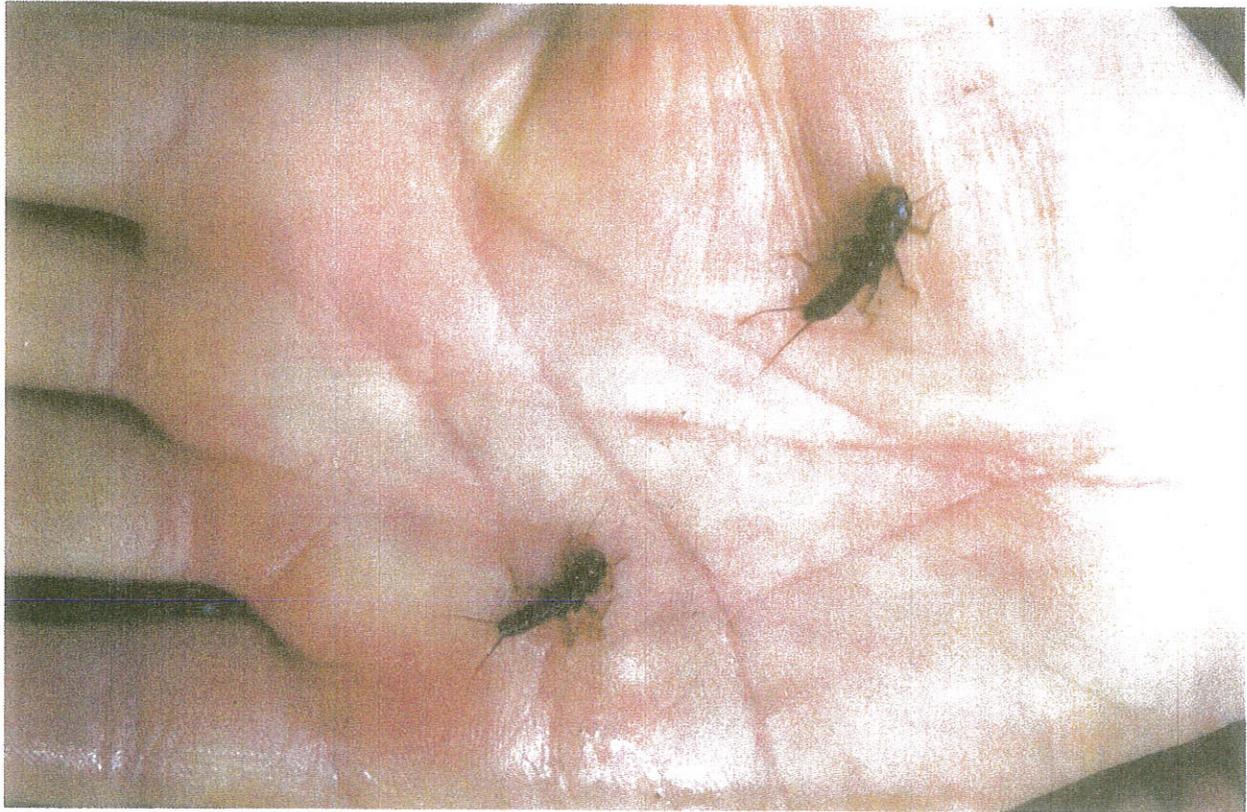
Figure 7. Stoneflies sampled in Humboldt Creek on 8/21/14.
