### **Accessibility / Recreational Assessment**

July 18, 2013

Re: Kilarc-Cow Creek Hydroelectric Project  
FERC Project No. 606  
Environmental Impact Report – Accessibility/Recreational Assessment

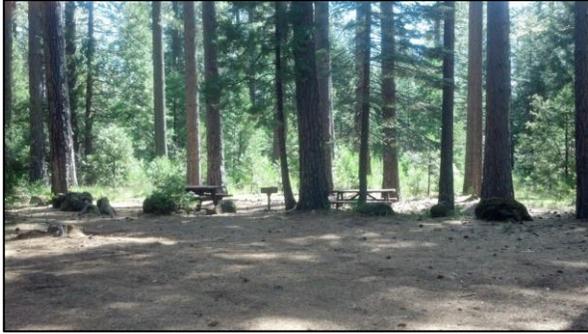
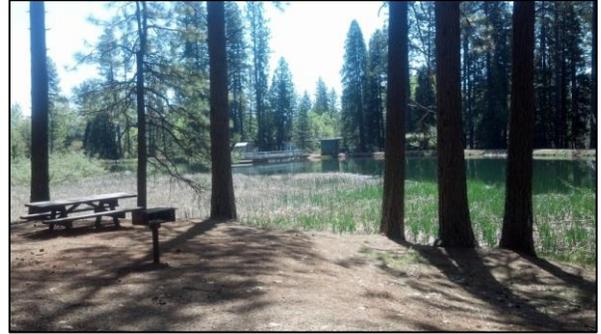
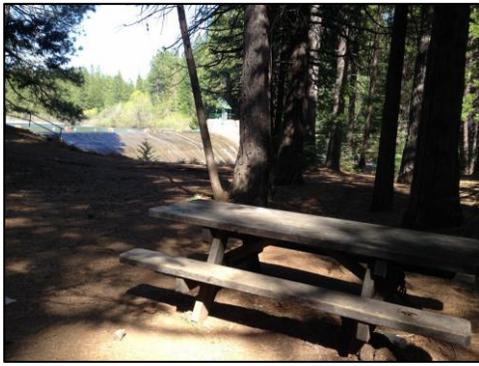
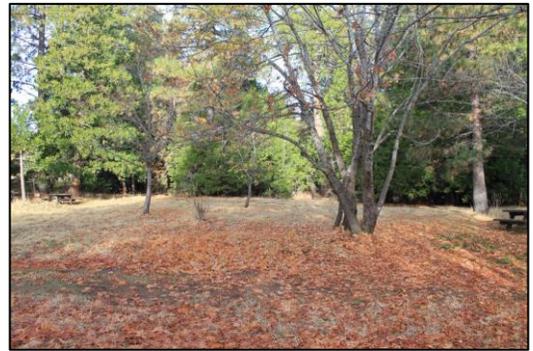
Parking at each site was essentially the same with accessible, level, dirt parking spots just off the entrance road to each site, as well as in and around the picnic areas. Overall, access at each site is limited to the vicinity surrounding each water body; there are no trails apparent at any of the sites. Access and ease of use of the picnic areas was relatively similar among all sites with level, unpaved ground leading up to accessible picnic tables, as shown in Figures 2-5.

Figure 2: Picnic Area, Lake Grace

Figure 3: Picnic Area, Lake Nora

Figure 4: Picnic Area, McCumber Lake

Figure 5: Picnic Area, Kilarc Forebay

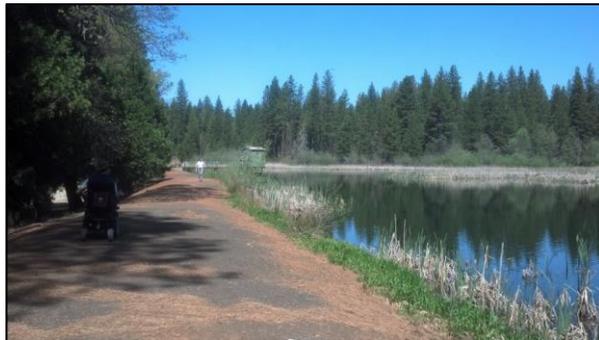
Pedestrian pathways were limited to berms surrounding each water body. The berm surrounding Lake Grace was accessible with a wheelchair near the spillway, although the slope going up to the berm is somewhat steep, but is accessible. Once on the berm, it was relatively easy to traverse along the southwestern perimeter of the lake, as shown in Figure 6. There was no wheelchair access to the berm surrounding Lake Nora on either side; a closed gate (Figure 7) was encountered on the northern end, and an impassable footbridge that crossed over the spillway channel was encountered at the southern end of the lake. Thus, the only accessible area at Lake Nora was the relatively small vicinity around picnic tables located along the eastern perimeter of the lake (Figure 2). Similarly, there was no easy access to the berm surrounding the southwestern perimeter of McCumber Lake, as the slope from the picnic area up to the top of the berm was very steep, as shown in Figure 8, and would generally be considered not accessible.

Figure 6: Pedestrian Path, Lake Grace

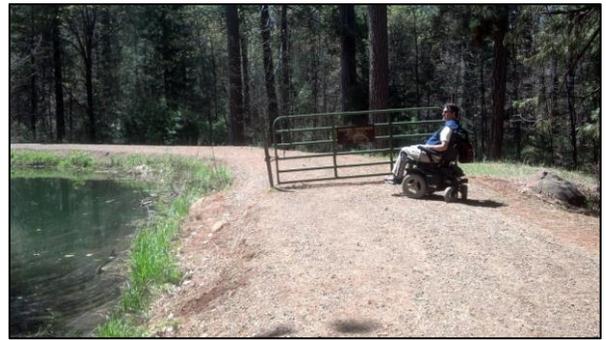
Figure 7: Pedestrian Path, Lake Nora

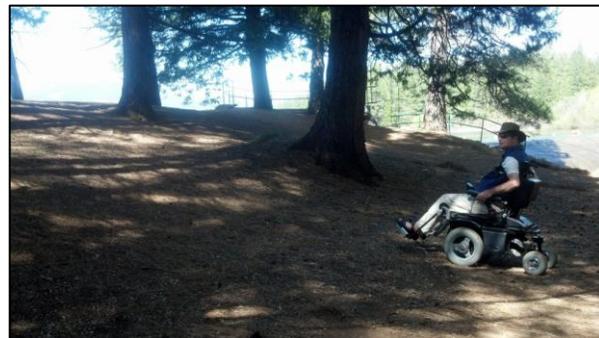
Figure 8: Pedestrian Path, McCumber Lake

1. Construct an ADA compliant ramp up to and along the top of the berm near the day use area/southwestern perimeter of the lake;
2. Construct a walkway with stopping points (“pull outs”) to facilitate places to enjoy the surroundings, fish, read, etc. along the eastern perimeter of the lake with access near the eastern side of the spillway/just off Deer Flat Road; and/or
3. Modify the unimproved (dirt-base) boat access ramp just off Ritts Mill Road/along the west side of the lake to make it handicap accessible.

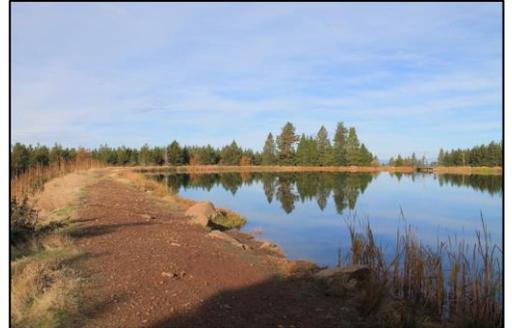
Accessible areas at McCumber Lake were thus limited to the relatively small vicinity around picnic tables located along the southwestern perimeter of the lake and at a relatively small accessible campground. Access to the berm surrounding Kilarc Forebay can be gained from the southern side of the inlet that leads to a level, relatively smooth path that surrounds the entire Forebay (Figure 9).

Figure 9: Pedestrian Path, Kilarc Forebay

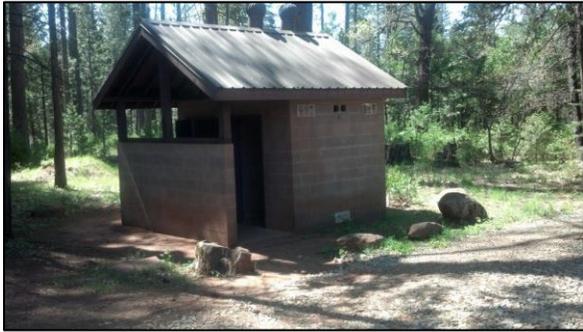
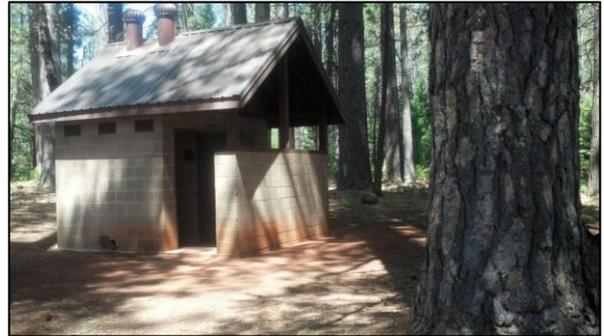
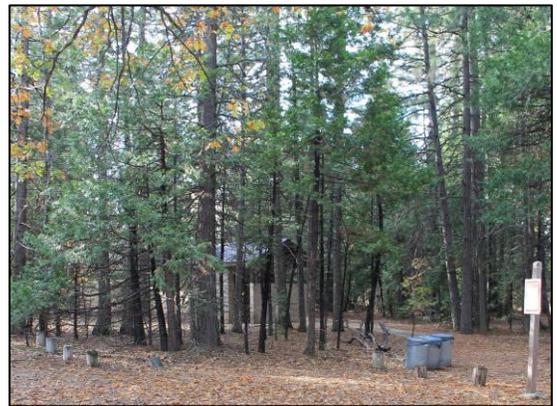
As stated above, all picnic areas and parking were comparable in both accessibility and for ease of use. Similarly, all sites had at least one “accessible” restroom (see Figures 10-13). It should be noted that the path to one of the McCumber Lake restrooms is paved and level (Figure 12); however, the entrances and interior sizes of the restrooms are somewhat small and certain wheelchairs may have difficulty negotiating going in and out of them. Furthermore, none of the restrooms at any of the sites had handrails for transferring onto the toilet.

Figure 10: Restrooms, Lake Grace

Figure 11: Restrooms, Lake Nora

Figure 13: Restrooms, Kilarc Forebay

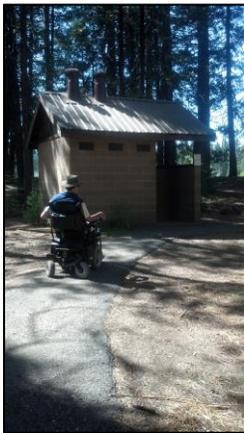
Figure 12: Restrooms, McCumber Lake

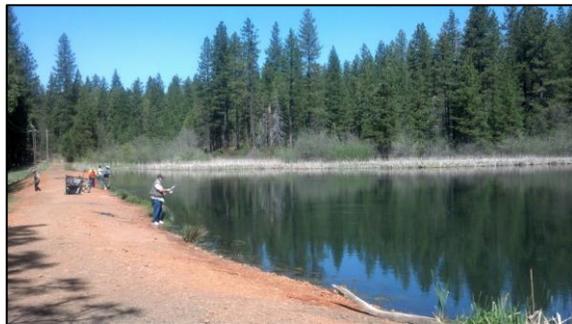
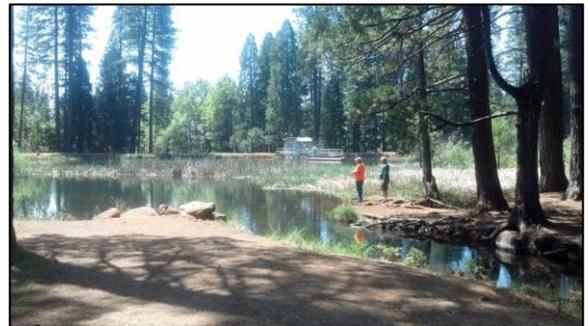
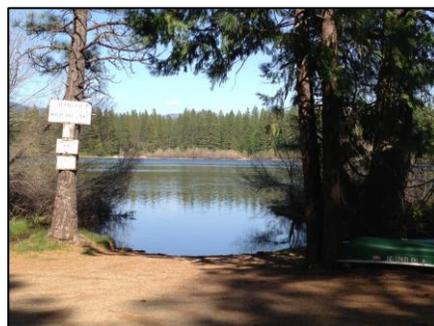
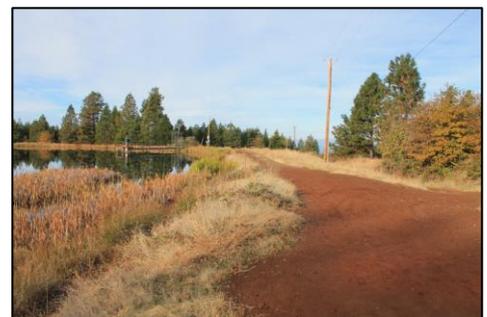
All lakes offered the possibility to fish, but differed in ease of doing so. At Lake Grace, once on the berm, there were numerous locations where an individual in a wheelchair could find a good spot to fish (Figure 14). Lake Nora was limited to locations in and around the picnic tables (Figure 15) and near the spillway due to an inaccessible footbridge crossing the spillway on one side and a gate on the other, as discussed above. The only somewhat accessible location at McCumber Lake was at the boat launch (Figure 16), but it would be difficult – at best – to fish at this location. In contrast, Kilarc Forebay offers numerous fishing locations along almost the entire berm surrounding the Forebay (Figure 17).

Figure 14: Fishing, Lake Grace

Figure 15: Fishing, Lake Nora

Figure 16: Fishing, McCumber Lake

Figure 17: Fishing, Kilarc Forebay

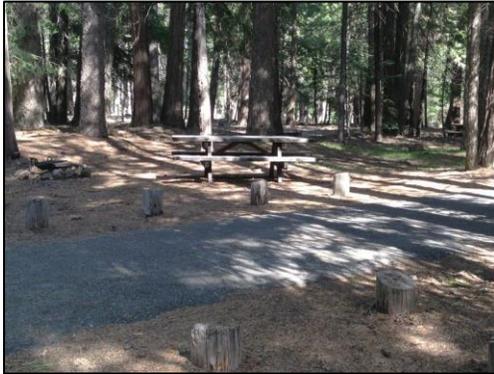
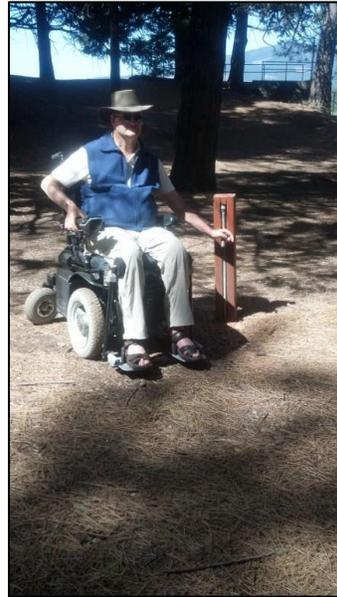
Other accessible amenities, not offered at any of the other sites, are available at McCumber Lake. These include accessible camping and water spigots, as shown in Figures 18 and 19, respectively.

Figure 18: Accessible campground, McCumber Lake

Figure 19: Accessible water spigot, McCumber Lake
