ENVIRONMENTAL CHECKLIST FORM

Relief Reach – Kennedy Meadows Riparian Restoration and Streambank Stabilization Project

APPENDIX B
PROJECT REACH PHOTOGRAPHS

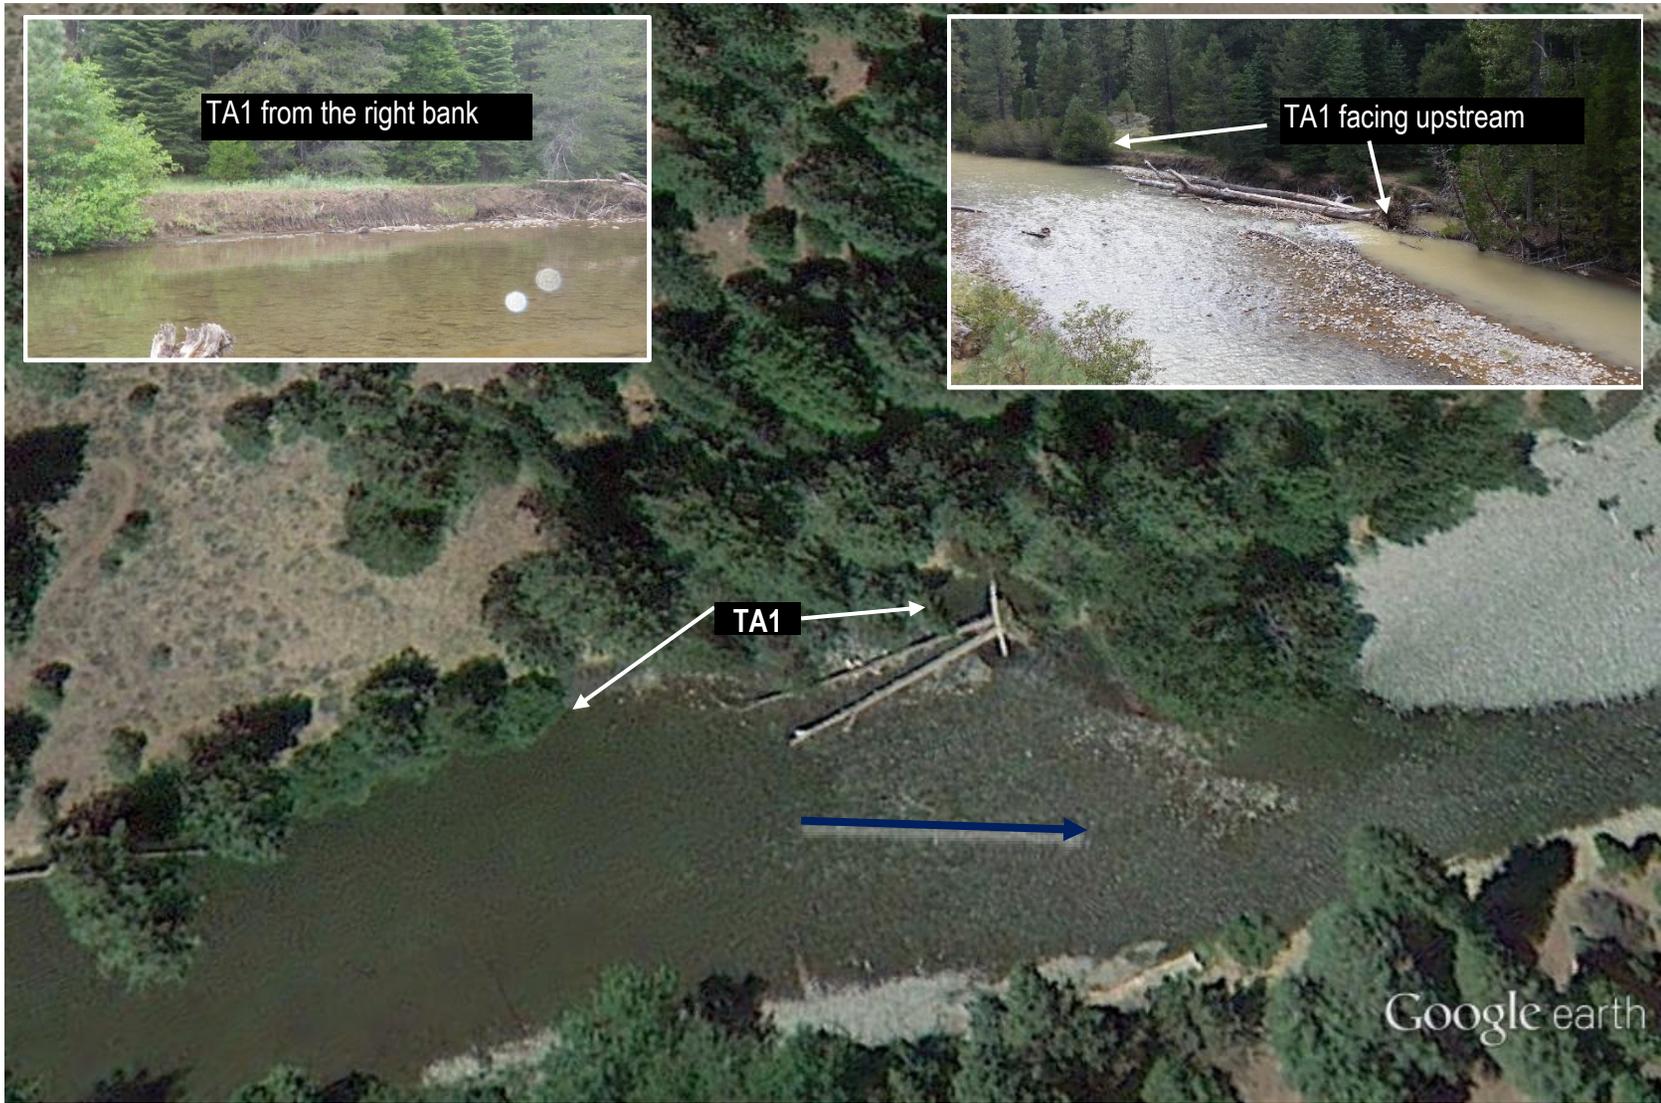
Treatment Area 1

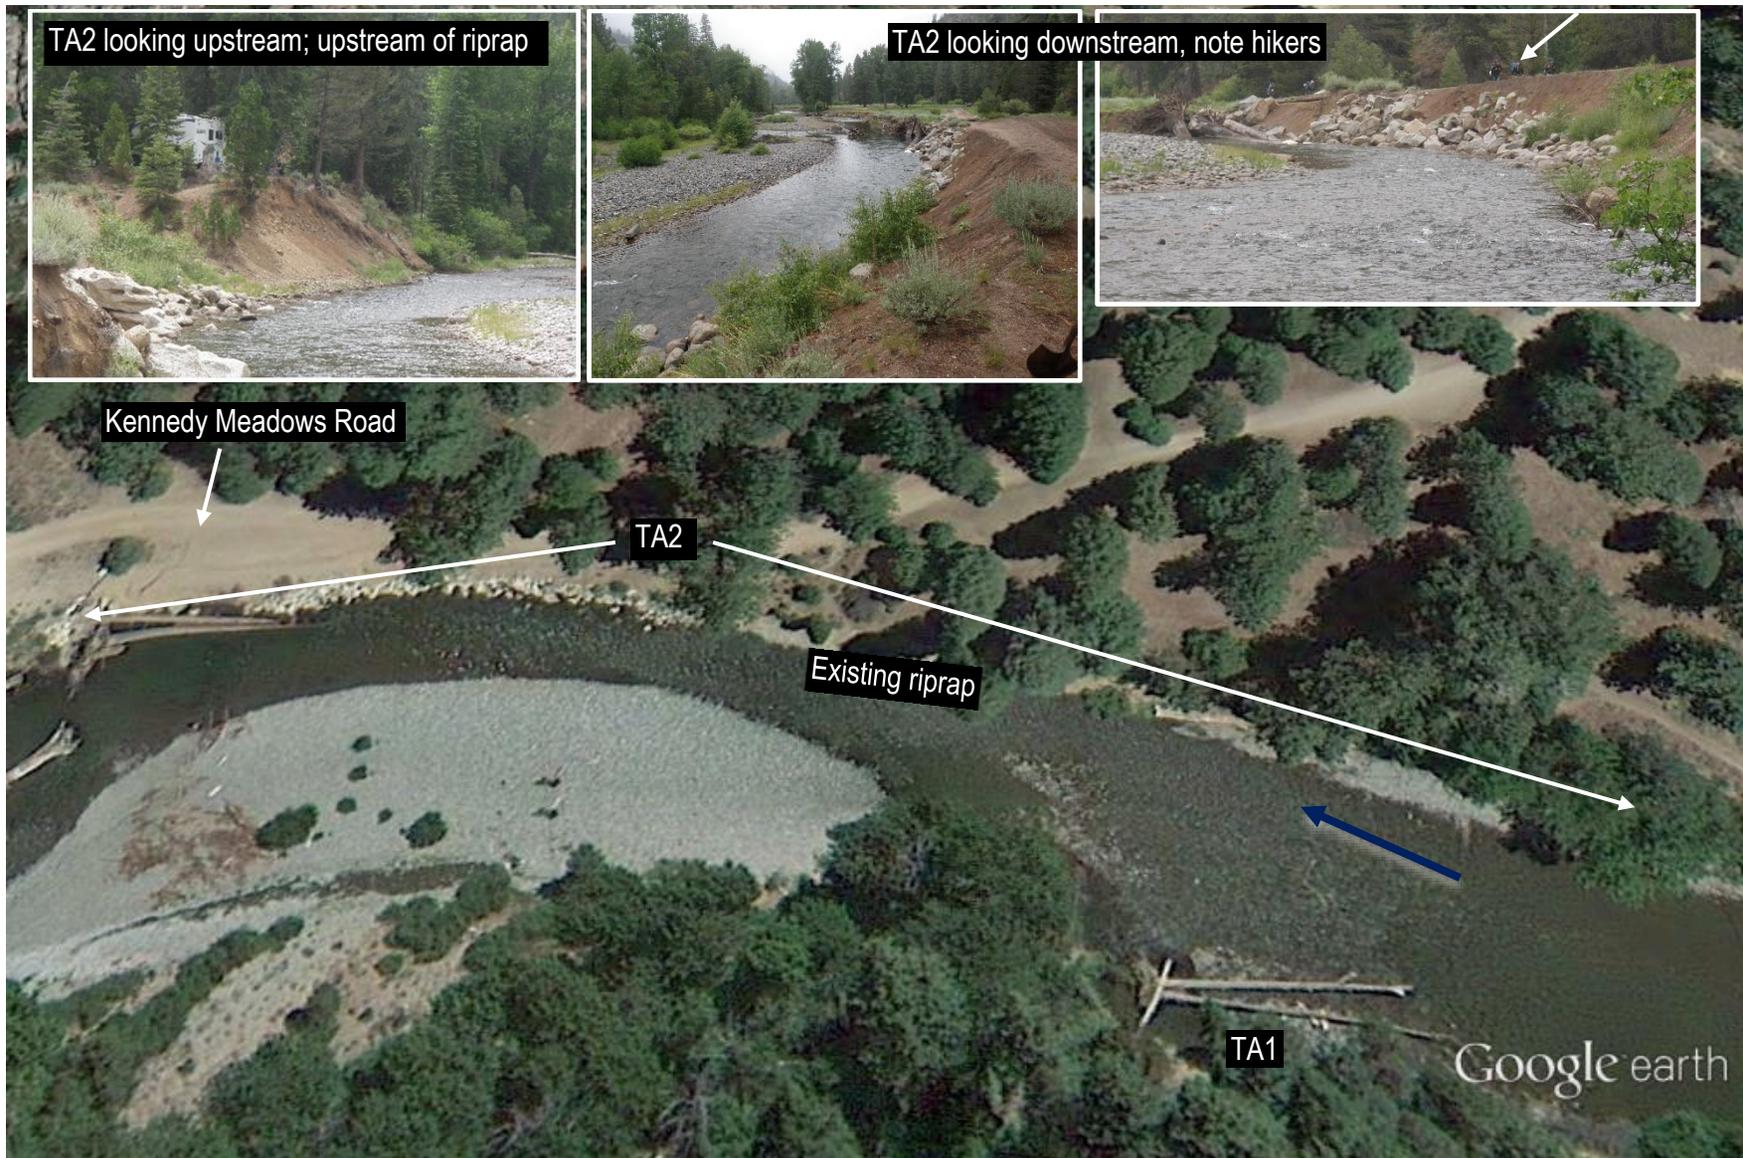
Treatment Area 2

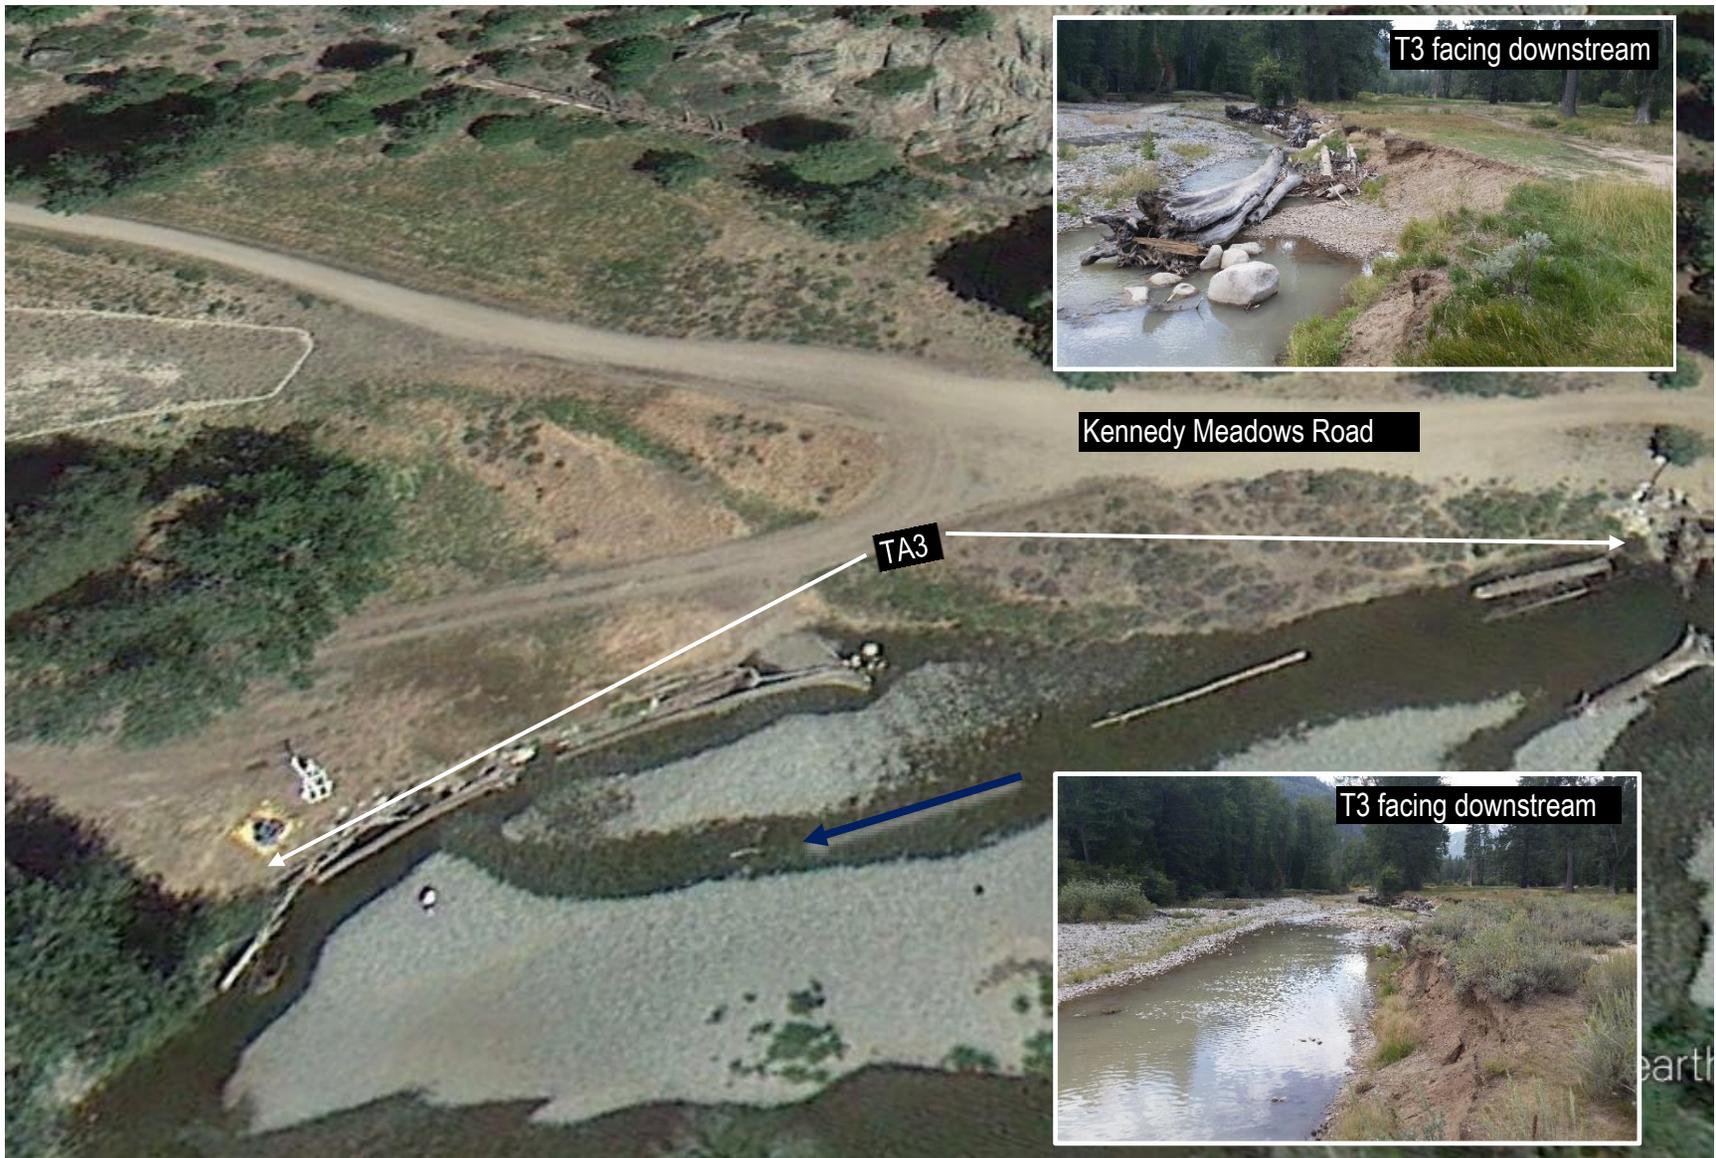
Treatment Area 3

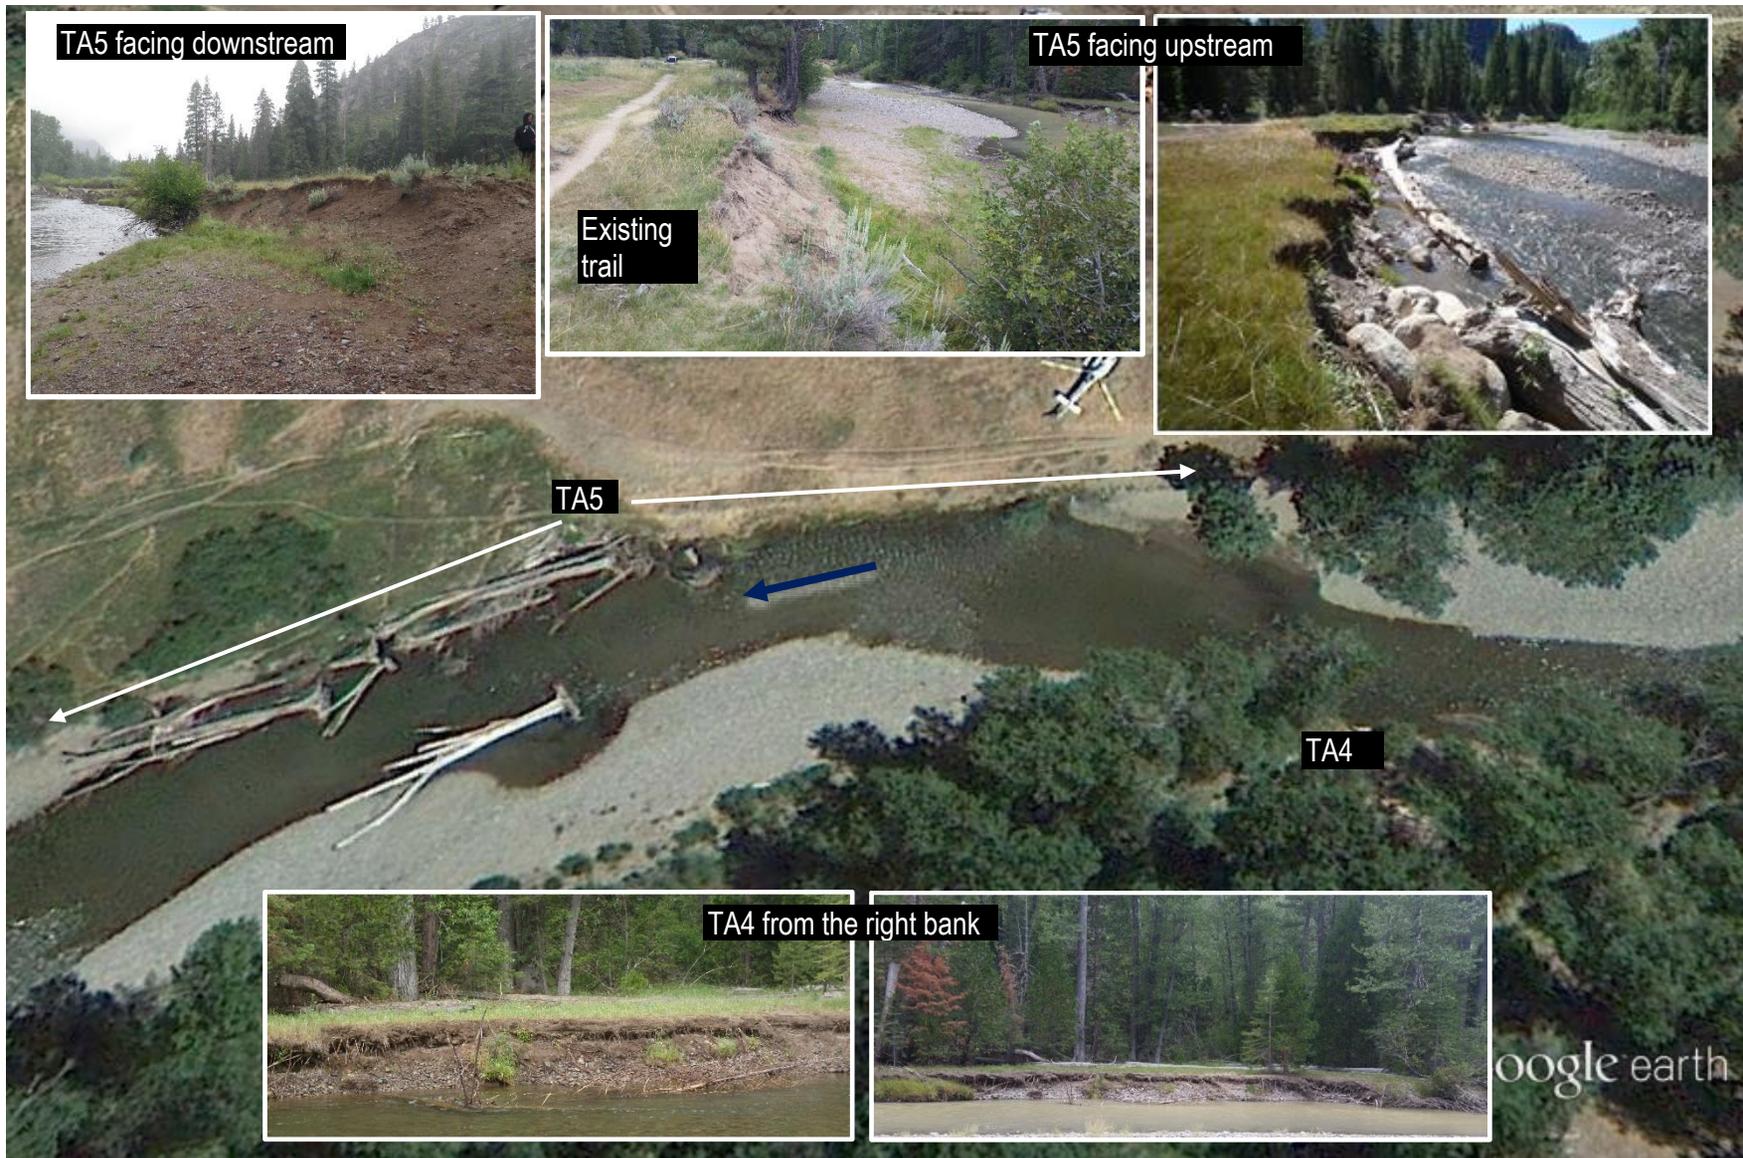
Treatment Areas 4 and 5

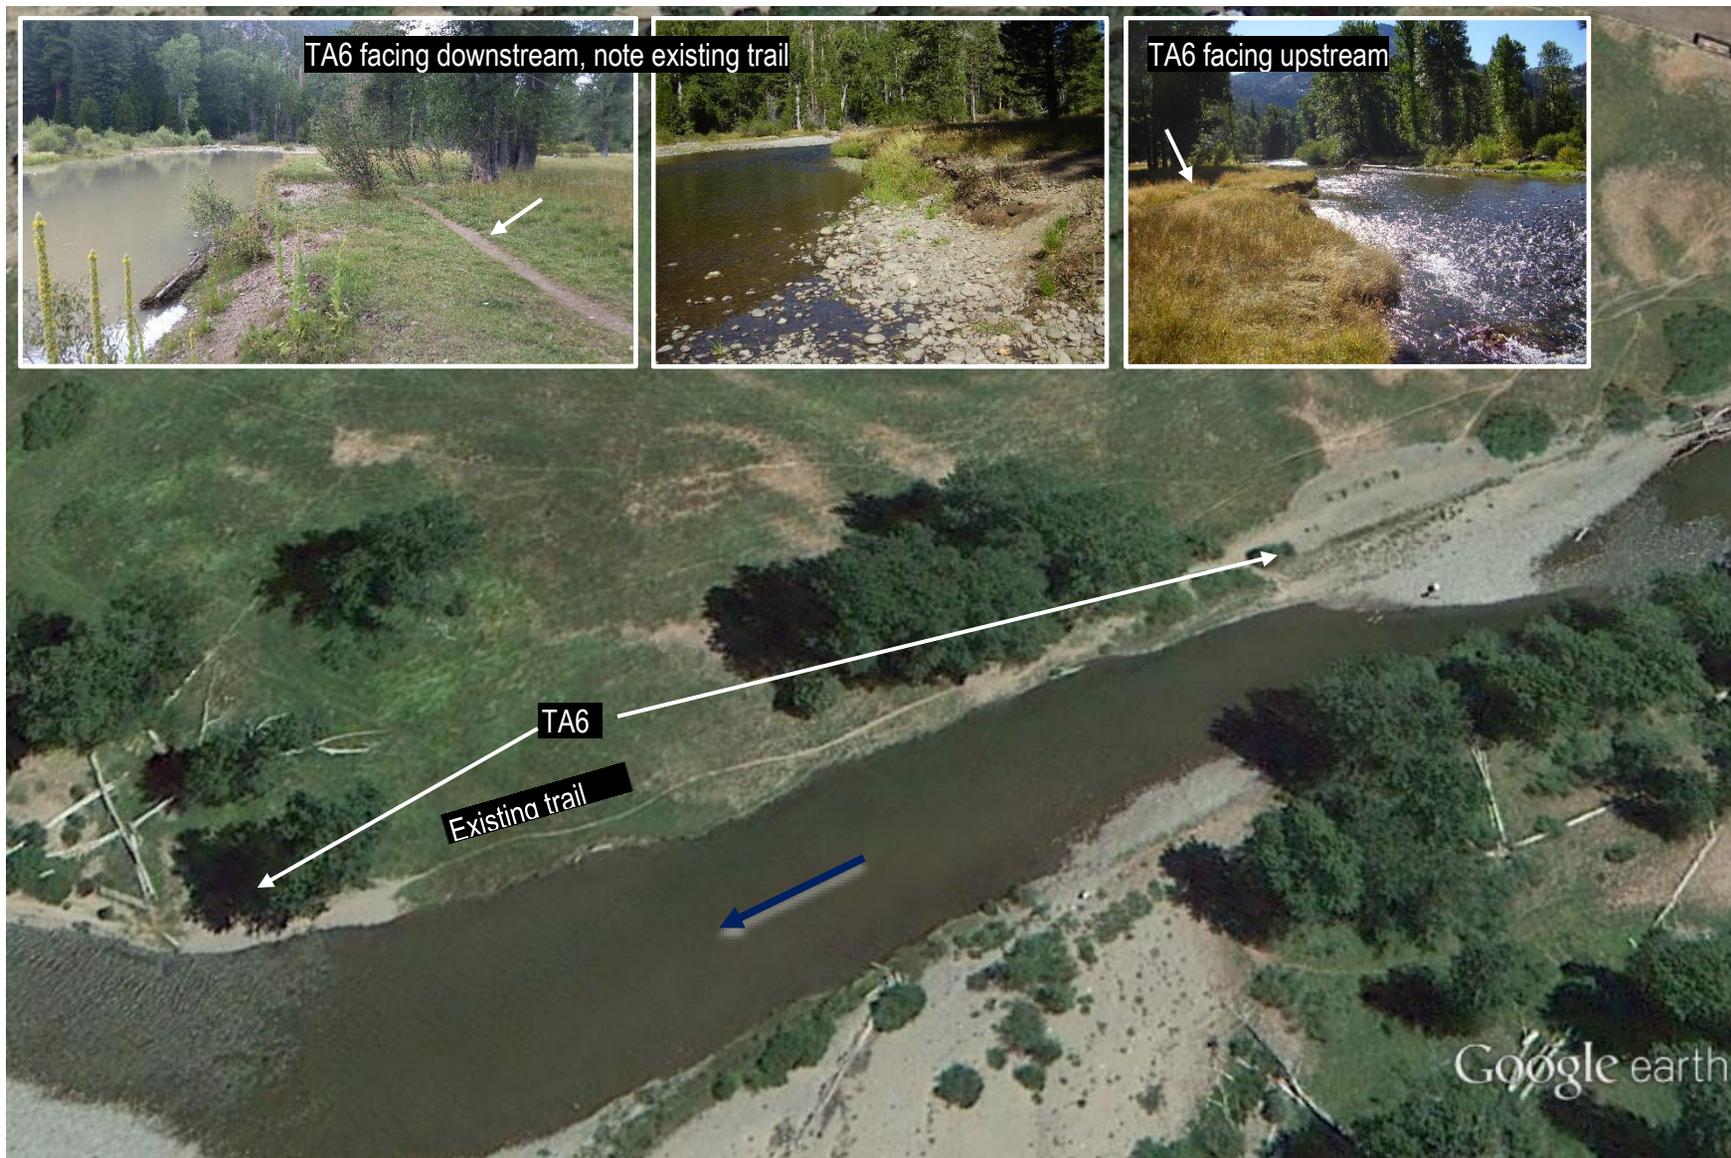
Treatment Area 6

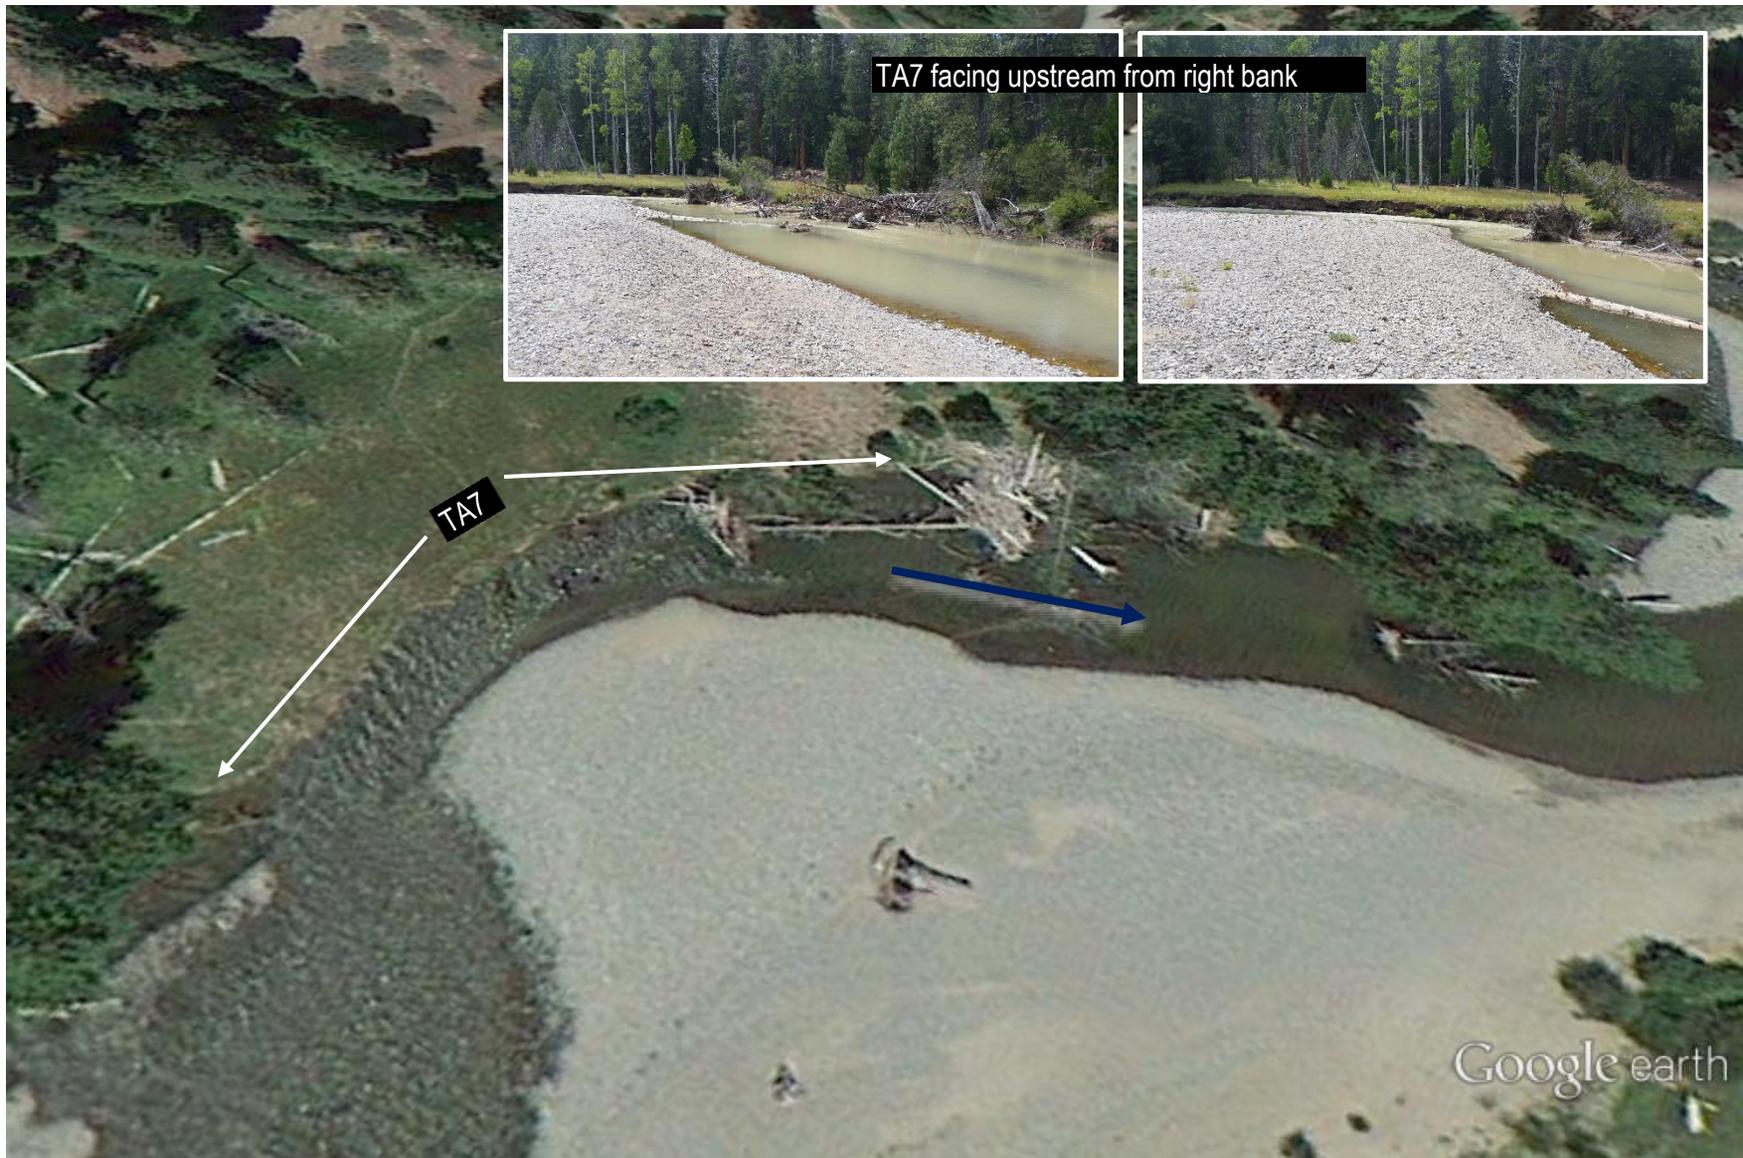
Treatment Area 7

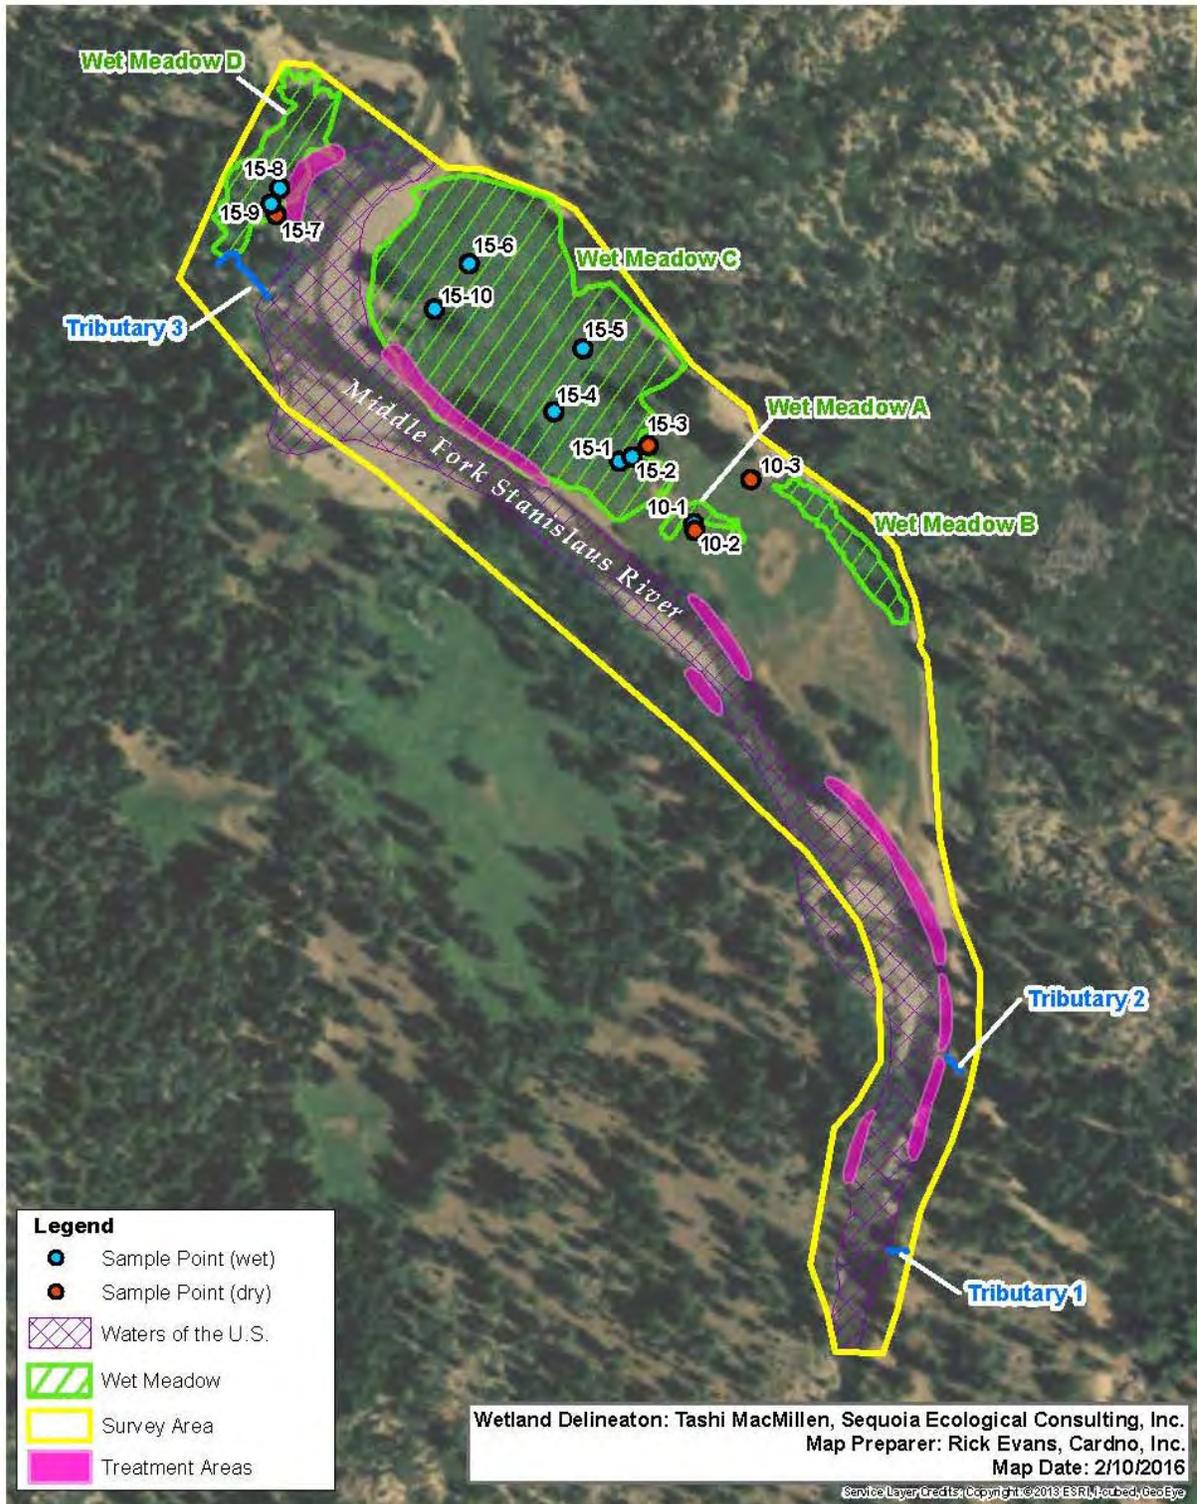
Figure A-1
Wetland Delineation and Other Waters of the U.S.

Figure A-1. Spring Gap Stanislaus Project: Relief Reach – Kennedy Meadows Riparian Restoration and Streambank Stabilization - Wetland Delineation and Other Waters of the U.S.

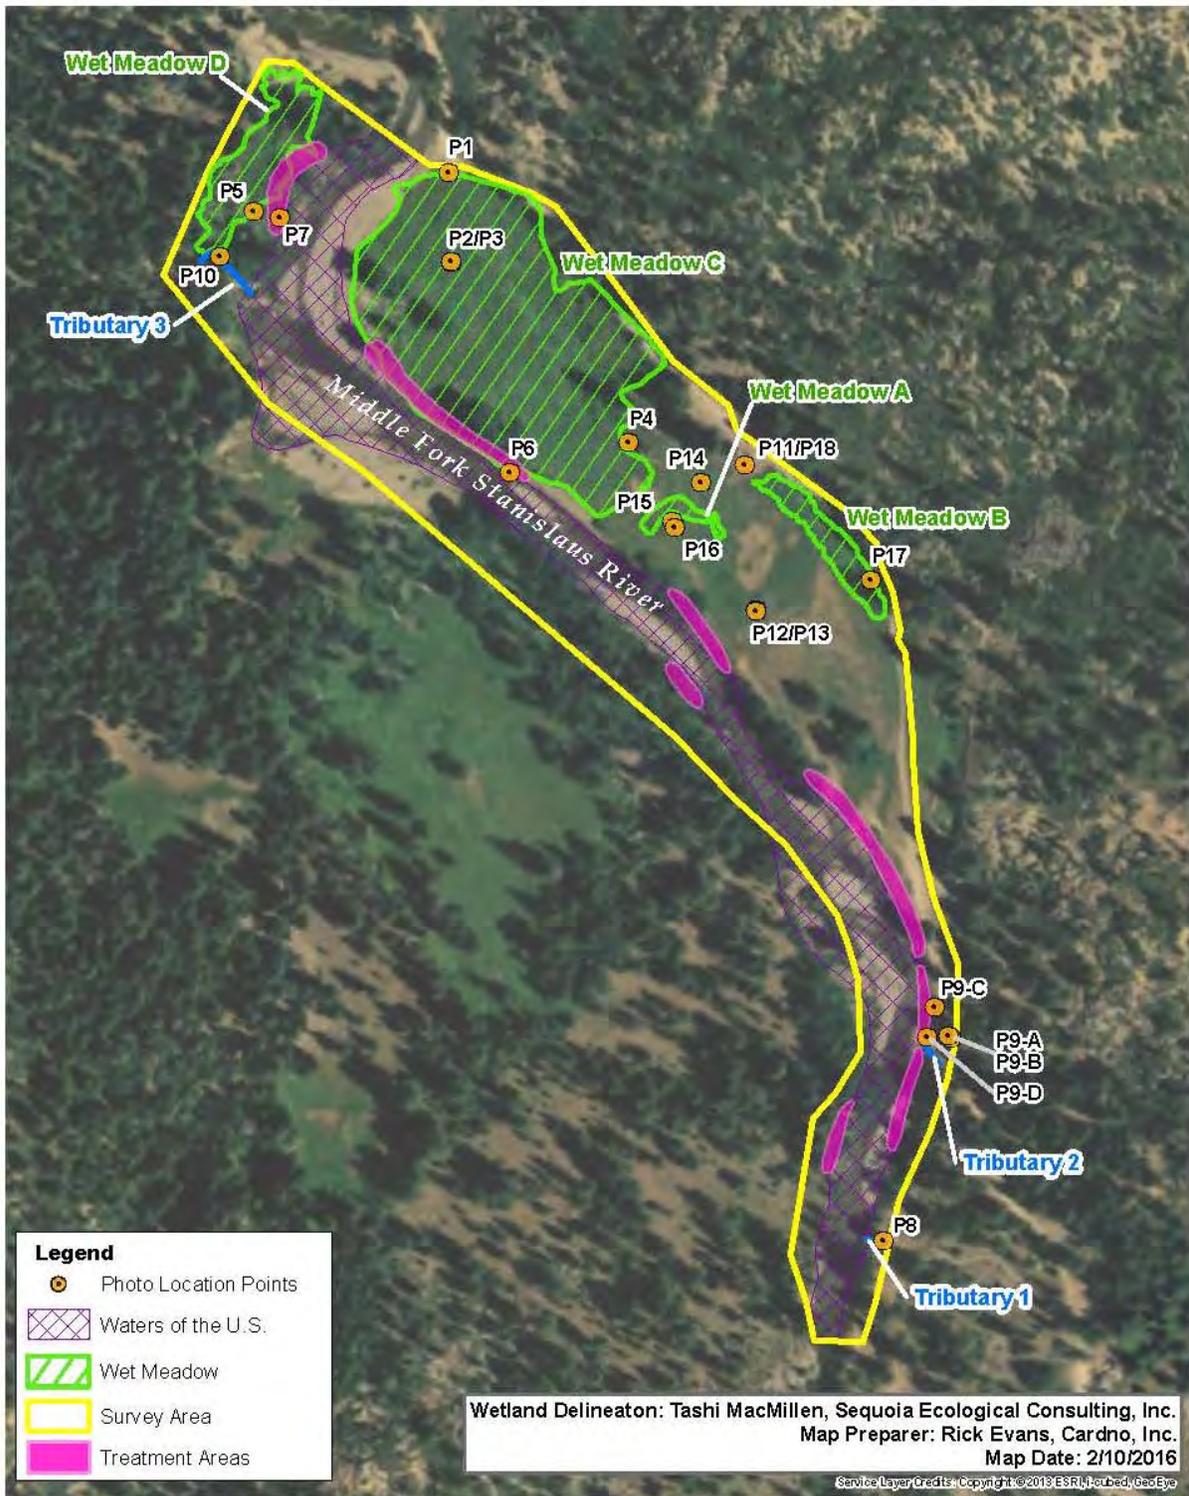
Figure A-2
Wetland Delineation and Other Waters of the U.S.
Photo Point Locations

Figure A-2. Spring Gap Stanislaus Project: Relief Reach – Kennedy Meadows Riparian Restoration and Streambank Stabilization - Wetland Delineation and Other Waters of the U.S. Photo Point Locations.

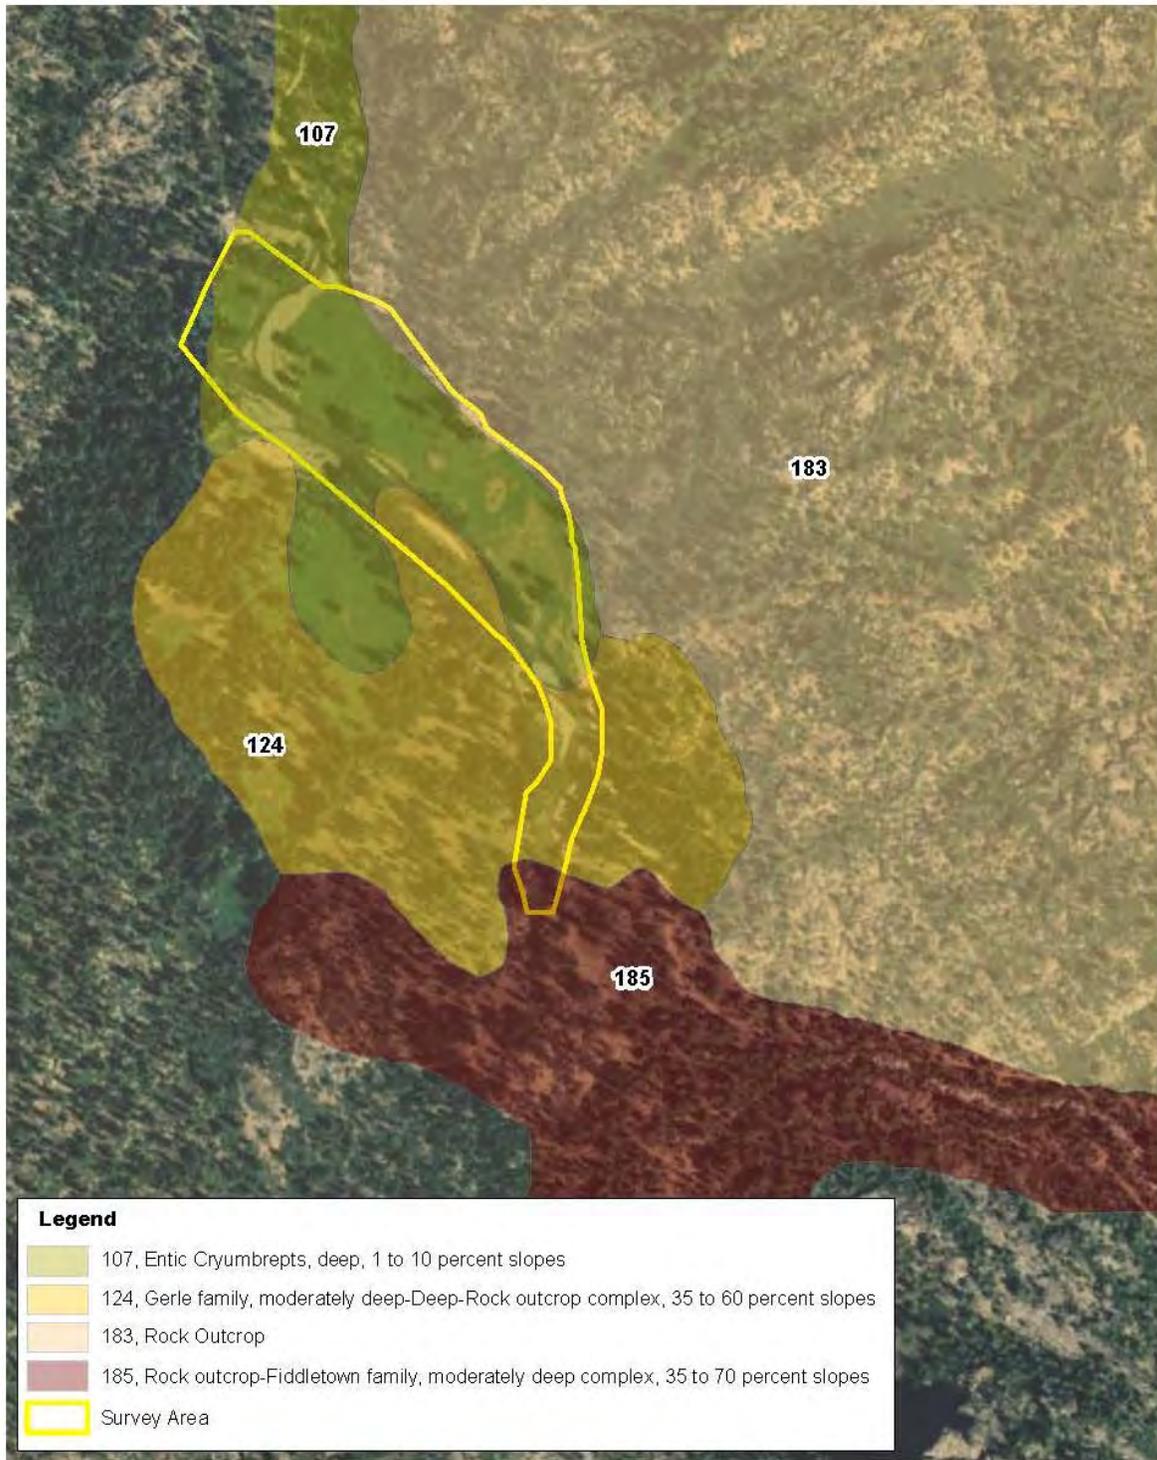
Figure B-3
Soils Map in the Vicinity of the Project Reach

Figure B-3. Spring Gap Stanislaus Project: Relief Reach – Kennedy Meadows Riparian Restoration and Streambank Stabilization – Soils Map in the Vicinity of the Project Reach

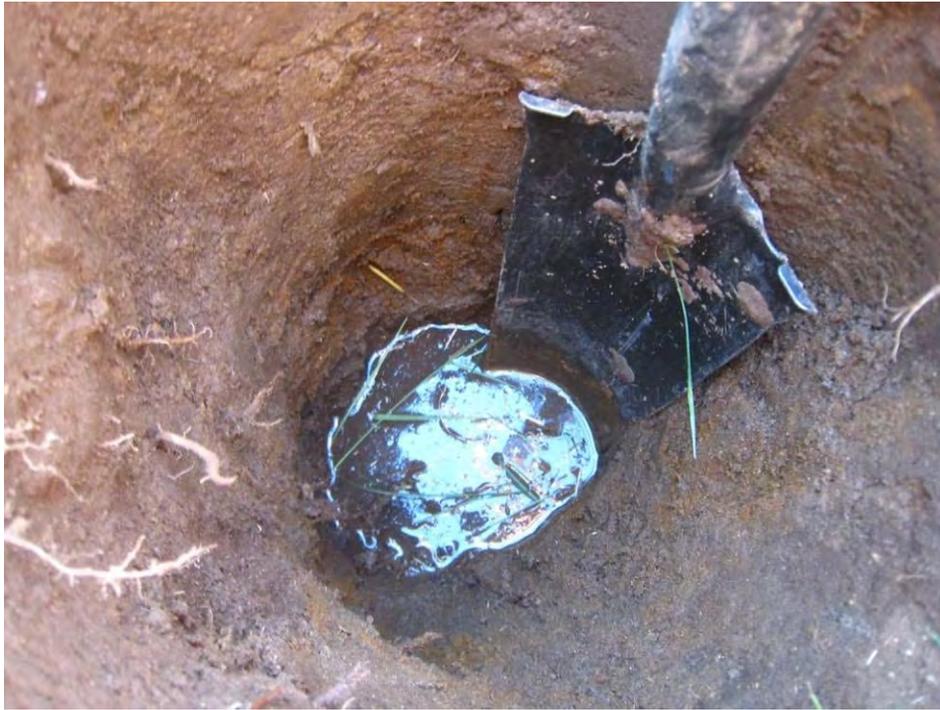
Photograph 3.

Sample Point 15-6, this sample point did meet the USACE wetland criteria.

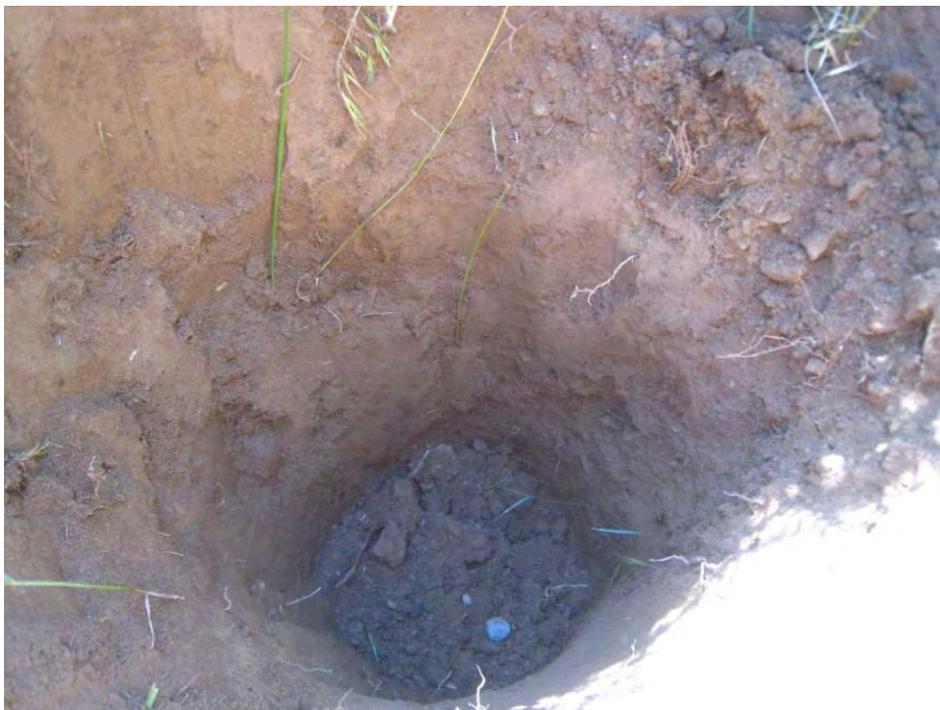
Photograph 4.

Sample Point 15-3 in upland area adjacent to Wet Meadow C. This sample point did not meet the USACE wetland criteria. Rounded grey item in pit is small rock.

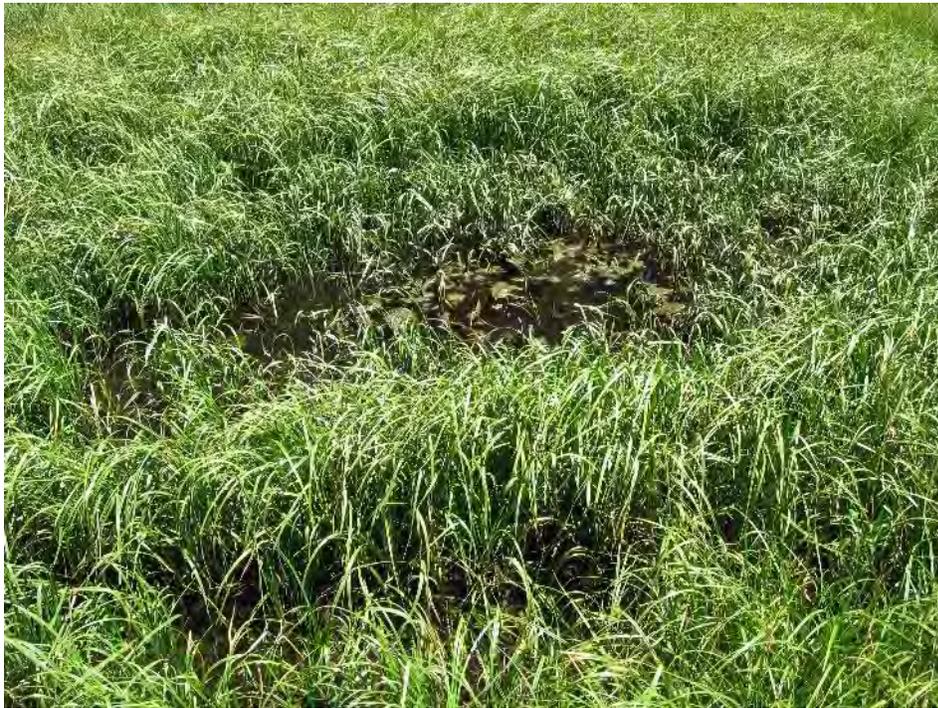
Photograph 15.

Wet Meadow A,
Sample Point
10-1. This
sample site did
meet the Army
Corp of
Engineers
wetland criteria.

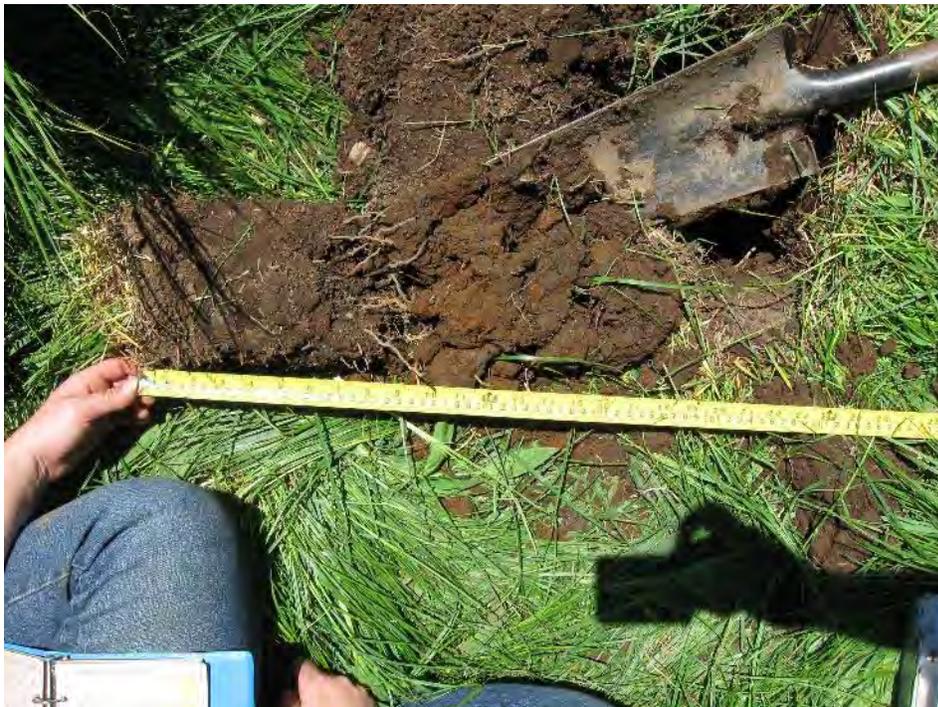
Photograph 16.

Sample Pit Point
10-2. This
sample site did
not meet the
Army Corp of
Engineers
wetland criteria.

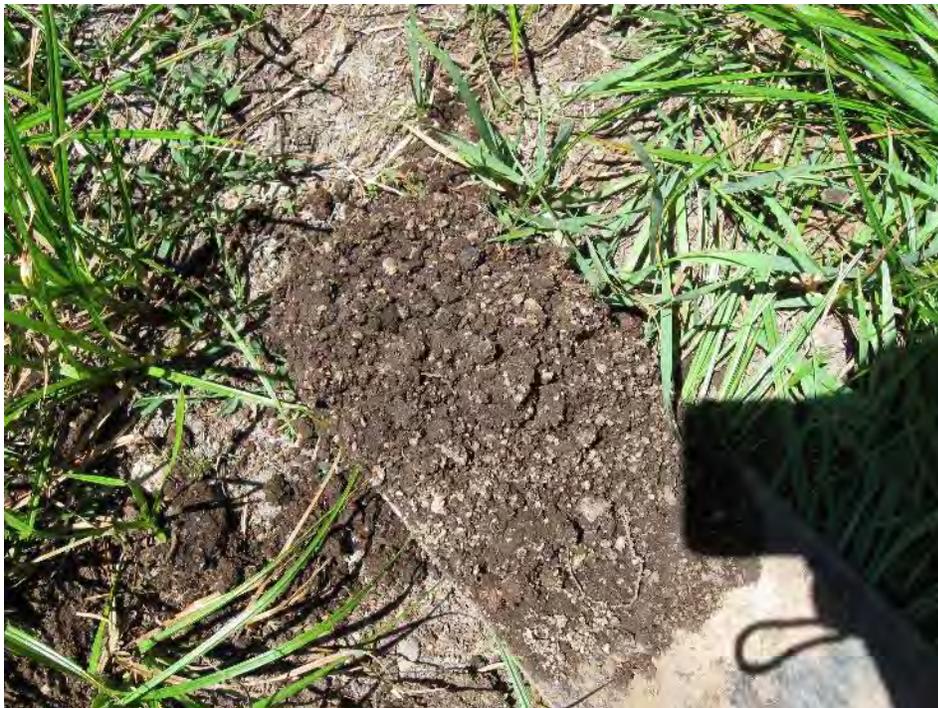
Photograph 18.

Sample Point
10-3. This
sample site did
not meet the
Army Corp of
Engineers
wetland criteria.
