ENVIRONMENTAL CHECKLIST FORM

Relief Reach – Kennedy Meadows Riparian Restoration and Streambank Stabilization Project

APPENDIX B
PROJECT REACH PHOTOGRAPHS

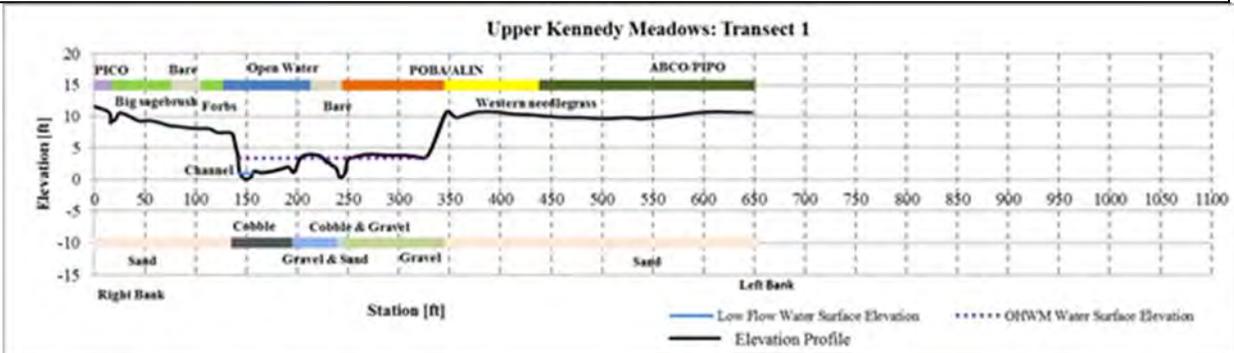
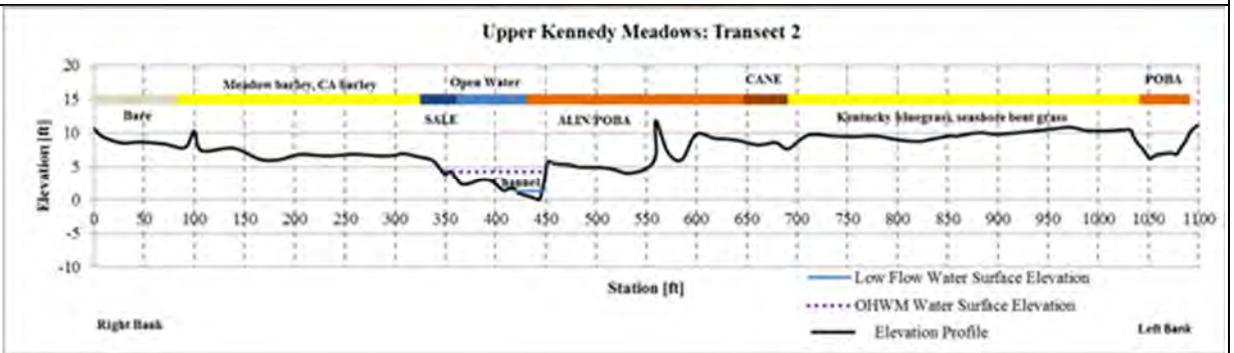
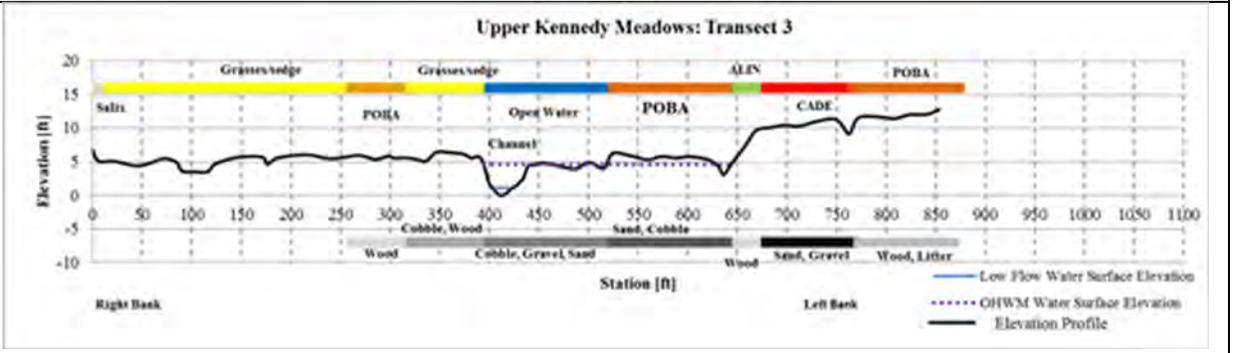
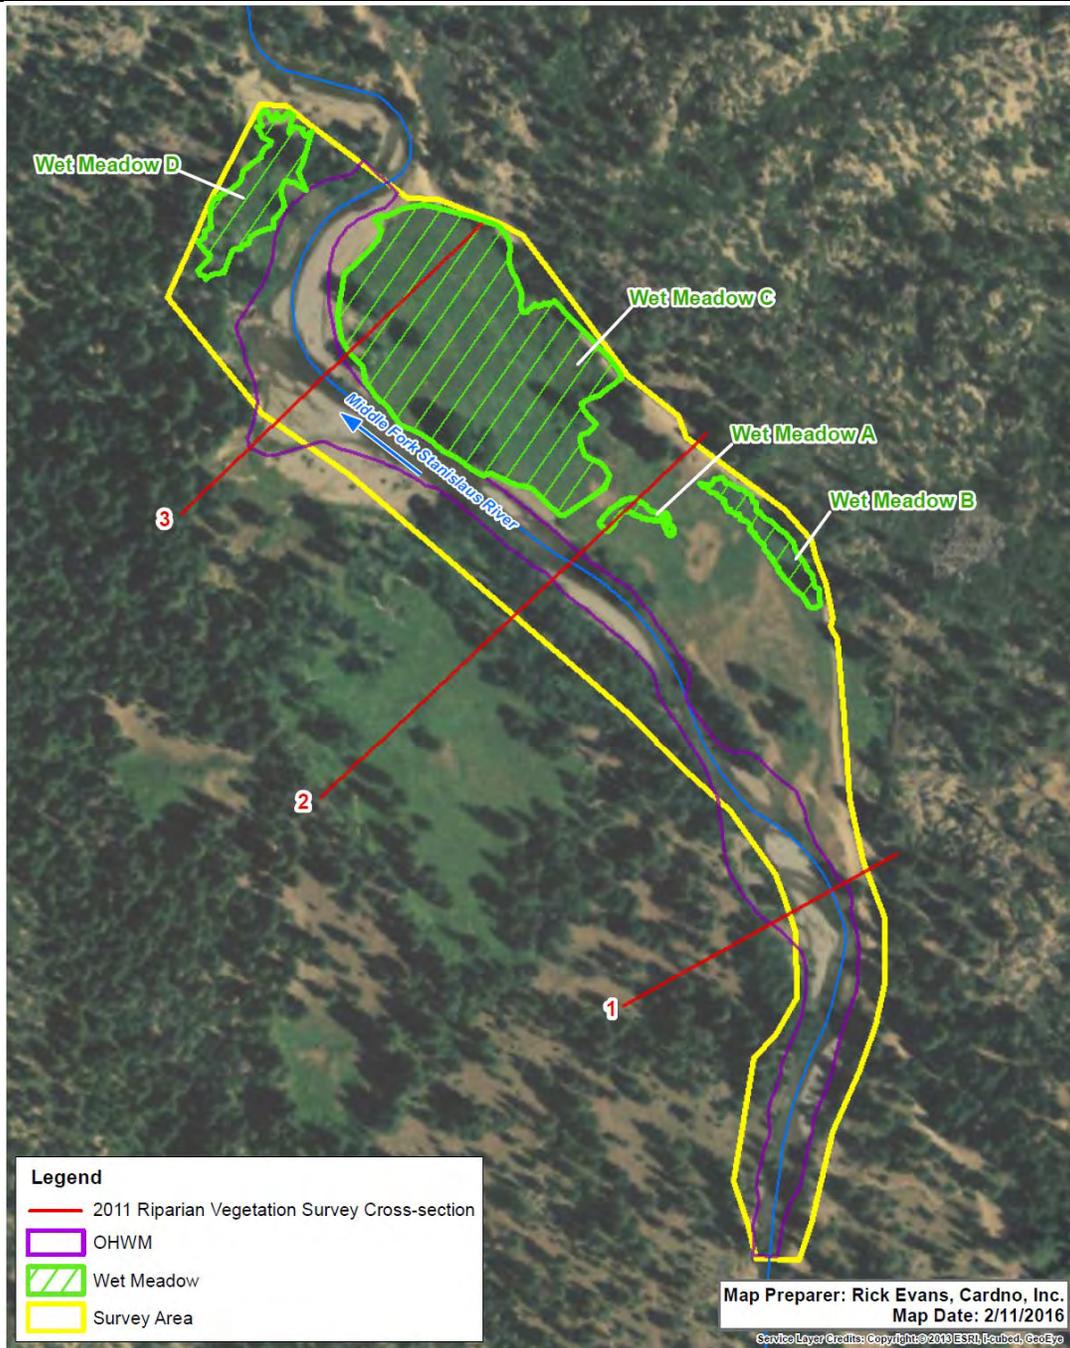
PG&E Spring Gap-Stanislaus Project:
Relief Reach - Kennedy Meadows Riparian Restoration
and Streambank Stabilization
Riparian Survey Cross-Sections

Three cross-sections were surveyed in 2011 as part of the Relief Reach – Riparian Restoration and Streambank Stabilization studies. These surveyed cross-sections, with vegetation community locations and the OHWM are shown below. A map, with the aerial imagery, shows the locations of these cross-section in relation to the mapped wetland features within the survey area.

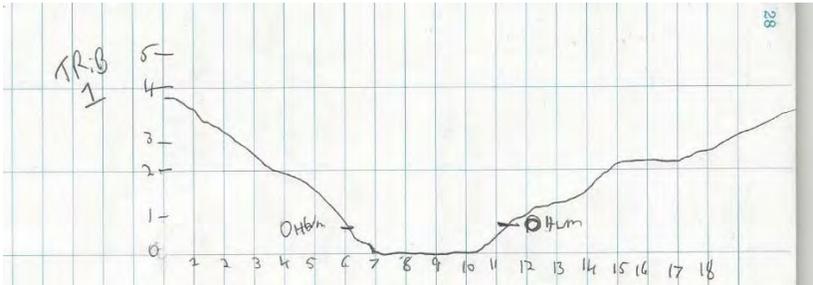
Tributary 1, Datasheet #: 2

Break in Slope at OHWM: Sharp (> 60%) Moderate (30–60%) x Gentle (< 30%)
 None

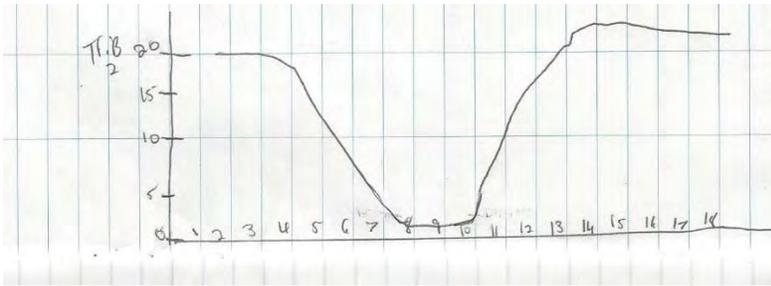
Tributary 2, Datasheet #: 3

Break in Slope at OHWM: Sharp (> 60%) Moderate (30–60%) x Gentle (< 30%)
None

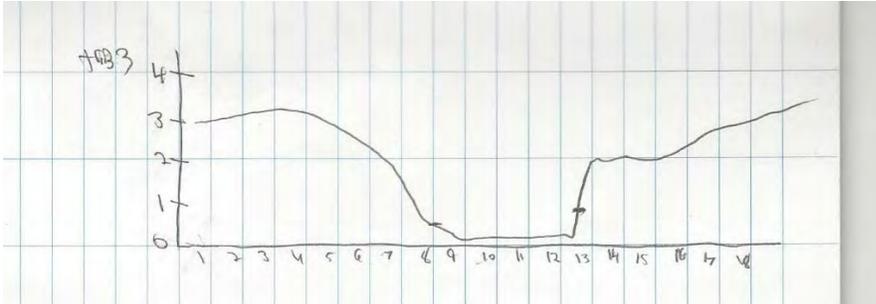
Tributary 3, Datasheet #: 4

Break in Slope at OHWM: Sharp (> 60%) Moderate (30–60%) x_Gentle (< 30%)
None
