STATE OF CALIFORNIA
STATE WATER RESOURCES CONTROL BOARD

In the Matter of Water Quality Certification for the
**PACIFIC GAS AND ELECTRIC COMPANY
RELIEF REACH-KENNEDY MEADOWS RIPARIAN RESTORATION
AND STREAMBANK STABILIZATION PROJECT**

WATER QUALITY CERTIFICATION FOR FEDERAL PERMIT OR LICENSE

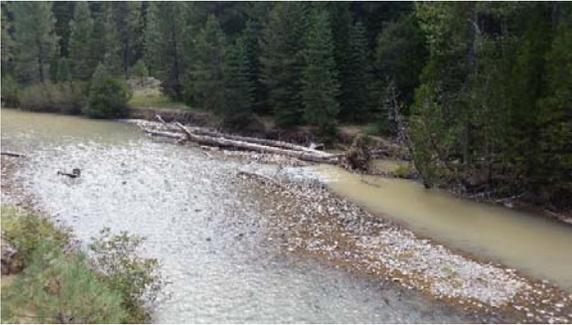
Treatment Area	Issue	Bank Grading	Large Wood Placement	Stakes/ Poles/ Bare Root Planting ^a	Root Wad Series	Rock Toe/ Additional Rock	Site Photograph
		Bank Stabilization Treatment Technique					
1	<ul style="list-style-type: none"> Lack of riparian cover Bank erosion – channel widening (wood present) Bank length: 130 ft. Photograph: facing west bank from east bank, upstream		2 logs	~25 riparian poles/ containers		see Table 2.6-5 ^b

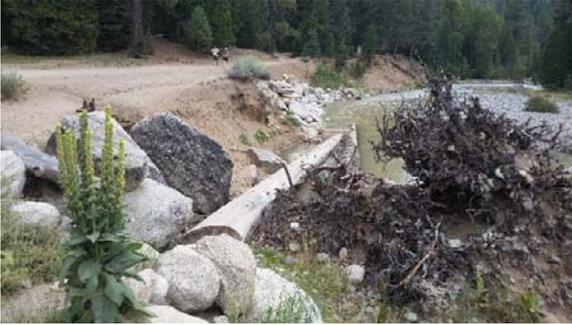
2	<ul style="list-style-type: none"> Lack of riparian cover Bank erosion – channel widening and incision (ongoing) Bank length: 350 ft. Photograph: east bank, facing upstream	●	9 logs	~80 riparian poles/ containers and 38 upland containers		see Table 2.6-5 ^b

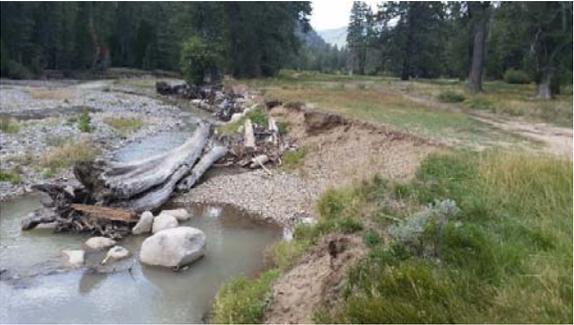
Treatment Area	Issue	Bank Grading	Large Wood Placement	Stakes/ Poles/ Bare Root Planting ^a	Root Wad Series	Rock Toe/ Additional Rock	Site Photograph
		Bank Stabilization Treatment Technique					
3	<ul style="list-style-type: none"> Lack of riparian cover Bank erosion – channel widening and undercut banks Bank length: 500 ft. Photograph: east bank, facing downstream	●	18 logs	~260 riparian poles/containers		see Table 2.6-5 ^b

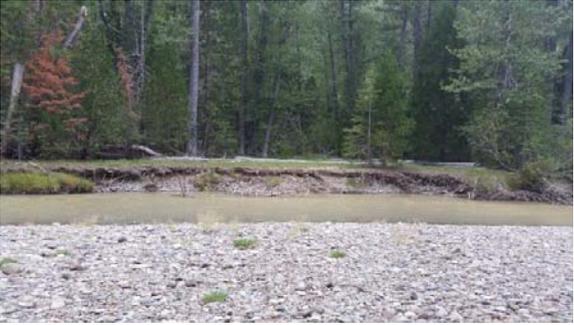
4	<ul style="list-style-type: none"> Lack of riparian cover Bank erosion – channel widening (minimal vegetation present) Bank length: 130 ft. Photograph: facing west bank from east bank			~25 riparian poles/containers

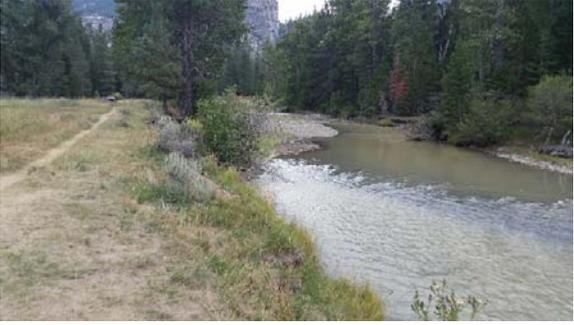
5	<ul style="list-style-type: none"> Lack of riparian cover Bank erosion – channel widening, bank slumping/ block failure Bank length: 200 ft. Photograph: east bank, facing upstream	●	3 logs	~157 riparian poles/containers		see Table 2.6-5 ^b

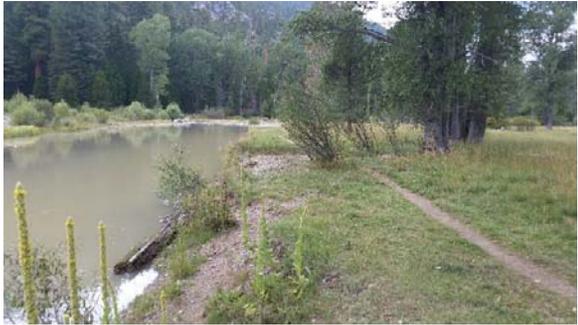
Treatment Area	Issue	Bank Grading	Large Wood Placement	Stakes/ Poles/ Bare Root Planting ^a	Root Wad Series	Rock Toe/ Additional Rock	Site Photograph
		Bank Stabilization Treatment Technique					
6	<ul style="list-style-type: none"> Lack of riparian cover Bank erosion – channel widening, bank slumping/ block failure Bank length: 400 ft. Photograph: east bank, facing downstream			~295 riparian poles/ containers

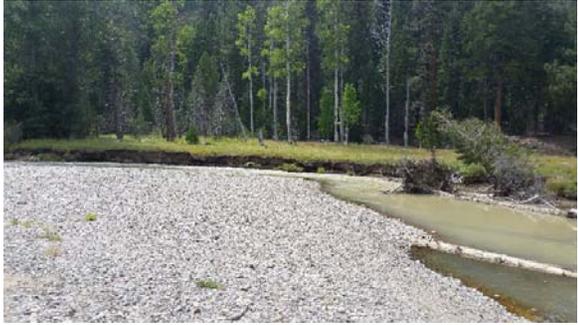
7	<ul style="list-style-type: none"> Lack of riparian cover Bank erosion – channel widening (meander bend) Bank length: 250 ft. Photograph: facing west bank from east bank, upstream	●		~87 riparian poles/ containers	14 logs	see Table 2.6-5 ^b

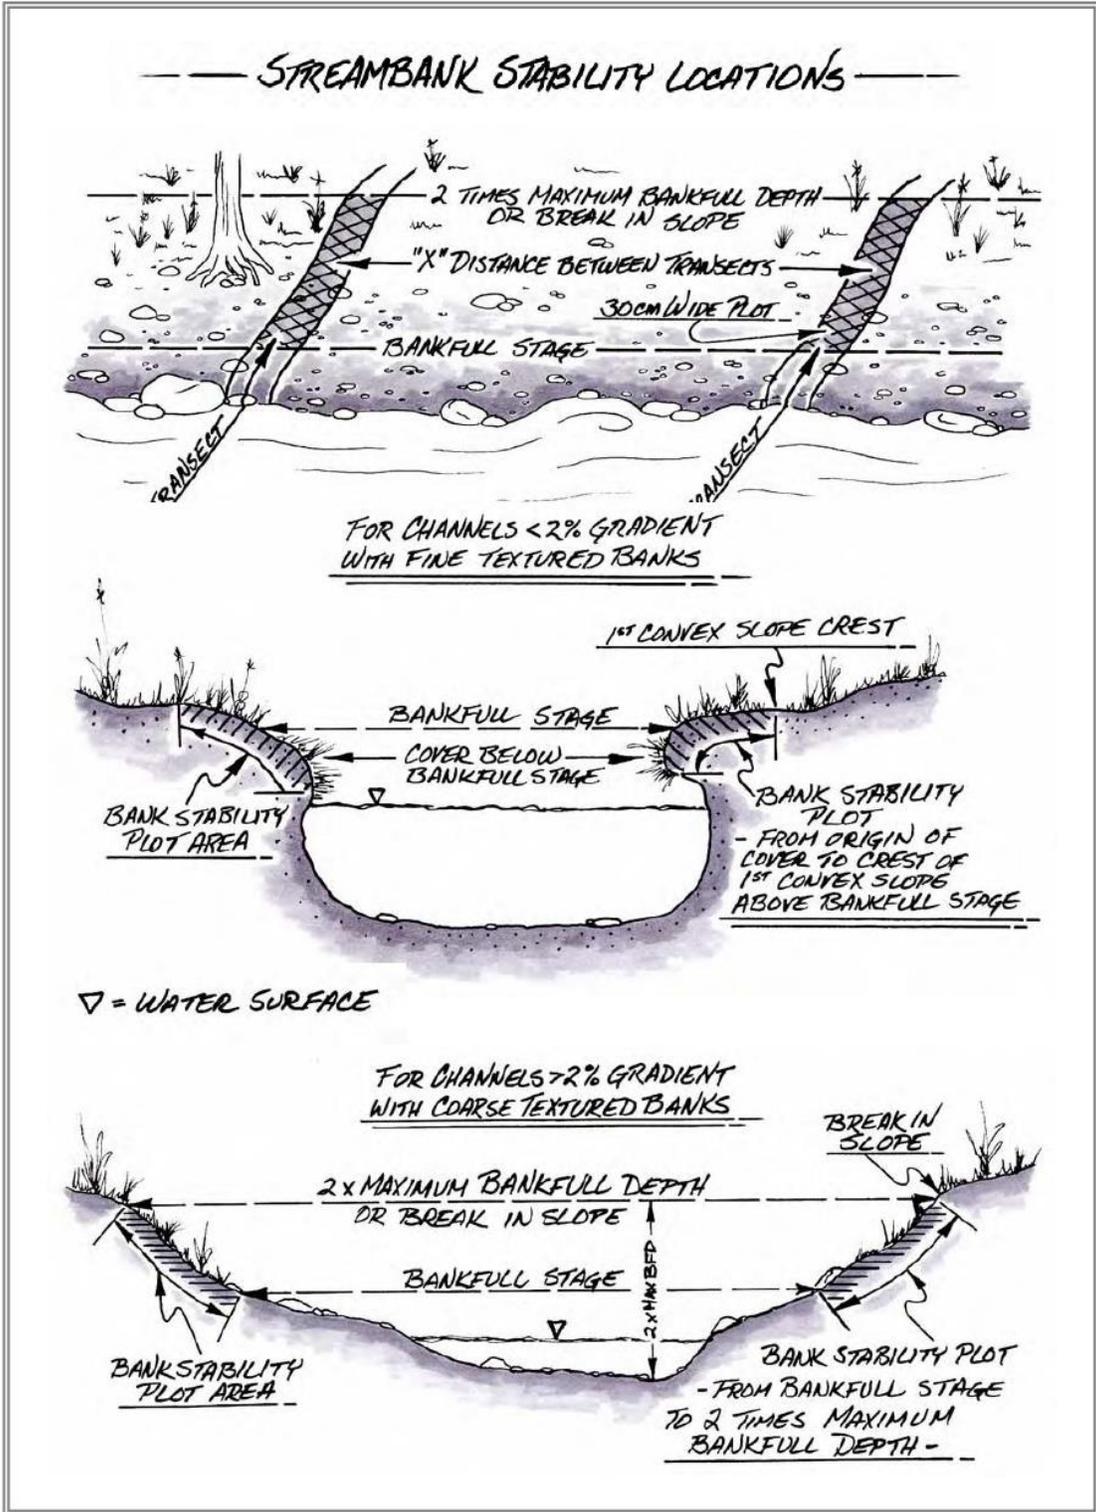
Figure 5 – Streambank Stability

- Stable - Stable streambank plots have 75% or more cover of living plants and/or other stability components that are not easily eroded, and have no indicator of instability.
- Vulnerable - Vulnerable streambank plots have 75% or more cover but have one or more instability indicators.
- Unstable - Unstable streambank plots have less than 75% cover and may have instability indicators. Unstable streambanks are often bare or nearly bare banks composed of particle sizes too small or uncohesive to resist erosion at high flows.

Remember that there are 100 plots that make up the average bank stability for the reach. Do not spend a lot of time determining individual plot condition. Once familiar with this rating system, streambank stability plots can be rated accurately and quickly. Record the numeric value (1 = stable, 2 = vulnerable or 3 = unstable) on Form 9 and move on to the next plot.
