SITE INSPECTION REPORT, RECOLOGY YUBA SUTTER LANDFILL, YUBA COUNTY

Recology Yuba Sutter
Compost Area Site Inspection

4 September 2014

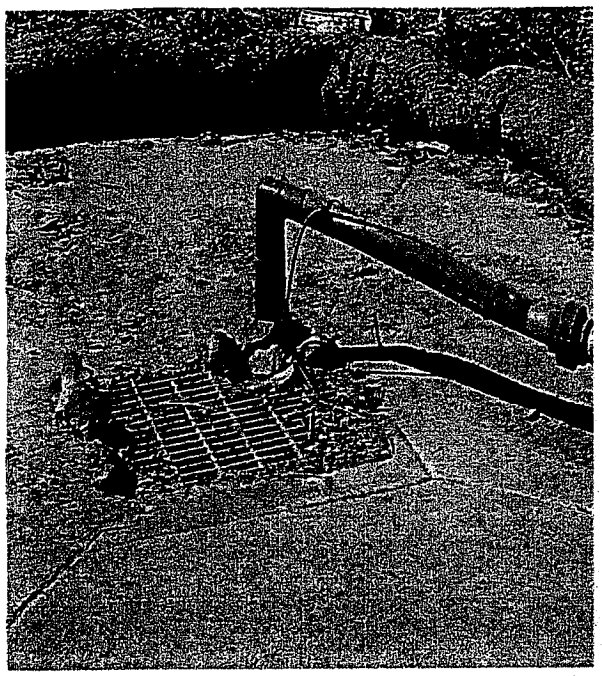
Photo 4: Discharge line from western sump to Baker Tank.

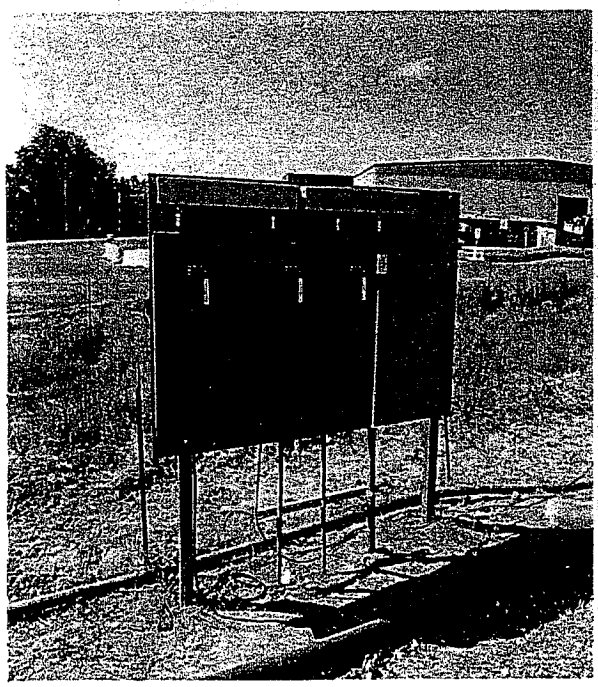
Photo 6: Southern Area Baker Tank with J-STAND. Note discharge line from Eastern Sump. Baker Tank and discharge line are located behind low lying earthen berm. This is an area of concern. Discharger to install tanks inside of berm to contain potential leaks from hoses.

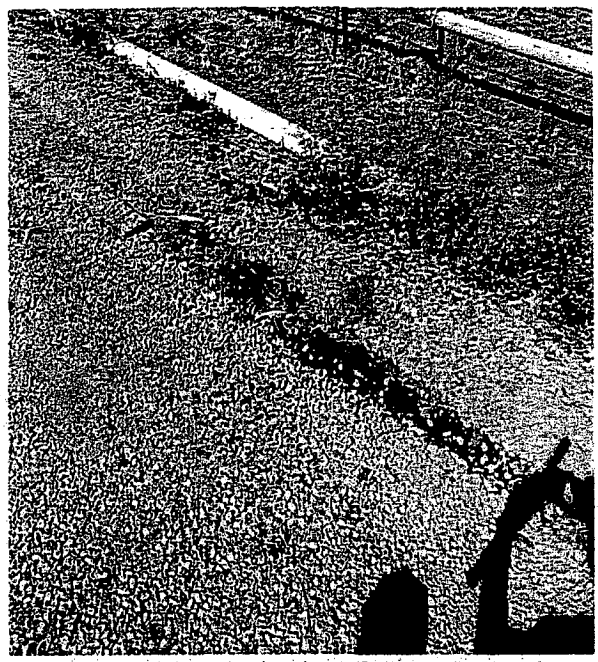
Several areas of concern were noted as shown in the Photo Log. The low permeable berm rimming the compost pad terminated behind the compost piles. The berm must be completed prior to the wet season and includes: approximately 500 feet needs to be constructed along the western boundary of the compost pad and drain pipes installed. The berm also needs to wrap around to the east to help isolate any leachate from other facility operations. The Discharger acknowledged that additional work was needed and that following this site inspection they were better able to order materials and equipment and complete the proposed collection system.

Photo 13: Terminus of earthen berm of compost area low permeable pad. Note leachate that has ponded at base of berm.

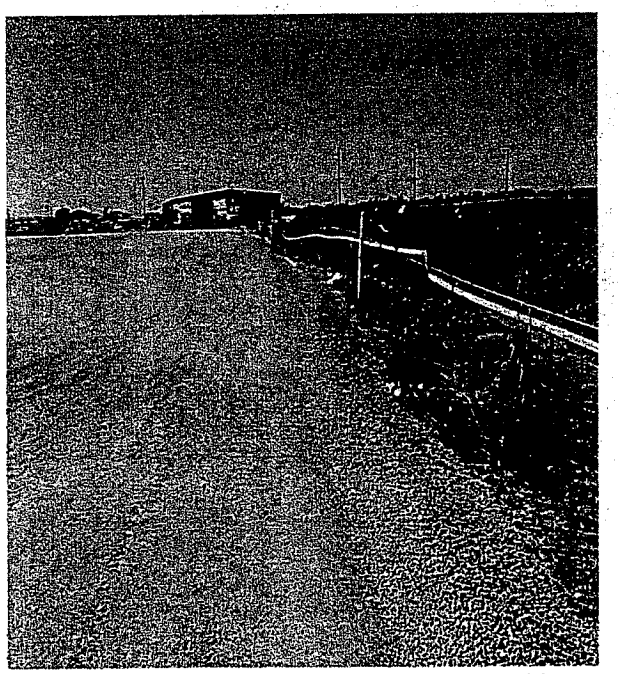
Photo 14: Dark liquid is leachate from compost piles. Note this is a "dry" season inspection. Leachate needs to be contained within compost pad area.

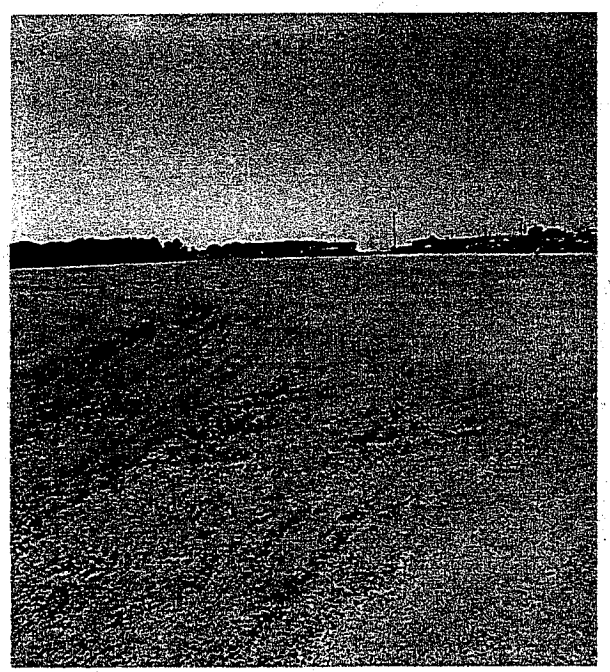
Photo 15: Looking southwest across low permeable pad recently constructed. Additional work required to build berm and install drain pipe.

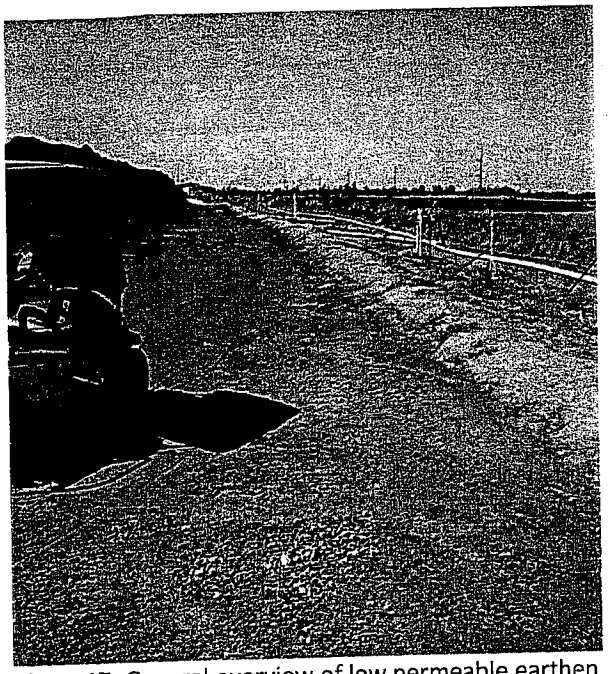
Photo 16: Looking southeast across newly constructed, compost area low permeable pad.

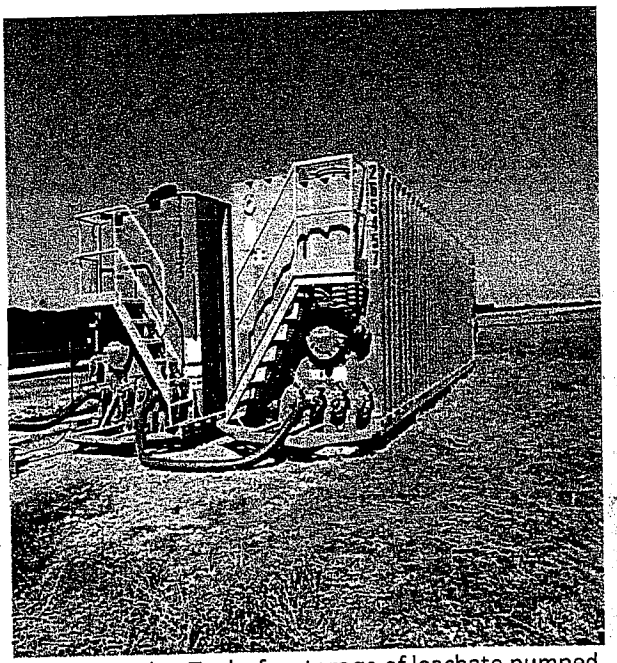
Photo 19: Sump that collects leachate discharged from the compost area. Leachate is pumped to Baker Tank shown in Photo 20.

Photo 20: Baker Tanks for storage of leachate pumped from sump shown in Photo 19. Additional capacity will be placed by Discharger.
