FIRST QUARTER 2011
QUARTERLY MONITORING REPORT

Berry Street Mall Landfill
901 Galleria Boulevard
Roseville, California

WDR No. 89-115

April 15, 2011

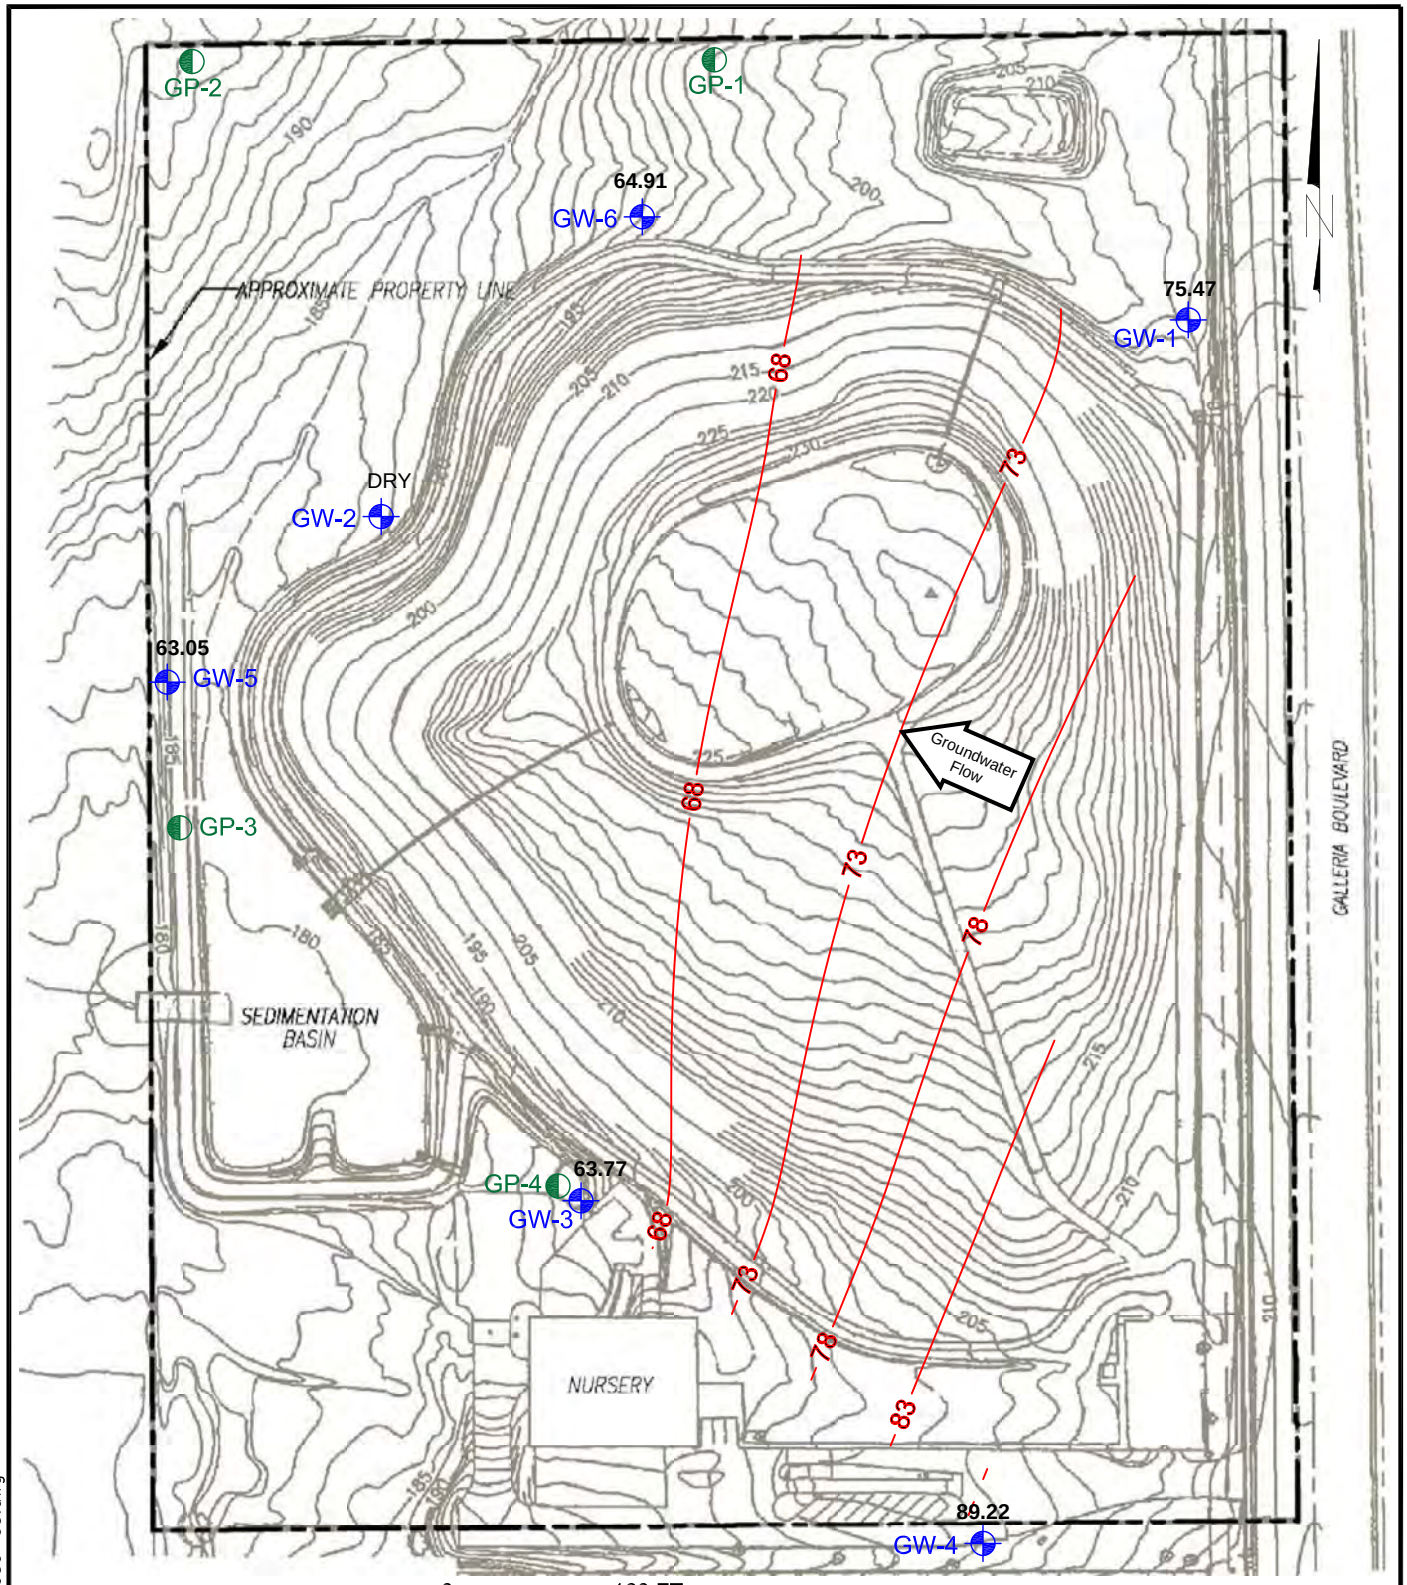
FIGURE 3

The results of groundwater potentiometric surface measurements conducted at the site on March 8, 2011 are summarized in Table 1. A potentiometric surface map illustrating the corresponding groundwater flow conditions is presented as Figure 3, “Groundwater Contour Map”. As shown in Figure 3, the southeast portion of the site is characterized by a northwesterly groundwater flow component, whereas a westerly groundwater flow component predominates beneath the central and western portions of the Landfill. These flows conditions generally mimic the original site topography and orientation of a

former ephemeral drainage that was present prior to landfill development.

The aforementioned variable groundwater flow component is also accompanied by variable hydraulic gradient conditions, with a fairly significant decrease in hydraulic gradient occurring from east to west across the site. As shown in Figure 3, the site exhibits a hydraulic gradient of approximately 0.023 foot per foot (ft/ft). Similar to the comparison noted above, the changes in hydraulic gradient generally mimic the former topographic features that characterized the site prior to landfill development.
