FIRST QUARTER 2012
QUARTERLY MONITORING REPORT

Berry Street Mall Landfill
901 Galleria Boulevard
Roseville, California

WDR No. 89-115

April 16, 2012

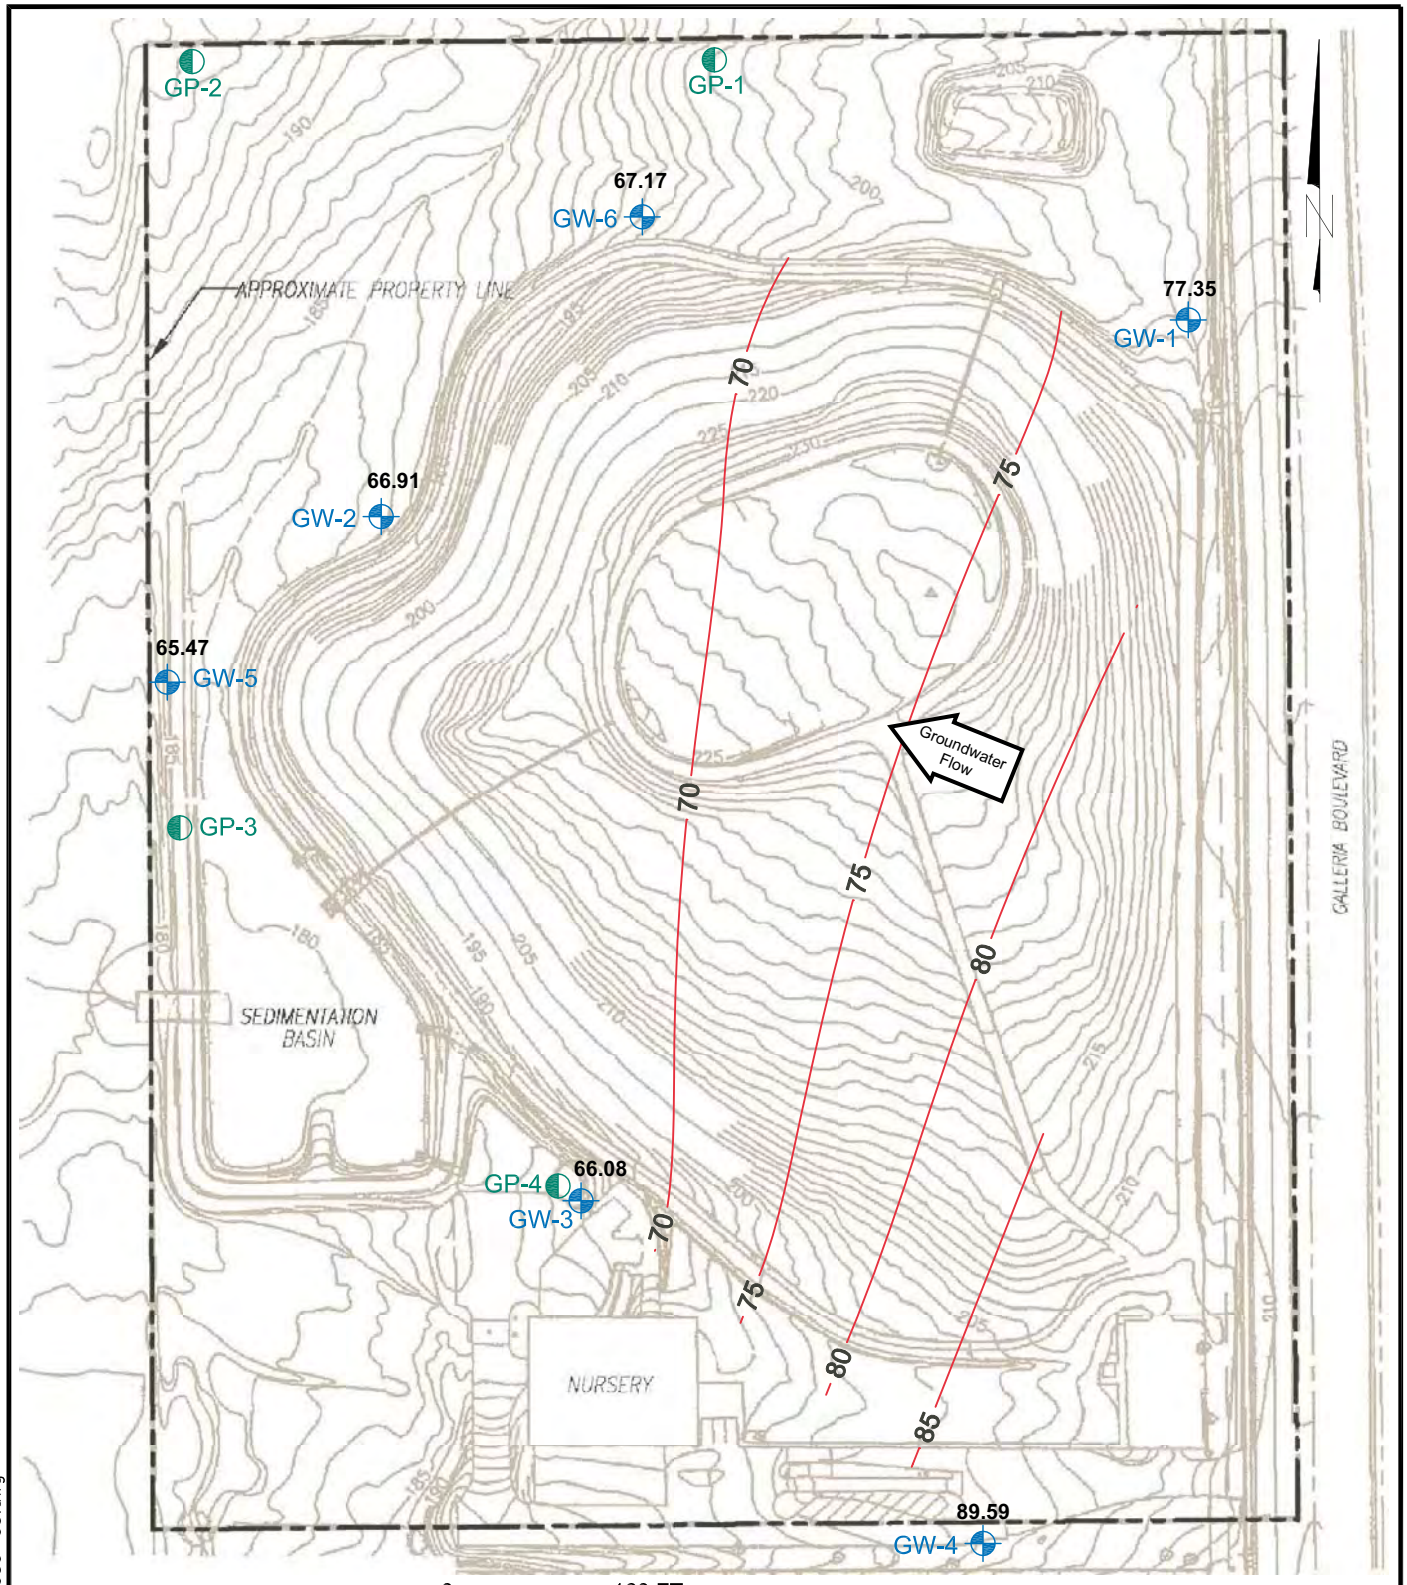
FIGURE 3

The results of groundwater potentiometric surface measurements conducted at the site on March 22, 2012 are summarized in Table 1. A potentiometric surface map illustrating the corresponding groundwater flow conditions is presented as Figure 3, “Groundwater Contour Map”. As shown in Figure 3, the southeast portion of the site is characterized by a northwesterly groundwater flow component, whereas a westerly groundwater flow component predominates beneath the central and western portions of the Landfill.
These flows conditions generally mimic the original site topography and orientation of a former ephemeral drainage that was present prior to landfill development.

The aforementioned variable groundwater flow component is also accompanied by variable hydraulic gradient conditions, with a fairly significant decrease in hydraulic gradient occurring from east to west across the site. As shown in Figure 3, the site exhibits a hydraulic gradient of approximately 0.034 foot per foot (ft/ft). Similar to the comparison noted above, the changes in hydraulic gradient generally mimic the former topographic features that characterized the site prior to landfill development.
