THIRD QUARTER 2013
QUARTERLY MONITORING REPORT

Berry Street Mall Landfill
901 Galleria Boulevard
Roseville, California

WDR No. 89-115

February 28, 2014

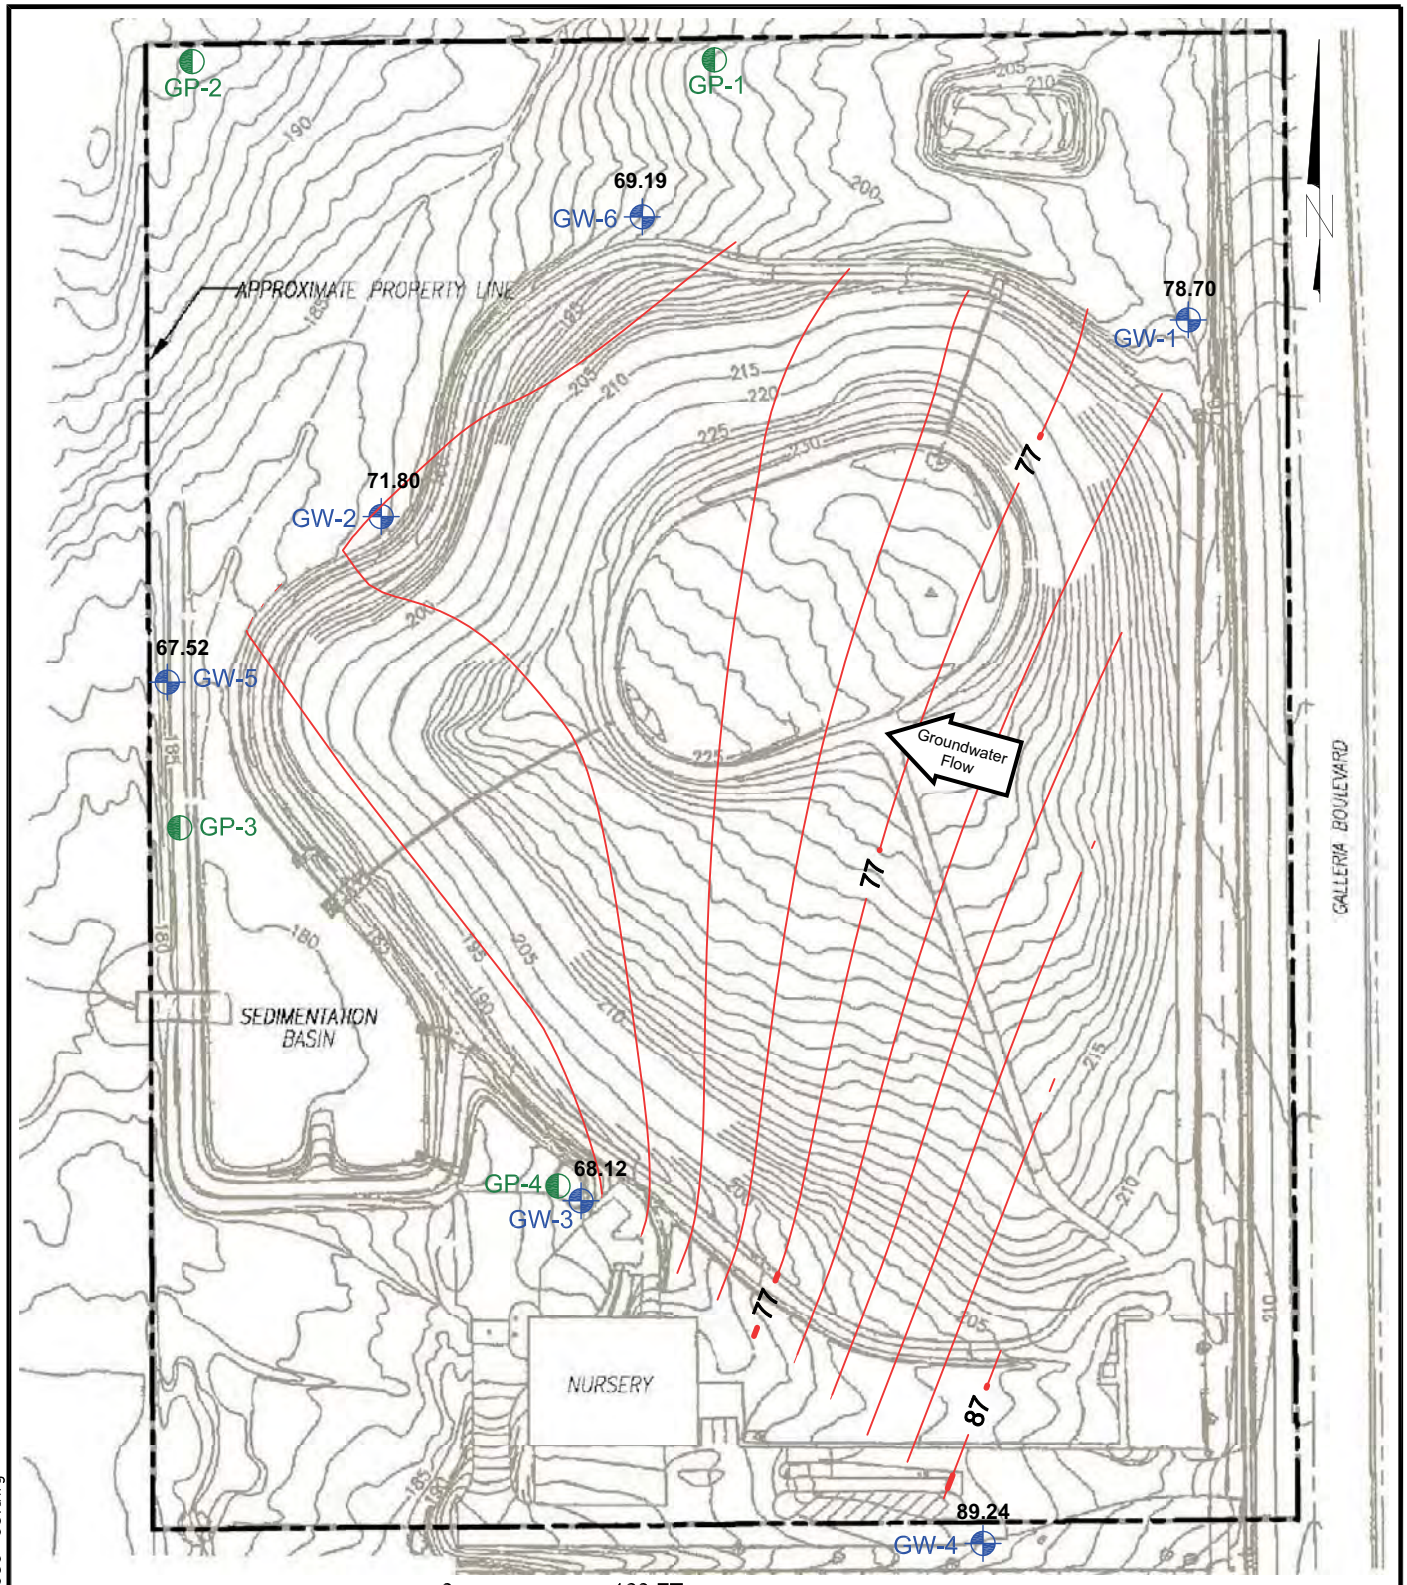
FIGURE 3

The results of groundwater potentiometric surface measurements conducted at the site on September 18, 2013 are summarized in Table 1. A potentiometric surface map illustrating the corresponding groundwater flow conditions is presented as Figure 3, “Groundwater Contour Map”. As shown in Figure 3, the southeast portion of the site is characterized by a northwesterly groundwater flow component, whereas a westerly groundwater flow component predominates beneath the central and western portions of the Landfill.

The aforementioned variable groundwater flow component is also accompanied by variable hydraulic gradient conditions, with a fairly significant decrease in hydraulic gradient occurring from east to west across the site. As shown in Figure 3, the site exhibits a hydraulic gradient of approximately 0.033 foot per foot (ft/ft). Similar to the comparison noted above, the changes in hydraulic gradient generally mimic the former topographic features that characterized the site prior to landfill development.
