SECOND QUARTER 2014
QUARTERLY MONITORING REPORT

Berry Street Mall Landfill
901 Galleria Boulevard
Roseville, California

WDR No. 89-115

August 28, 2014

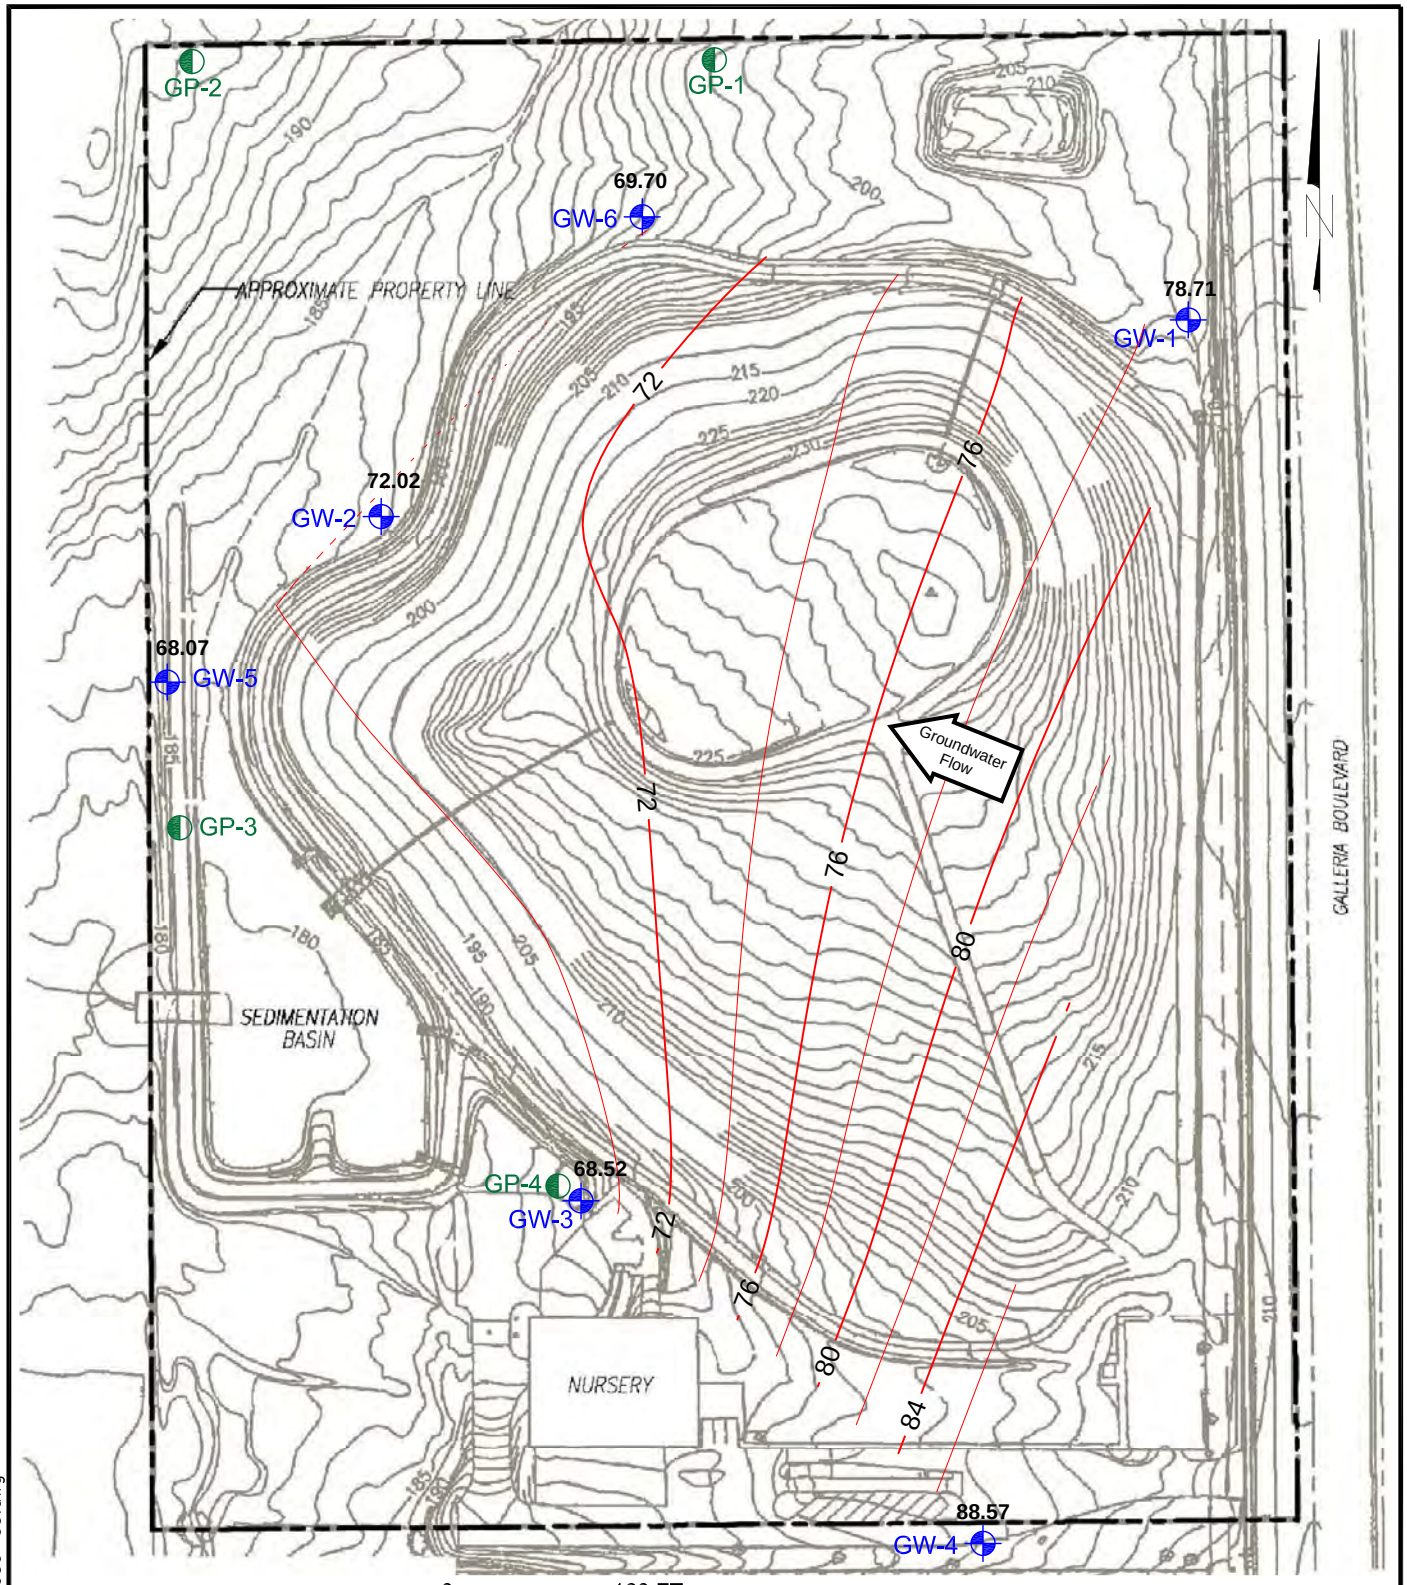
FIGURE 3

The results of groundwater potentiometric surface measurements conducted at the site on June 19, 2014 are summarized in Table 1. A potentiometric surface map illustrating the corresponding groundwater flow conditions is presented as Figure 3, “Groundwater Contour Map”. As shown in Figure 3, the southeast portion of the site is characterized by a northwesterly groundwater flow component, whereas a westerly groundwater flow component predominates beneath the central and western portions of the Landfill.

The aforementioned variable groundwater flow component is also accompanied by variable hydraulic gradient conditions, with a fairly significant decrease in hydraulic gradient occurring from east to west across the site. As shown in Figure 3, the site exhibits a hydraulic gradient of approximately 0.03 foot per foot (ft/ft). Similar to the comparison noted above, the changes in hydraulic gradient generally mimic the former topographic features that characterized the site prior to landfill development.
