Appendix C

Description of Flow and Water Quality Monitoring Upgrades and Photo Documentation

Up-Stream DO TMDL Project

February 2008

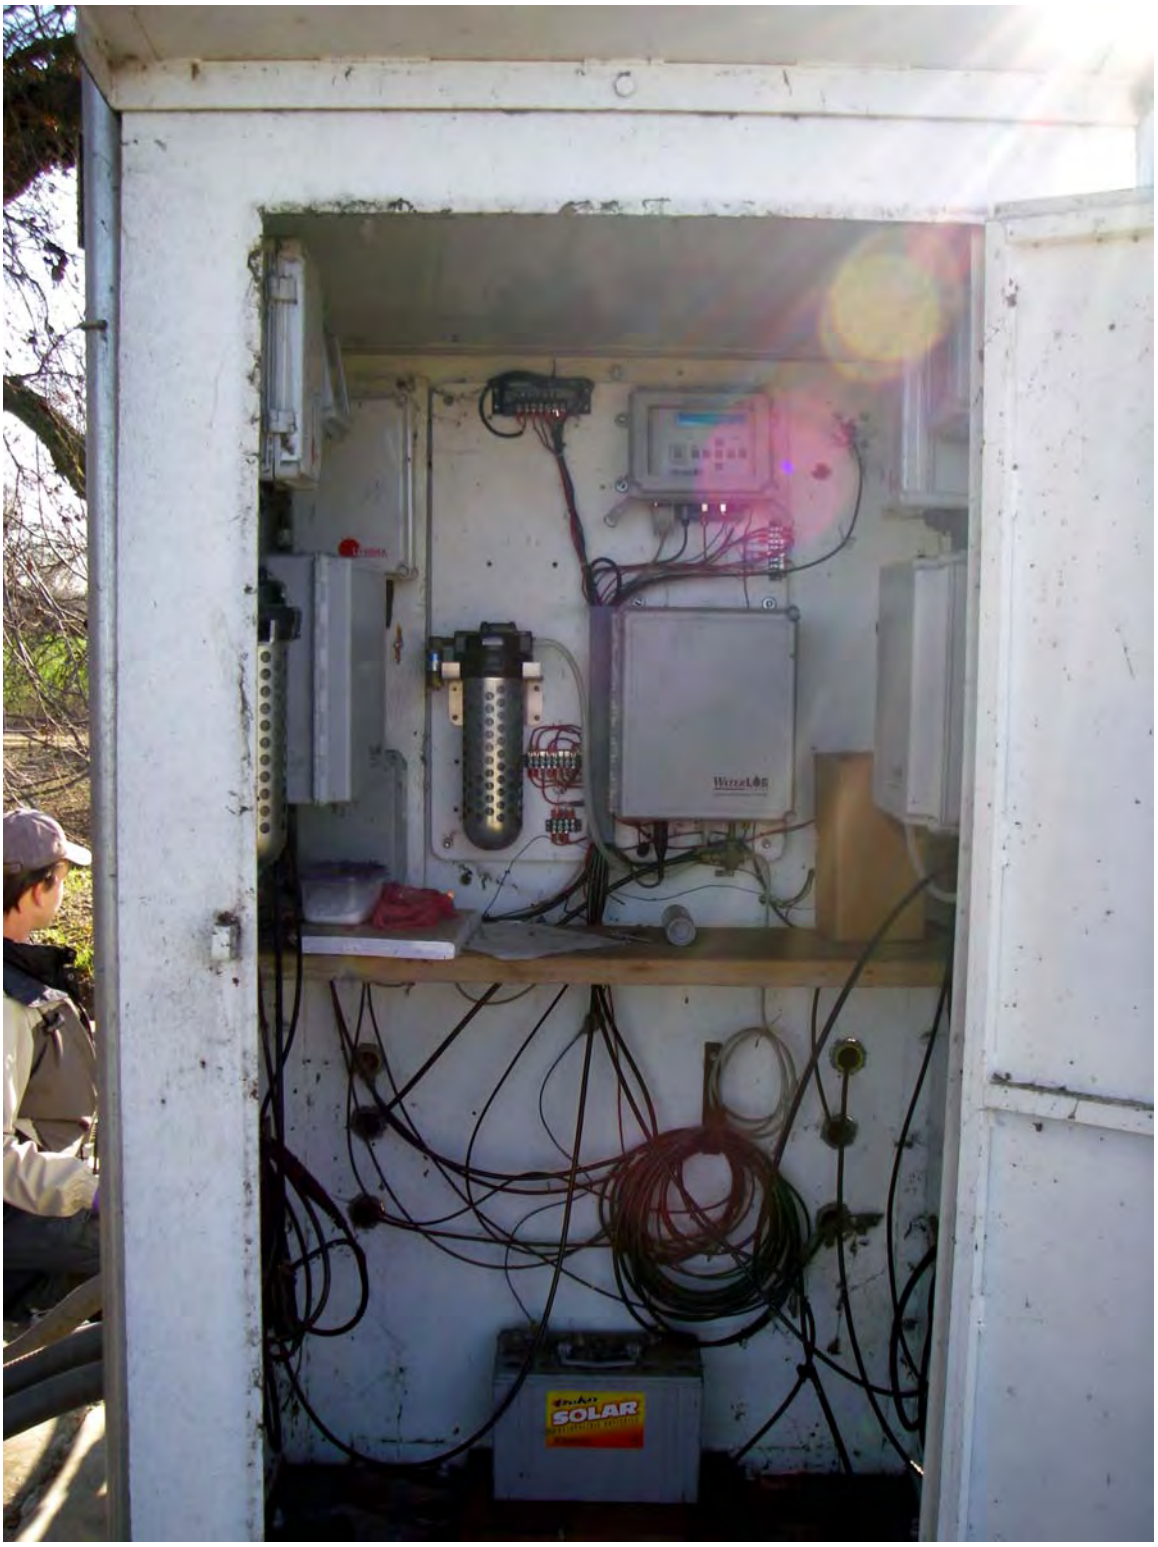
Figure 5: Flow station shed for Marshall Road, Spanish Land Grant, and Moran Drains.

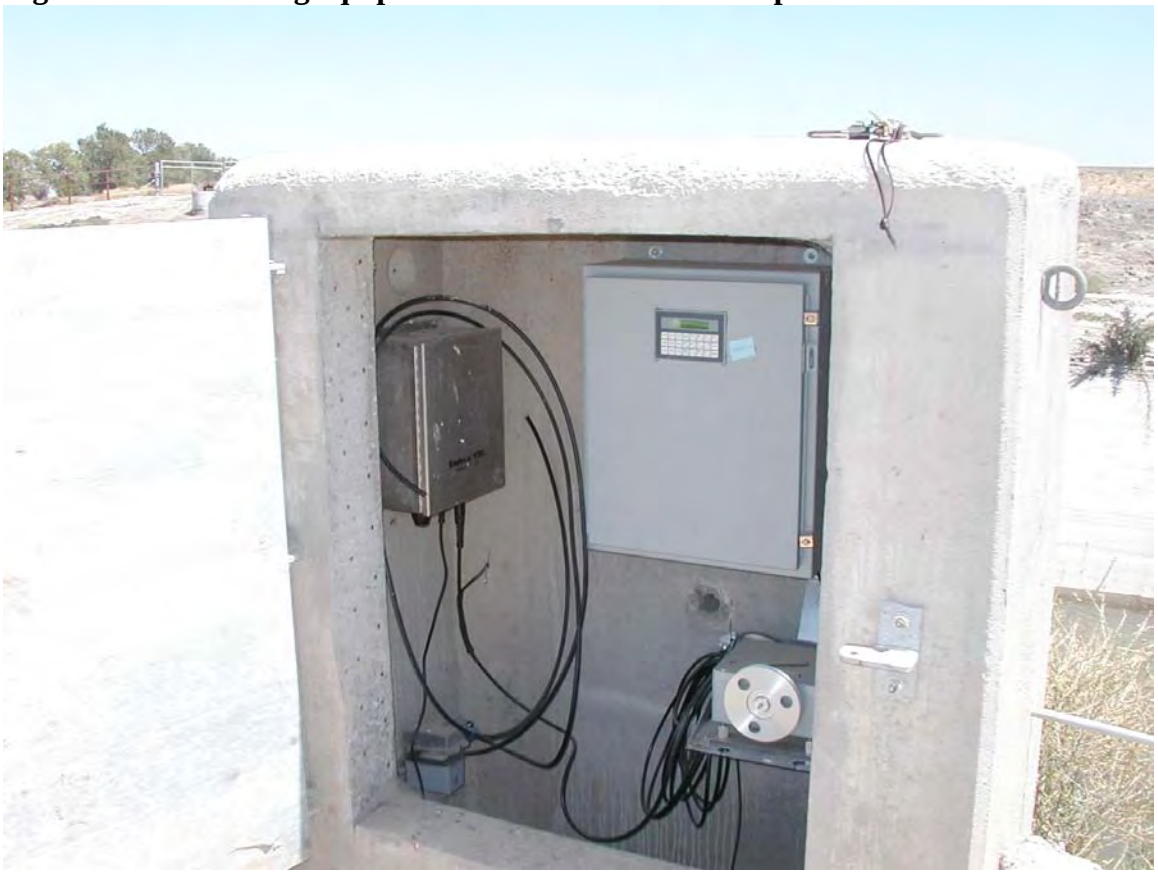
Figure 25: Monitoring equipment at TID Lateral 3 Westport Drain.
